## Estimating the Inner Ring Defect Size and Residual Service Life of Freight Railcar Bearings Using Vibration Signatures

Lima, J, Tarawneh, C, Aguilera, J, & Cuanang, J. "Estimating the Inner Ring Defect Size and Residual Service Life of Freight Railcar Bearings Using Vibration Signatures." Proceedings of the 2020 Joint Rail Conference. 2020 Joint Rail Conference. St. Louis, Missouri, USA. April 20–22, 2020. V001T09A003. ASME. <https://doi.org/10.1115/JRC2020-8059>

**ESTIMATING THE INNER RING DEFECT SIZE AND RESIDUAL SERVICE LIFE OF  
 FREIGHT RAILCAR BEARINGS USING VIBRATION SIGNATURES**

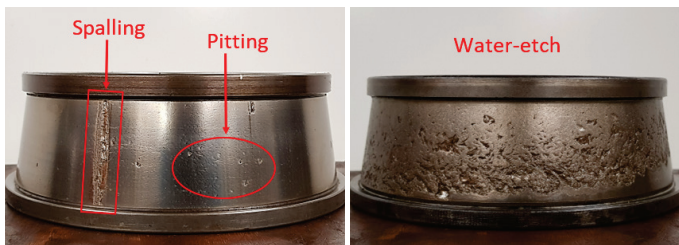
Figure 2. Examples of localized defects (left) and distributed defect (right).

Defects in bearings are generally classified under three categories; i.e., local, distributed, and geometric. Localized defects are small pits, cracks, or spalls that develop on one rolling surface, as pictured in Figure 2 (left). A distributed defect is one that spans major portions of one or more rolling surfaces. Localized defects present on multiple rolling surfaces of one bearing are considered to be a distributed defect. The water-etch cone (inner ring) shown in Figure 2 (right) is a prime example of a distributed defect. Out of tolerance bearing components and other geometric and manufacturing irregularities present on the rolling surfaces of the bearing are examples of geometric defects.

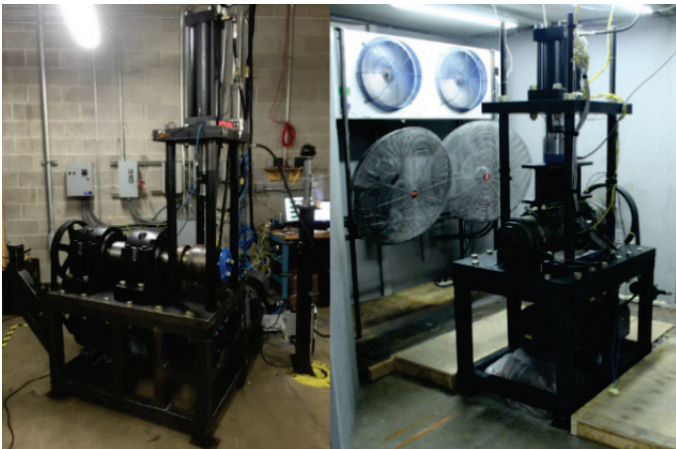
Figure 3. Single bearing test rig (left) and four-bearing test rig (right).

Two different bearing dynamic test rigs were used to perform the experiments for this study; namely, the four-bearing tester (4BT) pictured in Figure 3 (right), and the single bearing tester (SBT) pictured in Figure 3 (left). The four-bearing tester is housed in an environmental chamber that can mimic ambient conditions as low as  $-40^{\circ}\text{C}$  ( $-40^{\circ}\text{F}$ ) and as high as  $65.6^{\circ}\text{C}$  ( $150^{\circ}\text{F}$ ). Both testers are powered by a 22 kW (30 hp) variable speed motor that is controlled via a variable frequency drive (VFD) that can simulate train traveling speeds in the range of 8 to 137 km/h (5 to 85 mph). The vertical load, in both testers, is applied by a 18 cm (7 in) diameter hydraulic cylinder that is capable of applying loads of up to 150% of the full load (full load being 153 kN or 34.4 kips per bearing for a class F or K bearing). As the name implies, the four bearing tester can accommodate four class K ( $6\frac{1}{2}''\times 9''$ ) or class F ( $6\frac{1}{2}''\times 12''$ ) tapered roller bearings pressed onto a 4140 steel axle, whereas, the single bearing tester can only accommodate one class F or K bearing that is cantilevered at the end of a specially fabricated 4140 steel axle. However, unlike the four-bearing tester, the single bearing tester can also apply lateral and impact loads to mimic forces acting on the bearing as a result of the railcar negotiating curves on the track and forces resulting from wheel impacts or bad track segments. Finally, both testers employ two large industrial size fans to provide convective cooling over the test bearings simulating the air cooling that takes place when a train is in motion. The fans generate an average airflow of about 6 m/s (13.4 mph). A schematic of the top view of the four-bearing tester is presented in Figure 4.

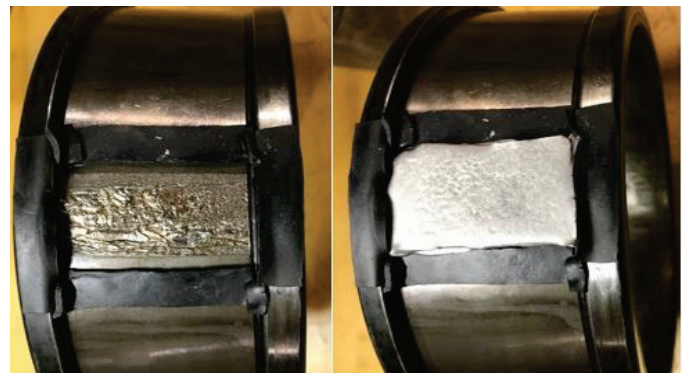
Figure 8. Casting procedure using bismuth and sealant tape

Once the detected vibration levels within a test bearing are above the typical threshold value for healthy bearings, the experiment is stopped, the bearings are then pressed off the axle, disassembled, and cleaned for a thorough visual inspection of the components. If a new spall has formed on any of the raceways or a previous spall has propagated, a casting is created by first surrounding the defective area with sealant tape capable of withstanding temperatures of up to 204°C (400°F). A molten bismuth alloy, with a melting temperature of 80°C (176°F), is then poured into the mold created by the sealant tape, as pictured in Figure 8. After the bismuth hardens, the casting is removed from the mold and the spalled region reflected on the casting is painted to highlight the defect. Creating a casting of the defect helps track spall propagation once the bearing is reassembled and pressed onto the axle to resume testing. The casting also aids in obtaining a precise measurement of the defect area. This is accomplished by taking an image of the casting with the painted spall which is then post-processed utilizing codes created in MATLAB™ that enhance the contrast of the darkened spall region. The image is then imported to Image Pro-Plus® where a digital analysis of the defect region is performed through optical techniques to acquire accurate defect area parameters.

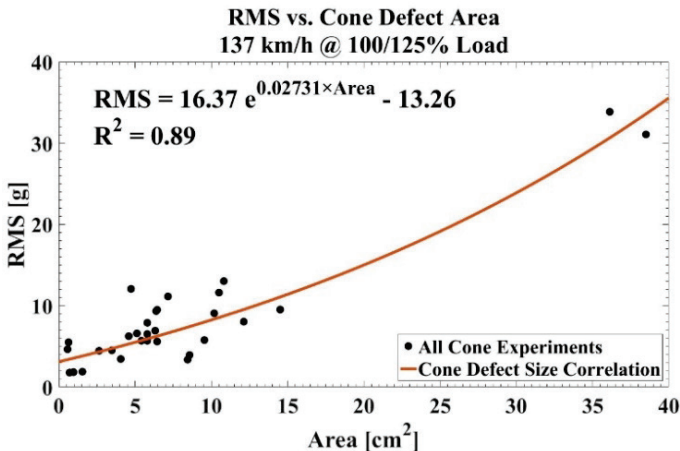
Figure 9. RMS versus cone spall area correlation.

defect area versus mileage correlation [9]. Table 1 provides the minimum, maximum, and average cone spall growth rates for spall sizes below and above 6.45 cm<sup>2</sup> (1 in<sup>2</sup>). The bearing vibration level data (i.e., RMS values) along with the defect area growth rates were used to estimate the defect size and the residual service life of the bearing. Figure 9 provides an experimentally acquired correlation that relates the RMS values of vibration in [g] to the cone spall area in [cm<sup>2</sup>] at operating conditions of 137 km/h (85 mph) and loads of 100% and 125% of full load. The data summarized in Table 1 and Figure 9 has been collected from numerous experiments performed over the span of a decade.

The correlation given in Figure 9 was used to estimate the defect size (spall area) based on the average RMS value over the last two hours of testing in Experiment 209. For convenience, the average RMS and bearing operating temperature above ambient values are provided in Table 2. Note that the average RMS value listed in Table 2 was calculated for the Smart Adapter (SA) location accelerometer (B2-SA) since the correlation of Figure 9 was obtained using accelerometers placed in the SA location. The estimated defect size along with the estimation percent error and the calculated growth rate in  $[\text{cm}^2/\text{km}]$  for this experiment are presented in Table 3. The estimated spall area of  $5 \text{ cm}^2$  ( $0.78 \text{ in}^2$ ) is only 3.1% off from the actual spall area measured during the visual inspection of the spall following Experiment 209. This accuracy is remarkable given that the spall area occupies only 1.85% of the total cone raceway surface area. Moreover, the calculated spall area growth rate seems to be in line with the values provided in Table 1.

The RMS value of Table 4 along with the correlation of Figure 9 were used to estimate the defect size of the test bearing. The results are presented in Table 5 along with the estimation percent error and the calculated spall growth rate. Again, the

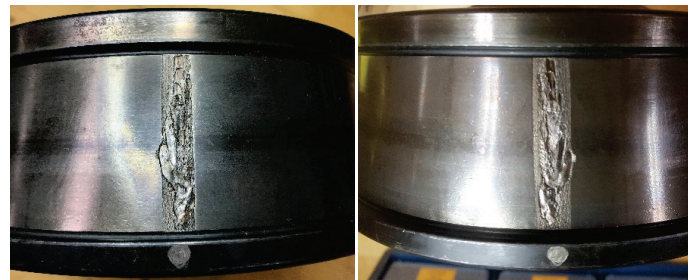
Figure 10. Initial cone raceway spall (left) and final cone spall (right) for bearing B2 in Experiment 209.

In Experiment 209, a bearing having a spall on its inboard cone (inner ring) raceway was placed in the B2 location (refer to Figure 4) of the four bearing tester. The cone raceway spall, pictured in Figure 10 (left), had an initial area of 4.58 cm<sup>2</sup> (0.71 in<sup>2</sup>). During the experiment, the test bearings ran a total distance of 122,006 km (75,811 mi), in which the defect area propagated to 5.16 cm<sup>2</sup> (0.80 in<sup>2</sup>), as depicted in Figure 10 (right). This new spall area constitutes only 1.85% of the total cone raceway surface area of 279.10 cm<sup>2</sup> (43.26 in<sup>2</sup>).

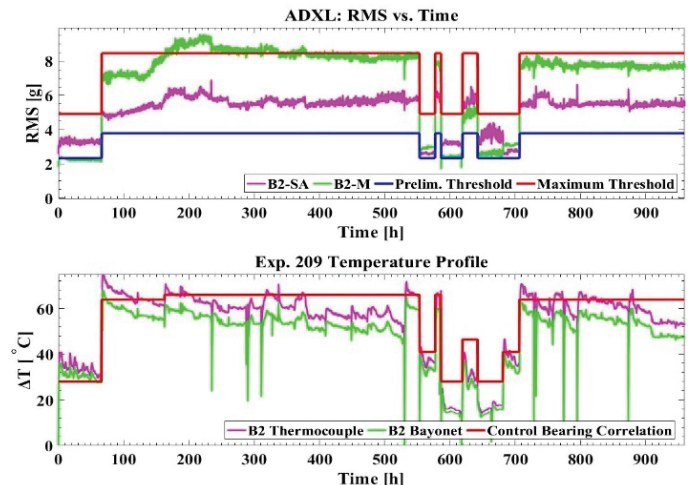
Figure 11. Vibration and temperature profiles for Experiment 209. The bearing operating temperature above ambient is plotted where the ambient temperature is 20°C (68°F).

The vibration and temperature profiles of bearing B2 for Experiment 209 are presented in Figure 11. The vibration level data as measured by the RMS values in [g] acquired from the Smart Adapter (SA) and Mote (M) location accelerometers (refer to Figure 6) are plotted. The bearing operating temperatures above ambient conditions are also provided, where the ambient temperature in the laboratory was maintained at 20°C (68°F). Examining the vibration signatures of B2, one can notice that the

RMS value started to increase at around 150 hours into the experiment as exhibited by both accelerometers. This increase continued until the RMS value read by the B2-M accelerometer exceeded the maximum threshold value indicated by the solid red line in Figure 11. The increase in the RMS value is a direct result of the defect propagating and introducing metal debris into the bearing, which disrupts the normal operation of the rolling surfaces. With continued operation, the metal debris gets grinded into much smaller pieces due to the forces exerted by the rolling elements and, thus, the RMS values tend to settle or slightly decrease once all debris is crushed, as exhibited by the RMS values after 350 hours into the test. In general, this cycle continues as the defect propagates.

Interestingly, while the vibration levels within the bearing undoubtedly indicate that the defect has propagated, the temperature profile does not show any signs of abnormal behavior. Except for the initial grease break in period and instances immediately following a sudden change in operating conditions, the operating temperature of the bearing is well within the control (healthy) bearing threshold indicated by the solid red line. One can argue that the bearing operating temperature decreases slightly throughout the duration of the experiment. These results agree with previous observations from

earlier studies [7]. The decrease in bearing operating temperature is believed to be the result of the spall region acting as a cavity in which grease accumulates and provides additional convective cooling to the rolling elements.

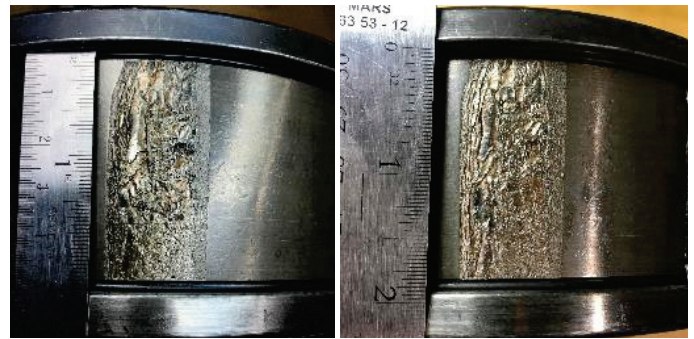
Figure 12. Initial cup spall (left) and final cup spall (right) for Experiment 202. [ruler in inches]

Experiment 202 was carried out on the single bearing test rig (SBT) using a class K bearing with a defective inner ring (cone) placed in the inboard location of the test bearing. The test bearing ran a total distance of 40,050 km (24,886 mi) during which the spall area propagated from an initial size of  $10.51 \text{ cm}^2$  ( $1.63 \text{ in}^2$ ), as pictured in Figure 12 (left), to an area of  $10.82 \text{ cm}^2$

( $1.68 \text{ in}^2$ ), as depicted in Figure 12 (right). This represents a calculated spall growth rate of about  $0.08 \times 10^{-4} \text{ cm}^2/\text{km}$ , which is lower than the values listed in Table 1.

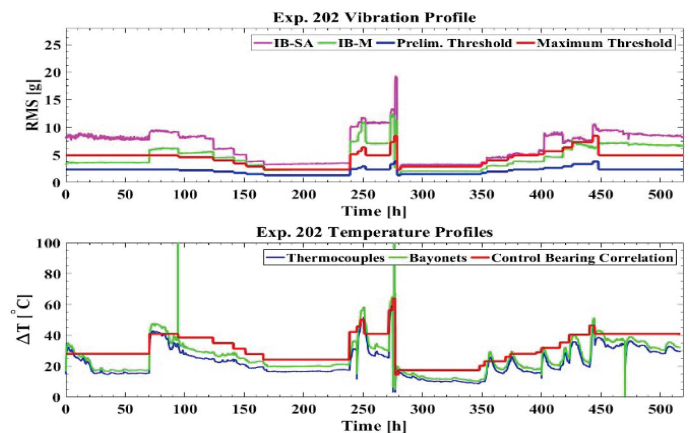
Figure 13. Vibration and temperature profiles for Experiment 202. The bearing operating temperature above ambient is plotted where the ambient temperature is  $20^\circ\text{C}$  ( $68^\circ\text{F}$ ).

The vibration and temperature profiles for Experiment 202 are plotted in Figure 13. As was the case in Experiment 209, the bearing operating temperature remained well below the threshold for control bearings indicated by the solid red line. The latter confirms that the operating temperature is not a good indicator of bearing health. In contrast, the vibration signature of the test bearing of Experiment 202 clearly indicates that the bearing is defective since the RMS values of both accelerometers (IB-SA and IB-M) are mostly above the maximum threshold value for healthy bearings specified by the solid red line in Figure 13. This becomes apparent in the periods between 240 and 280 hours and after 450 hours into Experiment 202. Table 4 summarizes the average bearing operating temperature and IB-SA accelerometer RMS value over the last two hours of Experiment 202.
