Construction Materials and Dam Foundation While Memve'ele Dam Building in the Craton's Region of South Cameroon

Sylvestre M. Ntomba, Christelle R. Magnekou Takamte, Dieudonné Bisso and Joseph Mvondo Ondo

Abstract

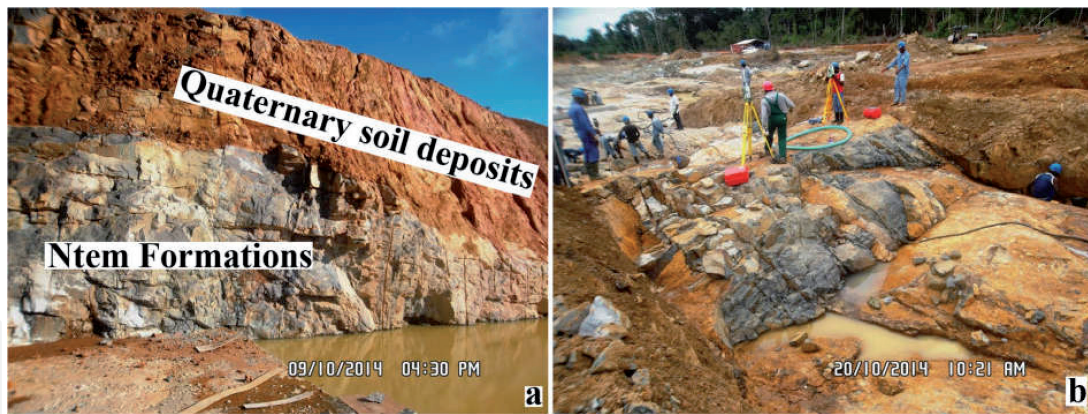
Figure 2.
 (a) Quaternary soil deposits underlain by Ntem formations that represent two geological units found in the whole dam site and (b) fractured and slightly weathered rock mass.

(Figure 2b) and densely jointed zones are found at rocky outcrops, dominantly striking NE30° ~ 40° and E-W with moderate to steep dipping angles (Figure 4a and b), indicating an outline sub-parallel for all tectonic features (gneissosity, shear zone, fault and jointed rocks). The quantitative description and statistical distributions of discontinuities of Ntem Formations derived from boreholes and those obtained from the geomechanical mapping through scan line at the dam site [5]. The stereographic projection can give an overall view of the number of dominant discontinuity sets of joint and bedding directions within the rock mass. A plot of contoured pole concentration is dominant along the mean direction of N034.44 SE (Figure 4c). Quantitative description of discontinuities shows that spacing is extremely close to moderate (0–0.1 m and 30–40 m), their length vary from 1 to 50 m with small

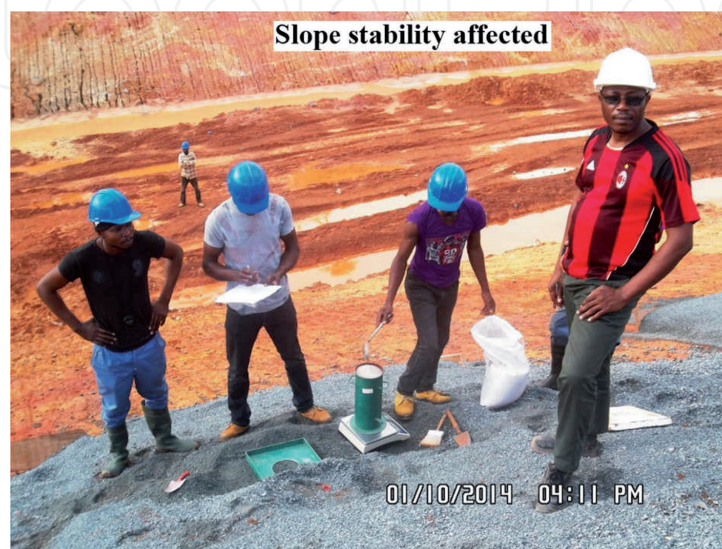
Figure 5.
Slope stability affected by raining water.

A geotechnical investigation into quaternary deposits that have represented construction materials and dam foundation of Memve'ele dam is described in this topic. Many boreholes were drilled by drilling rig to assess the geotechnical of the quaternary deposits from borrow areas and in the dam foundation site. The investigation of three borrows areas and dam sites comprised mainly laboratory tests of soil deposits. The results of mechanical tests are presented in **Table 1**. The specific gravity values vary from 2.60 to 2.76; wet and dry densities are ranged from 1.51 to 1.61 g/cm³ and 1.23 to 1.55 g/cm³ respectively; porosity values vary between 0.700 and 1.190%; liquid limit values vary between 58.4 and 76.2 wt. %; plasticity limit values are ranged between 28.3 and 40.1 wt. %. The deformation modulus values vary between 1.9 and 9.9 MPa; the coefficient of permeability varies between 8.62E-04 and 3.35E-05 cm/s. As per the exploration well, the reserve estimations is 182.39 × 10⁴ m³. However, slope occurs with erosion marks (**Figure 5**) after raining seasons.

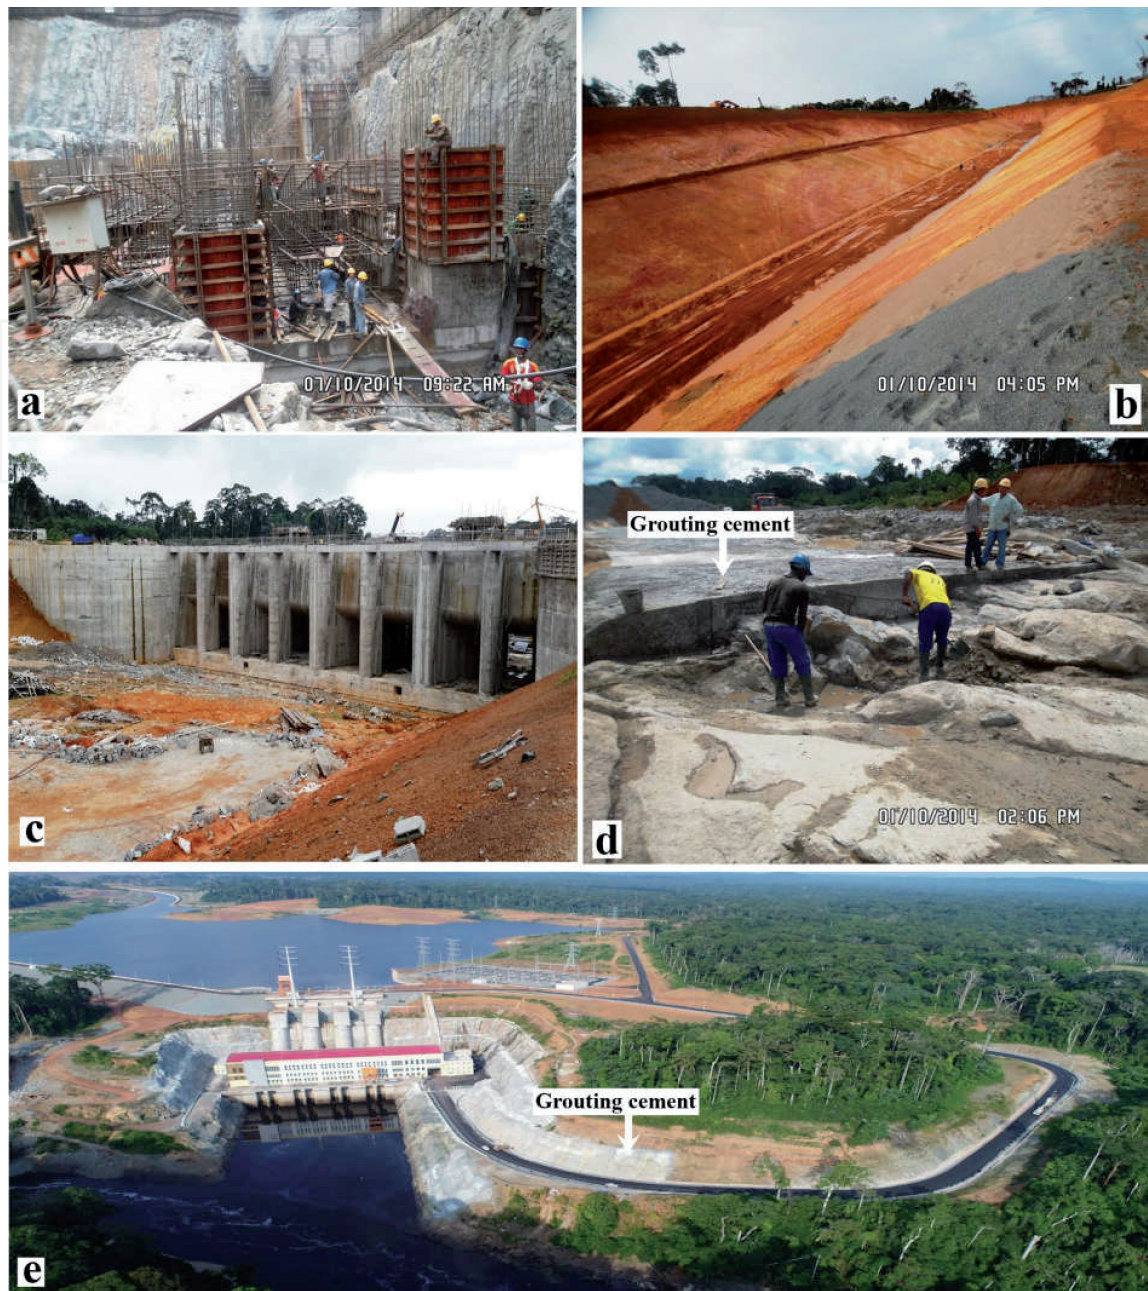
Figure 8.
 (a–c) Display different usages of Ntem formations and quaternary soil deposits; (d and e) amendment of Ntem formations and slope formed by quaternary soil deposits with grouting cement.

Ntem Formation conditions indicate that they are hard qualities in respect to physical properties and good resistance against scouring. The excavated quantity of rock material from the structure foundation is nearly 300×10^4 m³ and it has been used for obtaining crushed aggregate and ripping rap materials for dam construction. However, conditions of site with rocks and alluvial deposits indicate very good and relatively poor geological conditions which can constitute dam foundation materials [11]. Concerning dam foundation, evidence of two dam foundation materials is observed and some requirement needs. The thickness of upper residual soil where is weak in the dam axis can be move to obtain Ntem Formations as foundation materials but where, soil deposit is more thickened, it can be used as also foundation materials. This study has shown that Ntem Formations are fractured and weathered. These site conditions have contributed to improve it in excavating the weathered materials and using vegetable cover and Grouting Intensity Number (GIN) [12] for cover slope and introducing the cement grouting through fractures (**Figure 8**). This method leads to reinforce Ntem Formations and slope stability. Overall dam structure can be fitted on the quaternary soil deposits and Ntem Formations.
