EXPERIMENTAL ASSESSMENT OF STRENGTHENING STRATEGY TO IMPROVE THE MASONRY INFILLS OUT-OF-PLANE BEHAVIOUR THROUGH TEXTILE REINFORCED MORTAR

Keywords: masonry infill walls, out-of-plane testing, strengthening strategies, textile-reinforced mortar.

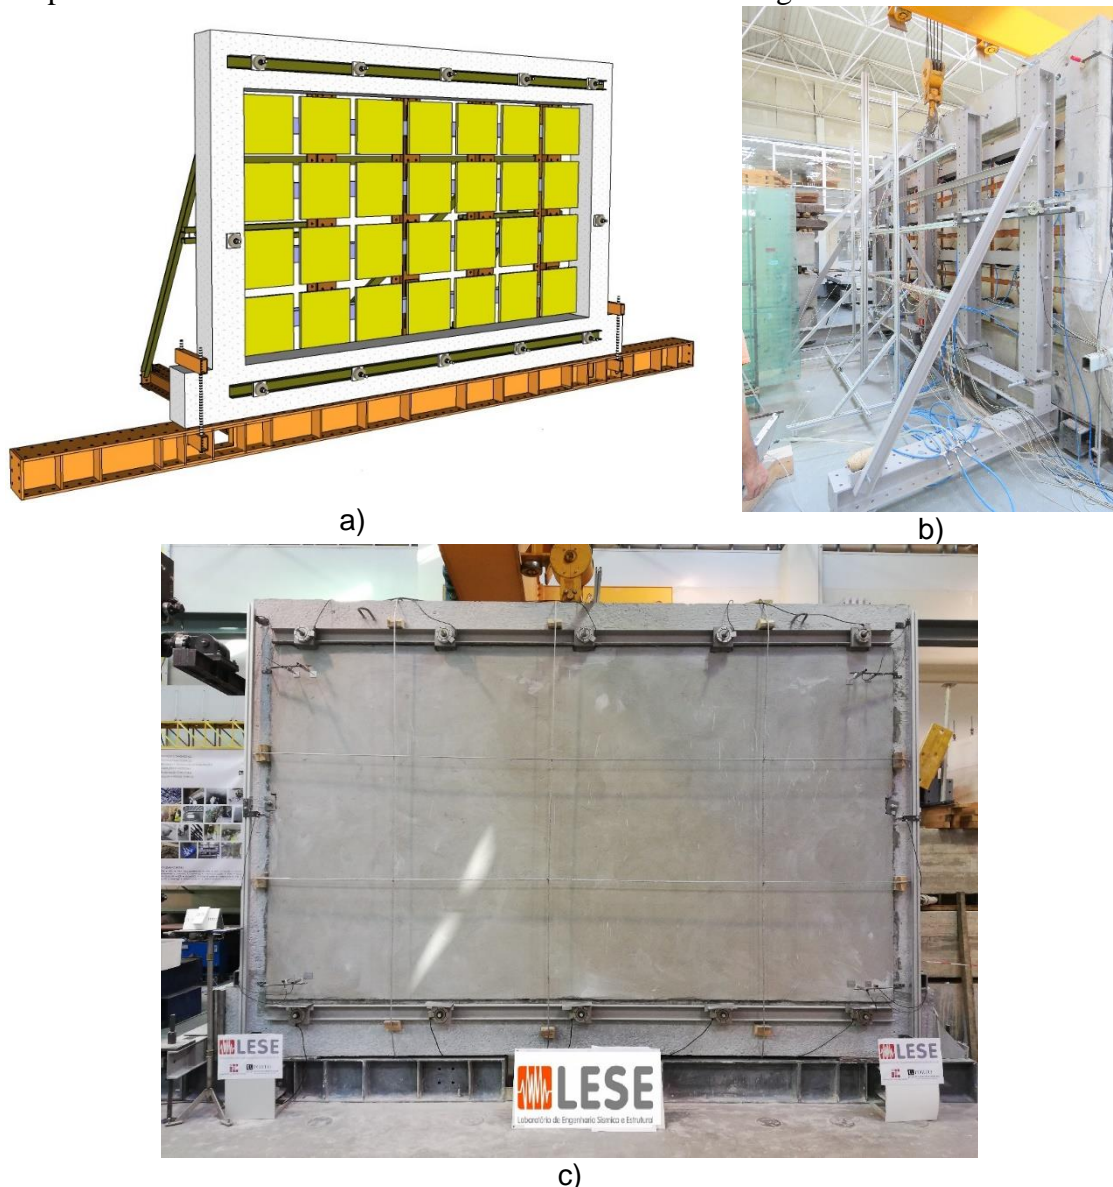
Figure 4: Test setup: a) schematic layout; b) lateral view; and c) front view.

The experimental test consisted on the application of a uniform OOP load applied by 28 pneumatic actuators, which are linked to a self-equilibrated reaction steel structure composed by four horizontal alignments made with HEB140 steel profiles and five vertical alignments made with HEB220 steel profiles (Figure 4). The vertical alignments are hinged, allowing their rotation during the tests. The steel reaction structure is attached to the envelope frame in twelve points (five in each top and bottom beam and one in each column). In each of these connections, it was placed a load cell that allowed to monitor the loads during the tests.

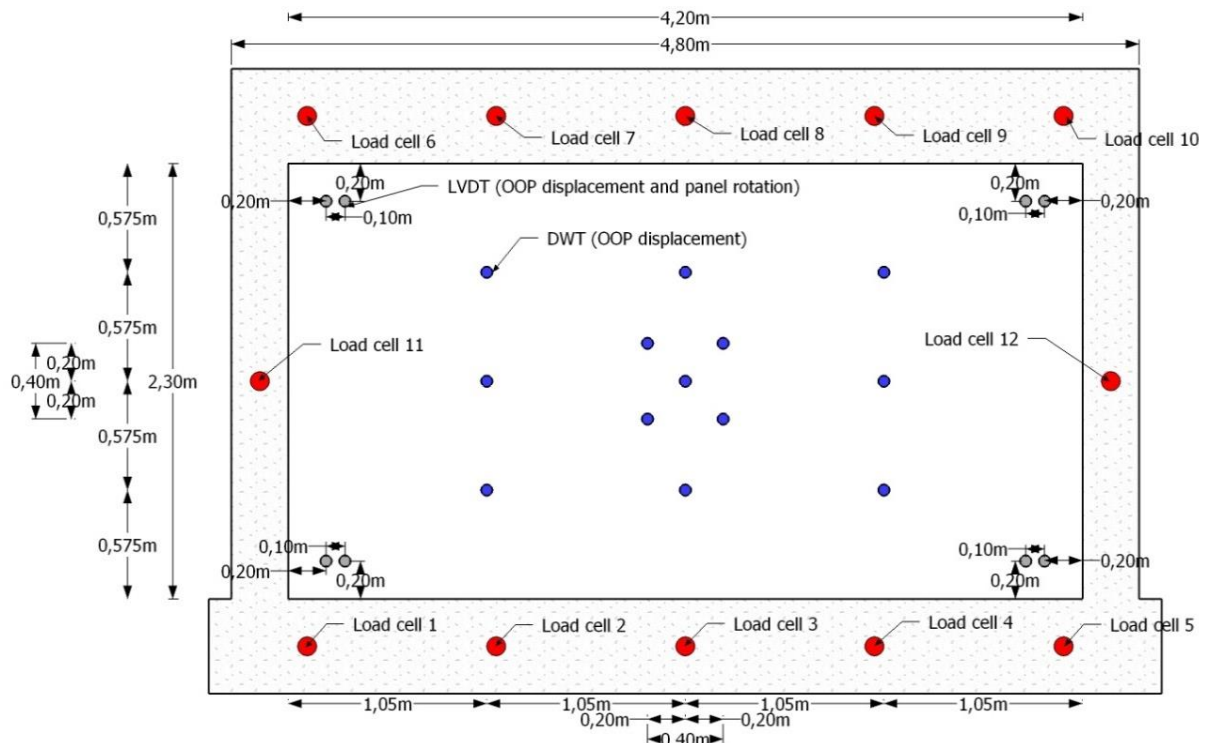
Figure 5: Test instrumentation - scheme layout.

The instrumentation was composed by 21 displacement transducers, thirteen of them related to the monitoring of the panel OOP displacements and the remaining eight to the rotation between the panel and the envelope frame (Figure 5). Apart of that, and as explained in the previous subsection, twelve load cells were used to monitor the loadings developed during the test. The pressure level inside the pneumatic actuators was set by two pressure valves which were

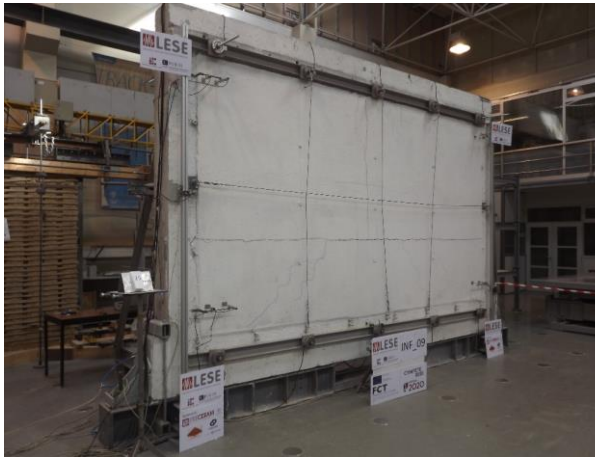
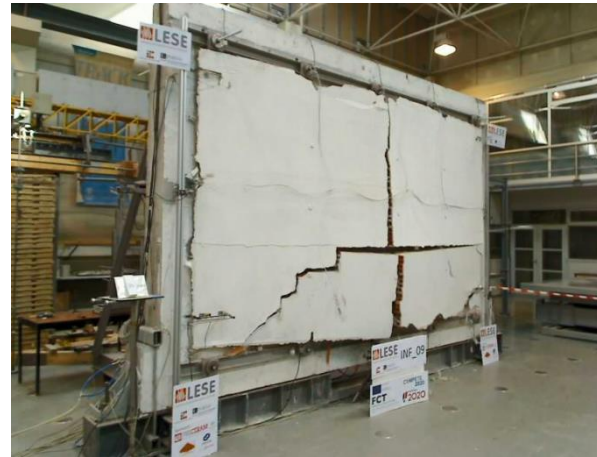
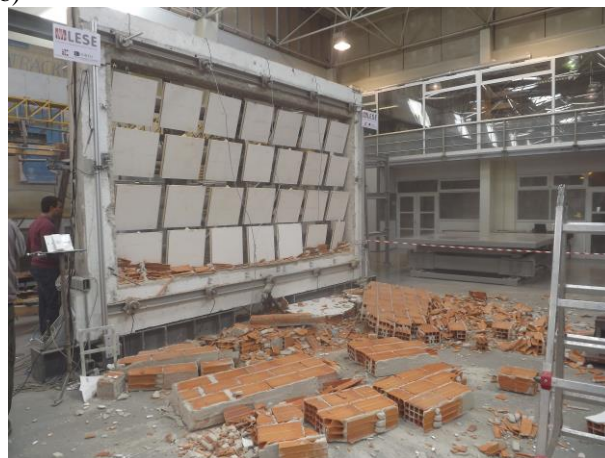
Figure 6: Specimen Inf_09: a) Cracking pattern; b) Final damage before the panel collapse; c) Beginning of the panel collapse; d) Final damage after the panel collapse.

During the test, it was not detected any damage until an OOP displacement equal to 5mm. At this level of OOP displacement occurred the plaster detachment in some parts of the panel. After that, at the OOP displacement equal to 7.5mm it was observed the beginning of a horizontal cracking at 1/3 of the panel height. When the panel reached the OOP displacement equal to 15mm, the horizontal crack becomes more pronounced and at the same time appeared a vertical crack at the middle of the panel, from the top until the horizontal crack. Quite often, when the OOP displacement reached 25mm diagonal cracks were visible, which started in the same alignment of the horizontal crack until the bottom of the panel. At the end, at the OOP displac-

ment equal to 30mm it occurred the panel collapse. The cracking pattern was essentially trilinear as evidenced in Figure 6a. Figure 6b and 6c presents the panel immediately before and after the collapse.

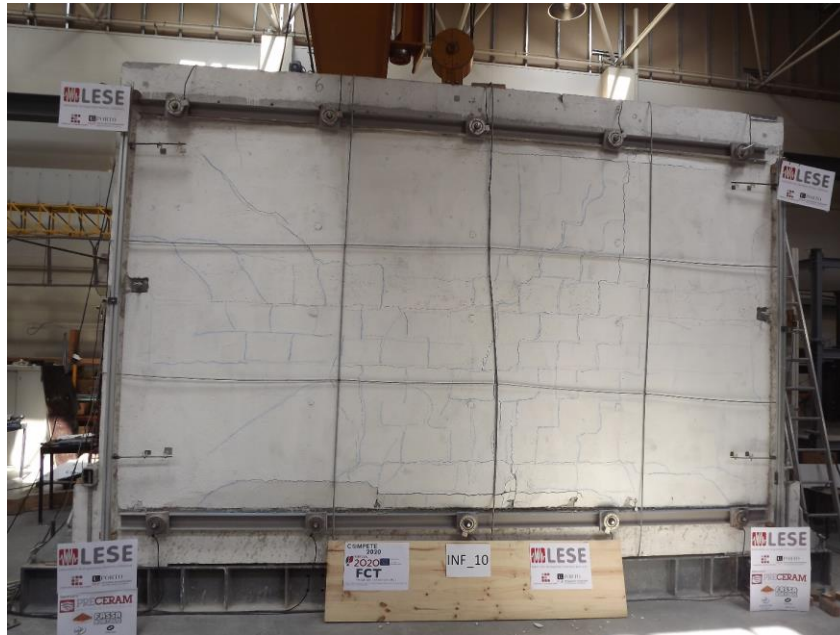
Figure 8: Specimen Inf_10: Cracking pattern.

During the test of the panel Inf_10, it was not visible any crack until the OOP displacement equal to 2mm, similarly to the panel Inf_09. At this moment it was noticed some plaster detachment. When the panel reached an OOP displacement equal to 10mm it was visible a horizontal cracking at the same height as the one observed in the specimen Inf_09 (1/3 of the panel height). After that, at the OOP displacement equal to 20mm two additional horizontal cracks parallel to the first one appeared the middle of the panel height and at 2/3 of the panel height. Following that, small diagonal cracks occurred until the four corners of the panel. When the panel OOP displacement reached 30mm, the two horizontal cracks were more and more visible (placed at 1/3 and 2/3 of the panel height) and the corresponding diagonals developed from both to the panel corners. Finally, the panel reached the OOP displacement equal to 70mm when it was visible a horizontal crack at the transition between the panel and the bottom RC beam (corresponding to the detachment of the panel from the frame). The panel collapse was prevented which allow to conclude that the strengthening solution was effective. Figure 8 presents the cracking pattern observed.

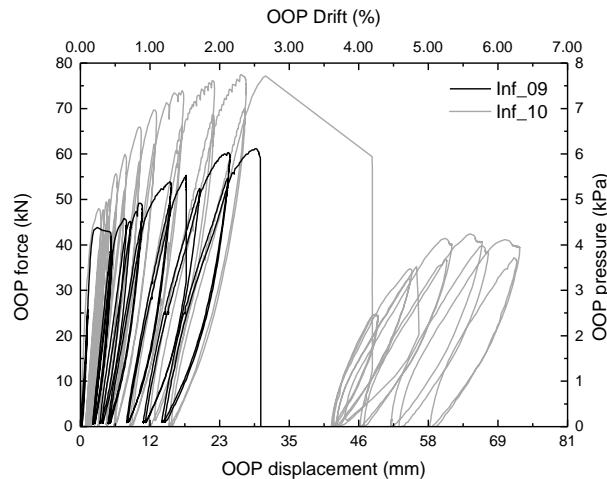
Figure 10: Global comparison: Force-displacement response of the Specimens Inf_09 and Inf_10.

Through the comparison between both specimens, plotted in Figure 10, it is possible to observe that both reached similar initial stiffness, as well as the force corresponding to the appearance of the first cracking and the respective OOP displacement. Regarding to the maximum peak load, the strengthened specimen achieved an increment equal to 30% for an OOP displacement 5% higher. The major contribution of the reinforcement was the prevention of the OOP collapse and the possibility to achieve OOP displacements 2.5 times higher.
