# Experimental analysis of Textile Reinforced Mortars strengthening strategies against the out-of-plane collapse of masonry infill walls

*Keywords: hollow masonry infills; strengthening solutions; textile reinforced mortar; out-of-plane testing; experimental results.*

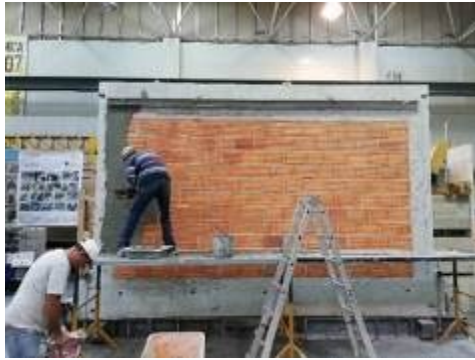
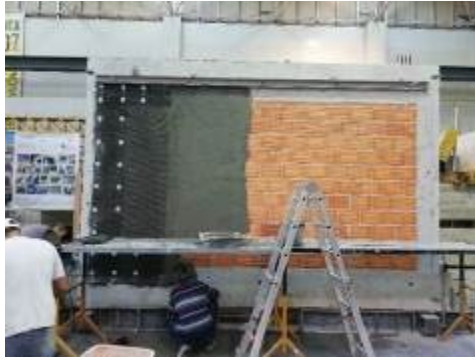
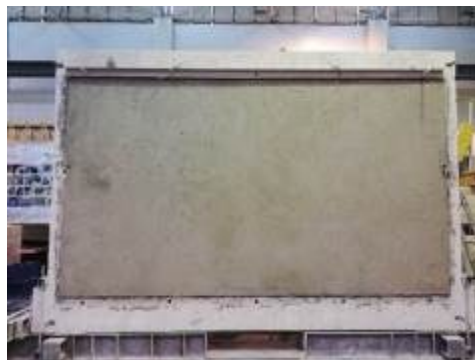
Figure 2. Phases of application of the TRM-based strengthening solutions.

The strengthening solution adopted for the specimen R1-OOP was a textile reinforced mortar composed by a glass-fibre (G-FRP) net with a 4x4 cm matrix, a nominal tensile strength equal to 56.25 kN/m and a maximum ultimate strain equal to 3%. The mortar used for the plaster was a glass fibre-reinforced mortar, with mean compression and tensile strengths at the day of the test equal to 24.4 MPa and 6.7 MPa, respectively. The net was positioned and fixed to the RC frame and to the infill panel by means of simple plastic connectors. Thus, the application procedure of this strengthening strategy started by the application of 1 cm of plaster (see Figure 2a). Then the net was positioned and fixed with the plastic connectors (Figure 2b). The roll of net was provided with 1 meter width and 50 meters length. Five vertical strips were used to strengthen the wall, as it can be observed in Figure 2c. The overlap length used between each vertical strip were assumed to be 10 cm, and for the transition RC frame-infill panel it was assumed a duplicate net with an overlap equal to 40 cm (20 cm for the RC frame and 20 cm for the infill panel). The disposition and distribution of the connectors is shown in Figure 2c, with a general view of the specimen R1-OOP. At the end, an additional 1cm layer of plaster was applied (Figure 2d), so that the final thickness of

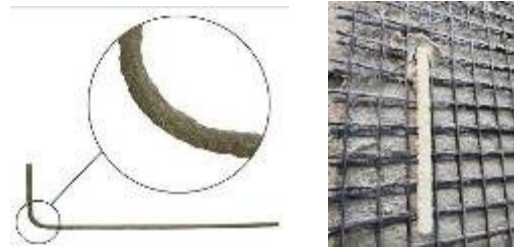
(b)

Figure 3. Net-to-frame connection details for specimens R1-OOP (a) and R2-OOP (b).

The strengthening solution selected for specimen R2-OOP was similar to that adopted for specimen R1-OOP. The difference among them was related to the typology of the connection system between the net and the frame. In this case, L-shape glass bars (see Figure 3b) were used as connectors to fix the net to the

surrounding beams and columns. The procedure adopted to apply this connectors was: 1) application of the first layer of plaster with thickness equal to 1 cm; 2) application of the net; 3) drilling a hole with  $\phi 6$  mm diameter and 10 cm length for each connector; 4) full filling of the hole with epoxy resin; 5) application of the L-shape connector; and 6) application of the second layer of 1cm plaster. The net and the mortar used for plaster were the same used in the specimen R1-OOP.

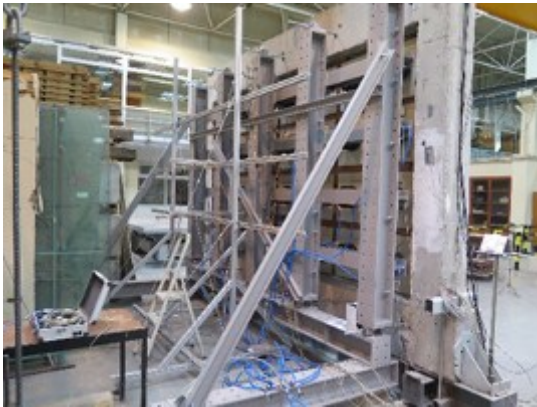
Figure 4. Test setup view (a) and instruments location on the wall (W), on the column (C) on the top beam (BT) and bottom beam (BB) (b).

The OOP test setup used for all the specimens consisted in the application of a distributed OOP loading through 28 pneumatic actuators that mobilized the whole infill panel surface resorting to wood plates with dimensions  $0.5 \times 0.5$  m<sup>2</sup> placed between the actuators and the panel. The pneumatic actuators were linked to four horizontal alignments performed by HEB140 steel shapes which reacted against five vertical alignments performed by HEB200 steel shapes. The horizontal alignments were coupled with hinged devices that allow lateral sliding. This steel reaction structure is a self-equilibrated structure designed with a concept similar to the previous experimental campaigns carried out by Furtado et al. (2016; 2018). The steel structure is attached to the RC frame in twelve points (5 in the bottom beam, 5 in the top beam and 2 in middle-height columns) with steel bars that are coupled with load cells that allow monitoring the OOP loadings. Figure 4a shows the general view of the adopted test setup.

About the instrumentation (see Figure 4b), 34 displacement transducers were used for each test

to measure the OOP displacements of the panel, the OOP displacements of the frame, the relative displacements between the panel and the frame.

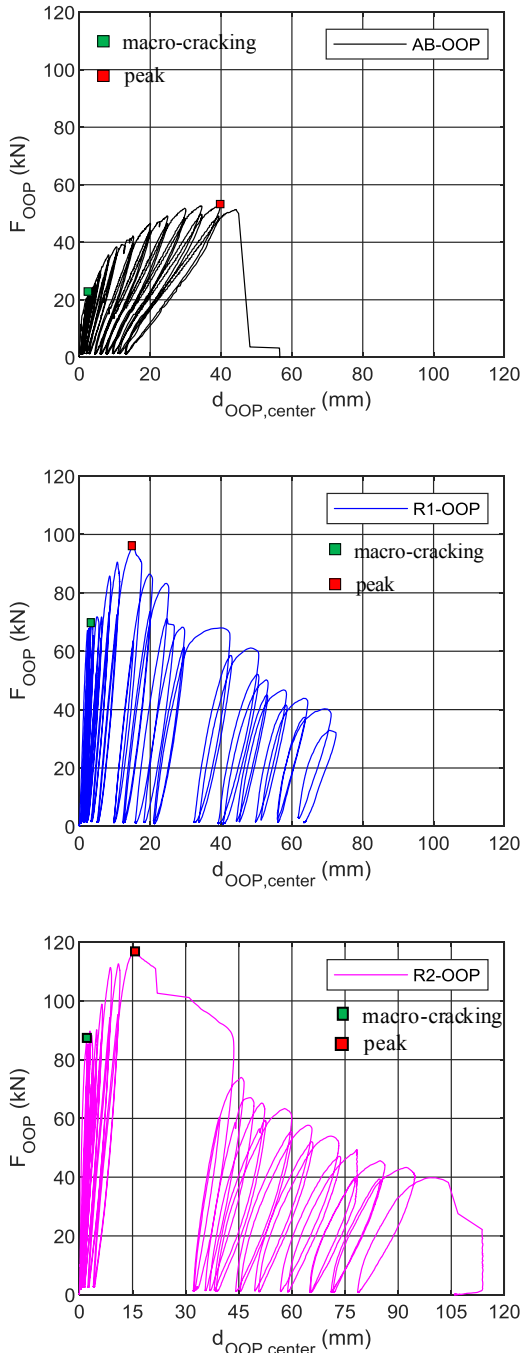
Figure 5. Out-of-plane force-central displacement responses of the tested specimens.

By increasing the applied OOP displacement, a first visible macro-cracking was observed on the panel for an applied OOP displacement in the centre equal to 2.5 mm, at  $F_{OOP,cr} = 21.81$  kN (see Figure 5a). At this stage, a horizontal crack along a mortar bed joint occurred in the middle of the panel. The secant stiffness related to this first cracking is thus slightly lower than the initial one, and, in particular, equal to 8.72 kN/mm.

By increasing the applied OOP displacement, first visible (macro-) cracks were observed on the panel for an applied OOP displacement in the centre equal to 3.6 mm, at  $F_{OOP,cr} = 70.47$  kN (see Figure 5b). At this stage, hairline horizontal and vertical cracks appeared in the middle of the panel. The secant stiffness related to this first cracking thus reduced to 19.58 kN/mm.

For increasing applied OOP displacement, a first visible (macro)-cracking was observed on the panel, at  $F_{OOP,cr} = 89.73 \text{ kN}$  and  $d_{OOP,center}$  equal to about 3 mm (see Figure 5c). At this stage, a hairline horizontal crack appeared in the middle of the panel together with some smaller vertical cracks on the bottom.

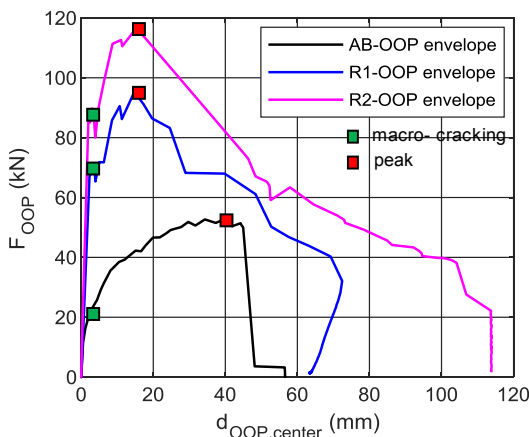
Figure 7. Comparison of the out-of-plane force-central displacement envelopes.

Figure 7 shows a comparison among the test results presented in the previous section in terms of  $F_{OOP}$ - $d_{OOP,center}$  envelopes (shown until the last first-cycle peak). Additionally, Table 2 provides a summary of the results reported in the previous sub-sections.

It can be noted that the maximum  $F_{OOP}$  for the retrofitted specimens are 1.82 and 2.22 times the  $F_{OOP,max}$  related to the AB-OOP specimens, for tests R1-OOP and R2-OOP, respectively. This aspect can be significantly important for typical code-based safety checks for the out-of-plane

Significant force increment are observed at the first (macro-) cracking condition:  $F_{OOP,cr}$  is 3.23 and 4.11 times the related value for the AB-OOP specimen, for tests R1-OOP and R2-OOP, respectively. Secant stiffness is also significantly affected by the presence of the retrofitting plaster, by increasing of at least of +228% with respect to AB-OOP specimen.

On the contrary, the OOP displacement at the peak OOP load ( $d_{OOP,center,max}$ ) is about the 40% of the related displacement of AB-OOP specimen for both the retrofitted tests.

The displacements corresponding to 20% of strength reduction (namely, corresponding to the 80% of the maximum load) on the envelopes ( $d_{OOP,center,u,80\%}$ ) are also reported in Table 2 and they resulted 43%, on average, lower than the reference specimen. The corresponding “ductility” capacity ( $\mu_{OOP,center,u,80\%}$ ), calculated as the ratio between  $d_{OOP,center,u,80\%}$  and  $d_{OOP,center,max}$ , are 53% and 43% higher than the reference specimen AB-OOP, for specimens R1-OOP and R2-OOP, respectively.
