# Journal of Tropical Resources and Sustainable Science

## Effectiveness of 2-D Resistivity Survey to Identify Lineament (Fault) from Photolineament Interpretation – Case Study at Kampung Dato' Mufti, Ampang, Selangor

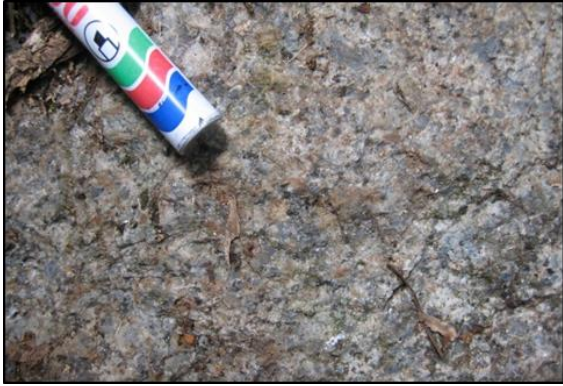
The geology of the site consisting essentially of granite. The granite is light grey, medium grained size (Figure 3). Granitic rock consist quartz, feldspar and plagioclase mineral which measures up to 0.5-1.0 cm in size. Biotite presents as minor mineralogy constituents. This granite rock mass had been excavated for the use as aggregate on the west of study area as shown in Figure 4.

**Figure 3:** Close-up view of fresh, medium-grained granite

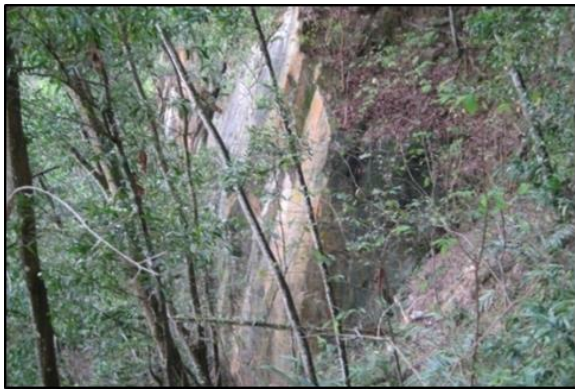
**Figure 4:** View of granite slope face of ex-quarry on the west of study area which have been excavate for aggregate

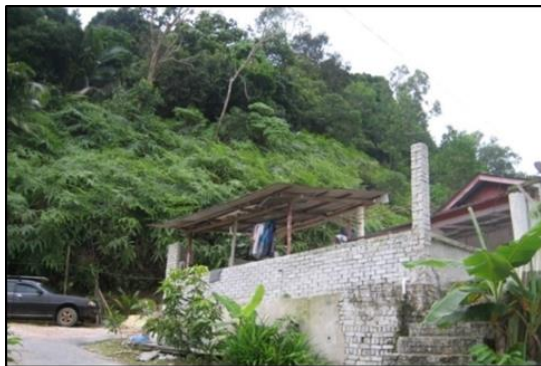
**Figure 5:** Heavy densities of vegetation around study area have cause difficulty for resistivity survey to be done

Resistivity lines survey are located at the ridge which orientated in north-south direction with the average slope gradient of 60°. The highest point of height is 135m from ground level. The length of the ridge is approximately 500m with covered with shrubs and small trees including on top of the slope (Figure 5). Pieces of rock fragment in various sizes from pebble to cobble can be observed on the north and top of the slope.

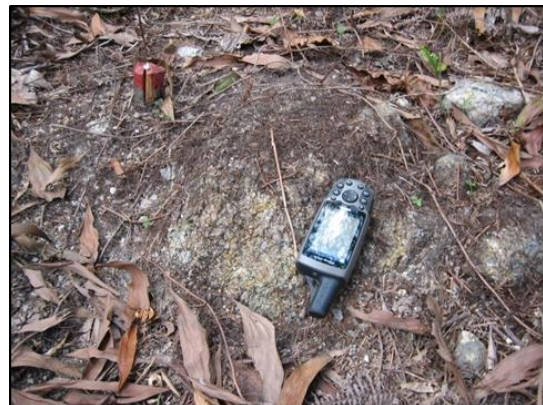
In this research, degree of weathering for the rock masses is described using the classification scheme by International Society for Rock (ISRM), 1981. The studied area is varies in weathering grade from fresh (grade I) to slightly and moderately (grade II-III) and highly to completely weathered (grade IV-V). The fresh and slightly weathered rocks are generally exposed at the east flank of the ridge, while the moderately (Figure 6) and highly weathered rock masses are exposed at the center and south flank of the ridge respectively. Grade VI or residual soils formed the overburden at the top of the slope.

**Figure 6:** Moderately weathered granite exposed at the top of study area

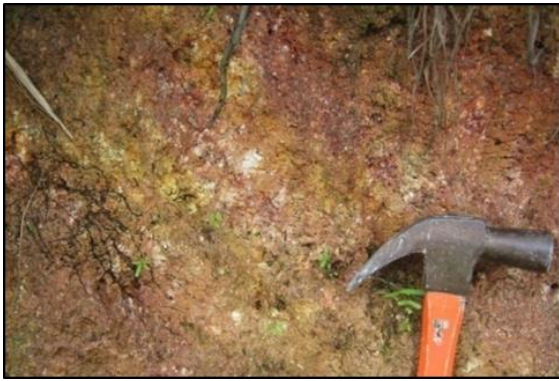
The fresh to slightly and moderately weathered granite rock material are generally very strong to extremely strong rock. As the weathering grade increase, the strength of the rock material decreases due to alteration and decomposition of its constituent materials. Highly weathered granite material generally became medium strong rock, and the completely weathered granite may become weak or very weak rock or behaving more towards soils (Figure 7).

**Figure 7:** Close-up view of completely weathered granite rock mass shown

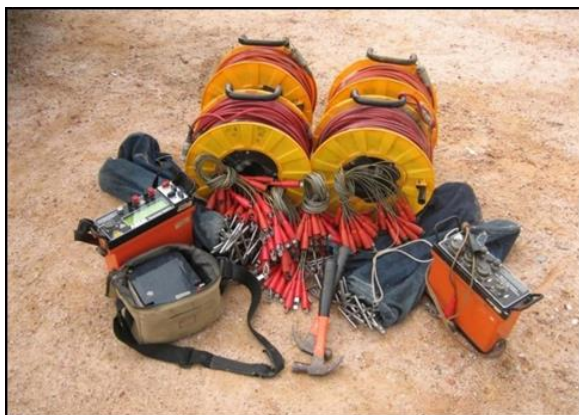
The 2-D electrical imaging survey was carried out with a SAS4000 resistivity meter and ABEM LUND ES464 electrode selector system (Figure 9).

**Figure 9:** The set of ABEM SAS1000 resistivity meter and ABEM LUND ES464 electrode selector system

This system is connected to 41 steel electrodes which lay out on a straight line with a constant spacing

via a multicore cable. A microcomputer connected to the resistivity unit then automatically selects the four active electrodes used for each measurement. The Wenner equal spacing electrode array was used for this survey. For more details about the survey and interpretation method, please refer to the papers by Griffiths & Barker (1993) and Loke & Barker (1996).

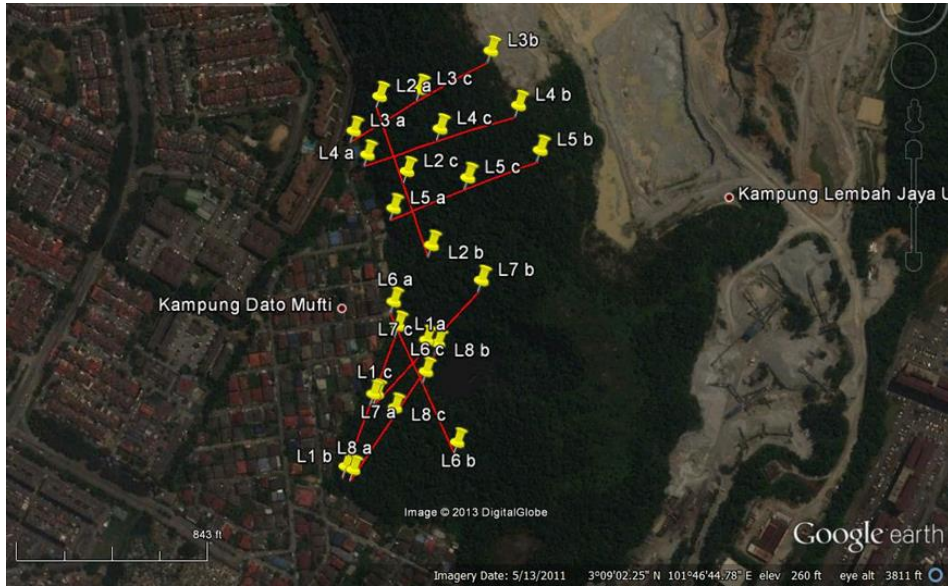
A total of eight lines of resistivity survey had been done. Total lengths for each resistivity survey lines are 200m and its electrode spacing is 5m (Figure 10). The measured resistivity survey data were interpreted using RES2DINV inversion software.

**Figure 10:** Location for 8 lines of resistivity survey which have been done
