### COMPONENT WORKS OF DRACSANI RESERVOIR

## RESULTS AND DISCUSSIONS

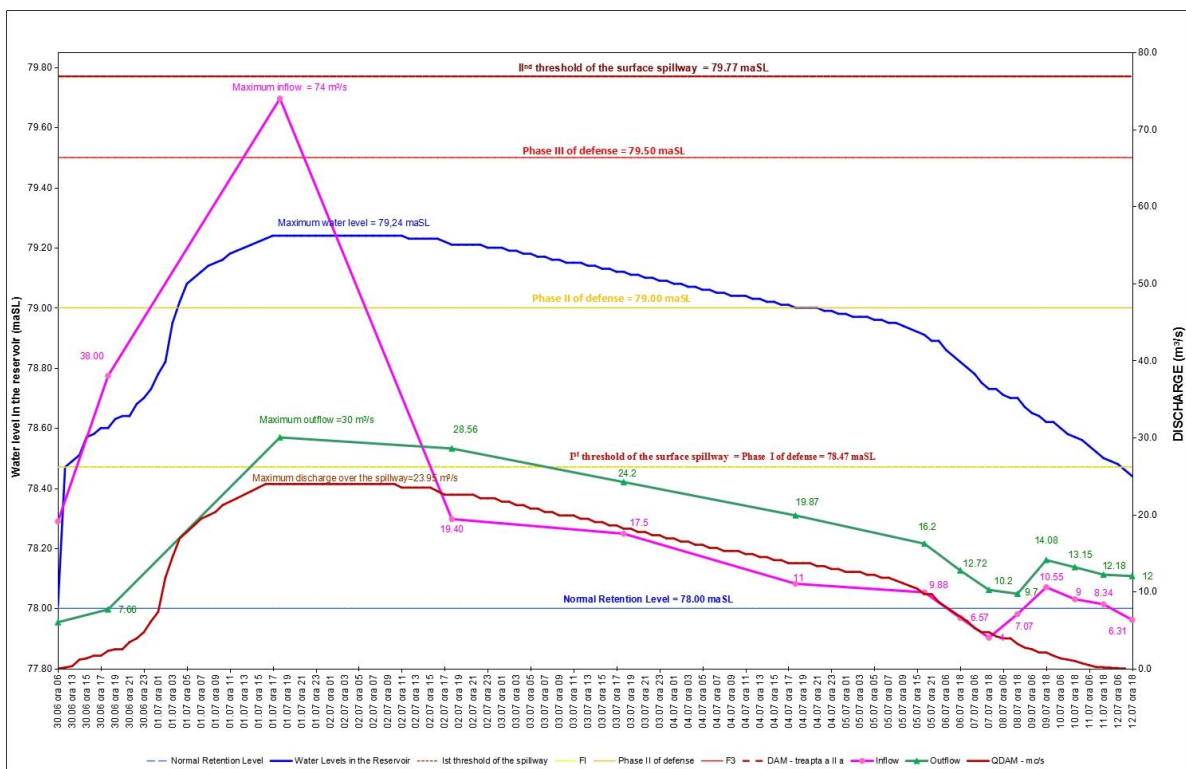
Figure 4 Water levels, inflow and outflow discharges registered during 30.06-12.07.2018

The table 2 and figure 4 present the extreme values of the water level registered in the period 30.06.2018 – 12.07.2018.

The maximum inflow was 74 m<sup>3</sup>/s in 01.07.2018 - 18<sup>00</sup> hour. The maximum level in the reservoir was 79.24 mdMN, so the surface outlet (I<sup>st</sup> threshold level - 78.47 maSL) was put into operation.

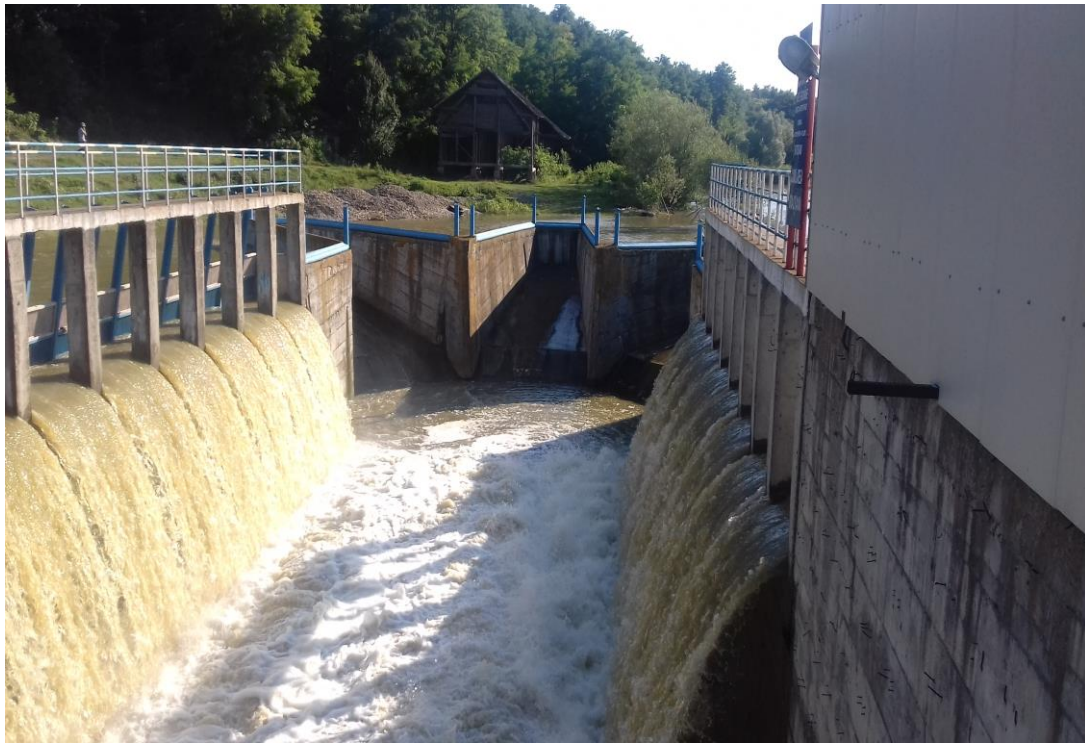
Figure 5 Dracsani dam – discharge over the surface spillway

reached the maximum level of 79.24 mdMN. The maximum height of the water discharged over the surface outlet was 77 cm. The maximum discharge over the spillway was 23.95 m<sup>3</sup>/s for a time interval of 18 hours. The surface spillway was put in operation for a period of 12 days (figure 5).

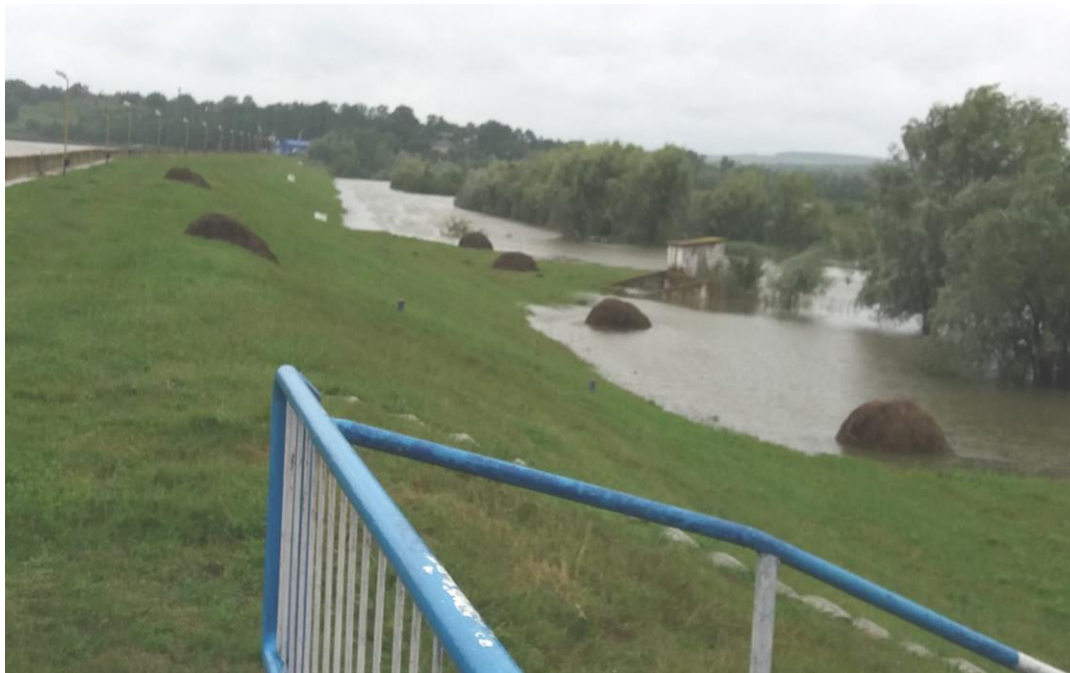
Figure 6 Dracsani dam – inundated downstream slope

The high level of water in Burla river caused a backwater volume to be accumulated immediately downstream of Dracsani dam, that inundated the downstream slope of the dam, on a 1.0-1.5 m height (*figure 6*).

The water withdrew after 4 days.

Due to high levels of the water in the reservoir, the joints between the tiles in the downstream slope of the dam were partially affected.
