CONSIDERATIONS ON THE EXPERTISE OF PUMPING PLANTS FROM IRRIGATION SYSTEMS

Abstract

Key words: design, hydraulic system, modernization, pumping aggregate

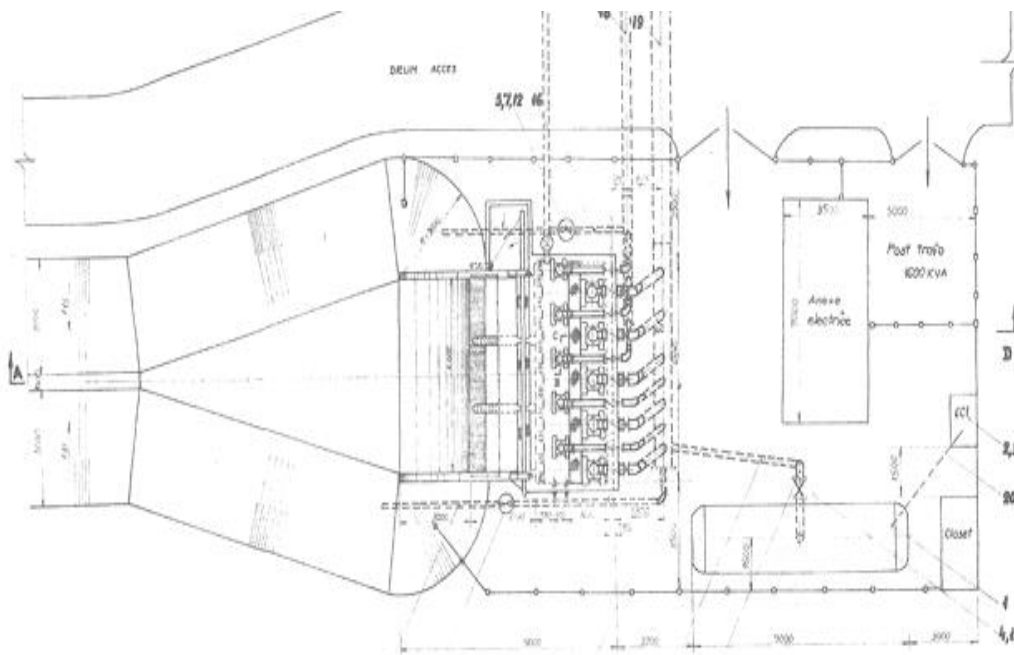
Most of the SPP irrigation plots were executed during 1970 - 1985 according to type projects (4824R-1984 Project). SPP and SPPM pumping plants were executed only with the infrastructure. The SPP constructive part, depending on water circulation is made of the following components: a - suction basin; b – grate; c – forebay - sand-clearing basin; d – screen

chamber; e – suction tank; f – hydromechanical installation; g – electrical transformer substation

Figure 2 SPP pumping plant constructive structure (top view): a - suction basin; b – grate; c – forebay - sand-clearing basin; d – screens; e – suction tank; f – hydromechanical installation; g – electrical transformer substation building.

The SPP constructive structure is made of reinforced concrete and metallic confections. The pumping aggregates, the SPP hydraulic installation and the screen installation are placed on top of the tank covering slab.

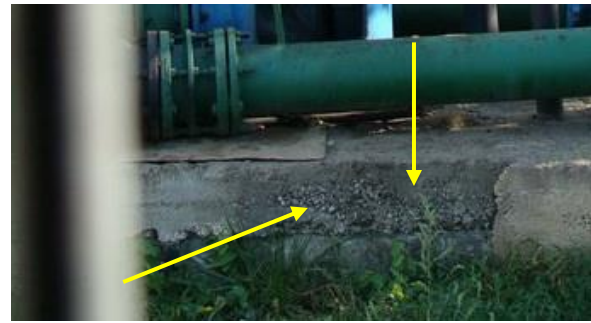
- the structural state of the channel – station tank connection area is unsatisfactory due to the concrete slabs' high degree of degradation;
- the constructive structure of the tank has areas with degradation of the protective plastering and the reinforced concrete exterior and interior walls; natural and anthropic actions on site have led to the fissuring of the constituent wall layers; during the execution phase material stripping was performed and deeper degradations were highlighted in the tank's reinforced concrete wall;

- the slab covering the tank has degradation areas due to the removal of the cement plaster and the fissures and cracks in the reinforced concrete structure (figure 3);

- the metallic confections included in the tank structure are corroded, worn out and degraded by the climatic factors and human action; the aging of the material is accentuated;

Figure 3 Degradation state of the SPP1b pumping plant tank covering slab (Luca Al., 2016)

The hydromechanical installation (pumping aggregate and hydraulic circuit), the hydraulic shock protection, the energetic installation, electric panel building, electrical transformer substation, the screen installation were presented in detail in the paper (Luca Al. L. *et al.*, 2016). The technical expertise characterises the SPP1b pumping plant structural and functional state as unsatisfactory. The expert recommended a rehabilitation works program which was completed in 2016.

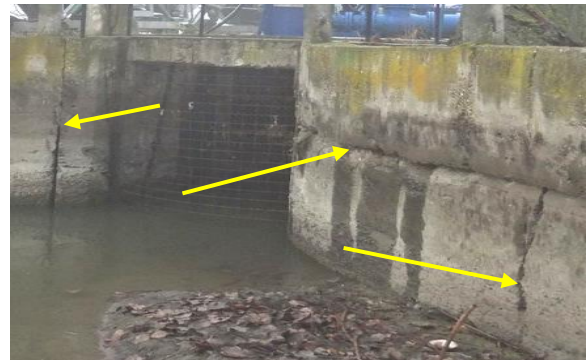
The expertise carried out at „Berezeni plot 16” from Albița Fălciu Complex Irrigation and Drainage Facility revealed the total unsatisfactory state of the SPP 16 and hydromechanical line constructive structure (figure 4) (Luca M., 2015).

Figure 4 SPP1b Berezeni pumping plant infrastructure degradation state (Luca M., 2015)

The SPP constructive structure is degraded at walls level, where it has fissures and cracks. The hydromechanical line still included VDF type pumps, which were eliminated during the 1980s.

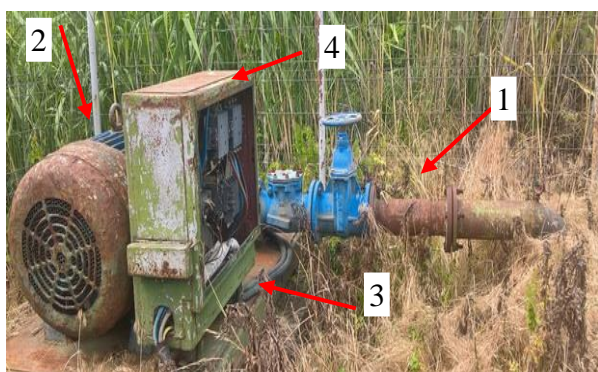
- the constructive structures made of reinforced concrete (the pumping aggregates foundation, anchoring blocks, valve homes) are in a state of total degradation (figure 5);

- the pumping aggregates are completely degraded, taking into account the equipment with 12 NDS and RDN 200 pumps, manufactured in the 1960s;
- the SPPM pumping plants are not equipped with priming installations (in the initial stage, the SPPM were manually primed);
- the SPPM hydraulic system is degraded and has an outdated service life (*figure 5*);
- the electrical motors driving the pumps are completely outdated by the current technical level; actually, SPPM has the equipment with which it was put into service (the 1970s).

Figure 5 Current state of Doniceasa – Fălciu Plot 7 SPPM: 1 – hydraulic installation; 2 – electrical motor; 3 – foundation of pump; 4 - electric panel (Luca M., 2016).

In this case, the expert has proposed two SPPM rehabilitation and reengineering options. One of the options included the priming installation into the hydromechanic installation system. Also, the expert proposed a SPPM conversion option from horizontal to vertical pumps, with a radical change of the constructive structure (Luca M., 2015).
