CONSIDERATIONS ON REHABILITATION OF MONOPHILAR PUMPING STATIONS OF THE IRRIGATION SPRINKLER PLOTS

Abstract

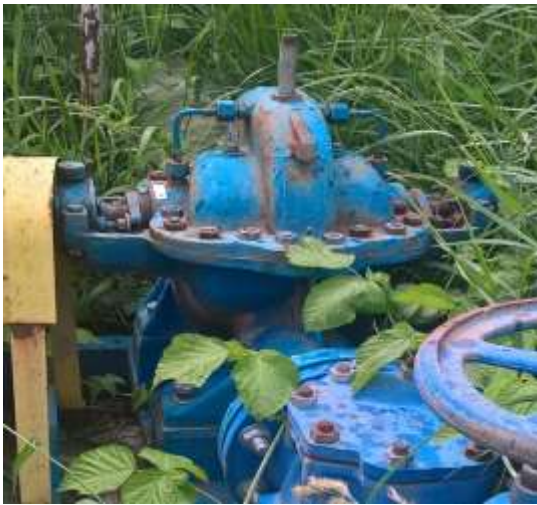
Figure 1 RDN 200-150-200 pump from Doniceasa - Fălcu Plot 7 SPPM (Photo Luca M., 2016)

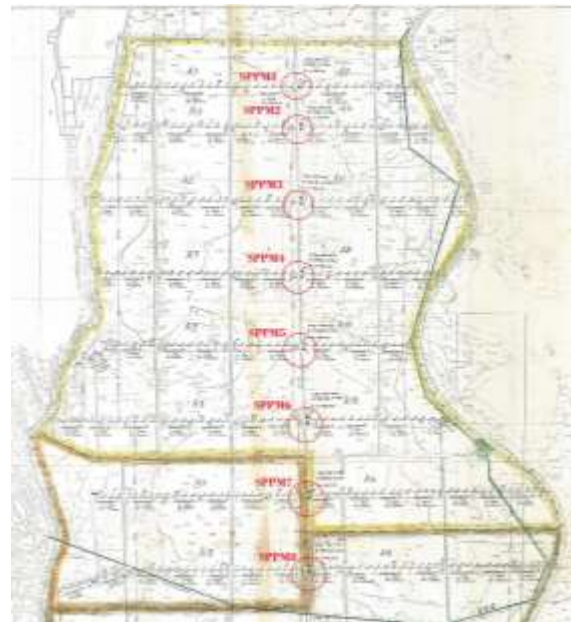
Plot 7 surface is 1222 ha. The plot is supplied with irrigation water from the CS82 canal, which is connected to the CA5 canal. The canal supplies 15 6NDS/RDN type electropumps ($Q = 270$ m³/h, $H = 70$ m, $n = 3000$ rpm, $P = 110$ kW) located in 8 single-line pumping and pressurising stations (figure 2).

Figure 2 Doniceasa-Fălcui Plot 7 site plan (original version) (Luca M., 2016)

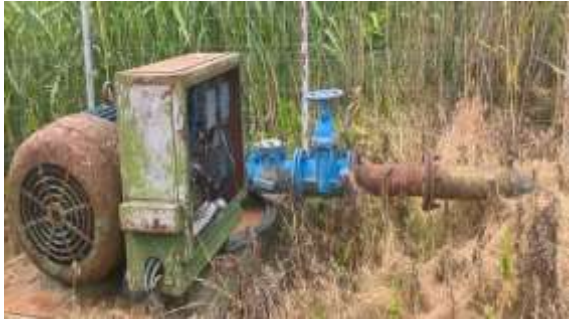
- The pumping units are manufactured during 1975-1980 and have an exceeded service period (figure 3, 4). The rehabilitation of some SPPMs was done by replacing the pump and the electric motor. Only the hydraulic connection of the pumping station to the single-line pipes is the original one.

Figure 3 View of 7/5-2 pumping unit (6NDS), electric panel and discharge pipe of the SPPM 7/5 (Photo Luca M., 2016)

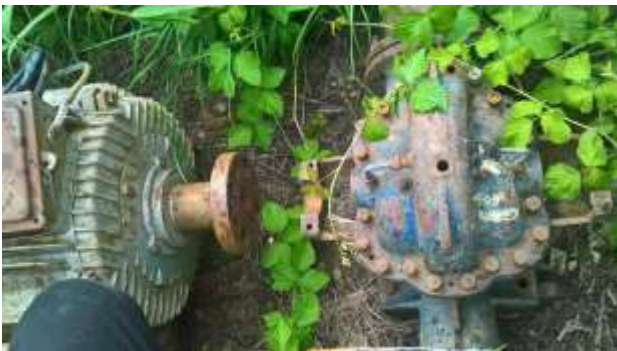
Figure 4 SPPM 7/7-2 pump aggregates status (RDN 200-150-200 pump and motor) (Photo Luca M., 2016)

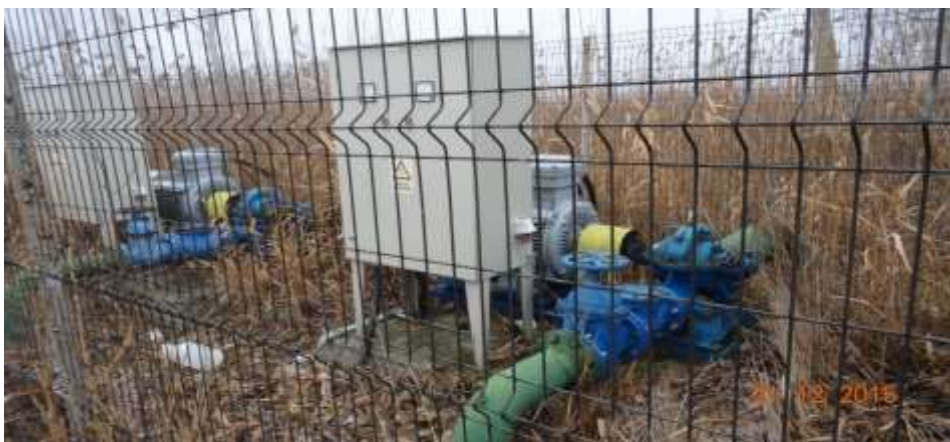
- The structural and functional state of the hydraulic installation in the pumping stations made of steel and cast iron (suction and discharge pipes, fittings, valves) is inadequate, being degraded in proportion of 60-85%.
- The horizontal pumping units, including those which have been rehabilitated (replacement of the pump and / or the electric motor), do not have primer

installations (figure 5, 6). The operational simulation of the single-line pumping station with modified pump parameters after 38 years in service showed an increase in energy consumption by about 32-41% compared to the initial state at the time it was put into service (Luca M., 2015).

Figure 5 **General view of Doniceasa-Fălcu Plot 7 SPPM SP 7/2, partially rehabilitated (replacement of electric motor and electric panel)** (photo Luca M., 2016)

- design and execution of a pump priming installation (vacuum electropump, liquid ring tank, pipe circuit), according to the parameters required by the new units; the installation will be suitably sized and mounted on a reinforced concrete platform or inside a container;

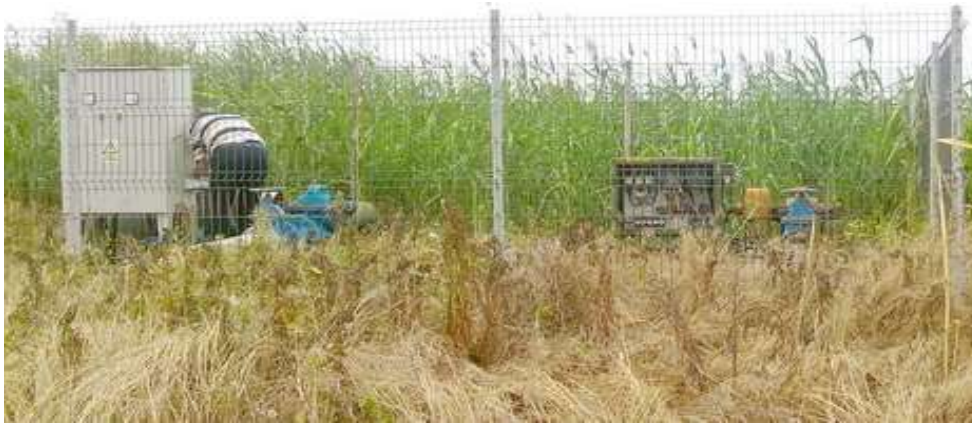
Figure 6 **General view of Doniceasa-Fălcu Plot 7 SPPM 7/5 partially rehabilitated (replacement of an electric motor and the electric panel for the pumping unit 7/5-1)** (Photo Luca M., 2016)
