TECHNICAL EFFICIENCY OF SOIL EROSION CONTROL MEASURES IN SOMUZUL MIC CATCHMENT, SUCEAVA PLATEAU

Abstract

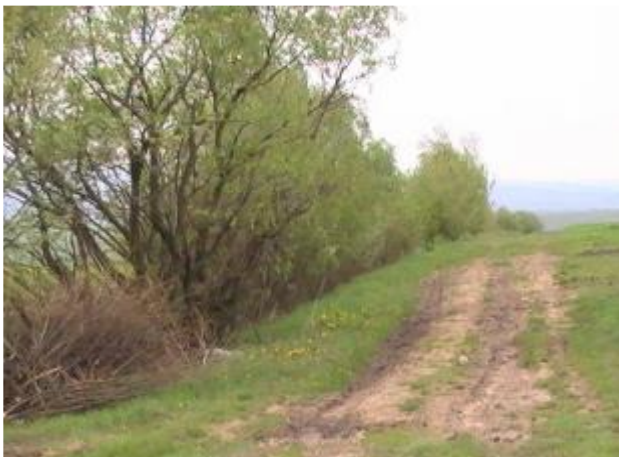
- 40% of the section of the outlets, main and marginal channels along their entire length is partially desilted (*figures 2 and 3*);
- 35% of the length of the drainage network is degraded;
- 30% of the number of inspection chamber from the drainage network, respectively 30% of the number of tail-race channel, are degraded;

Figure 2 Desilted channel and invaded by woody vegetation

- Desilting outlets, main, marginal and secondary channels, inspection chamber and tail-race channel;
- Rehabilitation works of the nonfunctional drainage network;
- Rehabilitation of the road platform along its entire length;
- Rehabilitation of degraded hydrotechnical constructions from the facility.

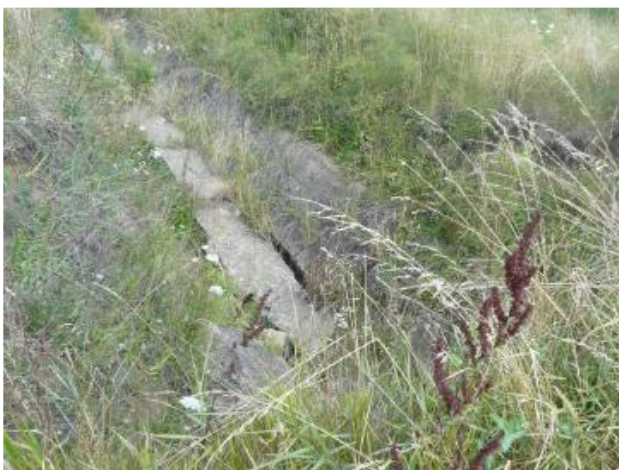
Figure 3 Tail-race channel made out of concrete is degraded

The absence of maintenance work, inappropriate agricultural practices, as well as certain natural factors (especially the relief and torrential precipitation) led to the degradation of the hydrotechnical constructions (Beasley R.P. *et al*, 1984, Ioniță I., 2000, Mihaiu Gh., 1983). Of course, with the degradation of these constructions,
