## Electrical Characteristics of Polyvinyl Chloride with Wollastonite Filler for High Voltage Outdoor Insulation Material

<sup>a</sup>Institute of High Voltage and High Current, Faculty of Electrical Engineering, Universiti Teknologi Malaysia, 81310 UTM Johor Bahru, Johor, Malaysia

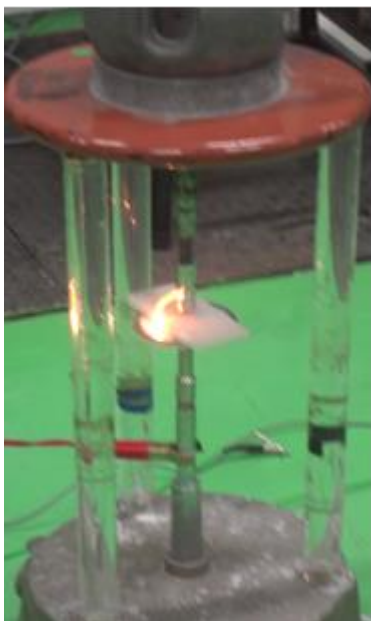
Figure 9 Breakdown voltage experiment
