**ACCEPTED FOR PUBLICATION IN COMPOSITES SCIENCE AND
TECHNOLOGY**

DOI: 10.1016/J.COMPSCITECH.2014.05.020

**DAMAGE DETECTION AND SELF-REPAIR IN HOLLOW
GLASS FIBER FABRIC-REINFORCED EPOXY
COMPOSITES VIA FIBER FILLING**

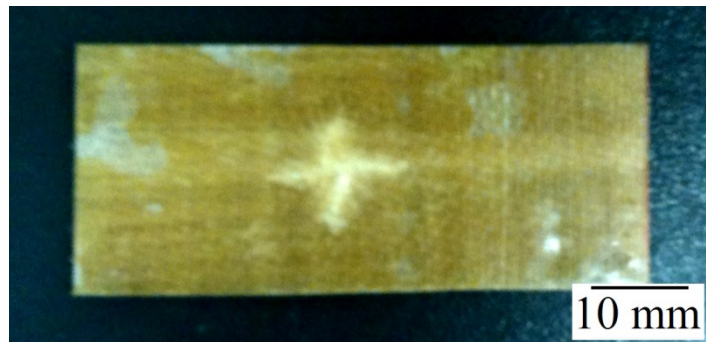
Figure 4

Figure 4. The formation of the impact damage

HGF reinforced composites were prepared by the HLU technique as described above. They were filled with the components of a polyester resin system, and the self-repairing ability was examined. The nominal size of the specimens was 24×1.25×60 mm. The energy of the impact was adjusted so that after the impact the residual strength and modulus could be measured in three point bending. The bending strength and the bending modulus were compared on different types of specimens: unfilled – undamaged, unfilled – damaged, filled – undamaged, filled – damaged, filled – healed. During the preliminary fracture tests it was observed that the filled specimens can absorb more energy than the unfilled ones. The energy of the incident impact was selected so that the residual strength remained well measurable. The weight of the falling dart was 3.62 kg, the falling height of the unfilled specimens was 40 mm (1.42 J), whereas the falling of the filled specimens was 110 mm (3.91 J). The filling of the hollow fibers increased the energy absorbing property of the composite specimens; the low impact energy did not result in fracture in the specimen, so the impact energy had to be increased so the healing could be measured. The formation of the impact damage on a specimen is seen in Figure 4.

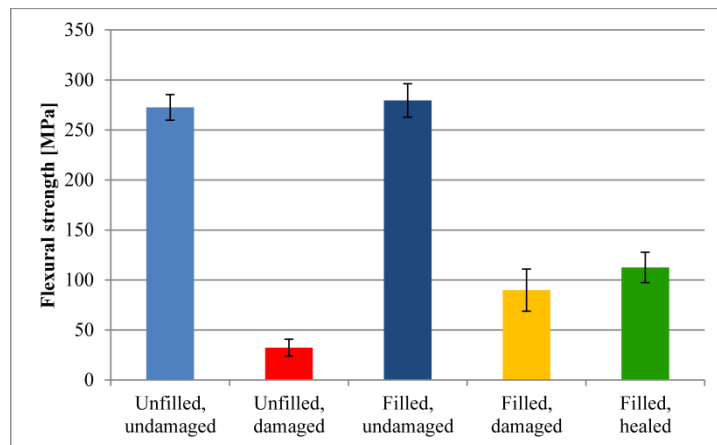
Figure 7

Figure 7. The flexural strength of the VARTM specimens

and then the three point bending tests were executed. The results of the examinations are seen in Figures 7. and 8.

The results obtained on the VARTM-manufactured specimens show a tendency similar to those of the HLU-manufactured specimens. The filling improved the bending properties. There is no significant difference between bending strength of the unfilled – undamaged and the filled – undamaged specimens, however, the bending modulus was increased by the filling by 16%. Filling also increased the residual flexural properties: the bending strength was 178% higher and bending modulus was 11% higher for the filled specimens. The improved properties of the filled specimens also resulted from the energy absorbing ability of the liquid inside the hollow fibers, which increases both the strength and the modulus. The bending strength of the healed specimens was 25% higher, and the bending modulus was 46% higher compared to the results obtained on the filled – damaged specimens.

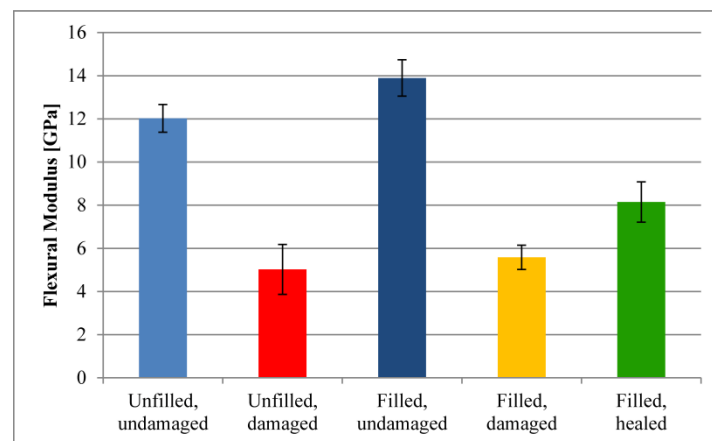
Figure 8

Figure 8. The flexural modulus of the VARTM specimens

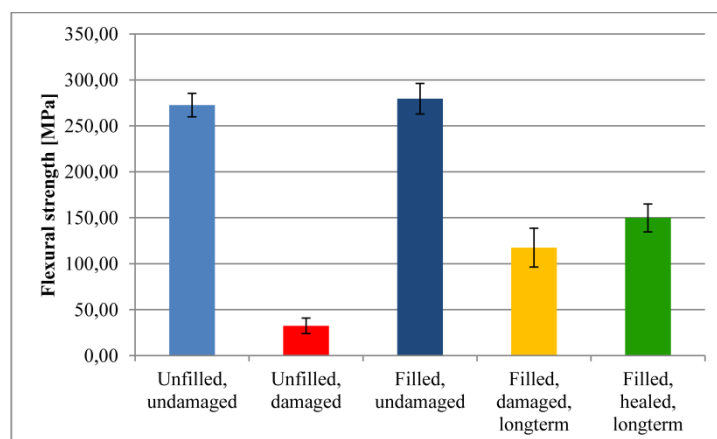
Figure 9

Figure 9. The flexural strength of the specimens healed at room temperature

The self-repair was also tested without putting the specimens into the oven. The related specimens were also manufactured by the VARTM method using 5 plies of hollow glass fabric. The previous test protocol as adapted, however, with one difference: After the damage the specimens were not heat-treated, but were instead stored at 23°C for 120 hours prior to performing the bending tests. The results of the flexural measurements can be seen in Figures 9. and 10.

The bending strength of the healed specimens was 20% higher, and the bending modulus was 26% higher compared to the filled – damaged specimens. It is observed that when sufficient curing time for the healing agent is provided, the self-repairing process can proceed.

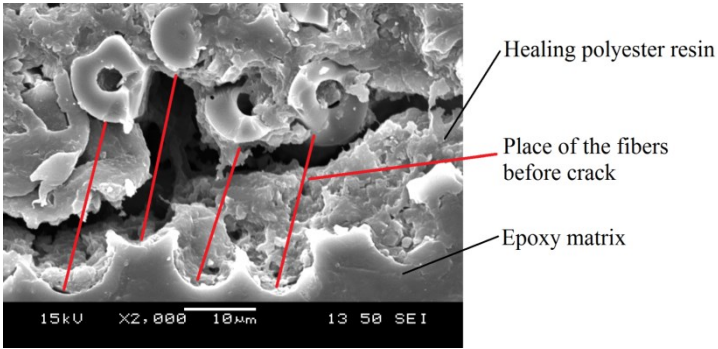
Figure 11

Figure 11. Scanning electron micrograph of the healing agent that has flowed into the crack

Healed specimens of the hollow fiber reinforced composites were embedded into resin, and it was polished to examine the traces of self-repair with a JEOL JSM 6380LA scanning electron microscope (Japan). An electron micrograph can be seen in Figure 11.

In the SEM picture in Figure 11, the locations of the fibers before they were separated by the crack are well visible – cf. arrows. Under the effect of the impact load delaminations with fiber fractures occurred. The healing agent flowed out from the fibers and filled the cracks. The cross-linked healing agent is observed inside the crack. Thus, the integrity of the structure was restored, and because of this, the bending properties improved after the healing phase compared to the damaged state.
