**KFKI-2003-01/G  
REPORT**

**CODEX-B4C EXPERIMENT:  
CORE DEGRADATION TEST  
WITH BORON CARBIDE CONTROL ROD**

**Hungarian Academy of Sciences  
CENTRAL  
RESEARCH  
INSTITUTE FOR  
PHYSICS**

The CODEX-B4C bundle test has been successfully performed on 25<sup>th</sup> May 2001 in the framework of the COLOSS project of the EU 5<sup>th</sup> FWP. The high temperature degradation of a VVER-1000 type bundle with B<sub>4</sub>C control rod was investigated with electrically heated fuel rods. The experiment was carried out according to a scenario selected in favour of methane formation. Degradation of control rod and fuel bundle took place at temperatures ~2000 °C, cooling down of the bundle was performed in steam atmosphere. The gas composition measurement indicated no methane production during the experiment. High release of aerosols was detected in the high temperature oxidation phase. The on-line measured data are collected into a database and are available for code validation and development.

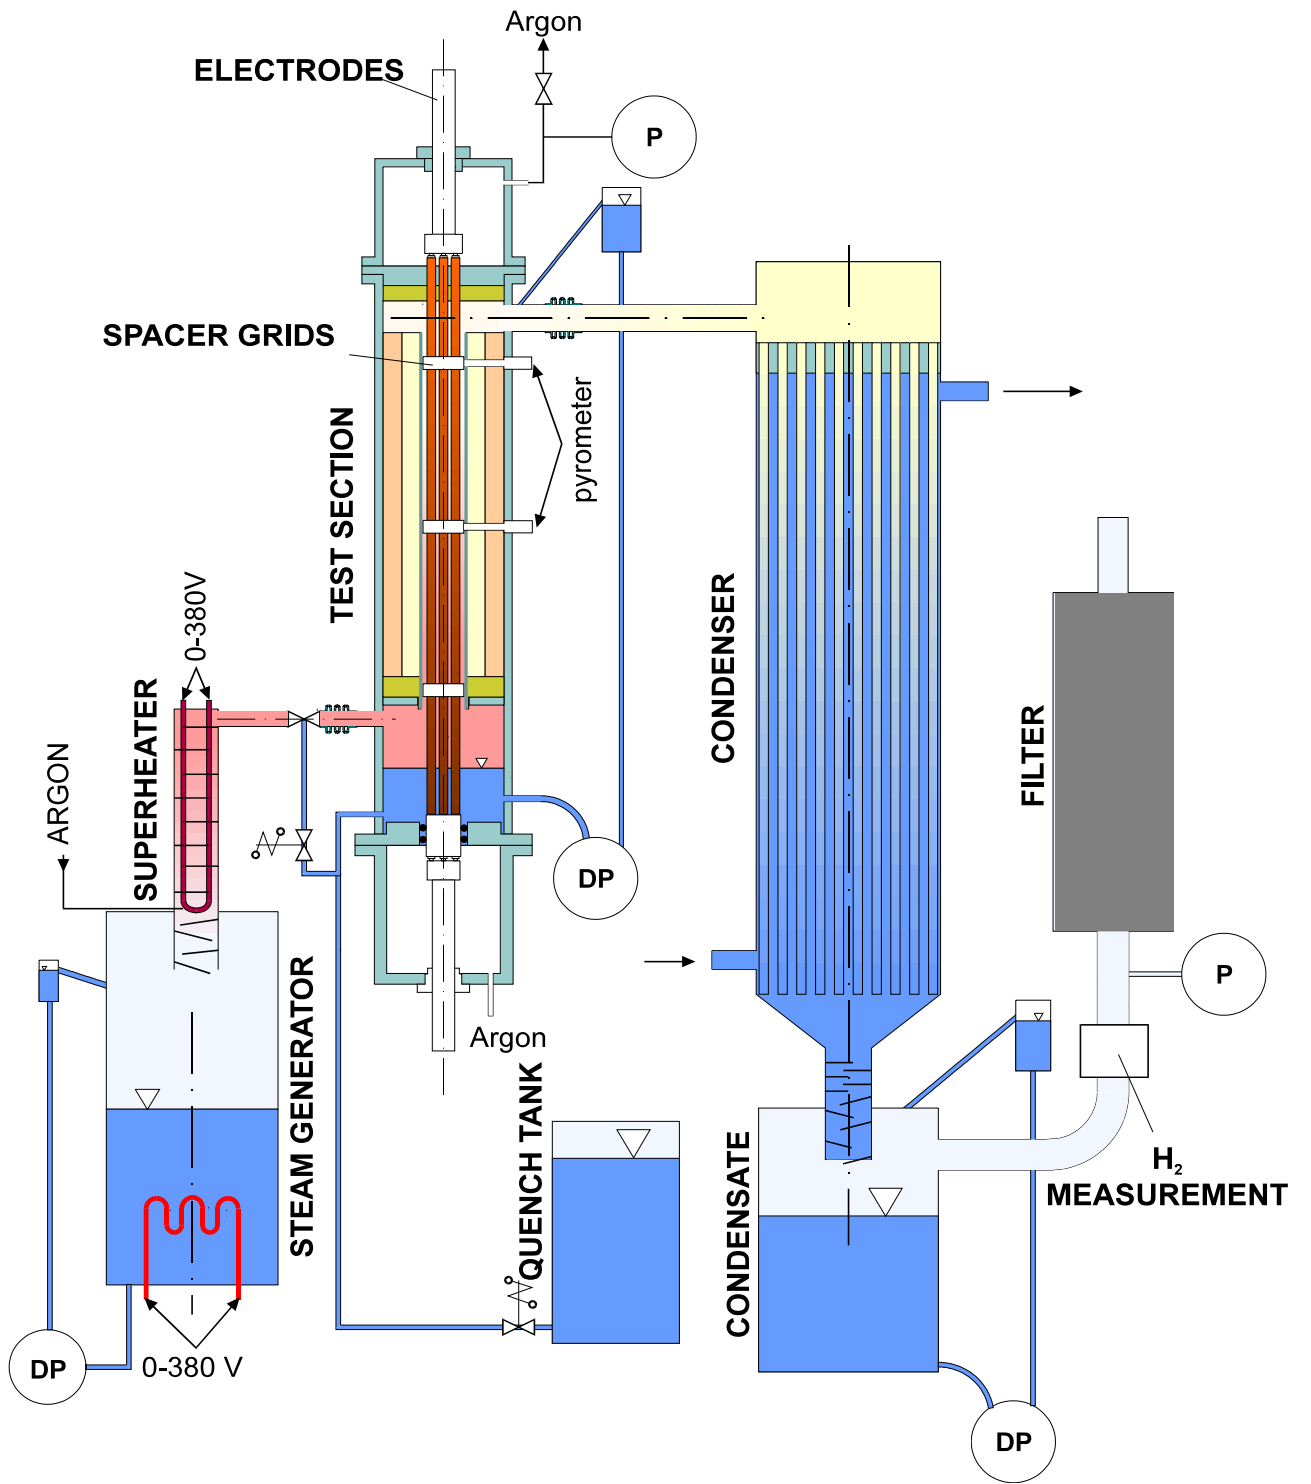
Fig. 1 Scheme of the CODEX facility

The current configuration of the CODEX (COre Degradation EXperiment) integral test facility represents the geometrical arrangement of a VVER-1000 reactor fuel assembly and has been constructed of VVER materials. A schematic view of the facility is shown in Fig. 1. The basic part of the facility is the test section comprising a seven rod bundle of 600 mm heated length. The rods are arranged in hexagonal geometry (Fig. 2 and 3), the external diameter of the cladding is 9,13 mm. The six peripheral rods are electrically heated by tungsten bars. The 3,0 mm diameter bars in the heated rods are surrounded with ring-shaped UO<sub>2</sub> pellets - 3,6% enrichment of U<sup>235</sup> - and enclosed in industrially fabricated Zr1%Nb alloy cladding. The central rod is a boron-carbide rod in steel cladding with Zr guide tube and is not heated (Fig. 6). The diameter of the hole in the pellet equals to 3,3 mm, while the external pellet diameter is 7,57 mm.

In the standard configuration of the facility the steam generator and superheater section of the facility provide argon and steam inlet flow for the test section during heating-up and cooling-down phases (Fig. 1). The 4 kW superheater and 6 kW steam generator powers produce high coolant temperatures (~600°C) for the experiments. In the CODEX-B4C test very low steam flowrate was foreseen and for this reason direct injection of room temperature water into the superheater was applied with manual regulation. The steam generator was in stand by conditions during the test, but was not used for steam supply.

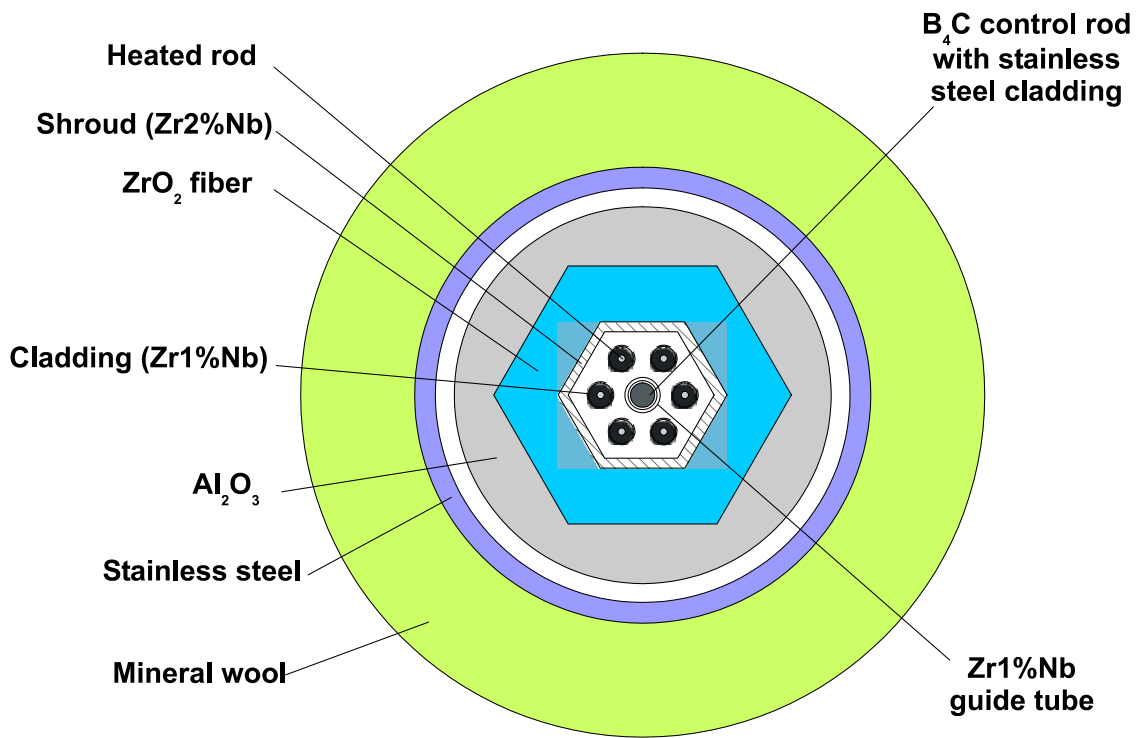
Fig. 2 Horizontal cross section of the CODEX-B4C bundle

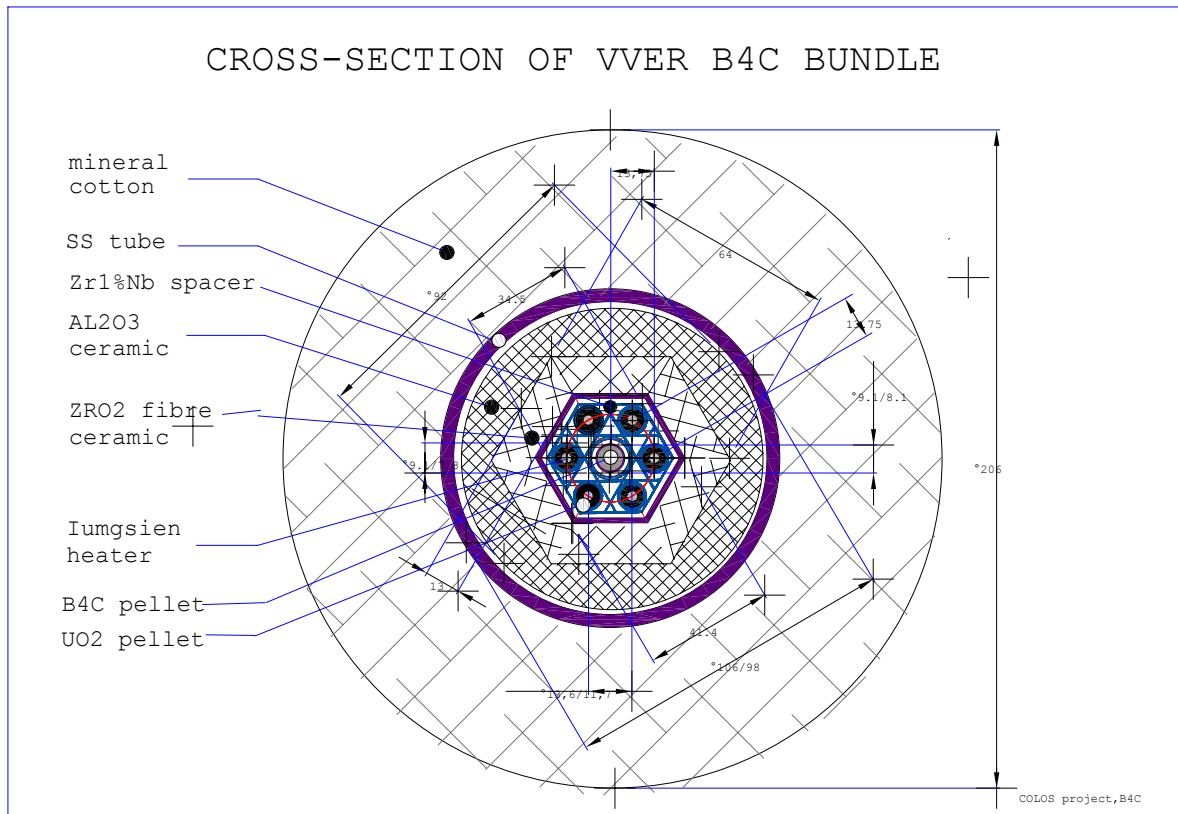
Fig. 3 Main geometrical parameters of the CODEX-B4C bundle

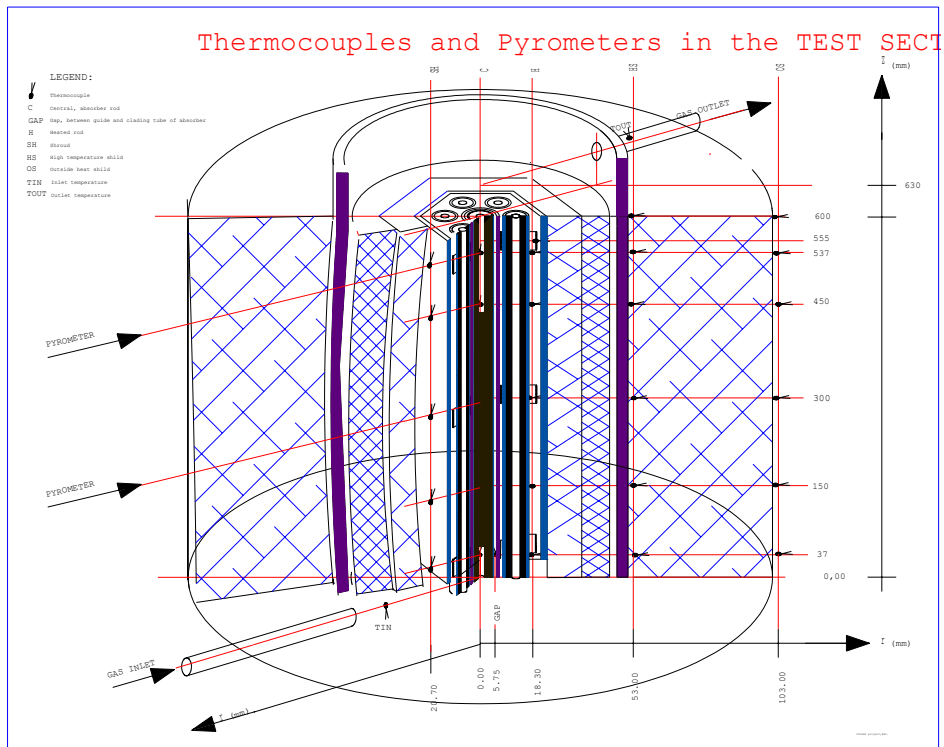
Fig. 8 Location of thermocouples and pyrometers in the CODEX-B4C bundle

The rods in the bundle are fixed by three spacer grids, which are made of Zr1%Nb alloy. The spacers are located at elevations of 55 mm, 300 mm and 555 mm. The bundle is placed into a hexagonal shroud. The shroud material is Zr2.5%Nb alloy. The shroud has no perforations and it is surrounded by several thermal insulation layers of ZrO<sub>2</sub> (13 mm thickness), Al<sub>2</sub>O<sub>3</sub> (92 mm external diameter), stainless steel (98 mm and 106 mm internal and external diameters) and mineral cotton (50 mm thickness). Between Al<sub>2</sub>O<sub>3</sub> and stainless steel layers a small air gap compensates the thermal expansion. The cross section of bundle is given in Fig. 2. The test section inlet and outlet junctions for the coolant gas are at 0 and 650 mm elevations, respectively (Fig. 5). Two observation windows make possible the temperature measurements at 300 and 465 mm elevations by pyrometers. An additional window at 550 mm is used for video recording.

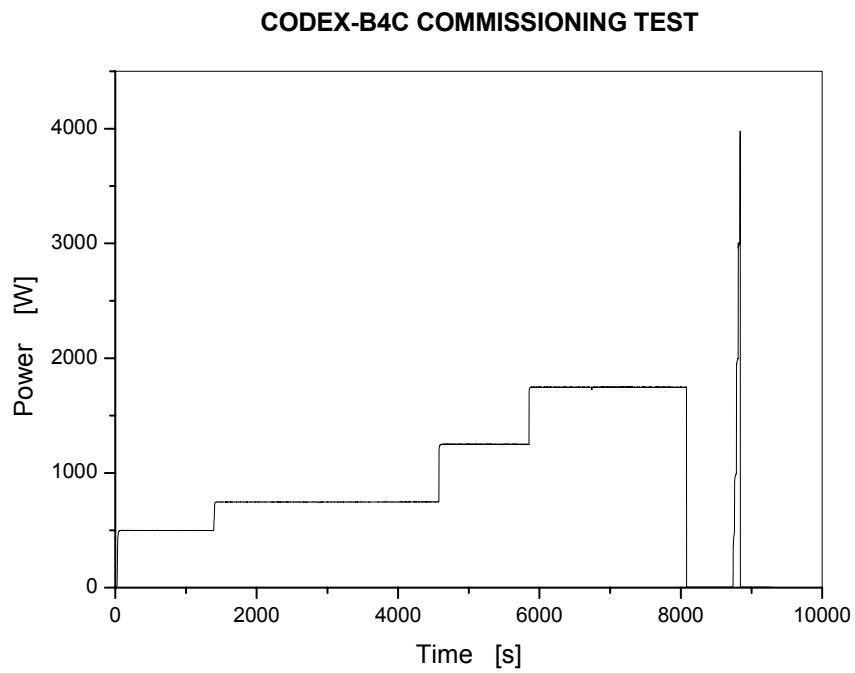
Fig. 14 Electrical power in the CODEX-B4C commissioning test

The commissioning test included a stepwise increase of power up to a final peak value of 4 kW in inert gas atmosphere (Fig. 14 and Fig. 15). The temperatures on the fuel rods risen above 1100 °C (Fig. 16). Continuous temperature increase was observed in the heat shield (Fig. 17). Thermocouple SH450 failed before the test and the temperatures

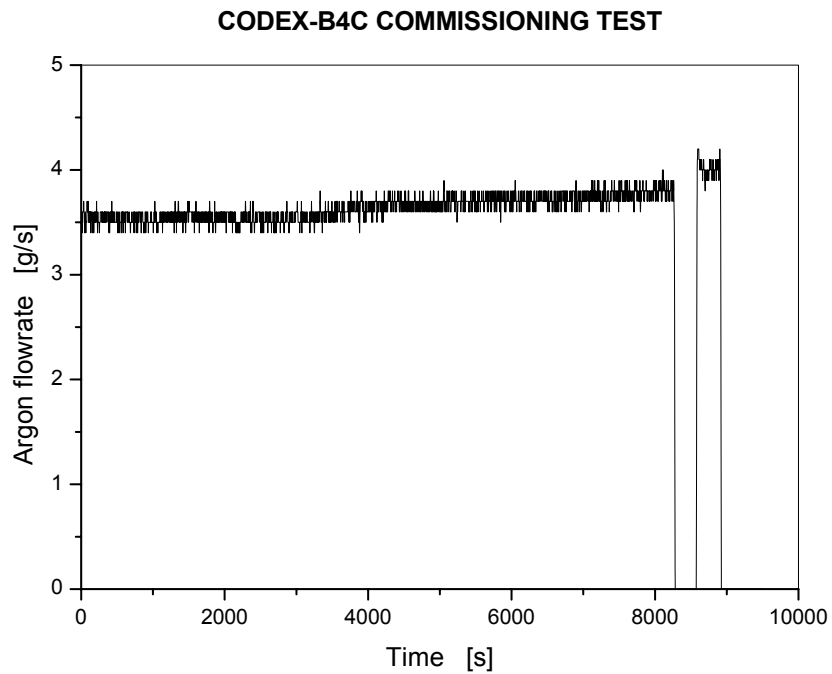
Fig. 15 Argon flowrate in the CODEX-B4C commissioning test

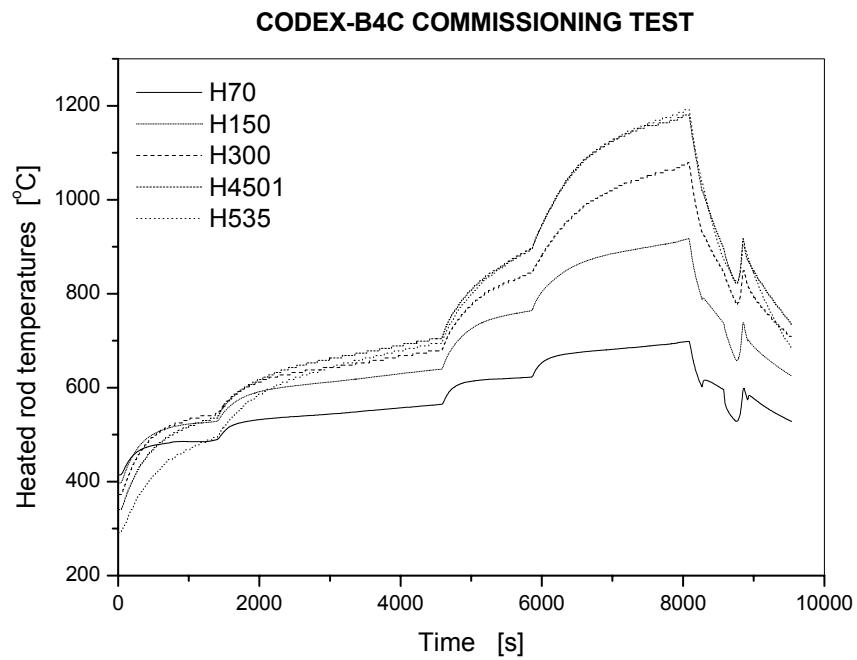
Fig. 16 Heated rod temperatures in the CODEX-B4C commissioning test

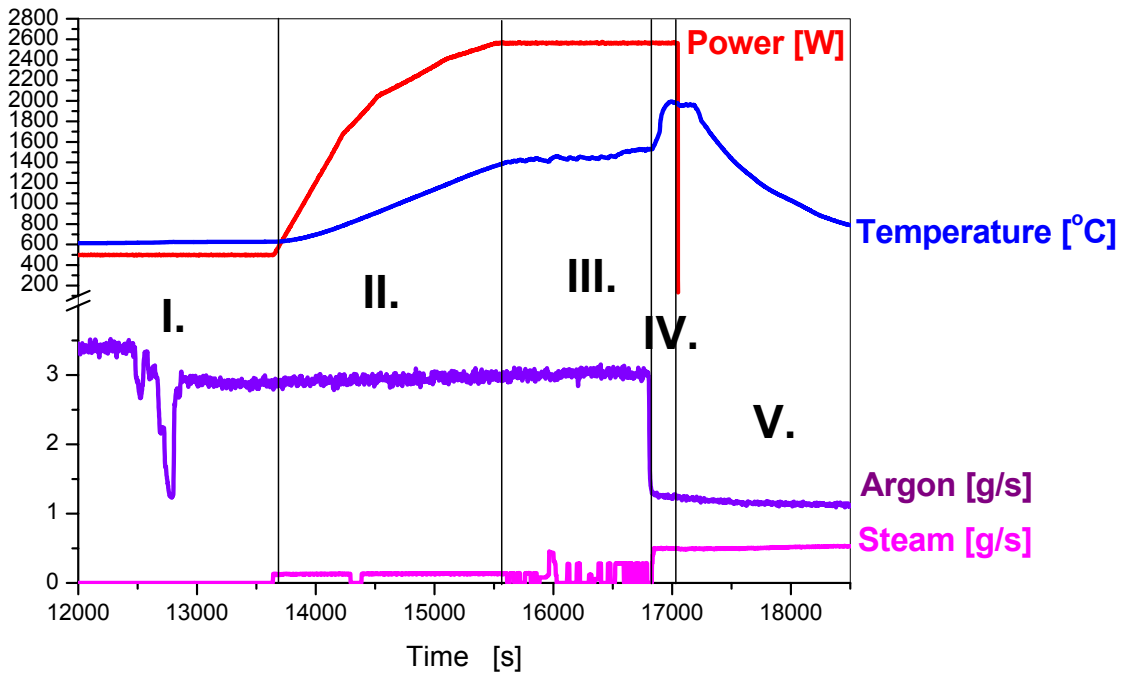
Fig. 22 Main phases of the CODEX-B4C test

The test conditions of CODEX-B4C experiment were selected on the basis of pre-test calculations [8],[9],[10] and were to simulate a severe accident scenario and emphasize the role of the control rod in the degradation process. The test included five main phases (see Fig. 22):

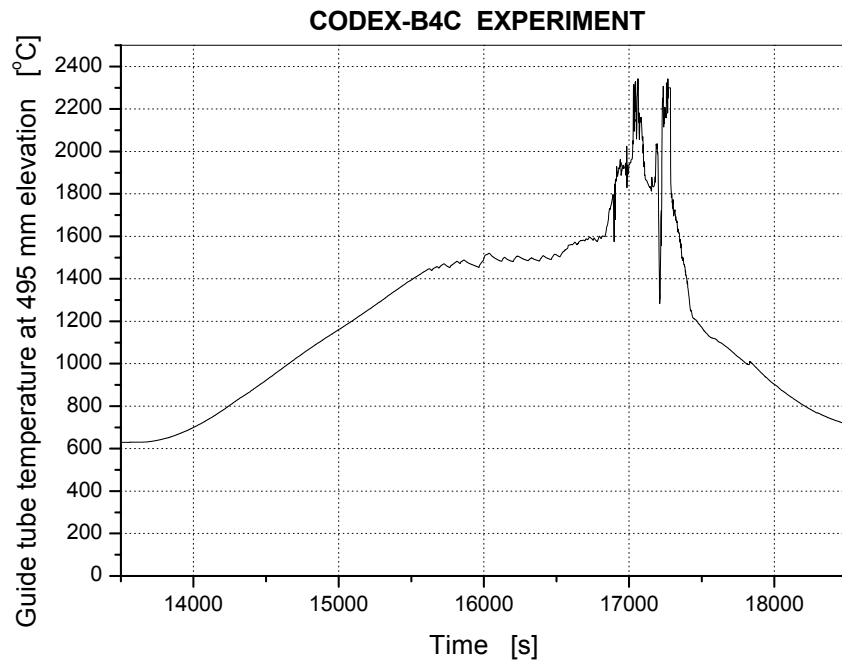
Fig. 28 GD495: Guide tube temperature at 495 mm

The temperatures increased until the initiation of cool-down. The highest temperatures were reached in the upper part of the bundle (~450 mm, Fig. 28, 33-34), but 2000 °C was seen at 300 mm elevation as well (Fig. 32). After switching off electric power some local temperature peaks were observed, probably as results of local oxidation and/or relocation processes. The temperatures measured in the gap between the central steel cladding and the guide tube were significantly lower than the surrounding heated rod temperatures (Fig. 25-27), these measurements correlated with the coolant temperatures more than with the rod temperatures. The maximum temperature ~2300-2400 °C was reached on the guide tube at 495 mm elevation (Fig. 28) and on the heated rods at 450 mm (Fig. 33-34). On the guide tube a second temperature peak with the same magnitude was also detected during the cool-down phase (Fig. 28).

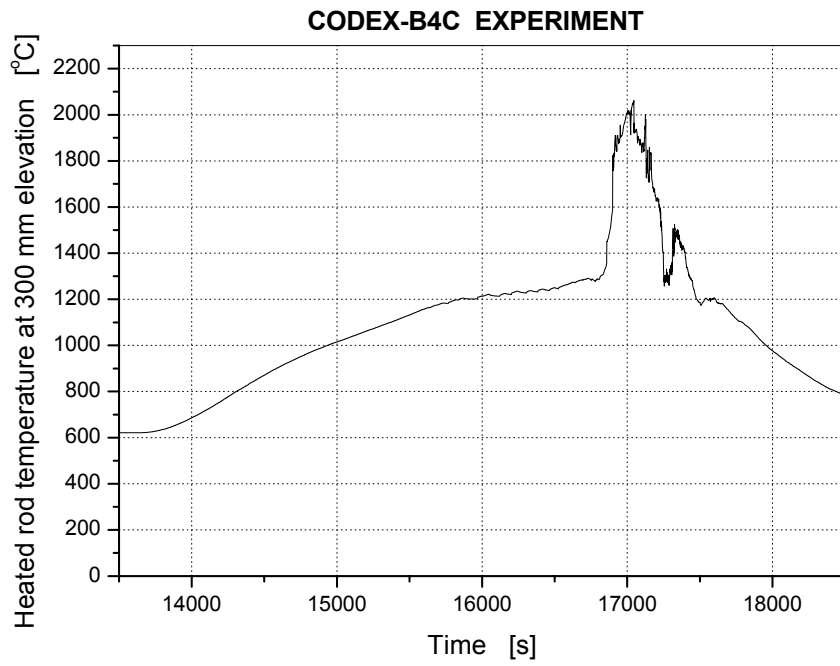
Fig. 32 H300: Heated rod temperature at 300 mm

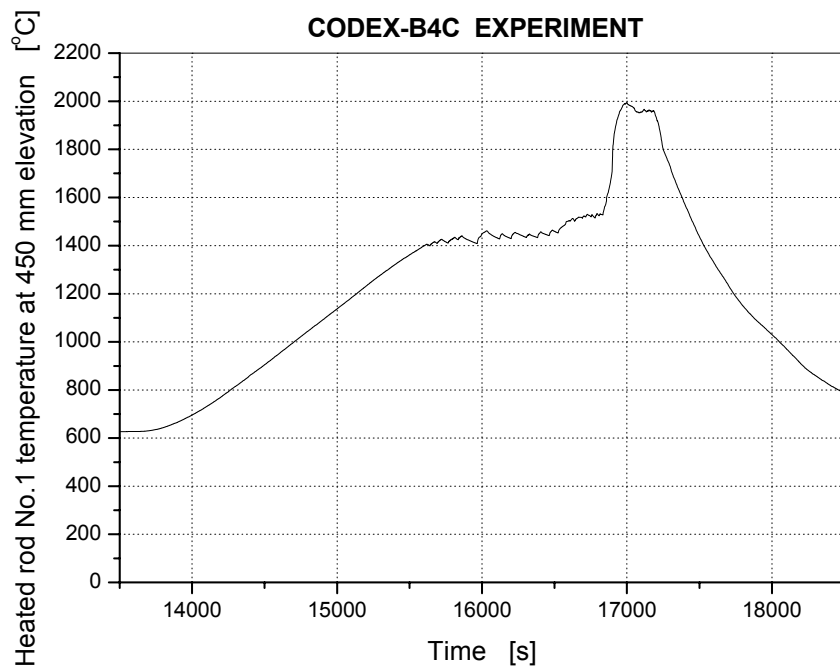
Fig. 33 H4501: Heated rod temperature at 450 mm, No. 1.

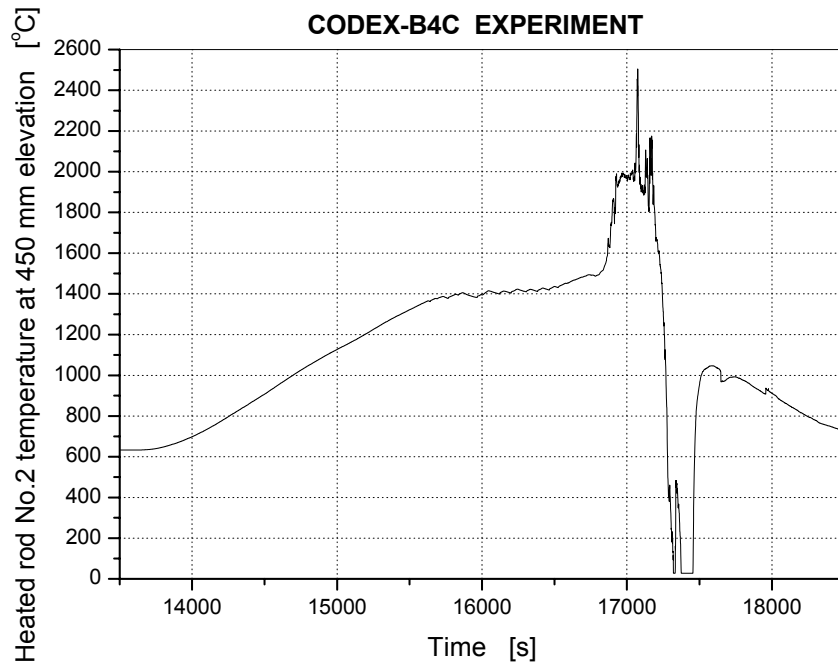
Fig. 34 H4502: Heated rod temperature at 450 mm, No. 2.

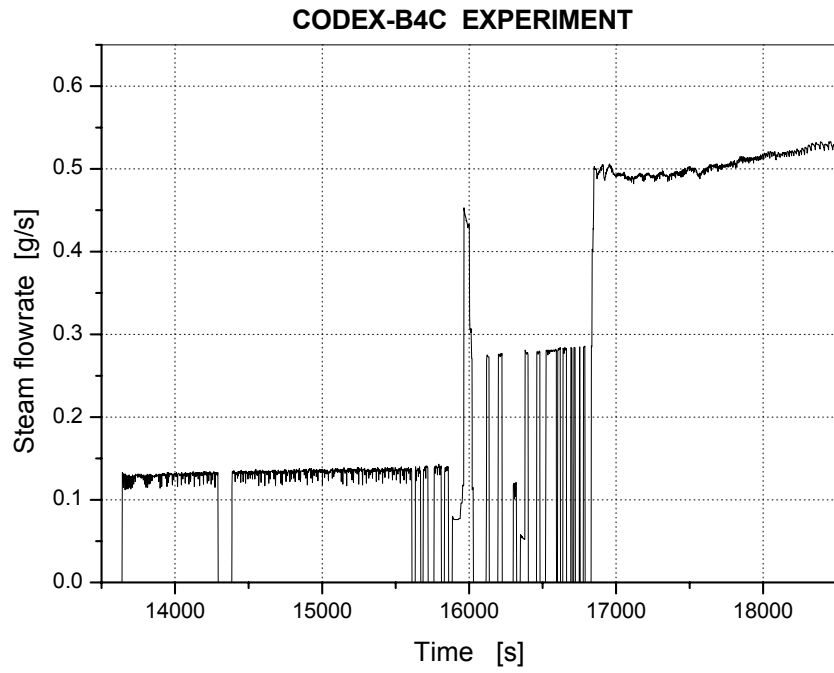
Fig. 62 STEAM: Steam flow

The argon flowrate was reduced from ~3 g/s to ~1,3 g/s (Fig. 63) and the steam flowrate was increased to 0,5 g/s (Fig. 62) in order to initiate temperature escalation. CO formation started about 3 minutes before the escalation (Fig. 73) and it could be considered as time of control rod failure (16600 s). At about 16900 s 2000 °C temperature was reached in the upper part of the bundle (Fig. 29, 32, 33-35). After the escalation phase the H<sub>2</sub> production increased together with CO (Figures 71 and 75). CO<sub>2</sub> appeared with some delay and no CH<sub>4</sub> was detected (Figures 72, 74 and 75).

The power was switched off (Fig. 64), but the coolant conditions were not changed at the initiation of cooling down (Fig. 62 and 63). This resulted in slow temperature decrease in the lower and central part of the bundle (e.g. Fig. 23). However the temperature measurements in the upper part indicated some temperature increase (Fig. 28-29), which was probably the result of local oxidation. During the cool-down period the gas production continued and the aerosol impactors indicated maximum release that time. Steam injection was stopped and cold argon was injected for final cool-down.

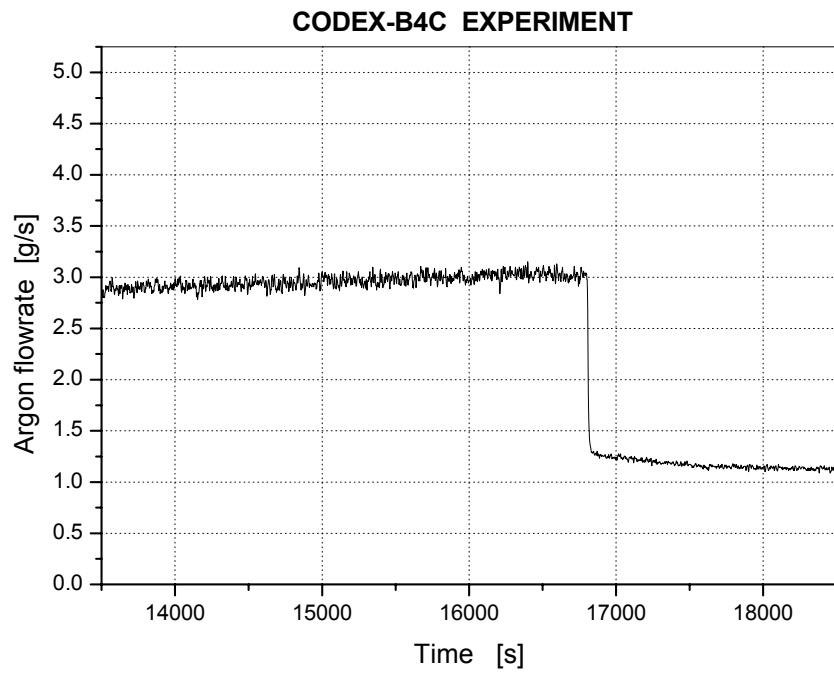
Fig. 63 ARGON: Argon flow

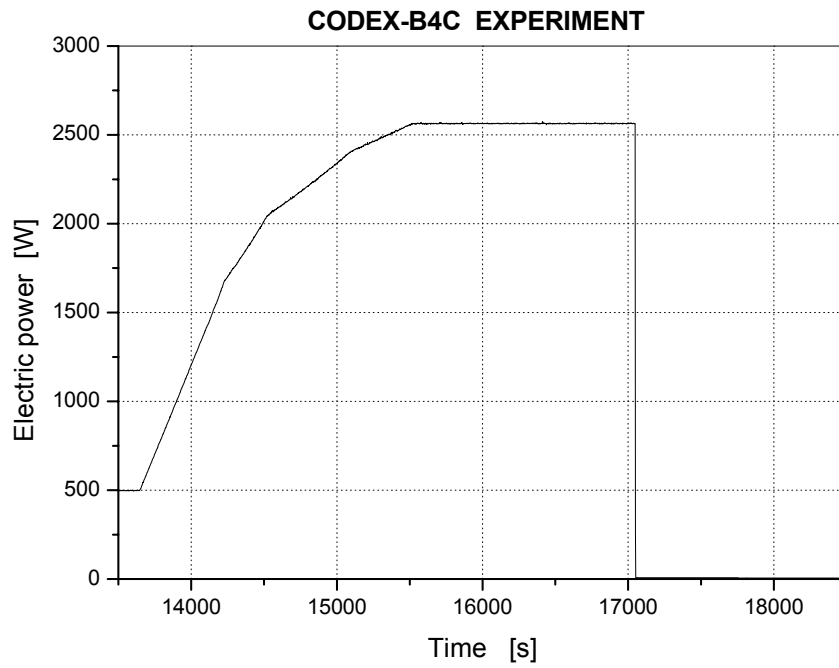
Fig. 64 POWER: Electric power

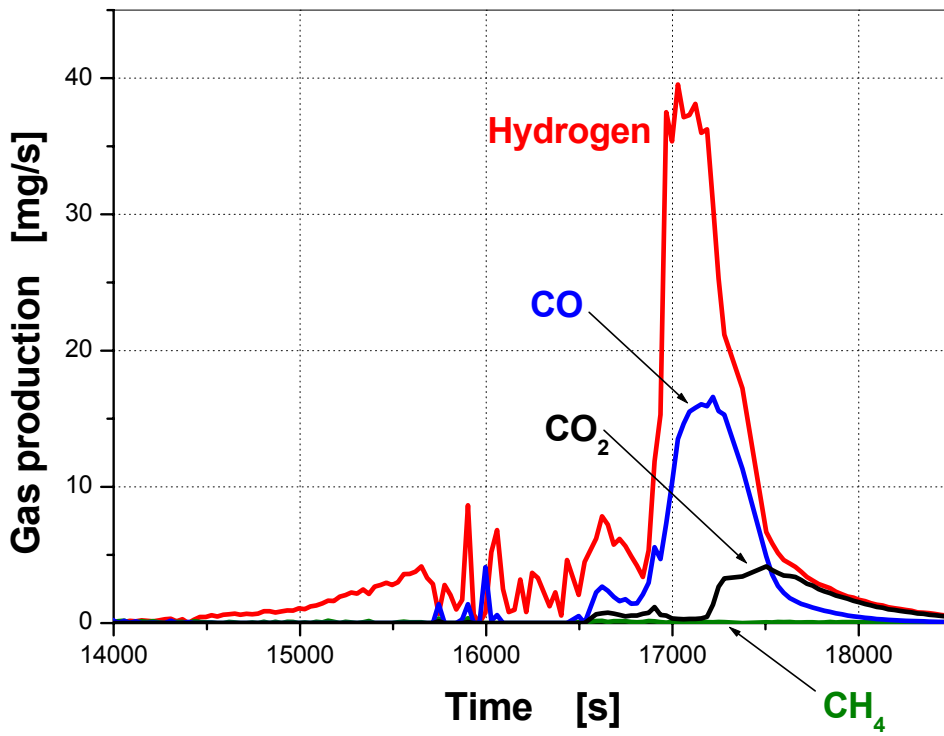
Fig. 75 Gas flowrates in the CODEX-B4C test

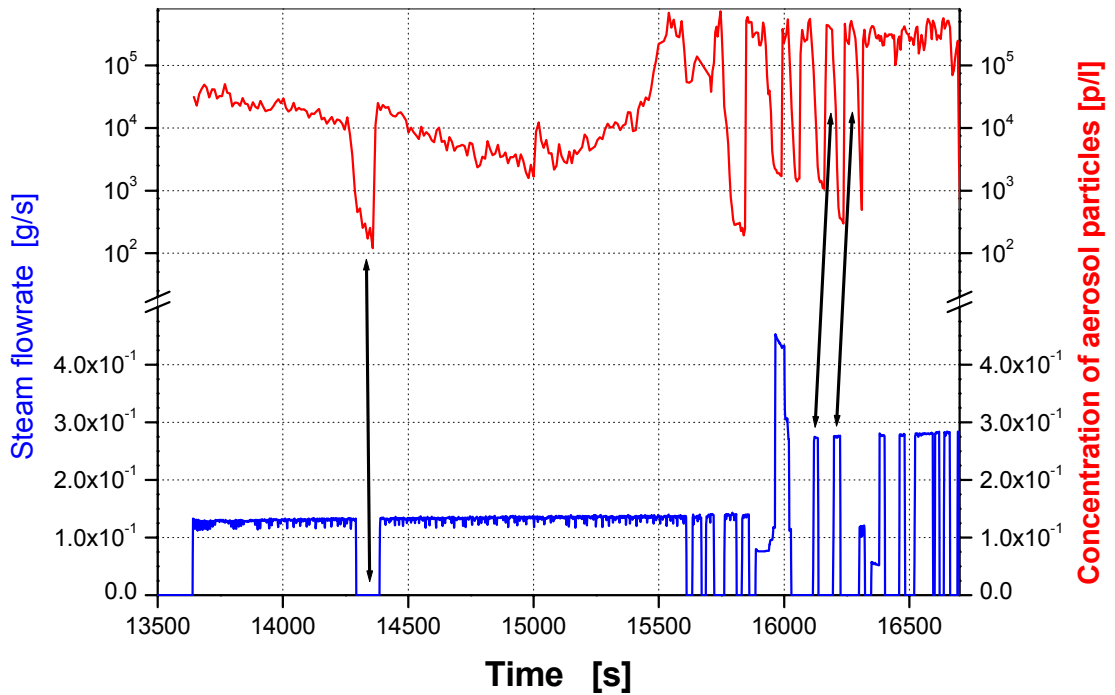
Fig. 89 Correlation between steam flowrate and aerosol particle concentration

The two particle counters indicated high release of aerosols when steam was available in the coolant (Figures 76-88). The number of particles increased after the beginning of steam injection. The steam supply was interrupted at ~14300 s for a short time and it resulted in a characteristic decrease of particle numbers (Fig. 62 and e.g. Fig 83). Dramatic increase was observed when the bundle temperature reached 1500 °C (e.g. Fig. 80). The typical number of particles in each measured range was close to 10<sup>6</sup>. The oscillating behaviour of the measured values was in direct correlation with the steam supply, which was in manual regulation mode. With no steam flow the number of particles decreased, while with available steam flow sharply increased (Fig. 89). It indicates that there was a strong correlation between the oxidation phenomena and the production of particles. The particle counters showed the start of the decrease of particle flow before the escalation period and it continued during cool-down.

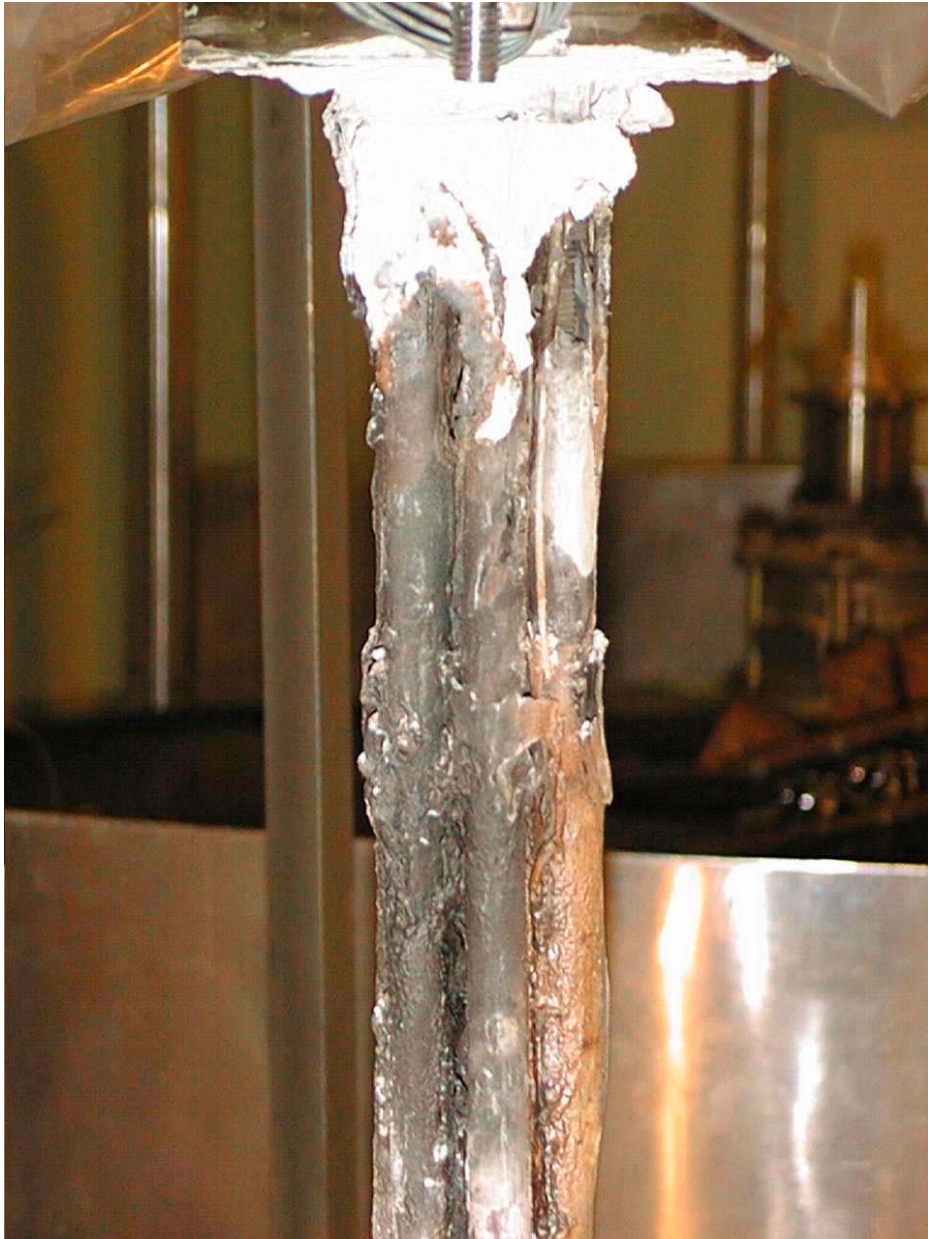
Fig. 90 View of the upper part of the CODEX-B4C bundle

The visual observation of the bundle indicated strong degradation. In the upper part the melting of the central rod produced some chemical compositions, which sticked together the rods (Fig. 90). The external surface of the shroud seemed to survive heavy oxidation (Fig. 91). The rod in the lower part was also oxidised and fragmented (Fig. 92). The shroud was very brittle and could be removed easily from the bundle. However after visual observation of the rods the shroud was put back to its original position and the structure was fixed with epoxy.

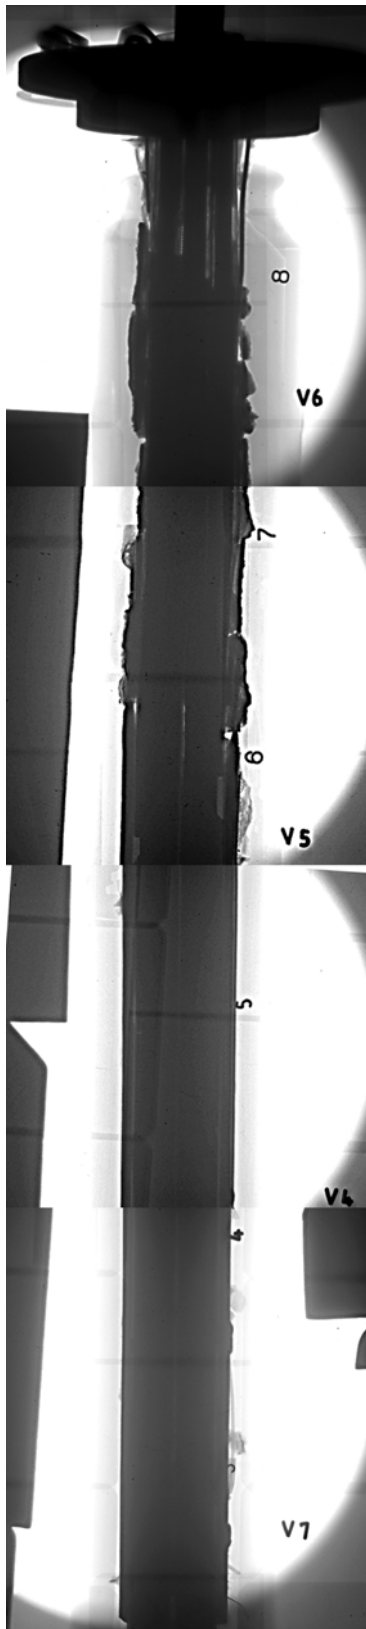
Fig. 97 X-ray radiography of the CODEX-B4C bundle after the experiment

Later useful information was offered about the damage of rod structure giving a map of the total length of the bundle, as it is shown in Figure 97. The upper part of the bundle showed heavy degradation, missing pieces of shroud could be seen close to the top. The lower part seemed intact. These pictures were taken at the dynamic radiography station at the Budapest Research Reactor.

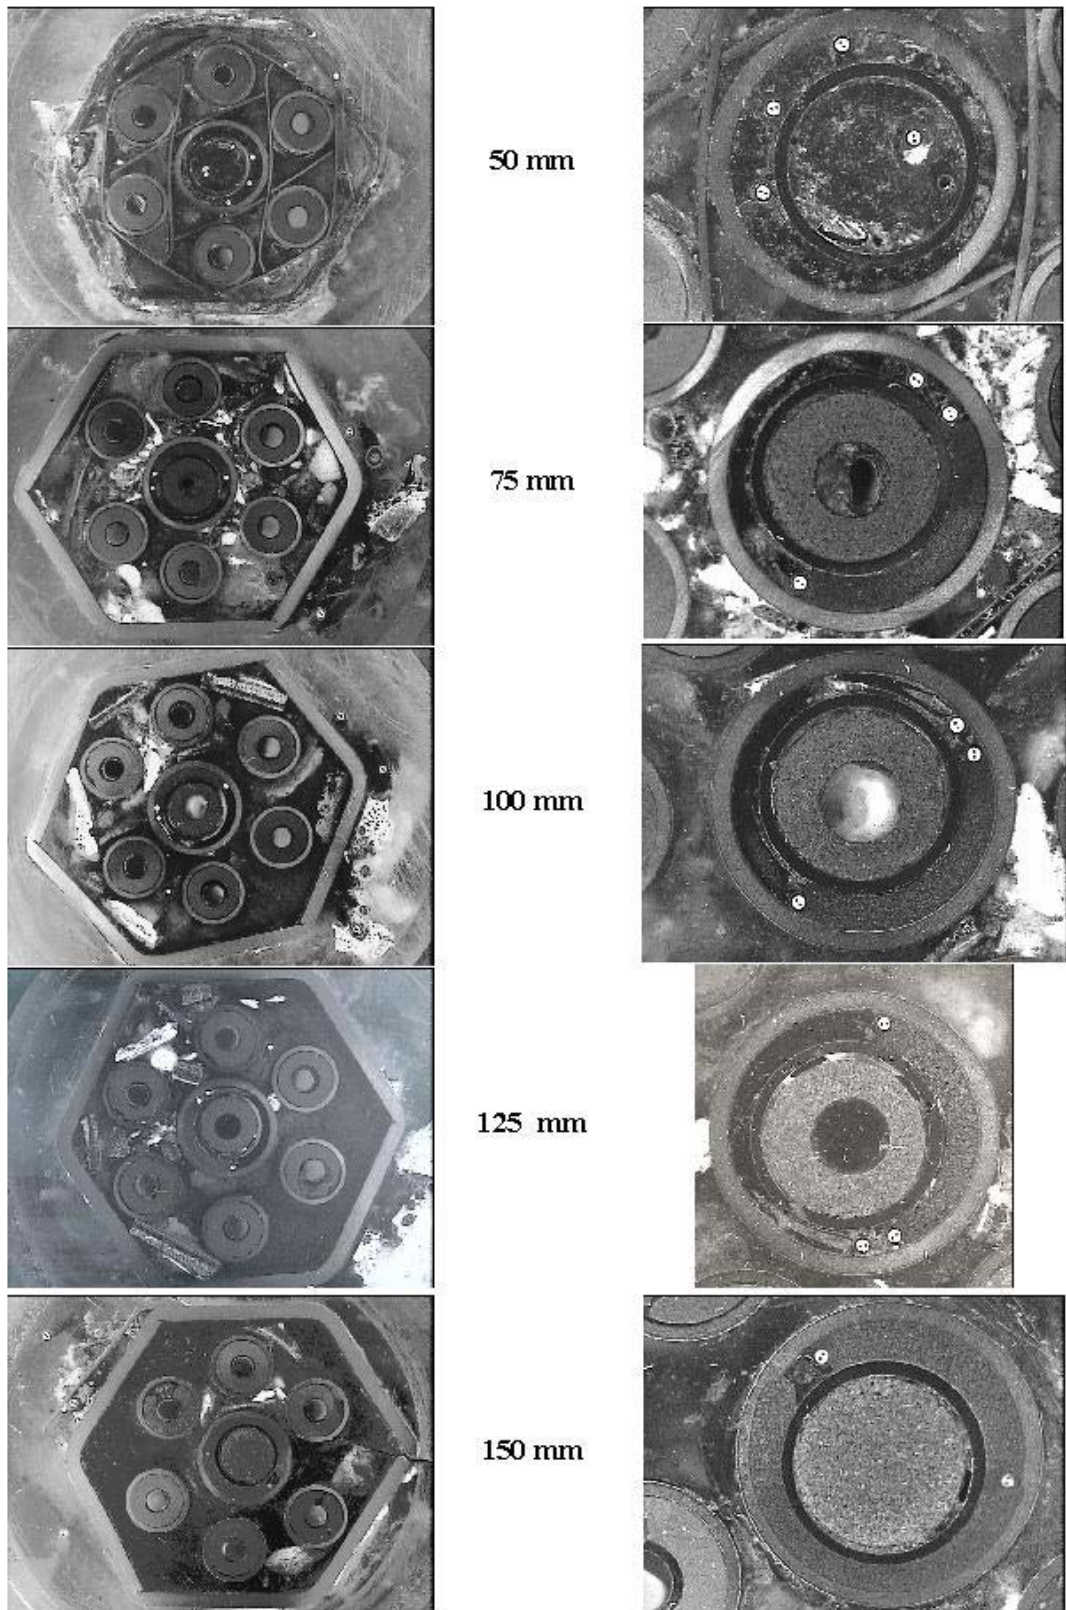
Fig. 98 Bundle cross sections (left column) and view of the control rod (right column) at elevations 50 mm, 75 mm, 100 mm, 125 mm, 150 mm

The main feature of the picture is, that the number of debris was very few (Fig. 98). One piece near to the central rod was from the upper spacer with oxide on both side and  $\alpha\text{-Zr(O)}$  layer in the middle. Ratio of their thicknesses was 1:1:1. A second interesting character had the molten metal between the stainless steel envelope of boron carbide and the guide tube. At this height it was flowed around the full circle of the gap (see Fig. 98). The oxide layer formed during the steam oxidation was not layered as at the previous elevation but formed a tight phase on the surface of zirconium alloy.

At elevation 410 mm the bundle was heavily damaged (Fig. 99). Large part of the shroud was deformed. Its shape remained slightly better in the vicinity of heated rods No.1 and 2. Presumably the streaming gas was slower at this side, because at lower elevations debris were up to higher level as could be seen at 125 mm (Fig. 98) and resulted in lower streaming rate.

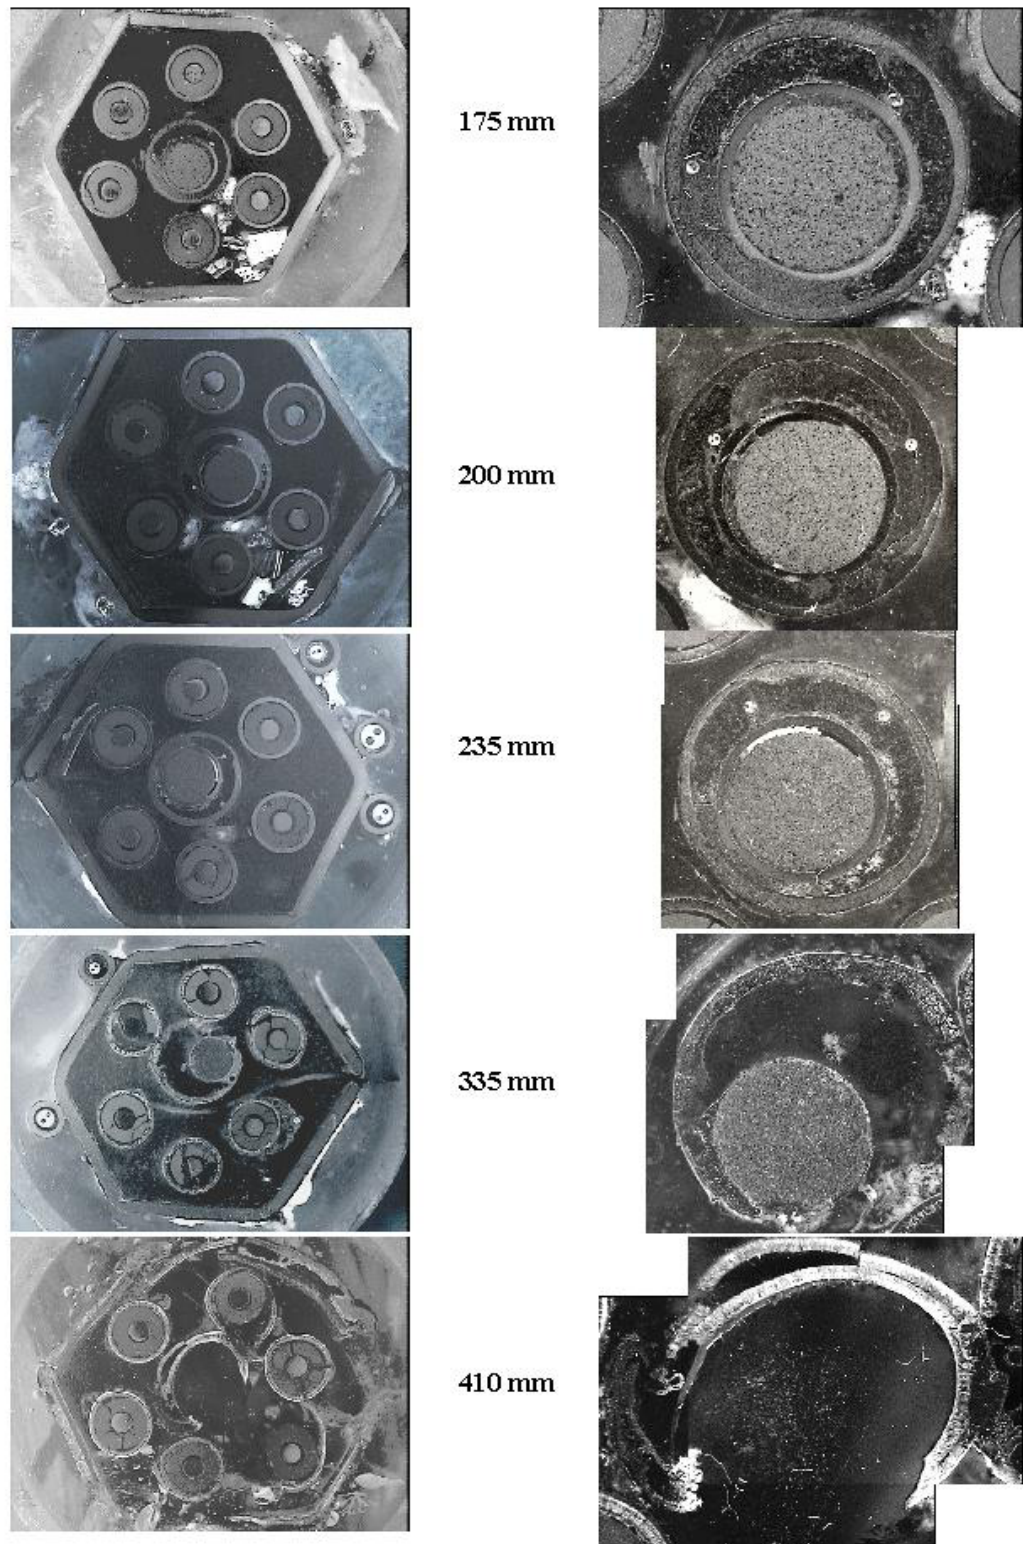
Fig. 99 Bundle cross sections (left column) and view of the control rod (right column) at elevations 175 mm, 200 mm, 235 mm, 335 mm, 410 mm

The bundle had the original geometry at this elevation too (Fig. 99). The main conclusions drawn from this picture of the cross section are the followings: the debris was between the heated rods in the right side bottom corner, it fell down from the top part of shroud broken down just at this side. The molten metal phase in the gap of central rod was substantially less than at elevation 150 mm (about 1/4 of total circle as can be seen in Fig. 99). The eutectic molten material thinned the steel cladding of B<sub>4</sub>C. The oxide layers on the heated and control rods were tight, homogenous phases as shown in Fig. 102 indicating high temperature (> 1000  $^{\circ}\text{C}$ ).

The bundle structure was near to the original shape but the control rod was slightly damaged (Fig. 99). The shroud has been broken up at the same edge as at previous cuts. (The shroud was welded at this corner, that is why the strength of the shroud material was lower enough to become broken during the slicing process.) Only two debris pieces can be seen. Both the Zr1%Nb guide tube and the steel cladding of absorber material has been thinned at the gap side by the eutectic material flowing down. The gap was filled with eutectic metal on 1/8 circumference only.

At the control rod the oxidized and opened up Zr1%Nb guide tube remained only (Fig. 99). Because this tube has been oxidized both on their outer and inner surface, it has been broken into two layers when the oxide phases met each other. The closely equal thickness of the two layers indicated, that the oxide formation rates were the same on both sides as shown in Fig. 106. The symmetrical oxide scale indicated that the guide tube opened in the early phase of the experiment and during the high temperature escalation the steam had access to the internal surface as well.

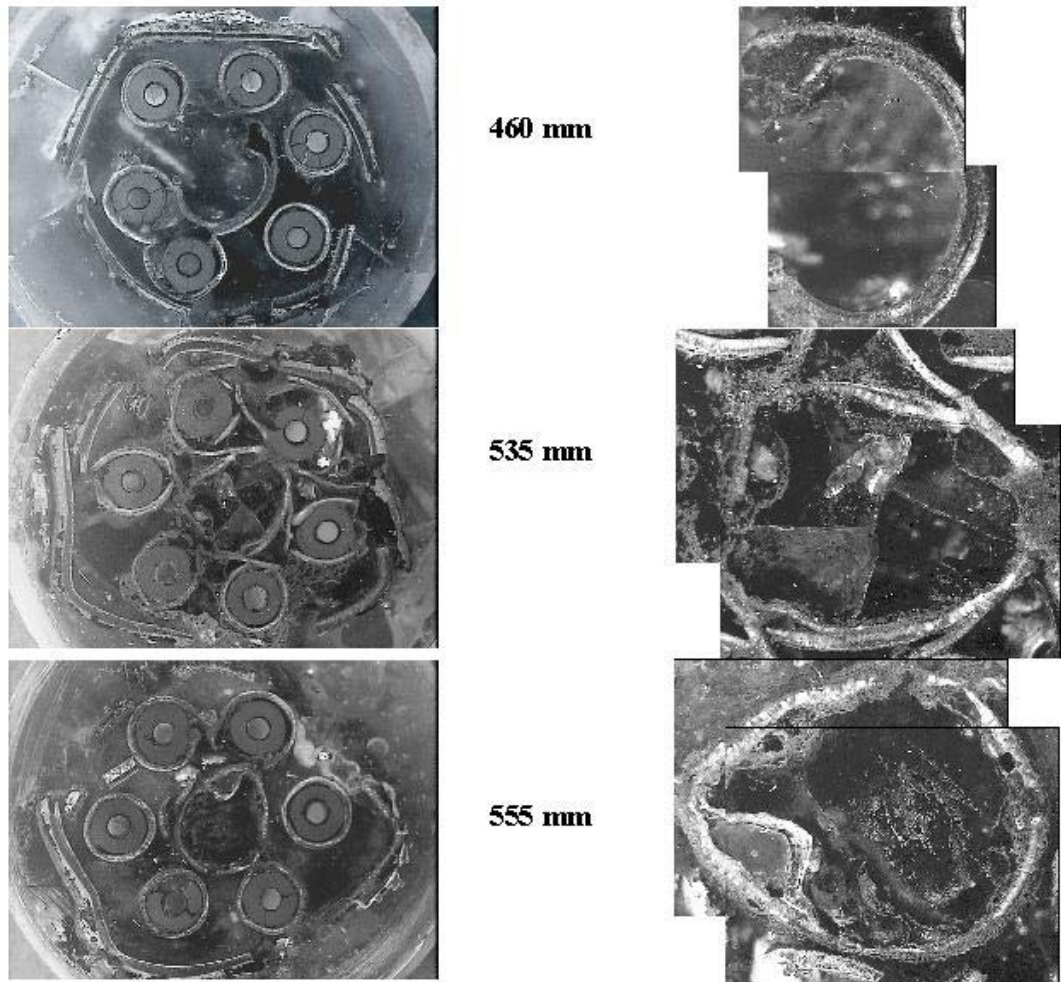
Fig. 100 Bundle cross sections (left column) and view of the control rod (right column) at elevations 460 mm, 535 mm, 555 mm

At this elevation the damage of the bundle was not stronger than at 410 mm (Fig. 100). The heated rods had their oxidized cladding on the original position except those two, where the opened absorber guide tube hurt the rigid oxide layer of the rods. The guide tube has been fully oxidized and it looked like at the 410 mm elevation. However the shroud was more damaged and has been broken into small pieces. Certainly the debris at the bottom of the bundle was originated mainly from this and higher elevation shroud.

At this height the upper spacer was built in (Fig. 100). It resulted in a stronger damage than at lower and higher levels. The mechanical force of the spacer kept the rigid oxidized zirconium alloy claddings around the uranium dioxide pellets. Some interactions of pellet, eventually oxidation was found only on the heated rod at the top of the cross section (Fig.108) Even the heavily oxidized guide tube has been fixed in its original position, of course without boron carbide pellet and steel cladding. The fully oxidized shroud has been broken up at many places.

The highest level cut has been prepared at 50 mm lower than the top of the bundle (Fig. 100). The damage of heated rods and the central control rod was slightly less than at lower elevations. Only the shroud ruined more heavily here than at lower levels. Certainly the broken pieces of shroud were falling down resulting large part of debris inside and outside the bundle. The uranium dioxide pellets and around them the fully oxidized cladding were fixed by the tungsten heaters. Chemical interaction was found only at heated rods in the top of the cross section, where the metal envelope of thermocouple inlet accessory resulted in eutectic interaction with the zirconium cladding and some extent with the UO<sub>2</sub> pellet (Fig. 109). Even the guide tube was fully oxidized, it remained in the central position with enlarged diameter but with full circle with deformed shape. Similar splitting to two layers could be seen as at lower elevations (Fig. 100).
