**KFKI-2003-01/G  
REPORT**

**CODEX-B4C EXPERIMENT:  
CORE DEGRADATION TEST  
WITH BORON CARBIDE CONTROL ROD**

**Hungarian Academy of Sciences  
CENTRAL  
RESEARCH  
INSTITUTE FOR  
PHYSICS**

The CODEX-B4C bundle test has been successfully performed on 25<sup>th</sup> May 2001 in the framework of the COLOSS project of the EU 5<sup>th</sup> FWP. The high temperature degradation of a VVER-1000 type bundle with B<sub>4</sub>C control rod was investigated with electrically heated fuel rods. The experiment was carried out according to a scenario selected in favour of methane formation. Degradation of control rod and fuel bundle took place at temperatures ~2000 °C, cooling down of the bundle was performed in steam atmosphere. The gas composition measurement indicated no methane production during the experiment. High release of aerosols was detected in the high temperature oxidation phase. The on-line measured data are collected into a database and are available for code validation and development.

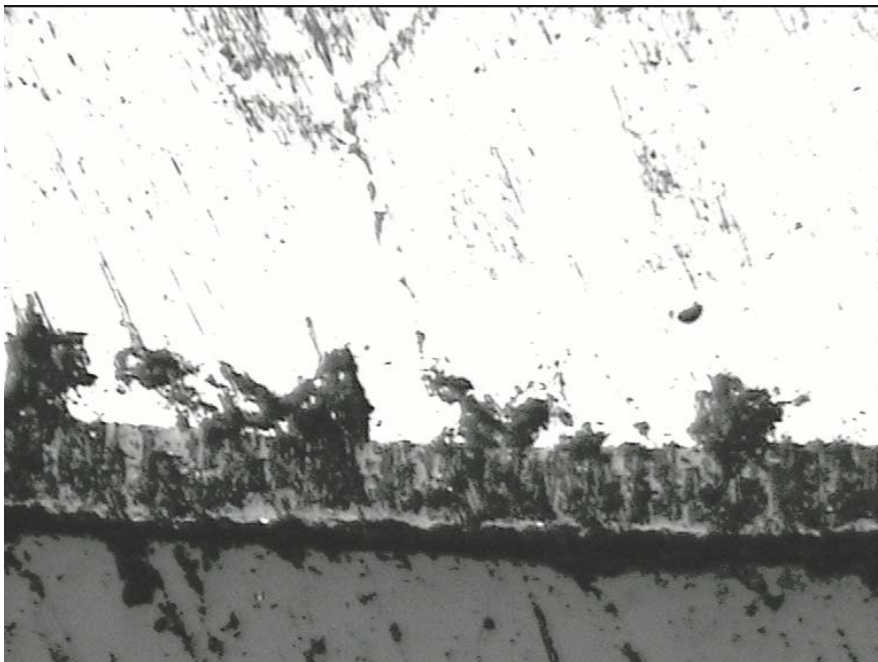
Fig. 102 Oxide layer on heated rod Nr.6 at 175 mm elevation

The bundle had the original geometry at this elevation too (Fig. 99). The main conclusions drawn from this picture of the cross section are the followings: the debris was between the heated rods in the right side bottom corner, it fell down from the top part of shroud broken down just at this side. The molten metal phase in the gap of central rod was substantially less than at elevation 150 mm (about 1/4 of total circle as can be seen in Fig. 99). The eutectic molten material thinned the steel cladding of B<sub>4</sub>C. The oxide layers on the heated and control rods were tight, homogenous phases as shown in Fig. 102 indicating high temperature (> 1000  $^{\circ}\text{C}$ ).

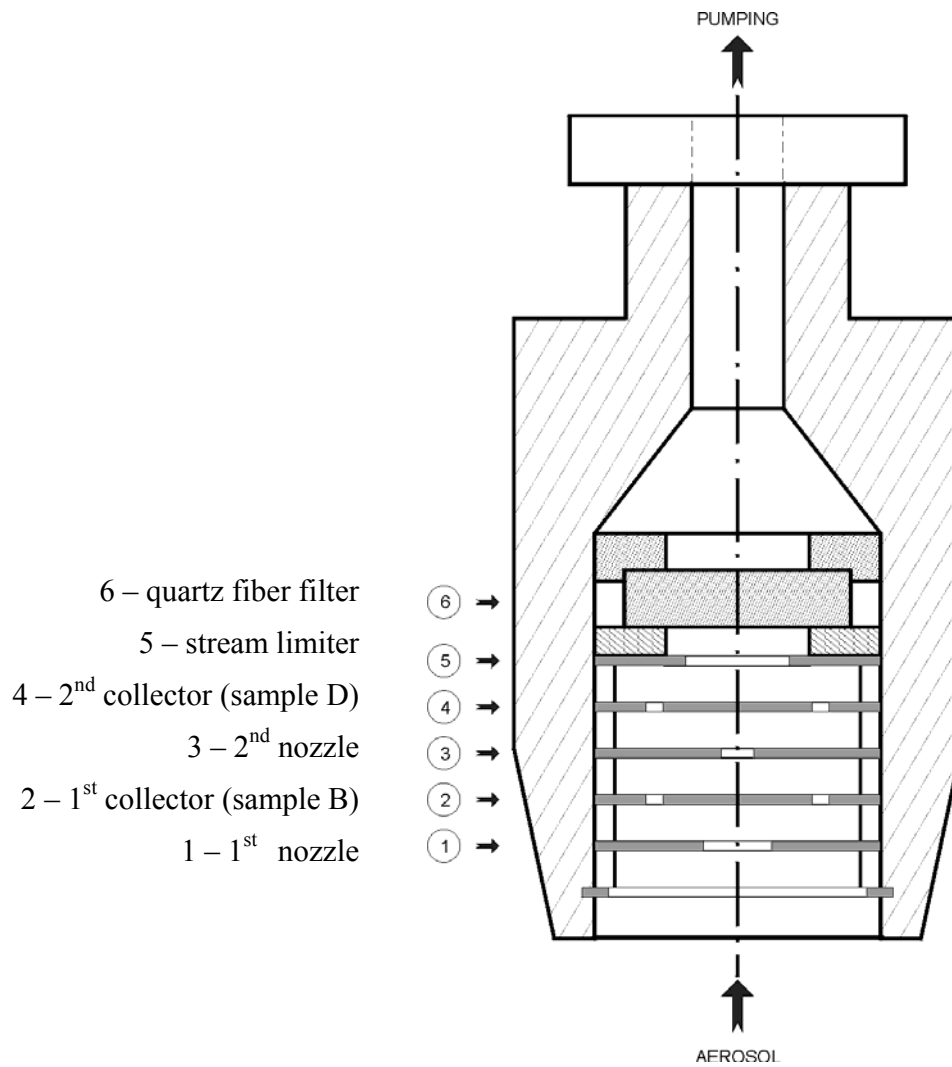
Fig. 115 Scheme of impactor sampler
