KFKI 1/2008

**CODEX-CT-1 EXPERIMENT:  
QUENCHING OF FUEL BUNDLE  
AFTER LONG TERM OXIDATION  
IN HYDROGEN RICH STEAM**

**Z. Hózer, P. Windberg, I. Nagy, L. Matus, N. Vér,  
M. Kunstár, A. Vimi, M. Horváth, T. Novotny, E. Perez-Feró, A. Pintér, M. Balaskó**  
Hungarian Academy of Sciences  
KFKI Atomic Energy Research Institute  
H-1525 Budapest, P.O.Box.49, Hungary

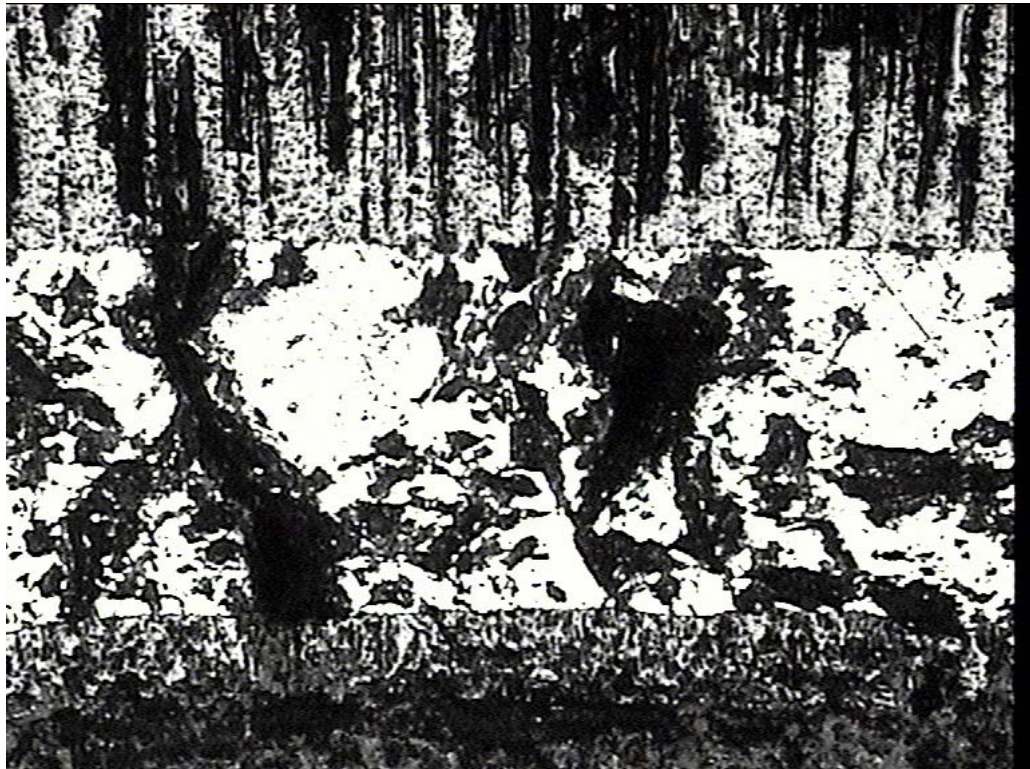
Fig. 86. Rod No. 1 at 710 mm elevation with external (top) and internal (bottom) oxide scales

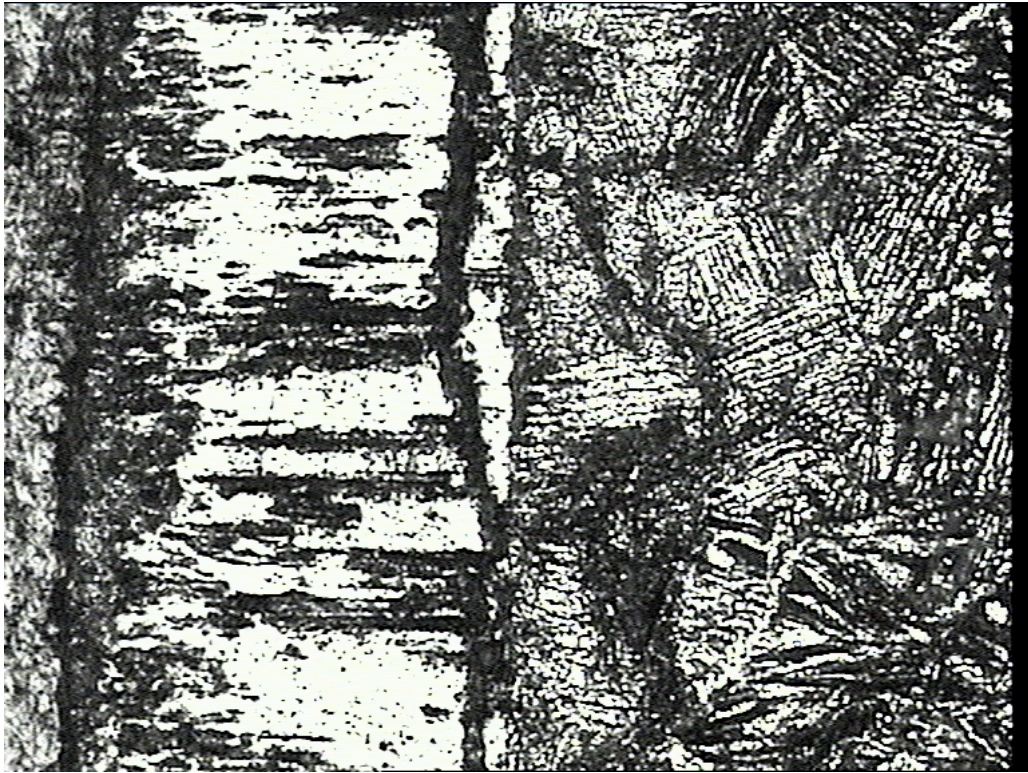
Fig. 87. Oxide scale on the shroud at 810 mm elevation

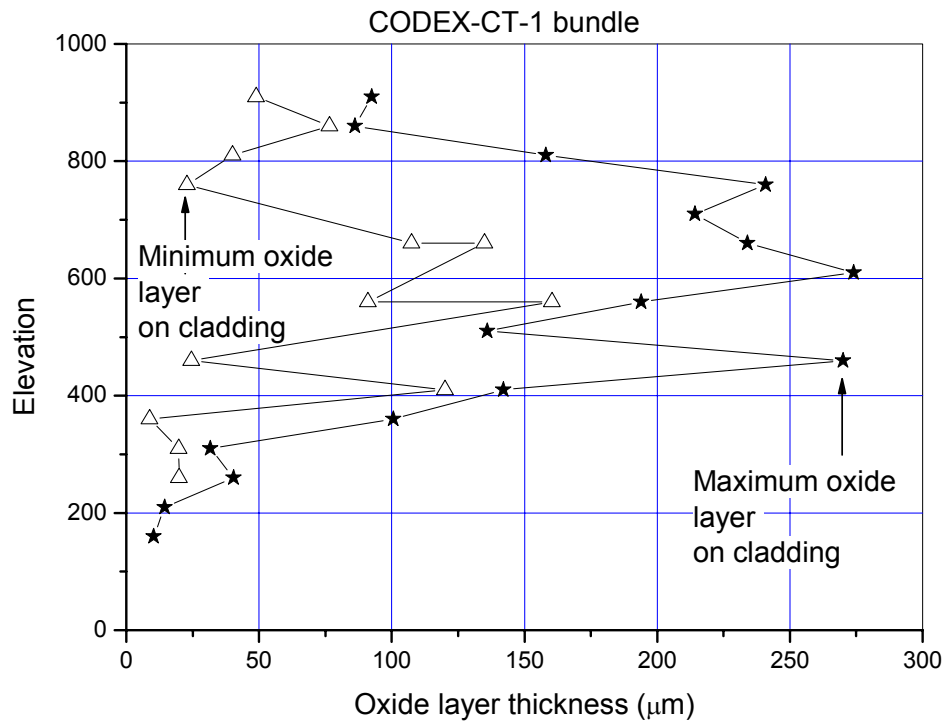
Fig. 88. External oxide layer thickness on cladding tubes

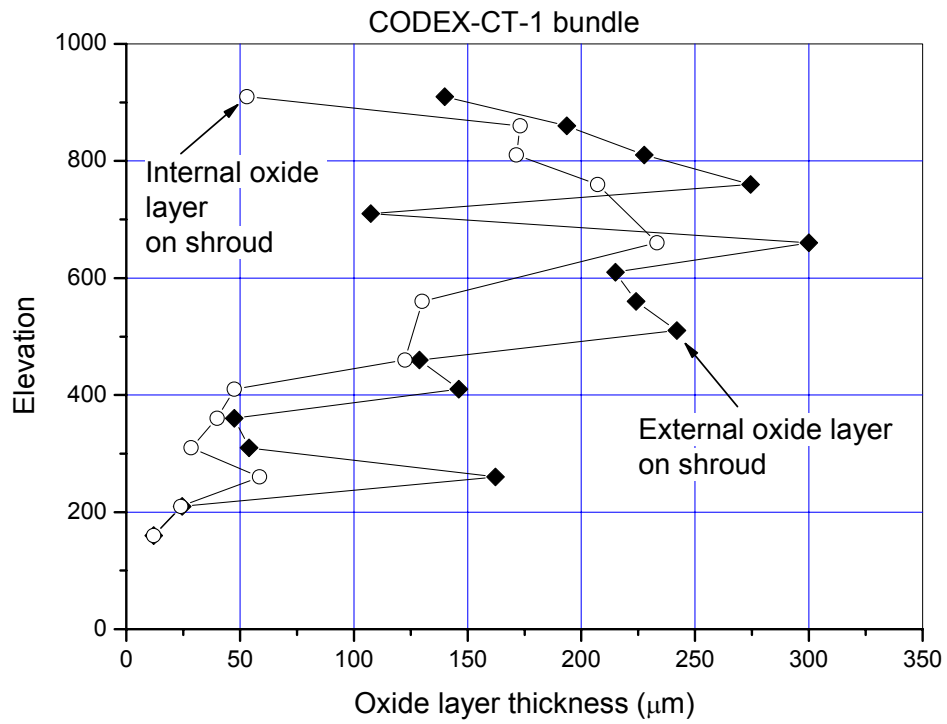
Fig. 89. Oxide layer thickness on shroud
