KFKI 2/2008

**CODEX-CT-2 EXPERIMENT:
LONG TERM TREATMENT IN
HIGH TEMPERATURE HYDROGEN
AND WATER QUENCHING
OF A FUEL BUNDLE**

**Z. Hózer, P. Windberg, I. Nagy, L. Matus, N. Vér,
M. Kunstár, A. Vimi, M. Horváth, T. Novotny, E. Perez-Feró, A. Pintér, M. Balaskó**
Hungarian Academy of Sciences
KFKI Atomic Energy Research Institute
H-1525 Budapest, P.O.Box.49, Hungary

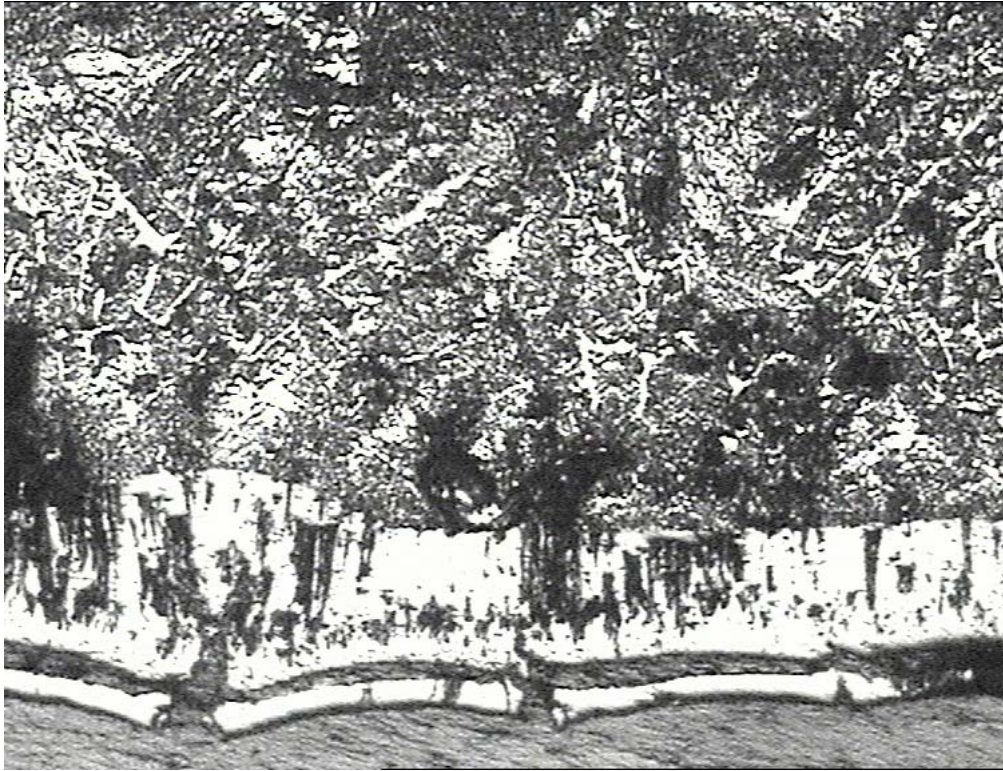
Fig. 62. Spalling oxide scale on rod No. 1 at 350 mm elevation

The oxide layer thicknesses were measured in several positions on each fuel rod and on the wall of shroud in each cross section. The oxide scale on the fuel rods had layered structure (Fig. 63) and the external oxide scales were spalling from the cladding (Fig. 62). The oxide scale on both internal and external surfaces of the shroud had more compact structure without layers (Figs. 64 and 65, Table 12). The axial oxidation profiles are shown in Figures 66 and 67. The maximum oxide layer was observed on the external surface of the shroud, where 300 μm thickness was measured at 700 mm elevation. On the internal surface of the shroud and on the external surface of the cladding tubes the oxide layer thickness was

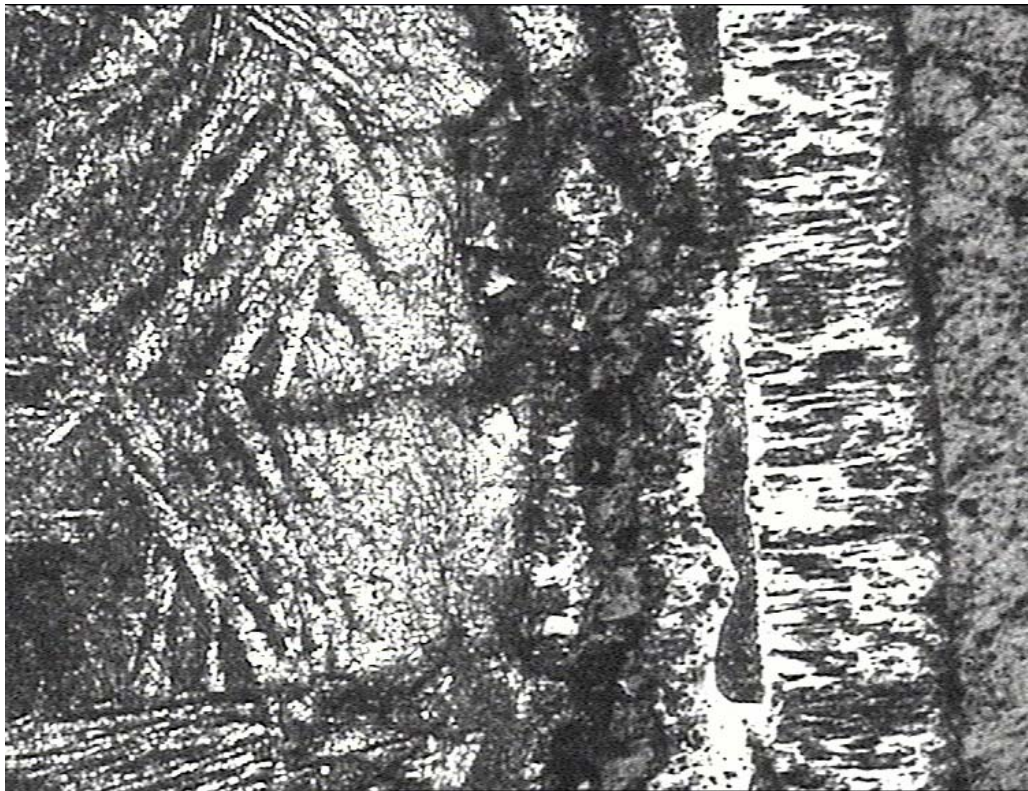
Fig. 65. Internal oxide scale on the shroud at 750 mm elevation
