Manuscript of the article: Sándor Szalai, Kitti Szokoli, Mohamed Metwaly, Delineation of landslide endangered areas and mapping their fracture systems by the pressure probe method. Appeared in: Landslides, 2014, Volume 11, Issue 5, pp. 923-932., doi: 10.1007/s10346-014-0509-6, ISSN: 1612-510X.

## Delineation of Landslide Endangered Areas and Mapping their Fracture Systems by the Pressure Probe method

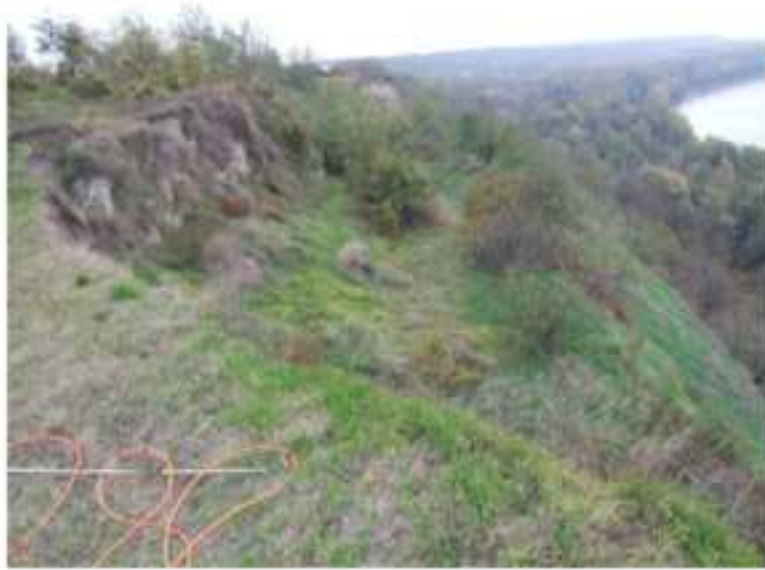
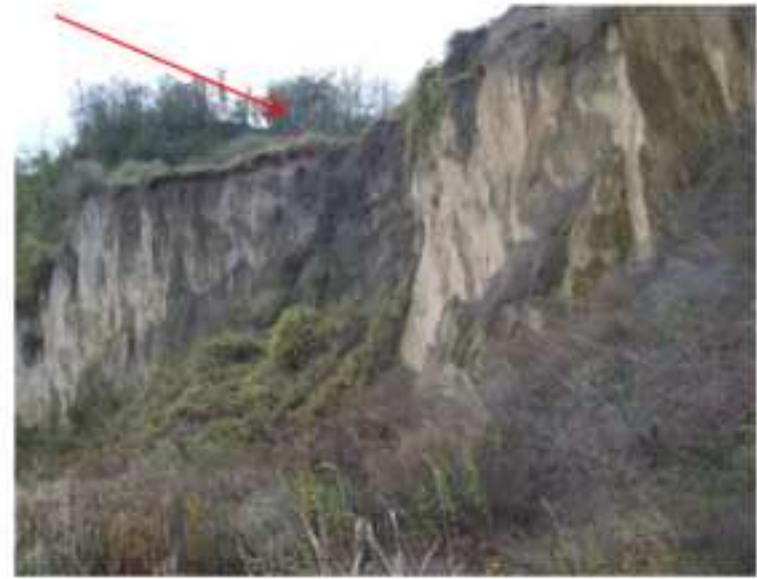
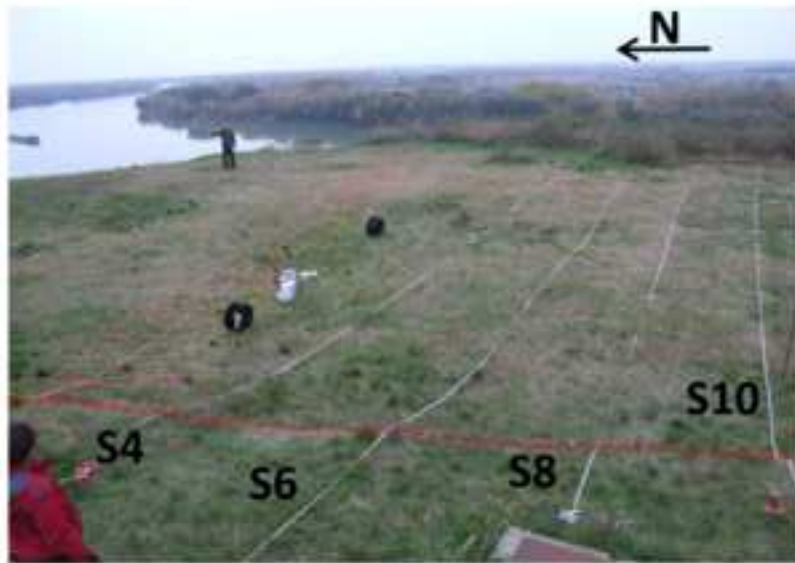
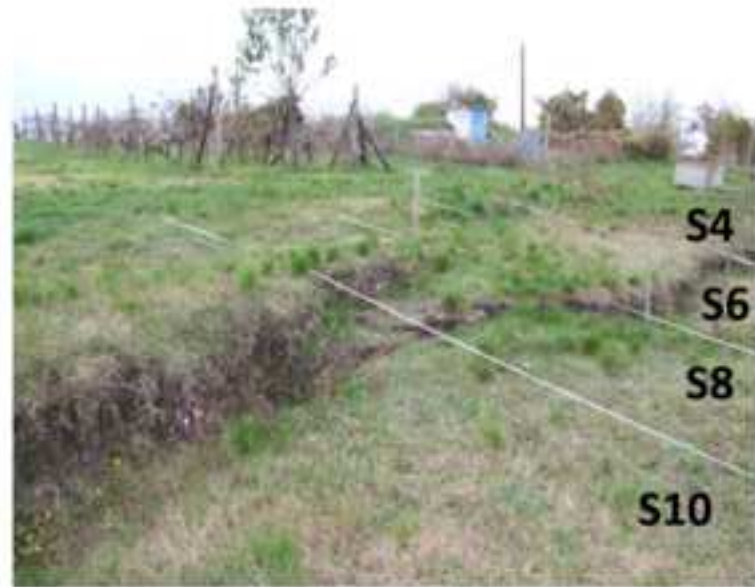
Figure 4  
[Click here to download high resolution image](#)

1  
2 **Fig. 4** a. The loess mass which has already slumped looking from the south, (the direction of the study area.) b.  
3 The quasi vertical scarp. The arrow indicates the research area. c. The study area from western direction with  
4 tapes along profiles S4-S10 and with Danube River in the background. The profiles are closely West-East  
5 orientated. The dotted red line shows the main fracture which is directly visible from the opposite direction. The  
6 scarp is about 6m from the east end of the tapes. d. The main fracture from the east with profiles S4-10. The  
7 main crack branches off here. The area which had been cultivated is in the background. The long profile (P2)  
8 elongated between two vineyards in line S10.

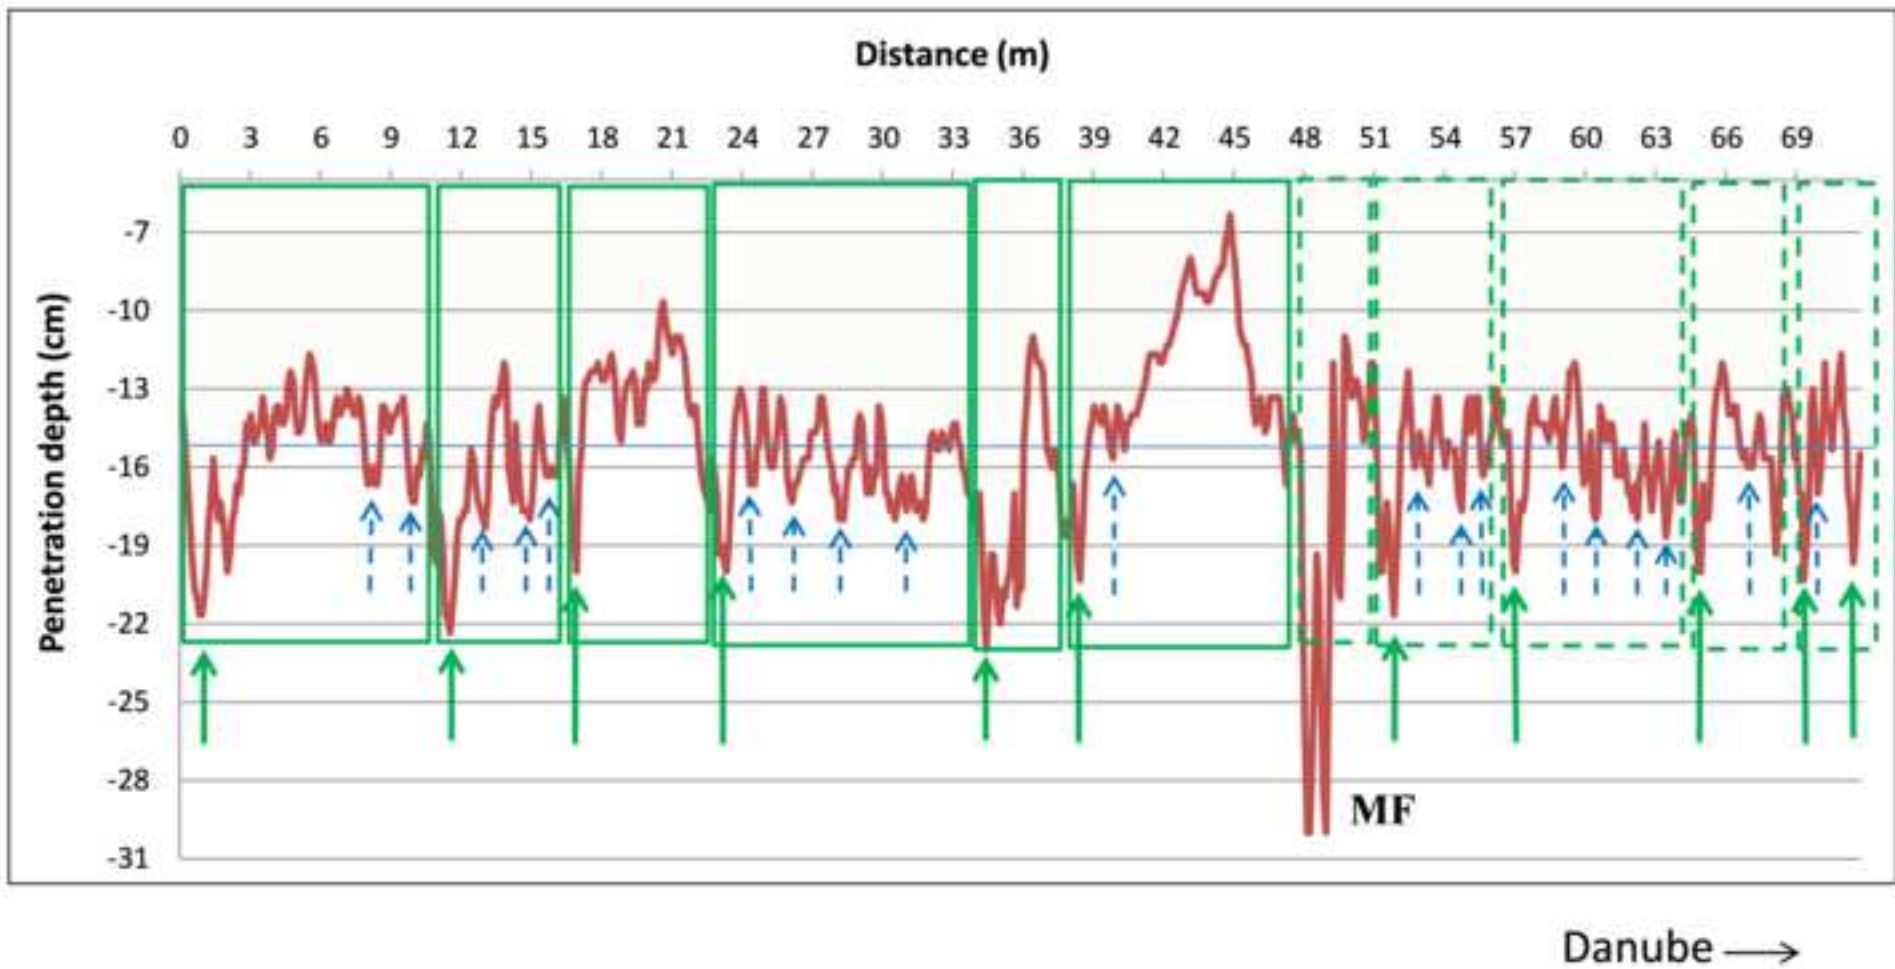
Figure 9  
[Click here to download high resolution image](#)

Figure 9 displays the running average each of 3 consecutive values measured on profile P1 (Fig. 2). (Such averaging enables simpler interpretation, but it can lead to information loss which has to be therefore controlled). It is clearly seen that the area, which is located on the stable, not-sliding, passive side (0-49 m) from the MF is also fractured. The cracks in this zone have greater amplitude than on the active side (49-72 m). The fragmentation of the loess appears to have been also started here. It is not surprising considering the dimensions of the Castle Hill: the height of the hill above the level of the Danube River is about 50 m while it is approximately 90 m long in the direction perpendicular to the riverbed (see Fig 3). It is worth mentioning that on the passive side of the MF there are 3 blocks, about 10 m wide (0-10 m, 23-34 m, 38-48 m). On the active side the blocks are only about 3-6 m wide. There are only two cases of penetration values below 13 cm: the anomaly at 43-45 m shows both wheel tracks which are definitely recognizable. The reason for the anomaly at about 21 m is unknown.

The active side of the profile is more fragmented as indicated by the higher density of thin cracks which is denoted by dashed arrows. Cracks are supposed to be where the Pre-P values exceed 15 cm. The selection of this threshold value is somewhat artificial but since the area is fairly homogeneous, the designation of such a specific value can be justified. If the area were more inhomogeneous, one would have to take the local anomalies into consideration. While in the active side of the MF there are 5+9 smaller and larger cracks within the 23 m length (MF is not taken into consideration), in the passive side there are 6+10 cracks 48 m in length. Thus while the average distance between the cracks is 1.5 m in the active side, it is 3 m on the passive side.

It is also important to note that it is although advisable to regard the running average representation for easier interpretation of the results (see e.g. Fig. 9) this form of presentation can lead to information loss. The original, not averaged values of the major anomalies are not smaller on the active side than on the passive one, so the width of the cracks must be about the same on both sides.

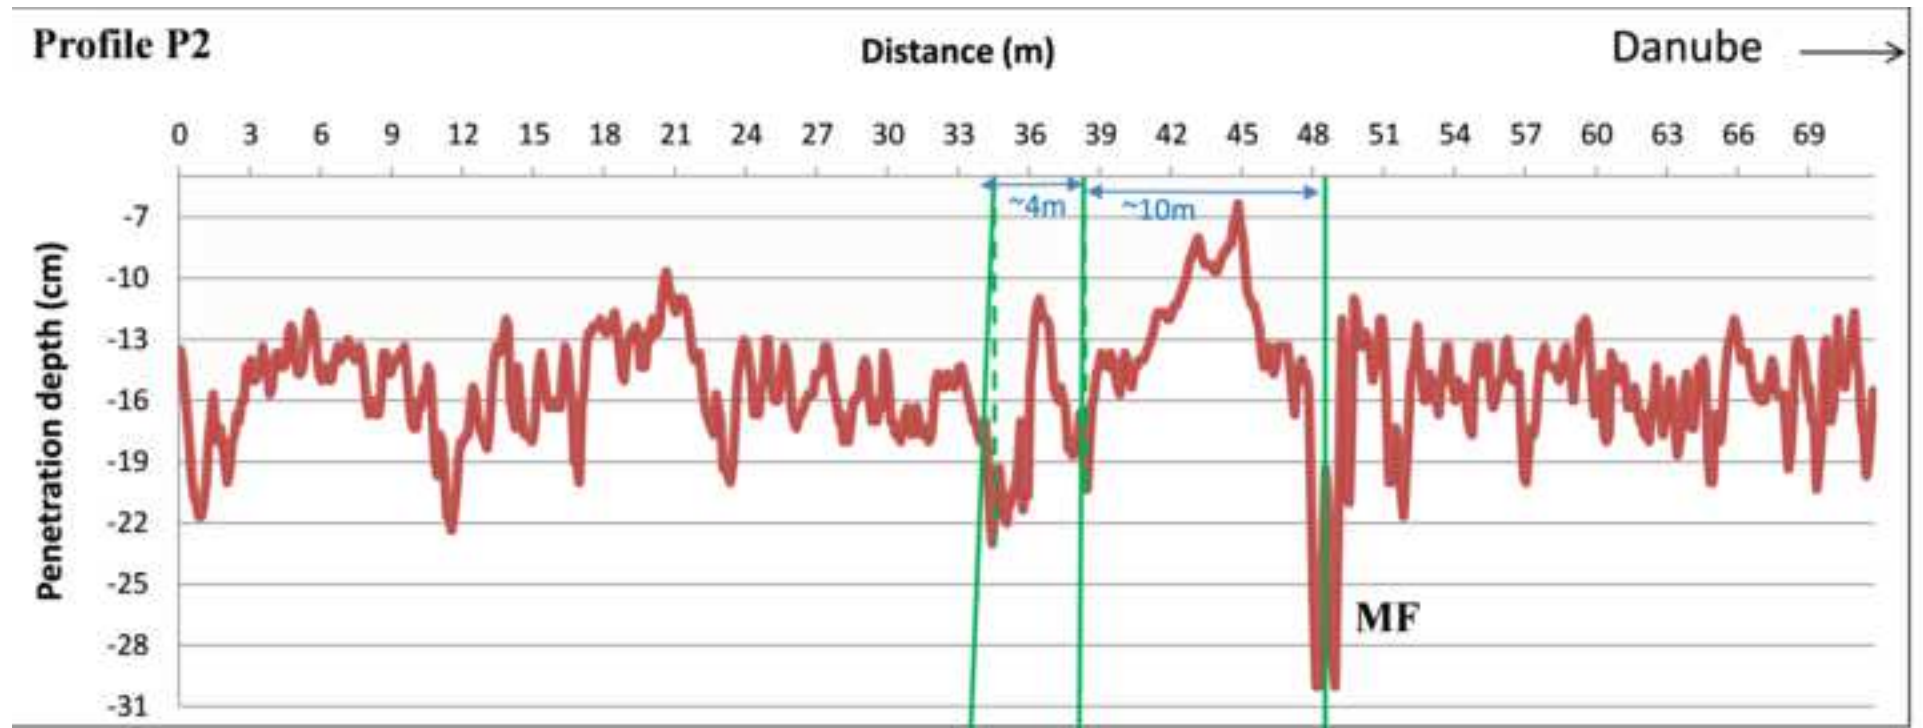
Figure 10  
[Click here to download high resolution image](#)

The results of the other profile, which is partly in the passive area (P1, shown in Fig 10, where the cracks are indicated by green lines) confirm the following: 1. There are also cracks in the passive area; 2. The major ones of the passive area are nearly parallel to each other having about the same 10 m and 14-15 m distance from the MF on both the P1 and P2 profiles; 3. While the background Pre-P value is about 15 cm on profile P2, it is only 11 cm on profile P1. This means that the area below P1 is most likely more consolidated. 4. The anomalies of P1 are at least as large, which may nevertheless be an alert.

29  
30 **Fig. 10** The profiles which extended into the passive area. The dotted lines project the position of the anomalies  
31 to the horizontal axis. The continuous lines connect fractures observed on both profiles which are assumed to be  
32 the same. MF: main fracture.
