DEMONSTRATION PROJECT IN LOW-COST
SHORELINE EROSION CONTROL

FINAL REPORT

County Administrator
County of Accomack, Virginia
Accomack, Virginia 23301

Virginia Institute of Marine Science
Gloucester Point, Virginia 23062
William J. Hargis, Jr., Director

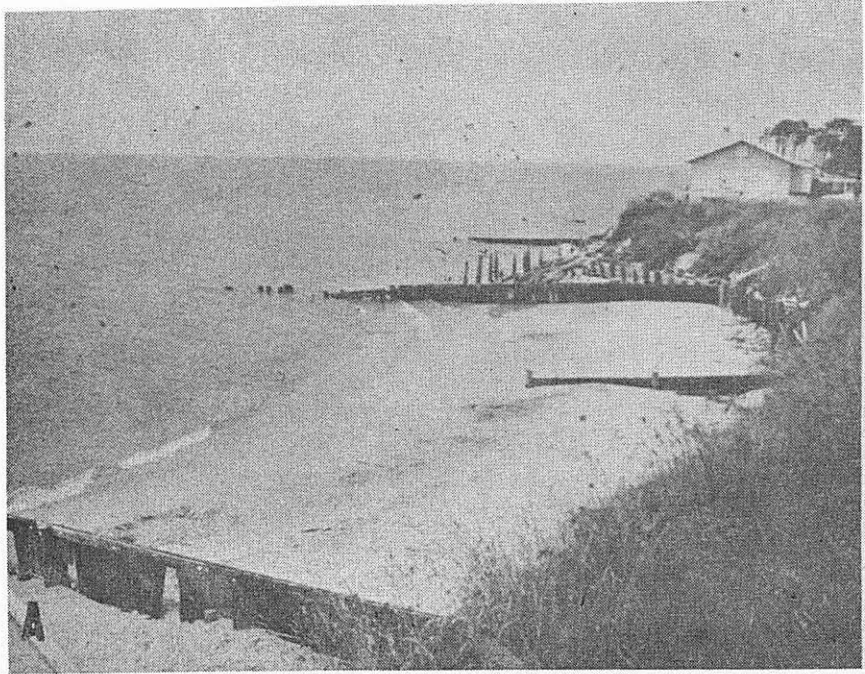
B. SILVER BEACH

After the installation of the sandbag sill on June 12, 1978, the beach had increased in volume as recorded in this photograph of July 26, 1978. Of particular interest is the accretion of sand around the short groin in the center of the site.

The installation was completed on 12 June 1978. During the relatively short monitoring time between installation and this report preparation, accretion was noticeable in the deepest part of the indentation of the shore (Figure 9). This response is shown in Plates 3 and 4 and in Profile Line 3 (Figure 10). At Profile Line 3 the beach berm had advanced approximately 10 feet by 10 July. Although Profiles Lines 4 and 5 (see Appendix B) did not show as much advance some accretion did occur as shown in Plate 5. In contrast to the profiles within the treated zone, Profile 6, located just south of the site, showed essentially no change in the berm position during the

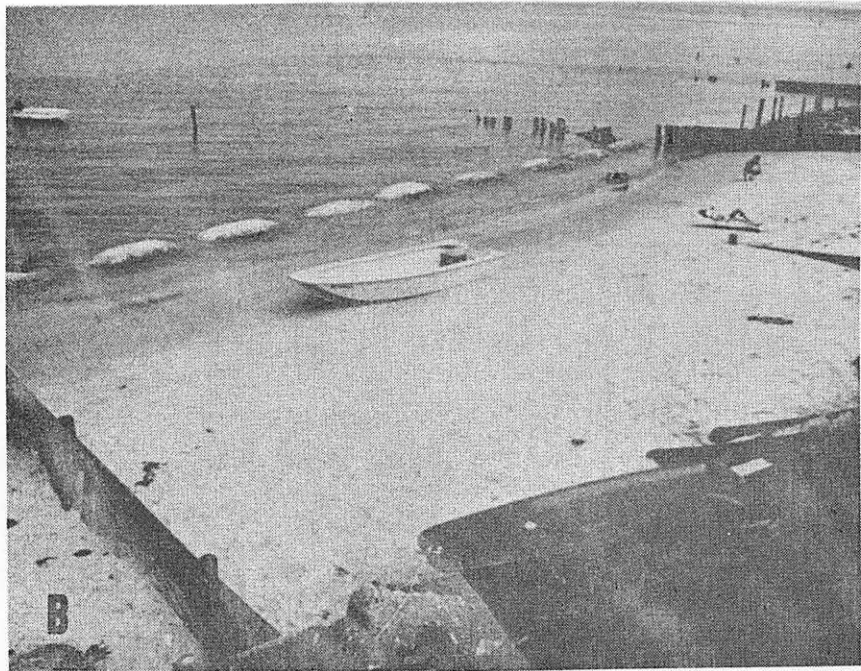
PLATE 4

The preinstallation conditions of the sandbag sill section are recorded in this photograph of June 8, 1978. The cottage on the bluff edge is typical of the erosional conditions at Silver Beach.

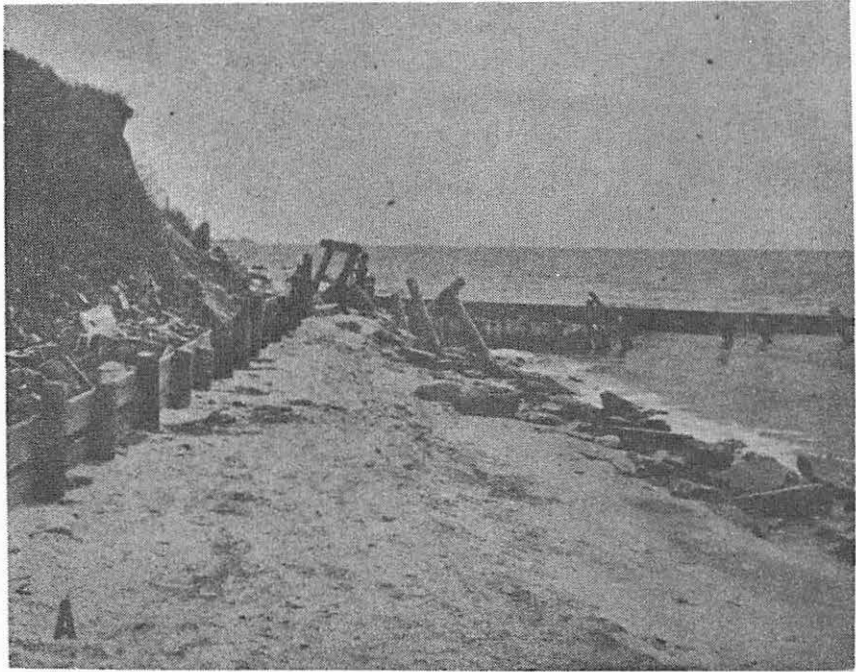
B. SILVER BEACH

This July 26, 1978 southward looking photograph demonstrates the beginning of accretion in the test cell. Sand is beginning to accumulate behind the gabion sill and starting to bury the rubble on the beach.

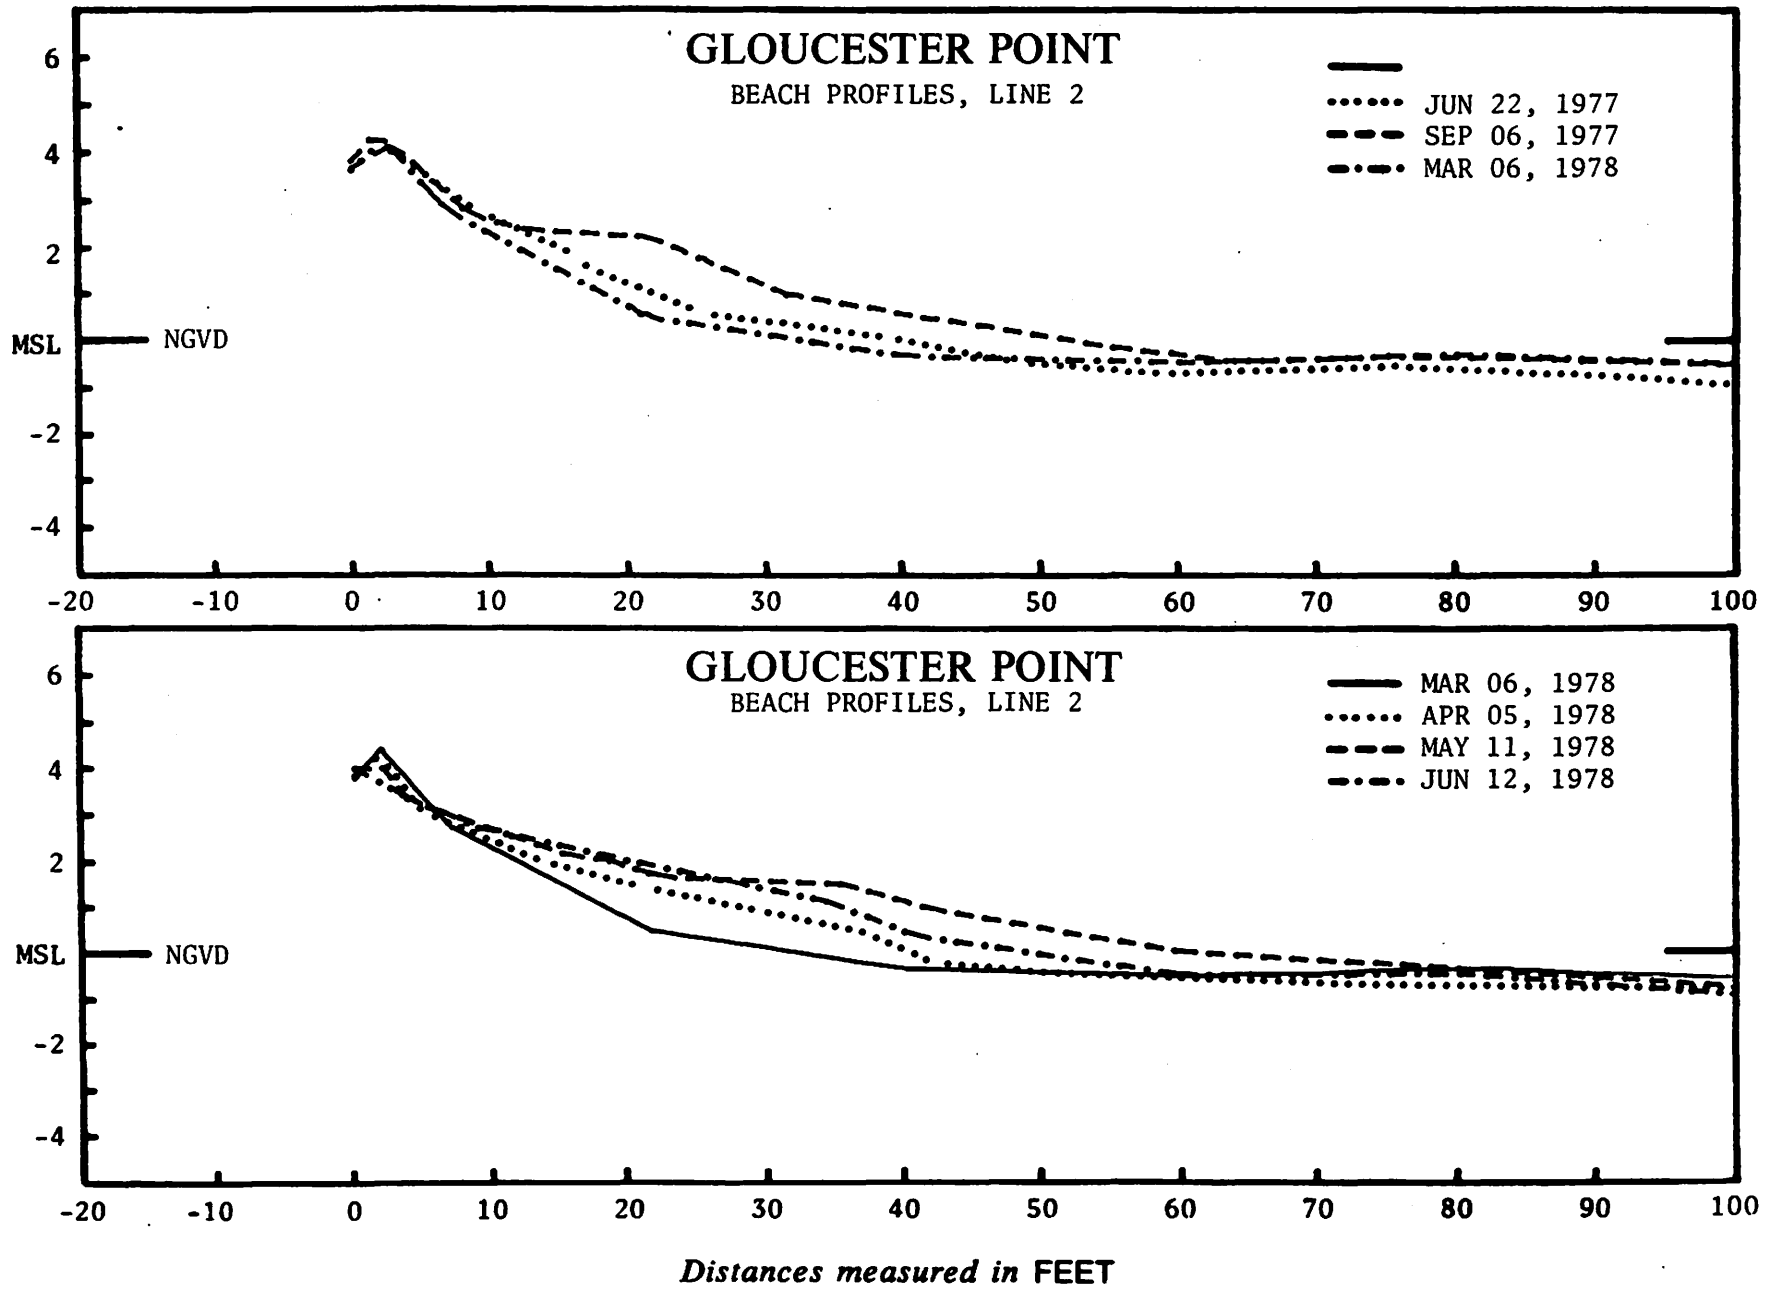
FIGURE 15. Profile Line 2 at the Gloucester Point site.

and 24 August 1978. Profiles Lines 3 and 4 also show accumulations that exceed the summer beach accretion of the previous year (see profiles in Appendix B). Further illustration of the accretion is shown in Plates 6 and 7. Thus, this installation can be considered a success in spite of the relatively short monitor time. The response was immediate and the wave climate conditions are such that no reversal in behavior can be expected.

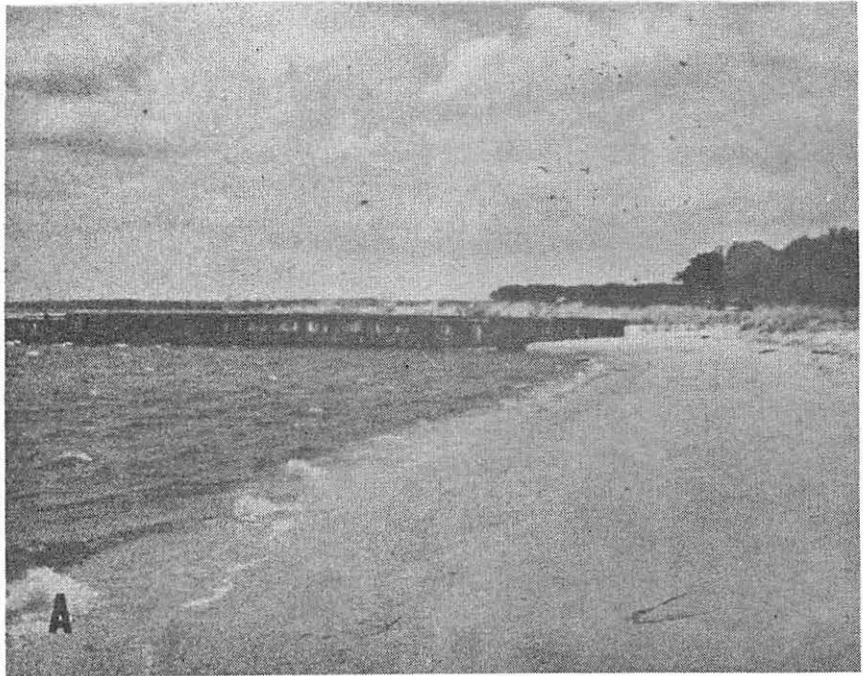
B. GLOUCESTER POINT

The beach on June 7, 1978 had continued to widen and heighten accreting to half the diameter of the tires. Note the 40 degree rotation of the spoiler. This rotation occurred during the April 26, 1978 "Northeaster".

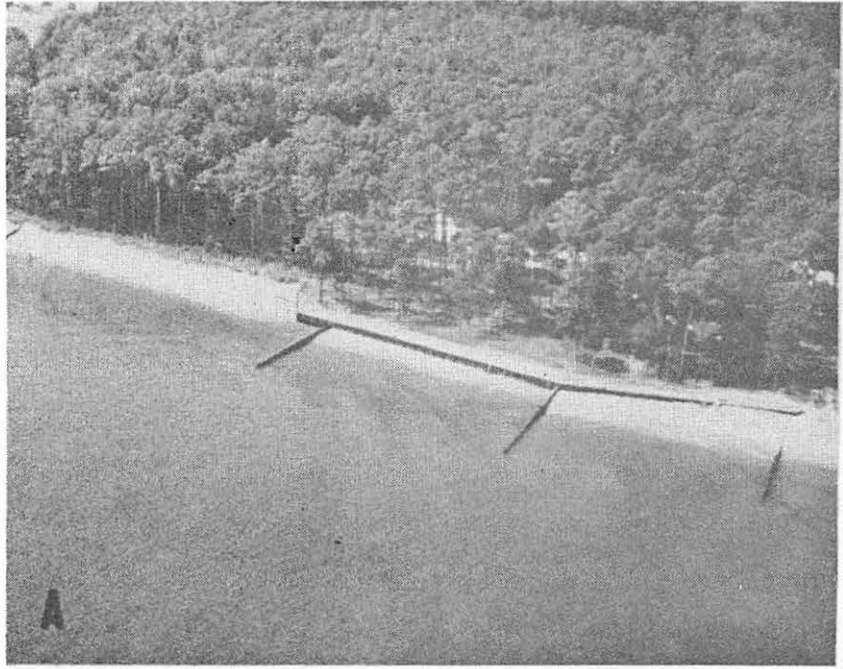
B. SCROGGINS/CREW

The bulkhead in this photograph of August 1, 1978 replaced the demolished structure in the photo above. Note the positions of the sandbags and gabions which were installed on July 3, 1978.

isolate it from direct wave attack and possible undermining. This combination of structures is frequently used when the region is subject to long fetch distances (Figure 17). The bulkhead shown in Plate 8A was destroyed in the northeast storm of 26 April 1978. The level of damage is illustrated in Plate 10A as is the reconstruction phase.

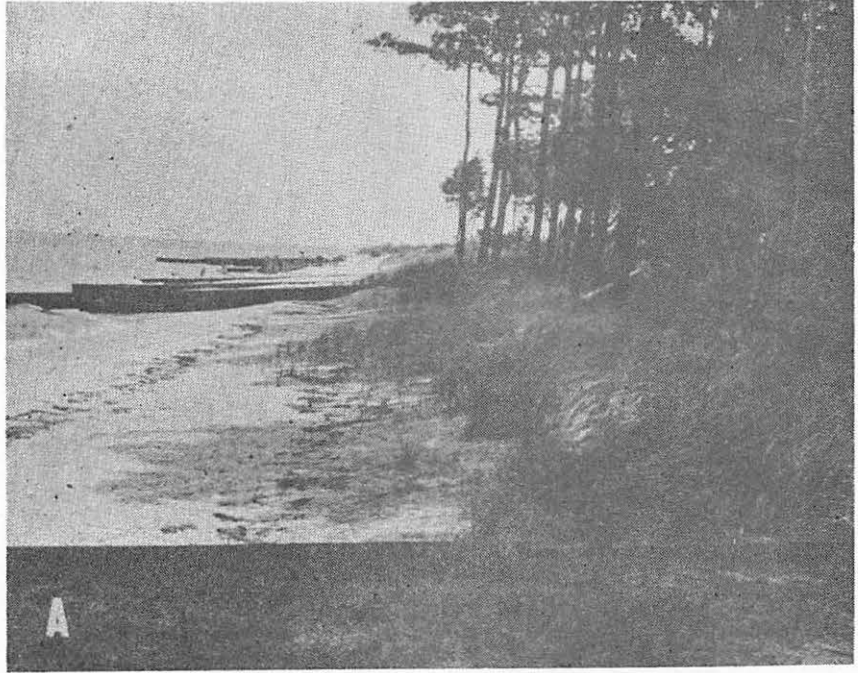
B. SCROGGINS/CREW

The April 26, 1978 storm removed the vegetation. This June 27, 1978 photograph illustrates the scarp cut into the fastland behind the beach.

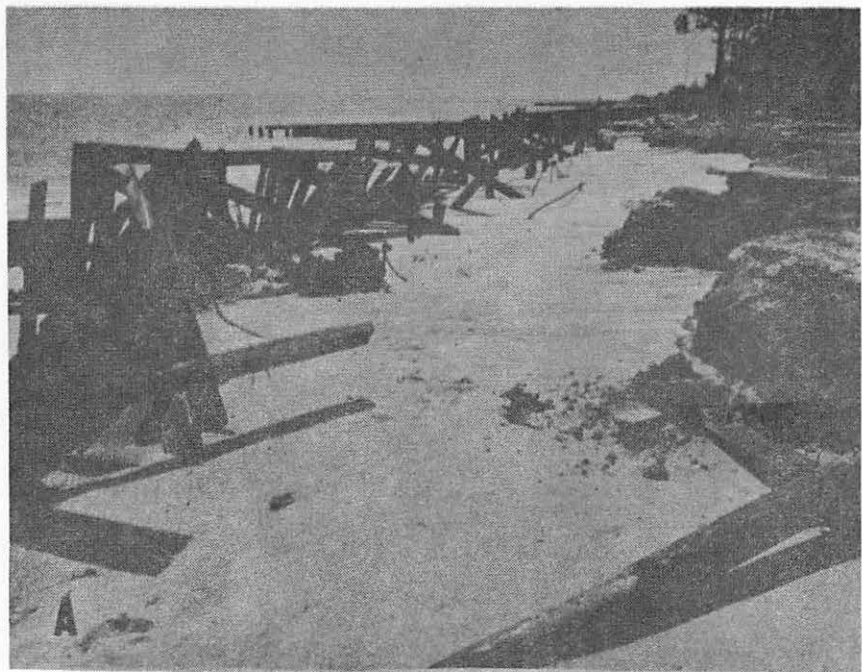
C. SCROGGINS/CREW

On July 24, 1978, the site had continued to rebuild as witnessed in this north looking photograph.

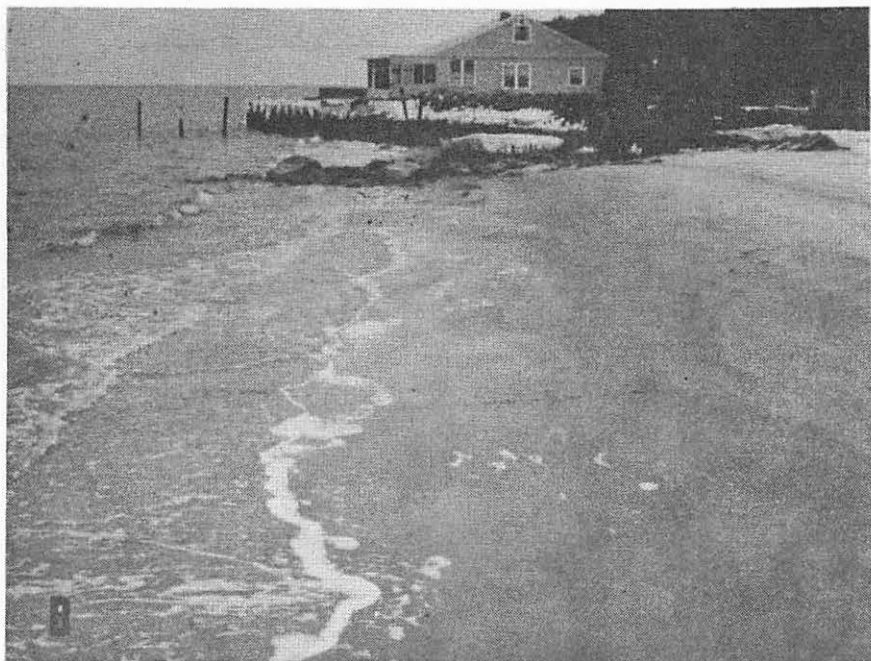
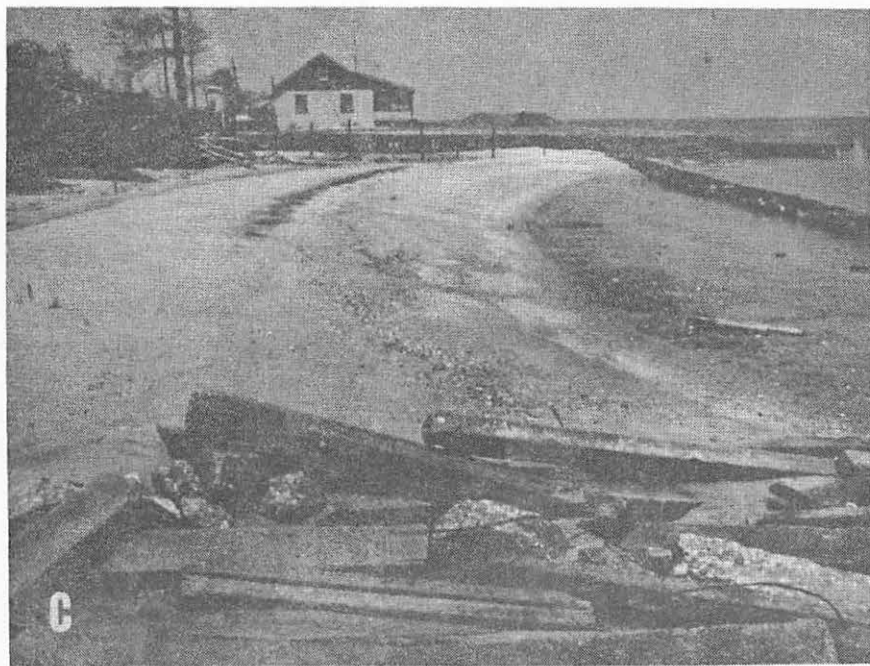
C. D. SMITH

The gabion sill was installed on May 5, 1978. By May 17, 1978 the beach had rebuilt dramatically. This is particularly in evidence at the north end of the beach adjacent the bulkhead. Pier remnants lie in the foreground.

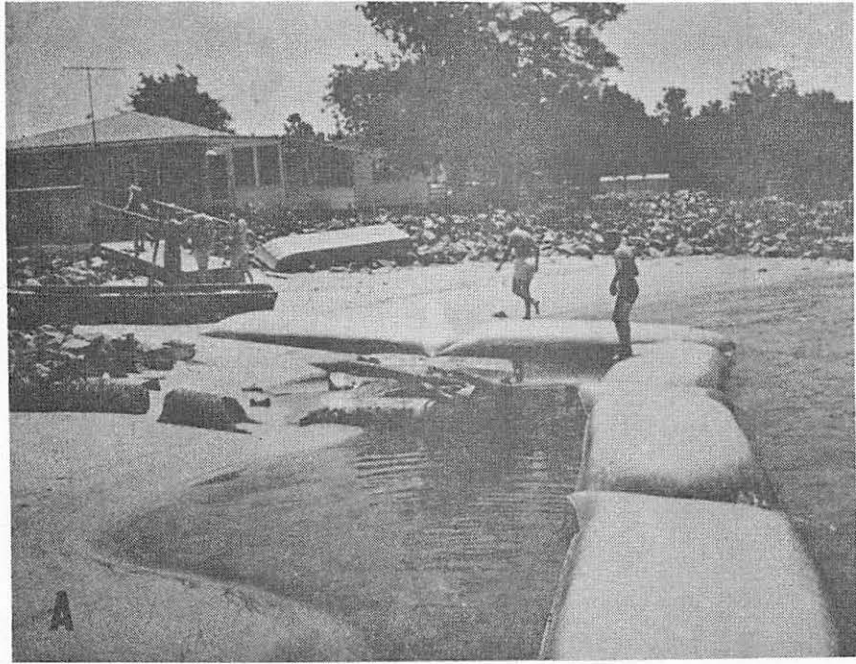
B. CHERRY POINT ASSOCIATION

This photograph of July 24, 1978 reveals further beach accumulation around the culvert pipe.

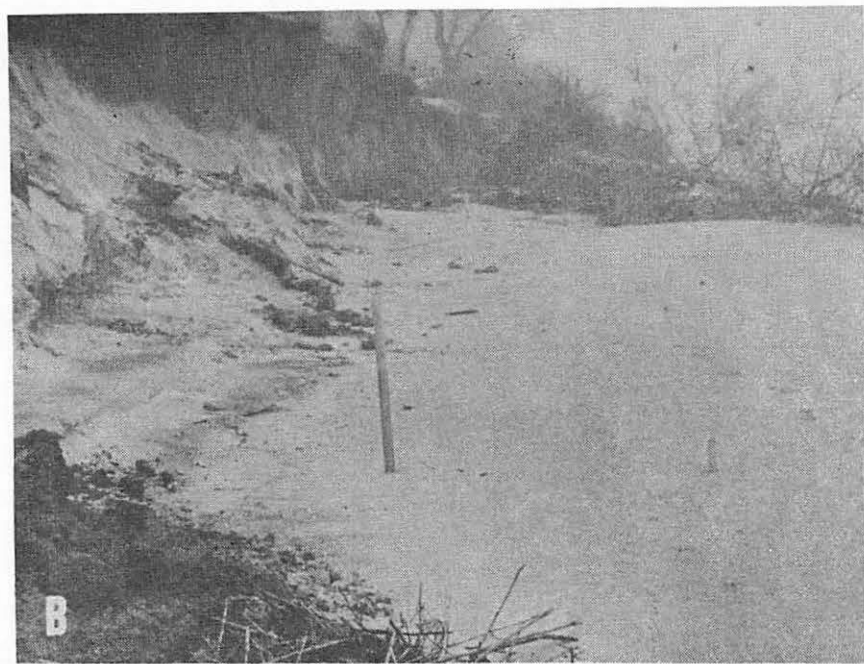
C. DENNIS

This eastward looking photograph of May 1, 1978 records the dramatic recovery of the beach. The sandbag sill is now all but buried by the beach. The sill, installed on April 25, 1978, extends away from the exposed sandbags in the picture's foreground and parallels the waterline.

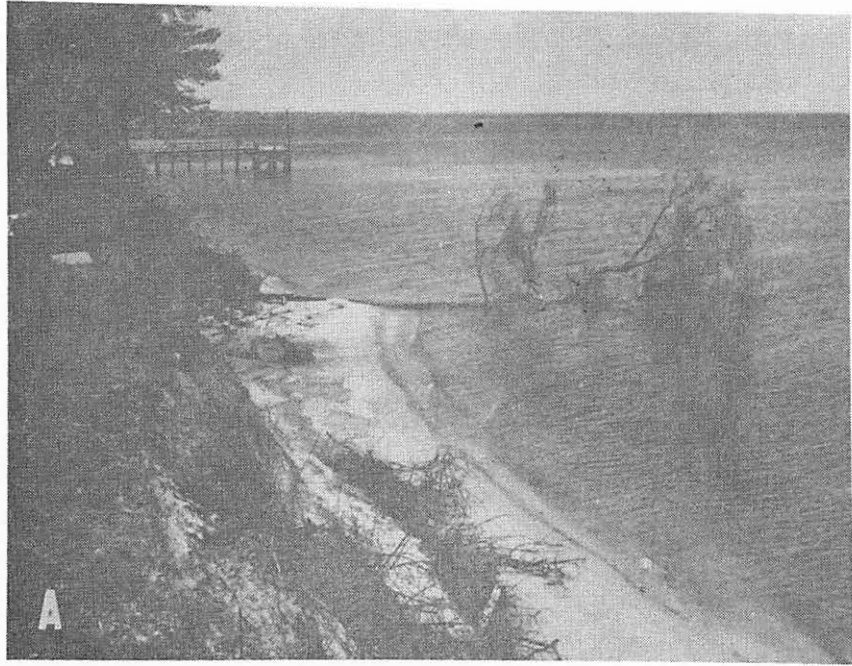
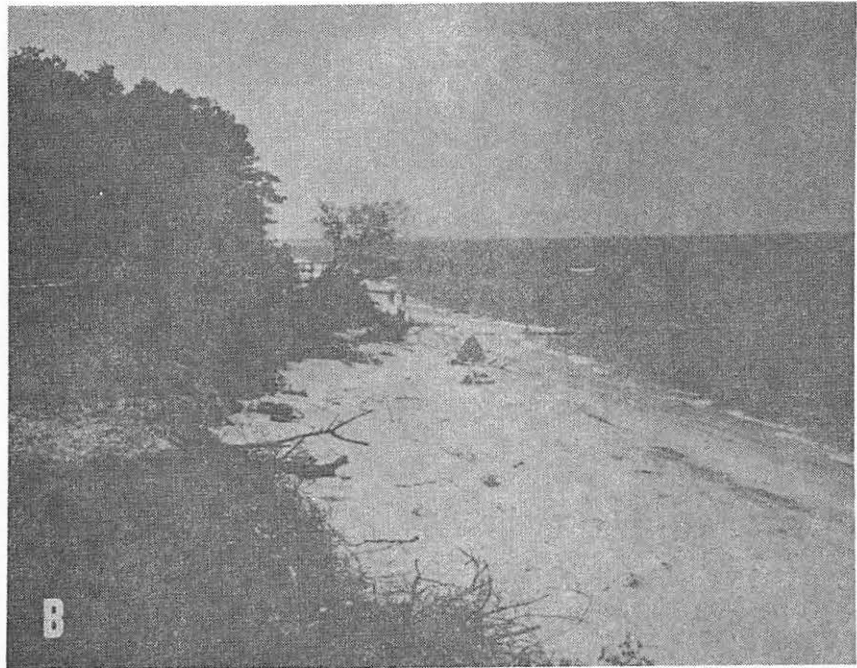
B. DENNIS

While the bluff had receded considerably the beach has widened dramatically in this June 28, 1978 photo taken from atop the bluff. Note that the water line is approximately at the same relative position to the fallen tree in both A and B, and that the waterline concavity no longer exists in the lower photograph. The profile pipes have been nearly completely buried with but a few inches exposed at pipes 1, 2, and 3. Tops of sandbags can be seen at the waterline in the vicinity of the fallen tree.

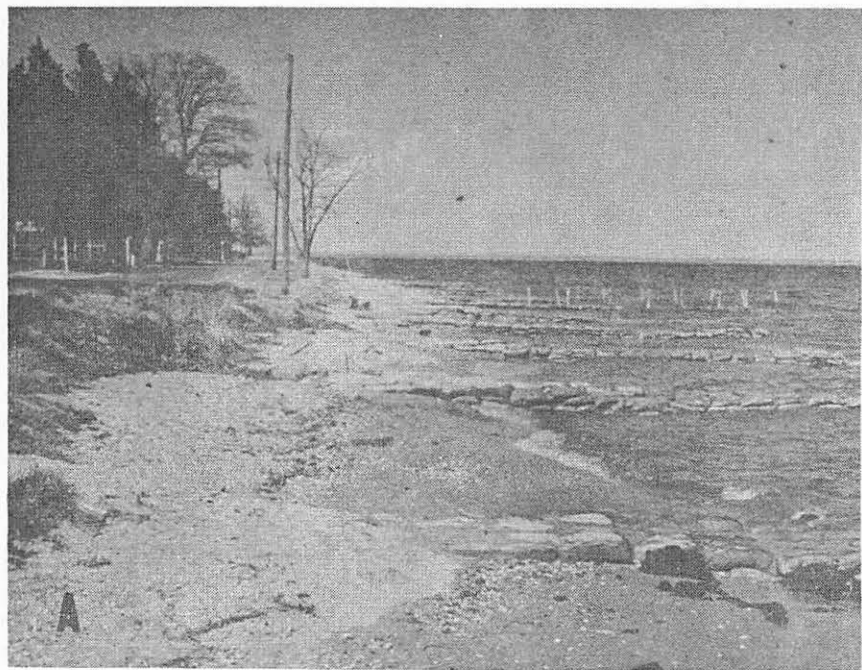
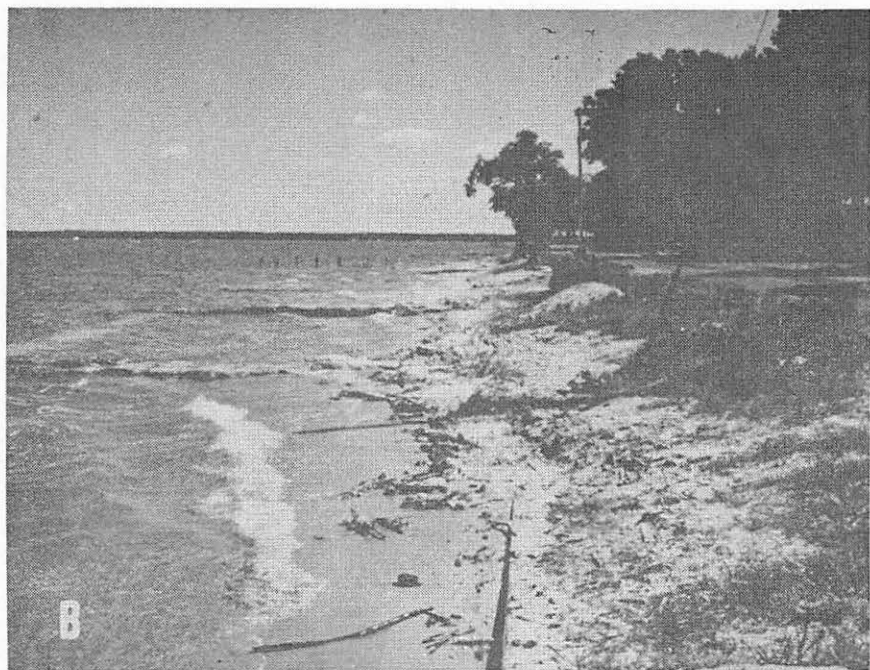
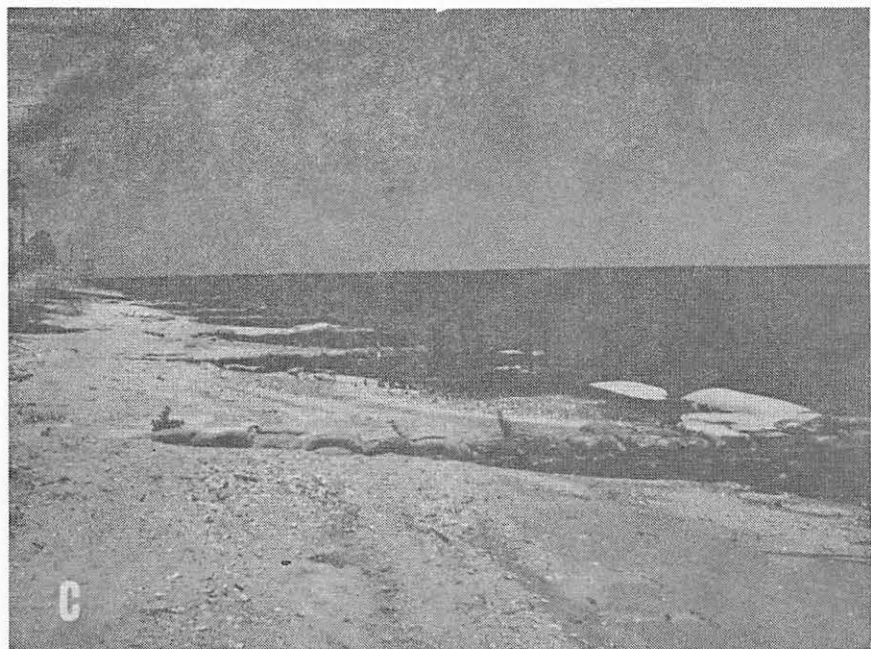
C. COLONIAL BEACH

By July 12, 1978, some response can be noted in several of the groin cells.

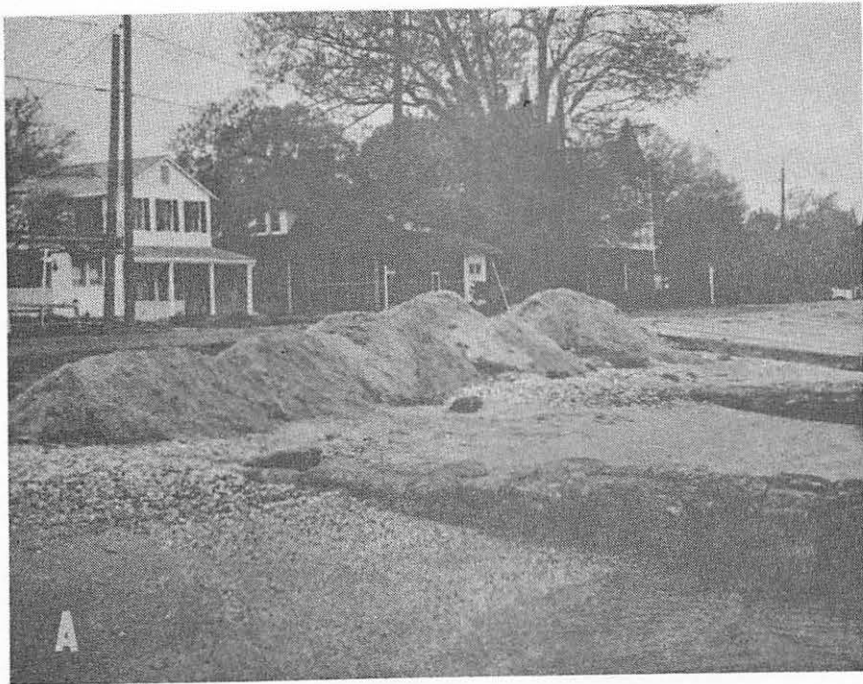
B. COLONIAL BEACH

This groin-sill cell demonstrates a modest entrapment of sand and gravel. Photograph was taken July 12, 1978.
