Strategies for Successful Mangrove Living Shoreline Stabilizations in Shallow Water Subtropical Estuaries

REBECCA FILLYAW
B.S. University of Central Florida, 2017

A thesis submitted in partial fulfillment of the requirements
for the degree of Master of Science
in the Department of Biology
in the College of Sciences
at the University of Central Florida
Orlando, Florida

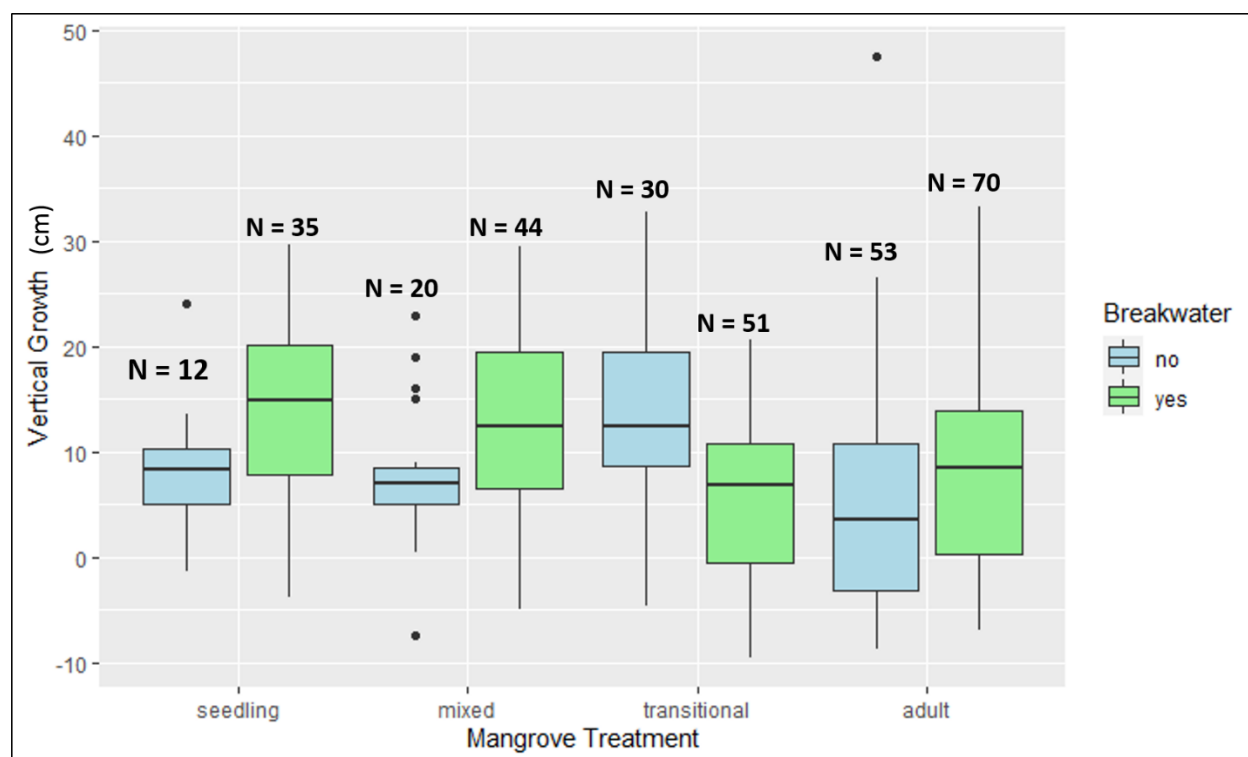
Seedling vertical growth rate (11.9 cm yr^{-1}) was 22.8% greater than transitional growth rate (9.7 cm yr^{-1}) and 59.2% greater than adult growth rate (7.5 cm yr^{-1}). Presence of a breakwater increased growth for seedlings, adults, and mixed treatments, but decreased growth for transitionals (Fig. 5). Growth rate for adults (5.6 cm yr^{-1}) increased by 67.0% and growth for seedlings (9.9 cm yr^{-1}) increased by 39.9% when a breakwater was present. For the transitional developmental stage, the absence of a breakwater increased vertical growth rate by 82.4% from 6.87 cm yr^{-1} .

Figure 5: Vertical growth (cm) from month 0 to month 12 based on mangrove and breakwater treatment. "N" represents sample size of each treatment.

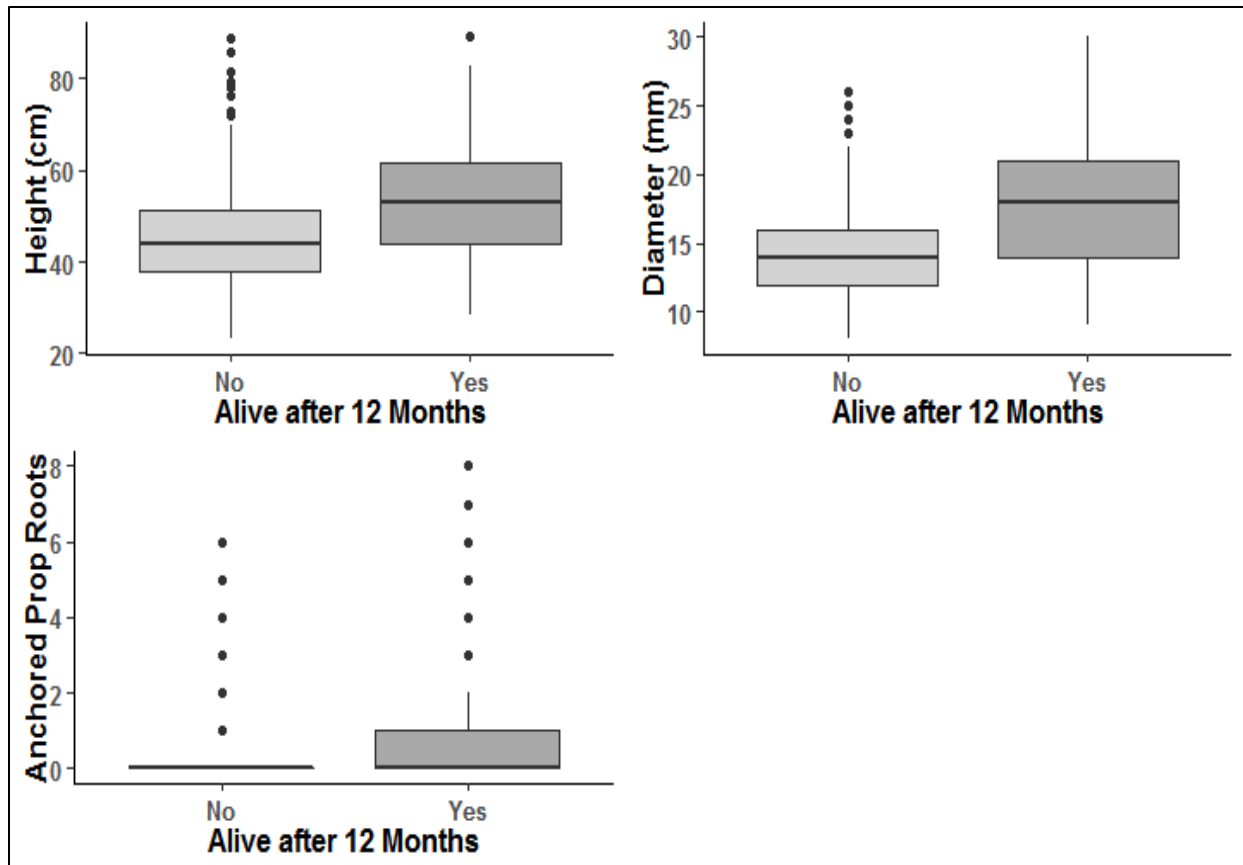
Height, diameter, and anchored prop roots had the greatest variation between mangroves that survived and those that did not at month 12. Greater starting size measurements for these categories all had a positive impact on survival (Fig. 11). Odds of survival increased by 11.0% for every mm of diameter, 3.5% for every cm of height, and 26.3% for every anchored prop root.

Figure 11: Size metric distribution for mangroves that survived versus mangroves that did not survive over the 12-month monitoring period.

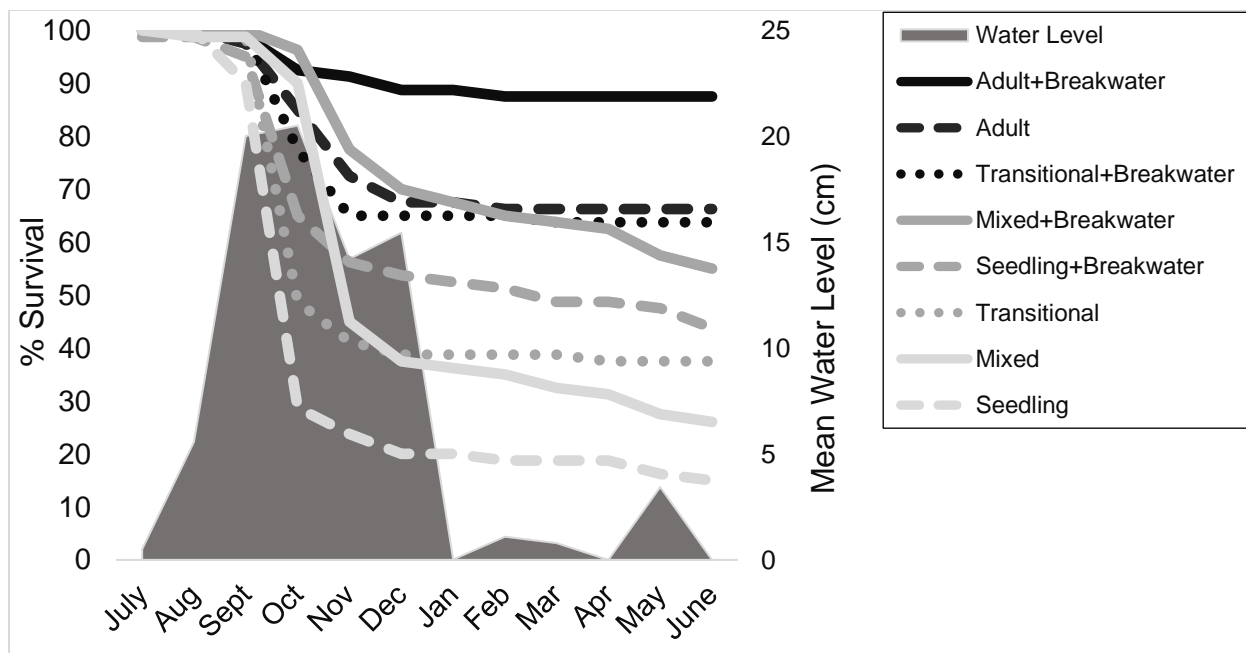
Water level ($p < 0.001$) was the best model predicting total mangrove mortality. The majority of the 324 mangrove mortalities occurred 4 months after the restoration, approximately 2 months after the onset of the annual high water season. More specifically, these mortalities occurred in October (62.0%), November (16.0%), September (8.0%), and December (4.6%) when the mean water levels (cm) (\pm SE) above the sediment interface of the mangroves were 20.5 ± 0.2 , 14.2 ± 0.8 , 20.0 ± 0.2 , and 15.4 ± 0.4 , respectively (Fig. 14). Total percent mortality for the remaining months ranged from 0% to 2.2% when mean water level was between 0.0 and 5.6 cm above the sediment (Fig. 14). Post Hurricane Dorian monitoring was conducted on 19 September 2019, at which time only 3 (11.5%) of the 26 mortalities from the month of September occurred. This equates to less than 1.0% of total mortalities.

Figure 14: Mean survival (“alive” *R. mangle*) of each treatment per month and mean water level (cm) per month at the base of the mangroves.

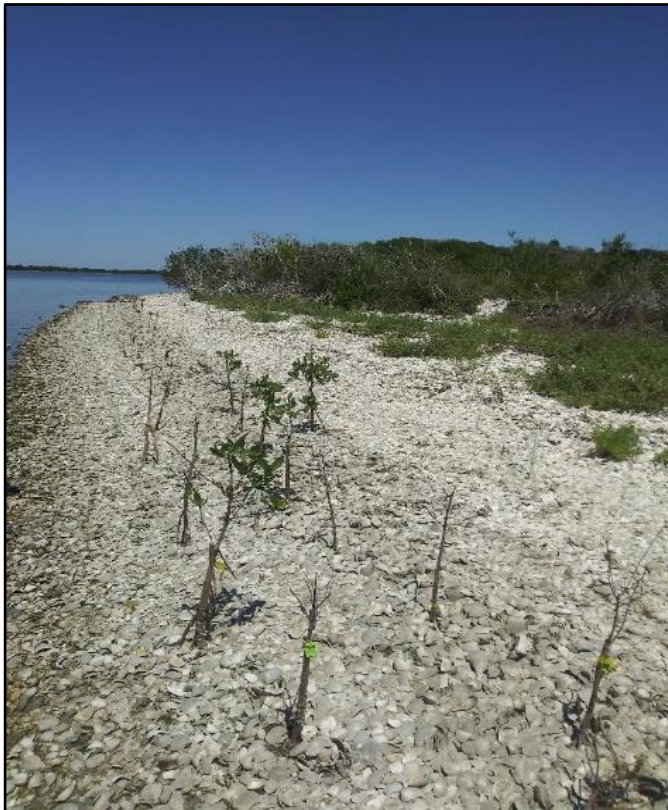
Figure 15: Water level of 0 cm in January 2020 at the base of the deployed mangroves at low tide.

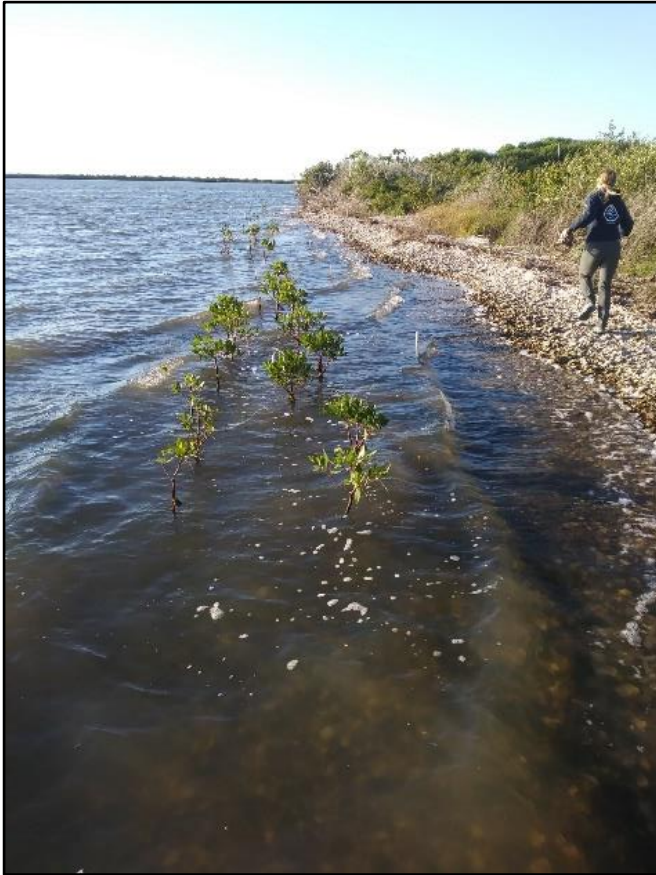
Figure 16: Water level of ~20 cm in September 2020 at the base of the deployed mangroves at mid-tide.

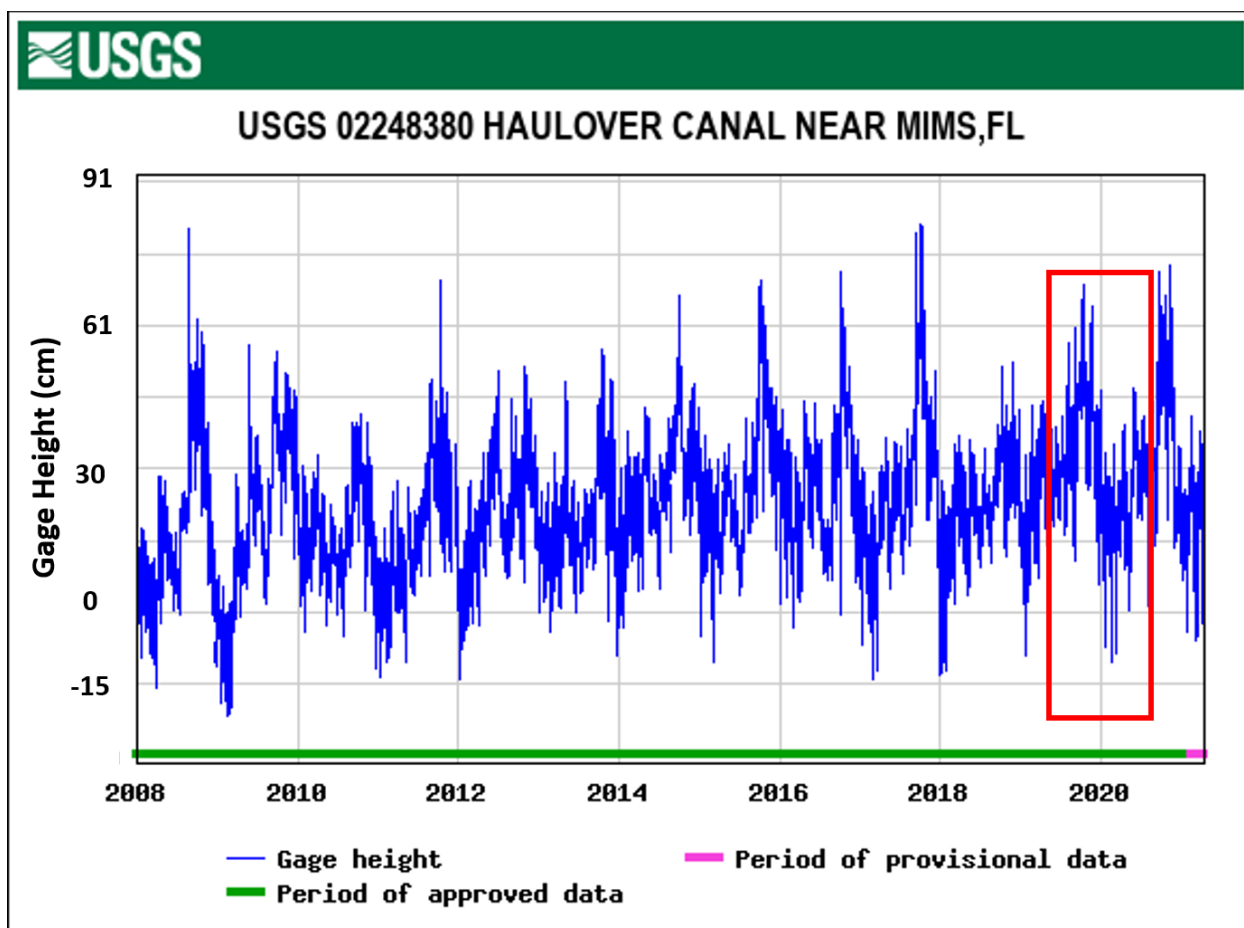
According to historical water gage data collected from Haulover Canal by USGS, between the years of 2008 and 2020, mean water level within the tidal zone was 23.7 cm. Mean water level for each year ranged from 18.6 cm (2008) to 30.4 (2020). For the experimental monitoring period at the restoration site (July 2019 to June 2020), the mean water level at the Haulover Canal station was 31.5 cm (Fig. 17).

Figure 17: Historical water level data from USGS for Haulover Canal from 2008 to 2020. Red box represents experimental period.

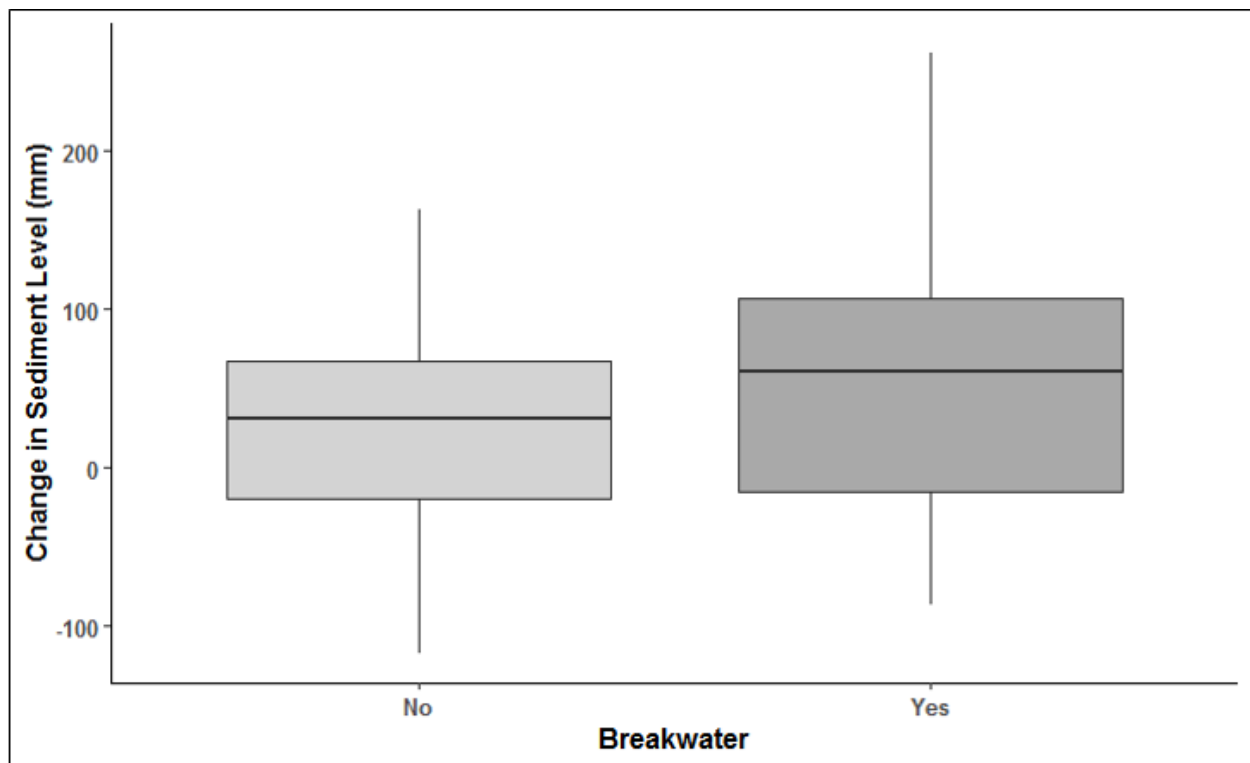
Distribution of erosion and accretion (mm) at month 12 based on breakwater presence can be visualized in Fig. 19. One erosion stake (control with no breakwater) was dislodged from the sediment and removed from the analysis. Results of the Shapiro-Wilks test indicated the change in sediment level data was normally distributed (breakwater: $p=0.74$, no breakwater: $p=0.93$); results of the Levene test showed homogeneity of variance ($p = 0.12$), satisfying the assumptions of the Welch's t-test. Results of the t-test indicate that the mean of the 2 groups was not significantly different ($p=0.18$).

Figure 19: Change in sediment level (erosion and accretion in mm) between treatments with and without a breakwater.

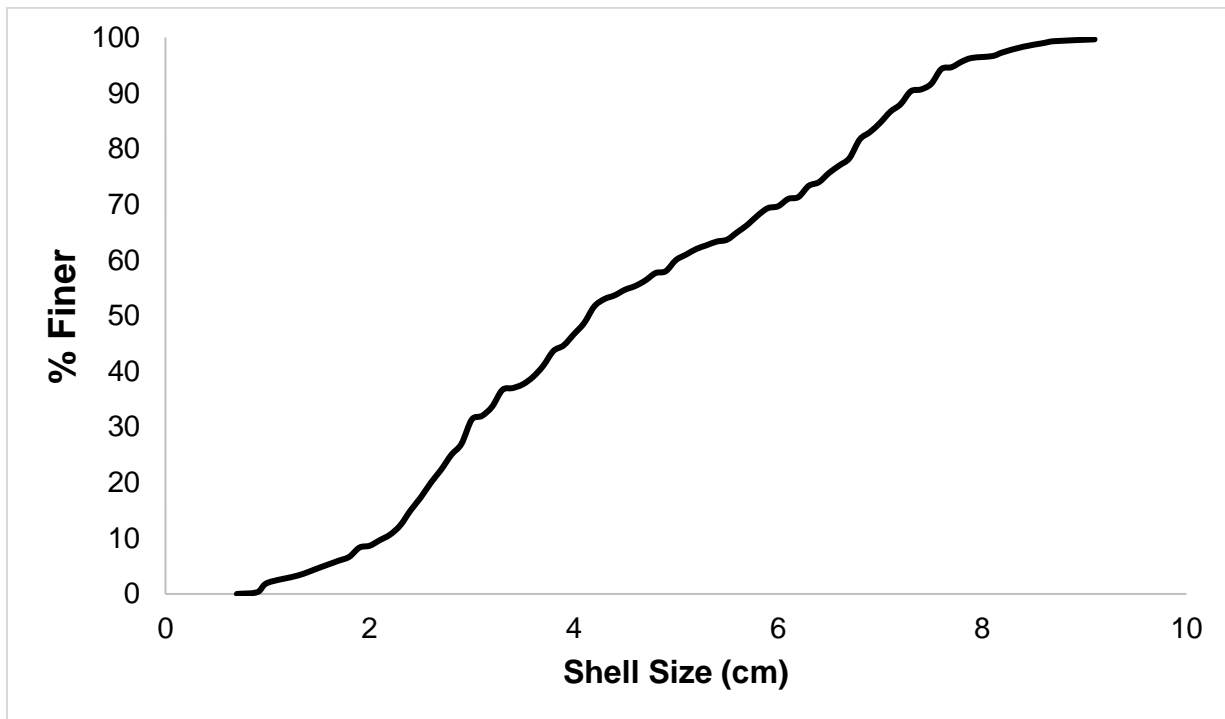
Of the 300 shells sampled along the restoration site, 67.7% were clam shells and 32.3% were oyster shells. Clam shells ranged from 1.50 to 9.10 cm with a mean of 5.16 cm; oyster shells ranged from 0.70 to 6.90 cm with a mean of 3.07 cm.

Figure 23: Shell size distribution curve results from the Wolman pebble count conducted along the restoration site.
