# An Intraoral Repair Method for Chipping Fracture of a Multi-unit Fixed Zirconia Reconstruction: A Direct Dental Technique

Alfredo Mikail Melo Mesquita<sup>1</sup> Nadin Al-Haj Husain<sup>2</sup> Pedro Molinero-Mourelle<sup>2</sup> Mutlu Özcan<sup>3</sup>

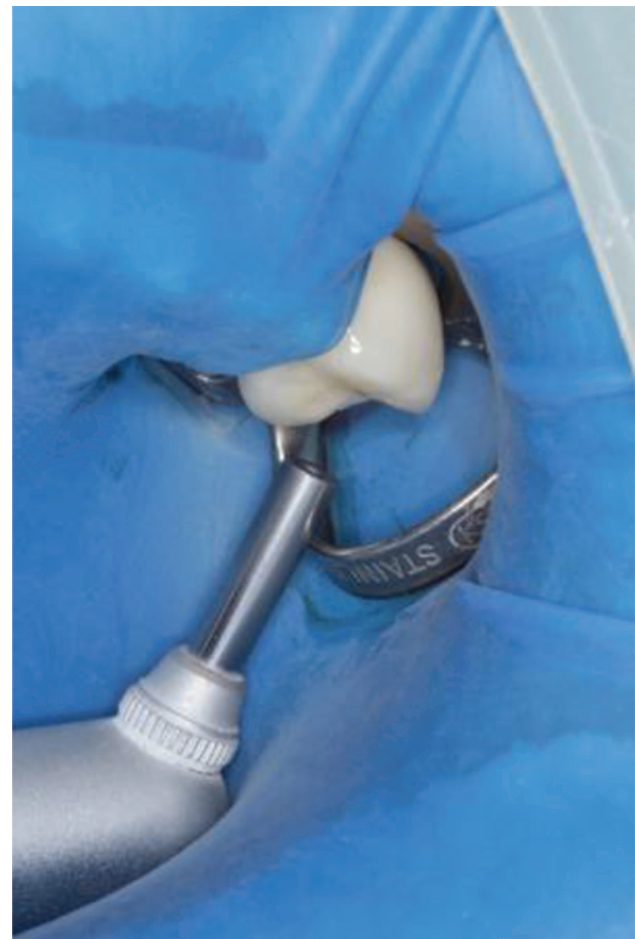
**Fig. 2** Air abrasion using a chairside device with silica-coated alumina particles (30 µm, 2.5 bar for 20 seconds).

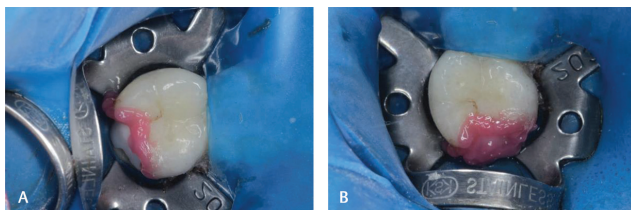
**Fig. 3 (A, B)** Etching of the fractured area with 5% hydrofluoric acid for 20 seconds of the (A) veneering and (B) core ceramic.

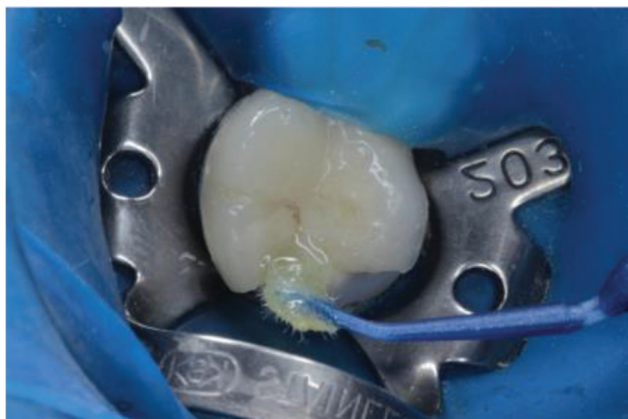
**Fig. 4** Application of adhesive resin.

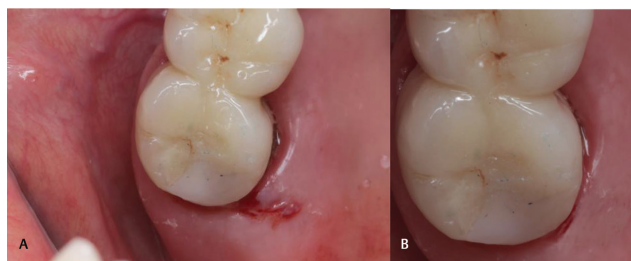
**Fig. 7** Final (A) over and (B) closeup view of repaired distal palatal veneering and core fracture.
