Corrosion and Biofouling of Offshore Wind Monopile Foundations

Claire Canning

*A thesis submitted in partial fulfilment of the requirements for the award of an
Engineering Doctorate*

The University of Edinburgh

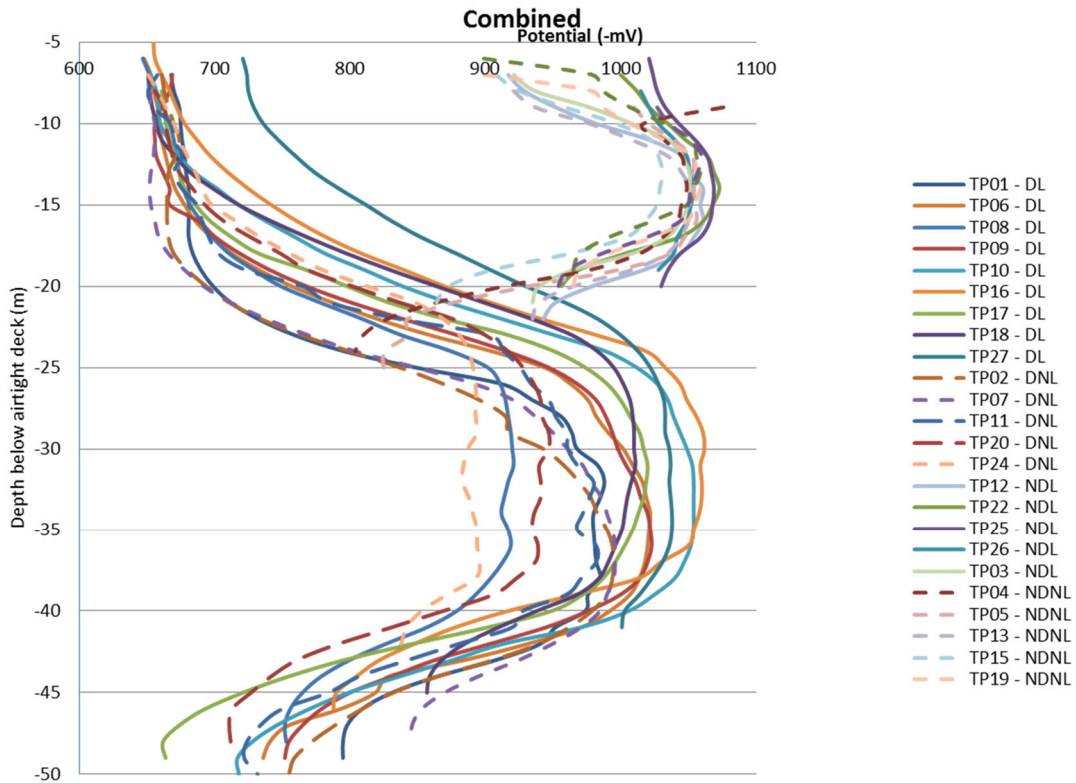
Figure 1.7: The profile of internal protective potential with depth of foundations at Teesside OWF (All foundations have been classified as one these categories DL-Drilled Leaker, DNL-Drilled Nonleaker, NDL-Non-drilled Leaker & NDNL-Non-drilled, Non-Leaker).

A range of potential recordings were taken from all 24 internal CP surveys and are shown in Figure 1.7. The survey highlighted specific regions of the internal steel surface that are not adequately protected by the CP system in that the protective potential is less negative than -800mV (or -900mV at the mudline). Additionally, there are some internal regions experiencing overprotection in potential, beyond the recommended DNV standard (more negative than -1000mV).

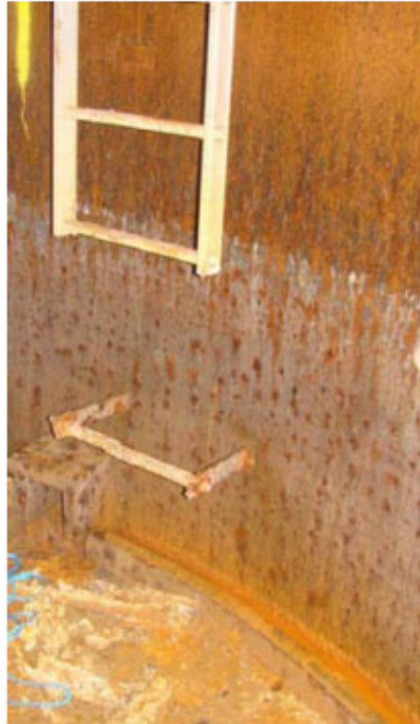
Figure 2.5: The lower part of an aluminium ladder above the lower working platform has corroded away due to tidal conditions inside an offshore wind monopile foundation [14].

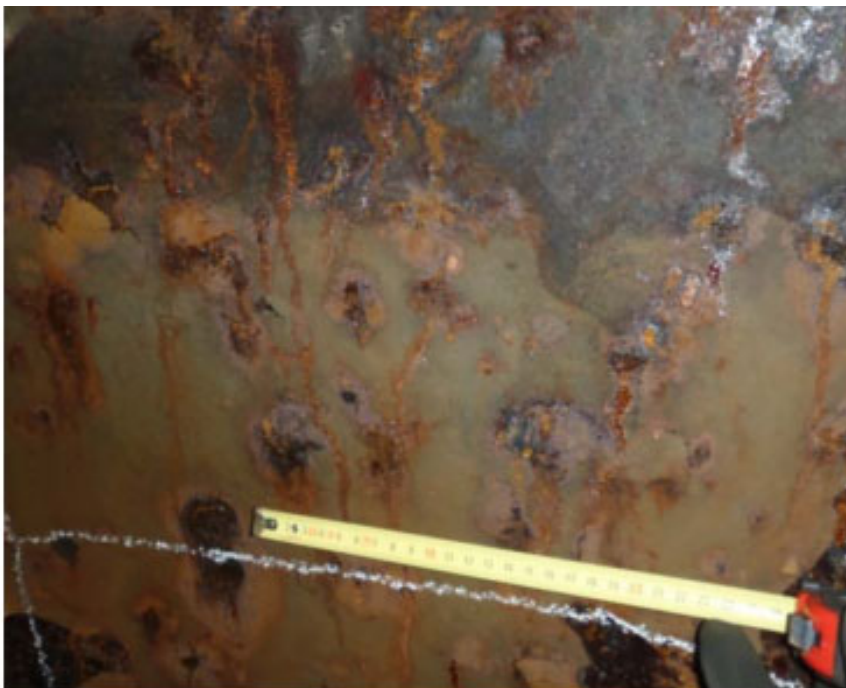
Figure 2.6: In another monopile foundation, areas covered in corrosion tubercles are observed [14].

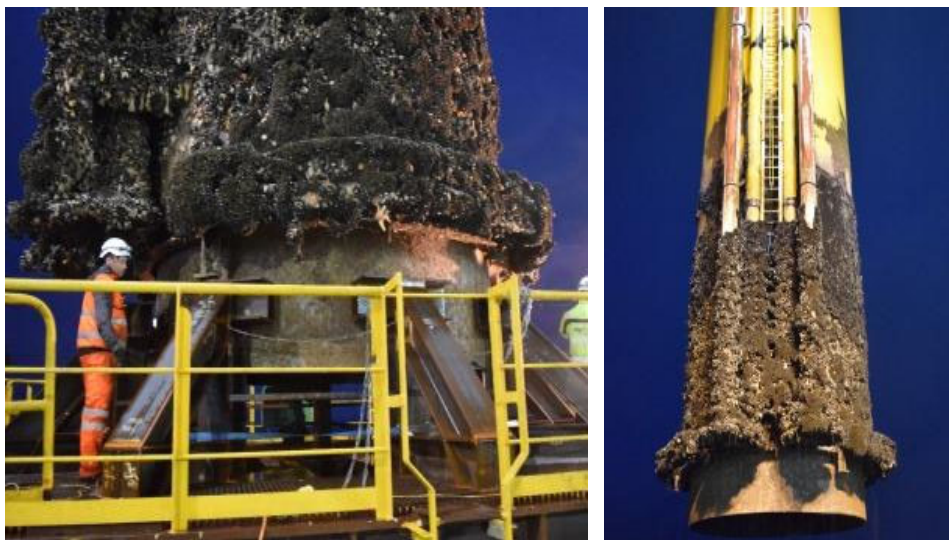
Figure 2.9: Decommissioned TP from Robin Rigg Offshore Wind Farm.

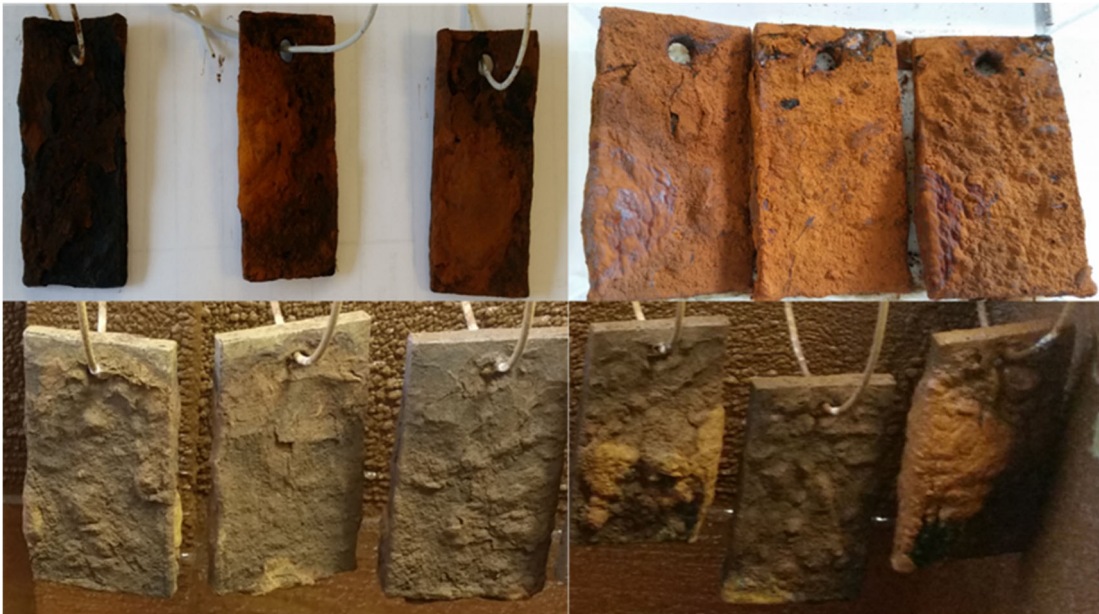
Figure 3.4: The accumulation of corrosion product on coupons extracted from the tidal chamber. From top left to bottom right the coupon exposure time was 3; 6; 9 and 12 months.

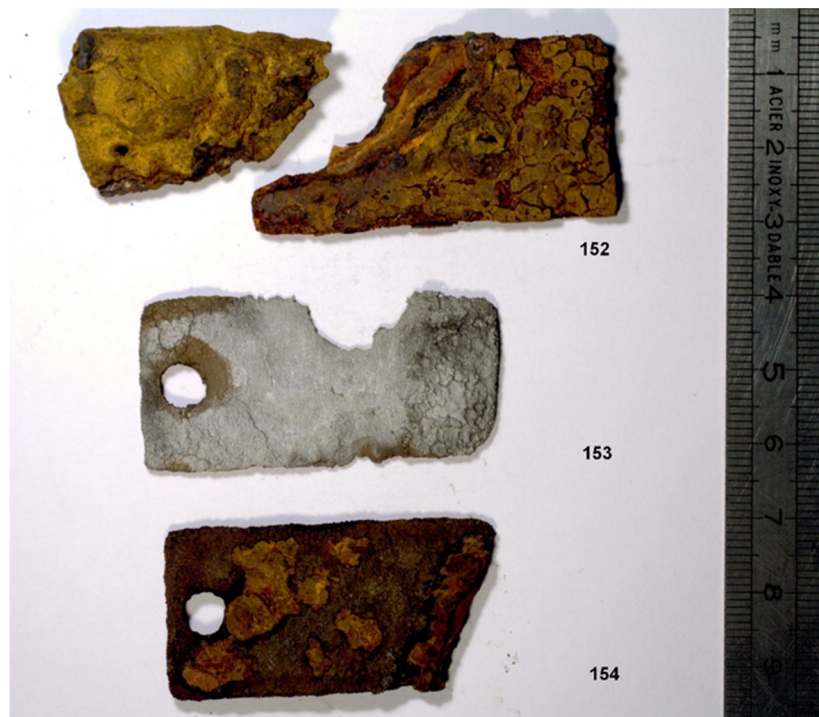
Figure 3.5: Appearance of corrosion coupons following 18 months of experimental tidal conditions

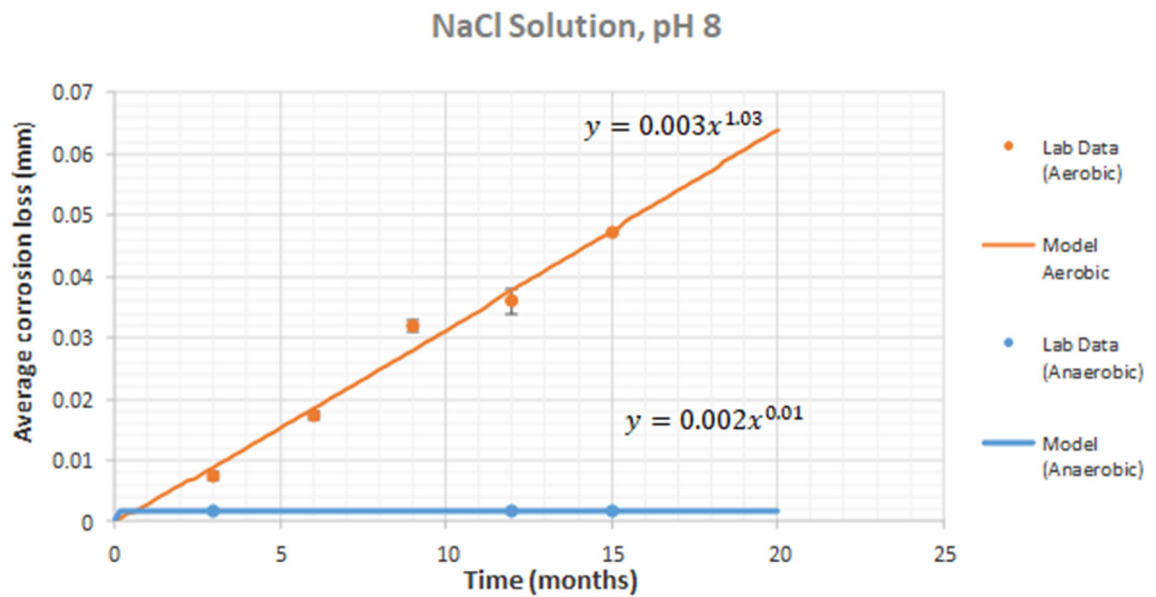
Figure 3.7: The average corrosion loss of carbon steel coupons immersed in NaCl solution at pH 8 in aerobic conditions (red markers) and anaerobic conditions (blue markers).

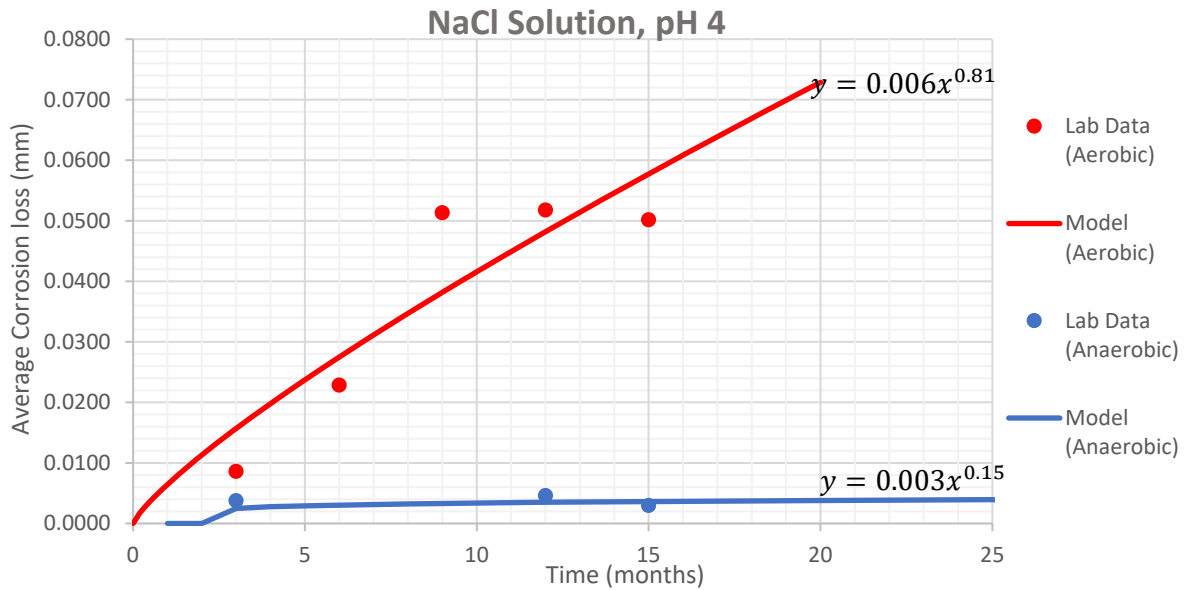
Figure 3.8: The average corrosion loss of carbon steel coupons immersed in NaCl solution at pH 4 in aerobic conditions (red markers) and anaerobic conditions (blue markers).

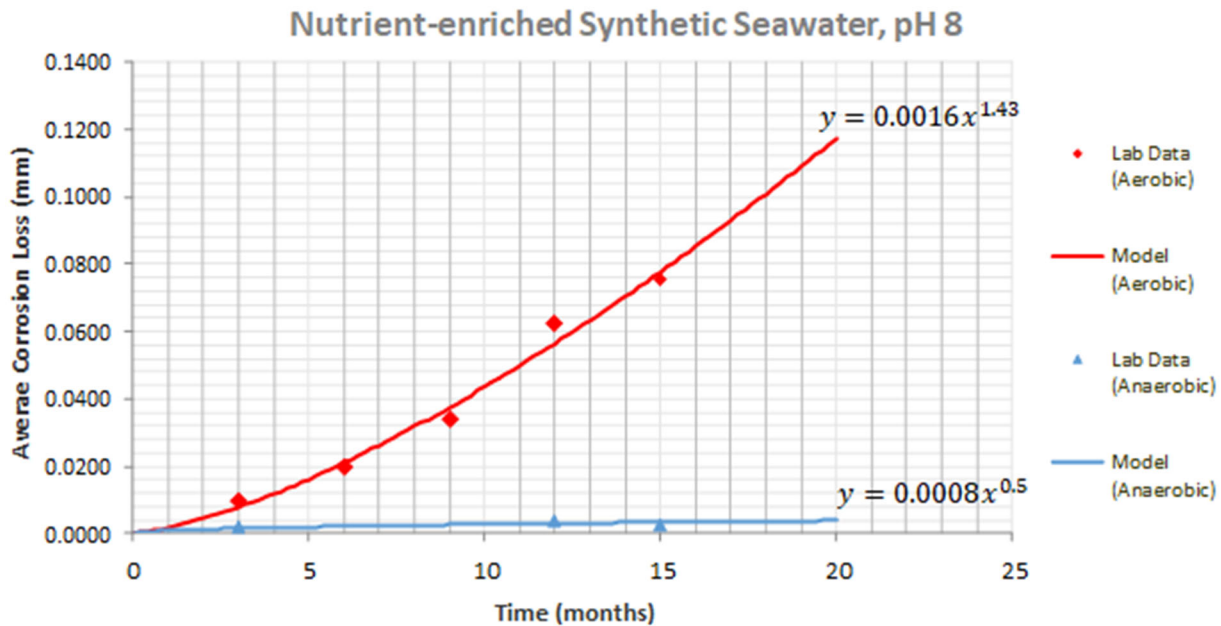
Figure 3.9: The average corrosion loss of carbon steel coupons immersed in nutrient-enriched artificial seawater at pH 8 in aerobic conditions (red markers) and anaerobic conditions (blue markers).

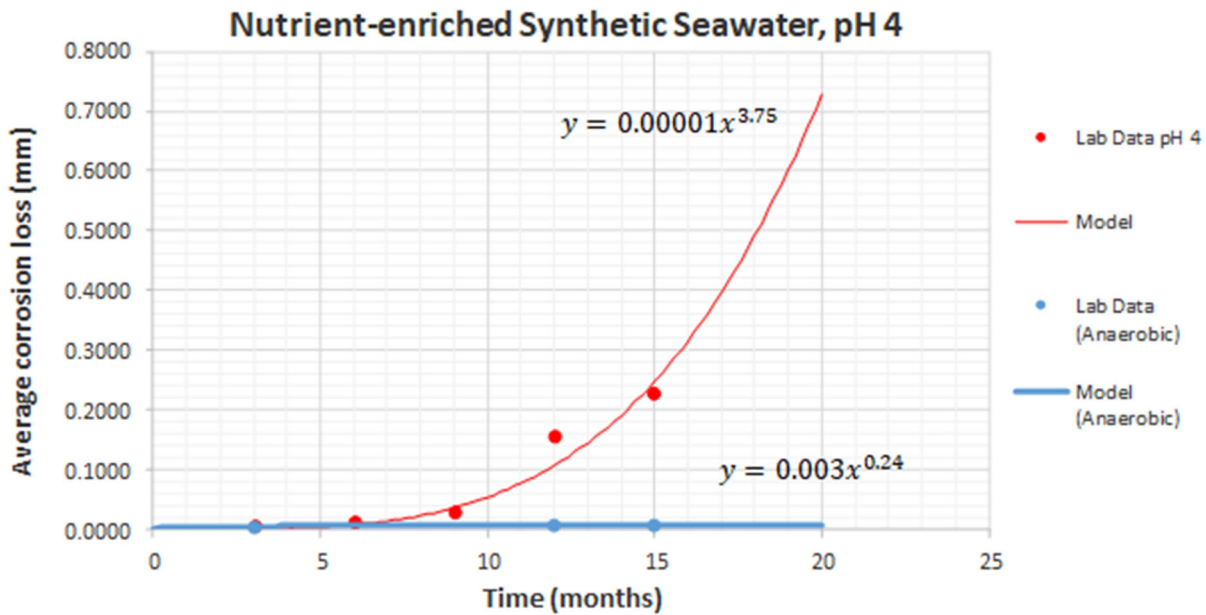
Figure 3.10: The average corrosion loss of carbon steel coupons immersed in nutrient-enriched artificial seawater at pH 4 in aerobic conditions (red markers) and anaerobic conditions (blue markers).

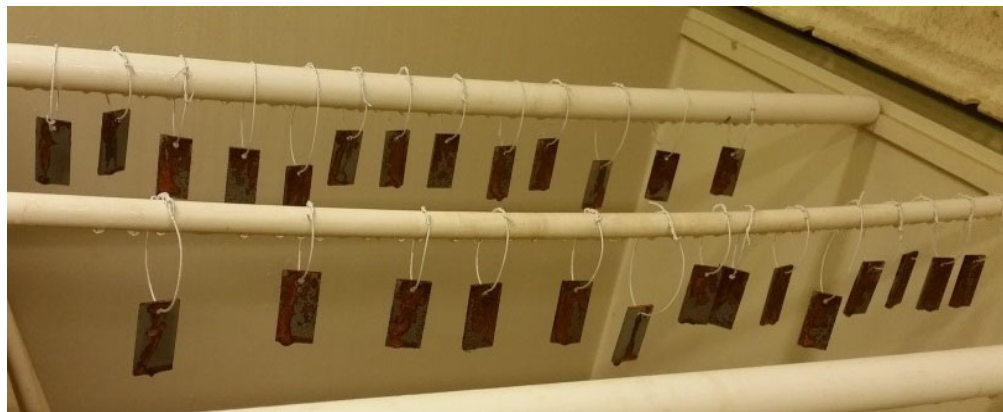
Figure 3.12: Coupons 25 to 46 immediately following 48 hours of salt spray treatment.

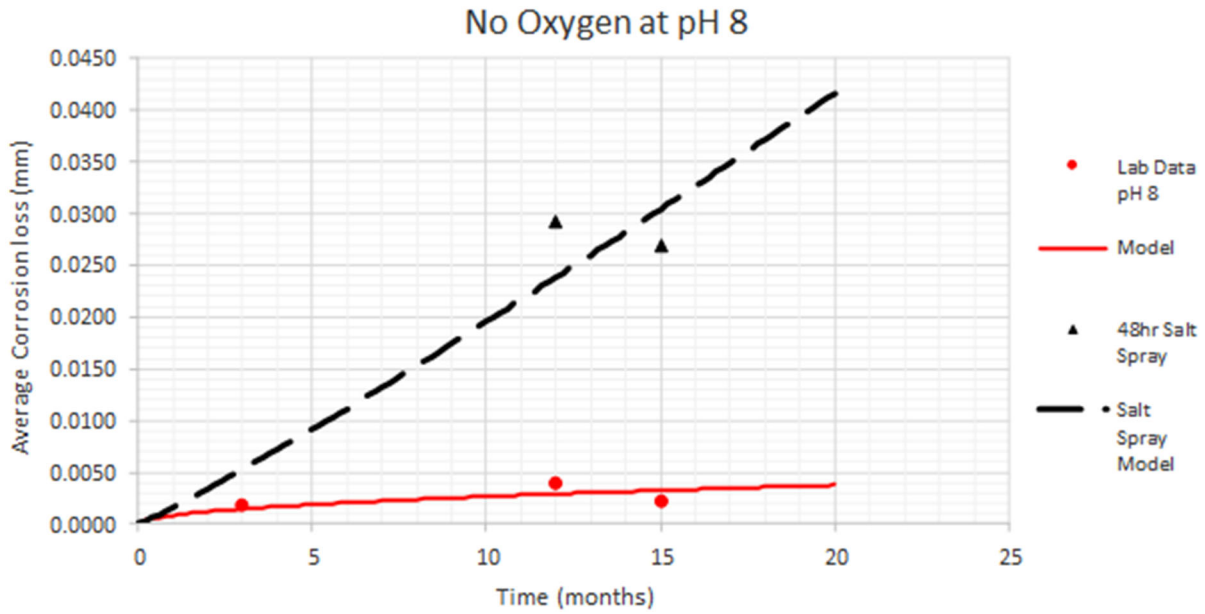
Figure 3.15: The average corrosion loss of coupons pre-exposed to 48 hours of salt spray testing before immersion in nutrient-enriched synthetic seawater (black markers), compared to the non-pre-corroded equivalent specimens at pH 8 and anaerobic conditions (red markers).

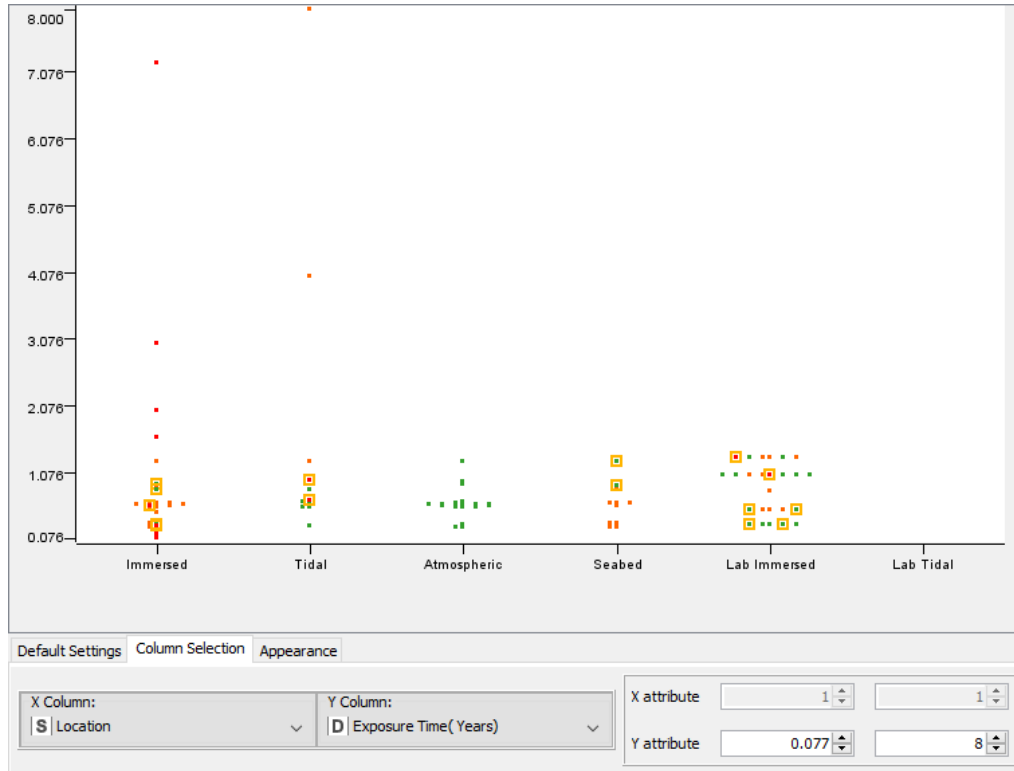
Figure 5.6: Predicted corrosion rates at each Location using decision tree model.

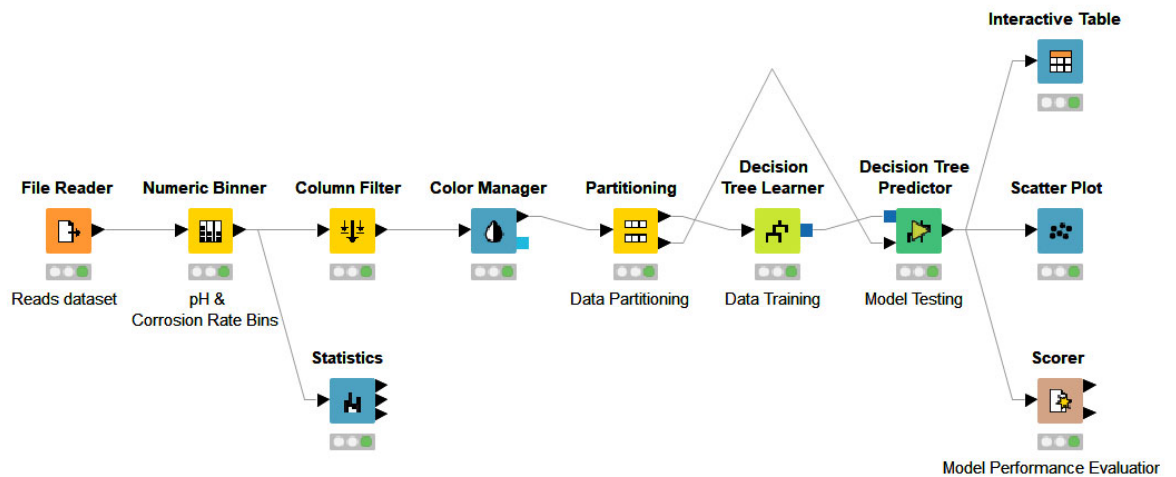
Figure 5.7 KNIME workflow of corrosion prediction decision tree model

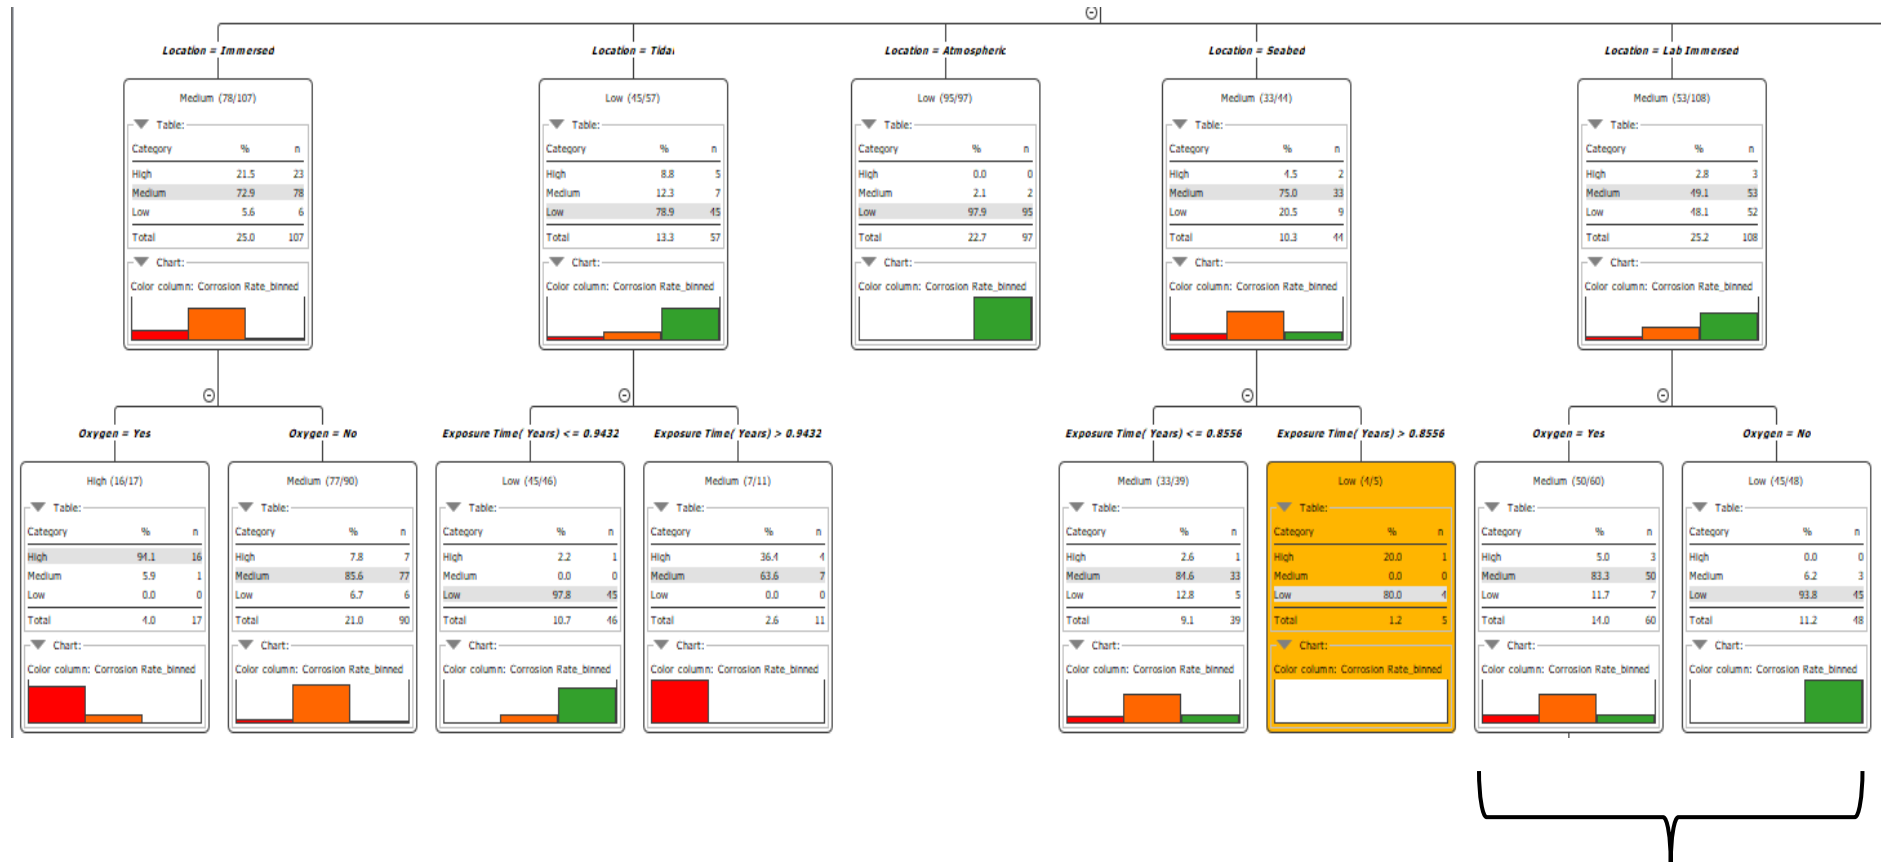
Figure 5.9: Decision Tree (2nd branch + leaf nodes for Immersed, Tidal and Seabed Locations)

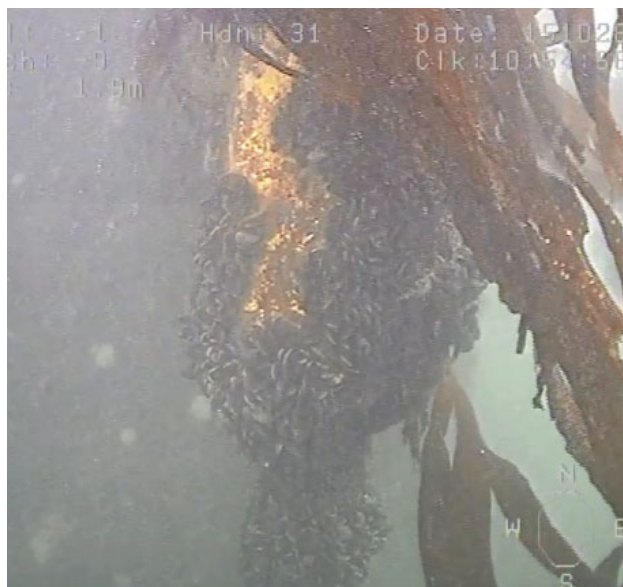
Figure 6.13: Kelp/Blue mussel transition zone at 1.9m depth on WTG B17.
