**FEASIBILITY STUDY
OF THE APPLICATION OF THE
ACOUSTIC EMISSION TECHNIQUE
TO CONCRETE BRIDGES**

Sabrina Colombo

The University of Edinburgh

May 2003

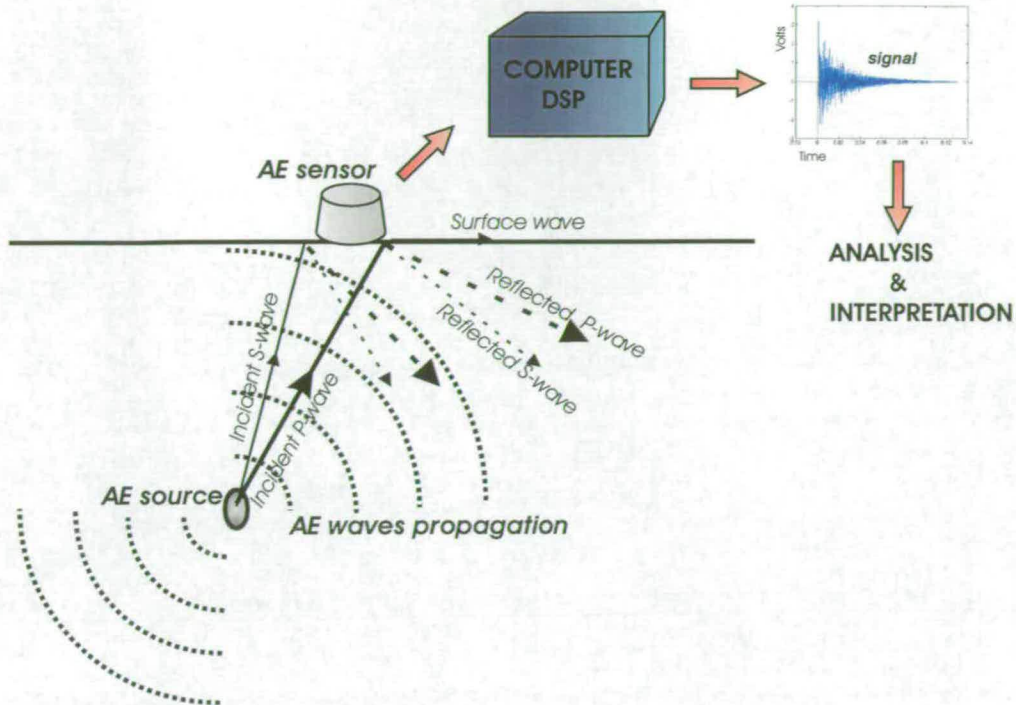
Figure 4.1: A schematic diagram of the AE Principle, from the AE source to the AE sensors and from the Digital Signal Processing (DSP) to the processing phase.

The term Acoustic Emission encompasses all phenomena where elastic waves are generated by the release of energy from localised sources. According to the BS EN 1330-9:2000 [BS, 2000] Acoustic Emission is a “term used for transient elastic waves generated by the release of energy within a material or by a process”. In every solid body subjected to stress - the occurrence of cracking, corrosion, slip or friction is followed by a release of stored strain energy that generates elastic waves, which is referred to as acoustic emission. These waves propagate through the material and can then be detected and recorded by AE sensors, previously mounted on or embedded in the material. The detected wave is turned into an electrical signal by the sensor and can be subsequently analysed and interpreted. As the source of the AE energy comes solely from the elastic stress in the material a lack of stress will result in no emission [Roca, 1997] [Pazdera, 2001]. The stress determines the presence of strain, which can be either elastic or plastic. Acoustic Emission is associated with plastic permanent strain. The general principle of AE is illustrated in Figure 4.1.

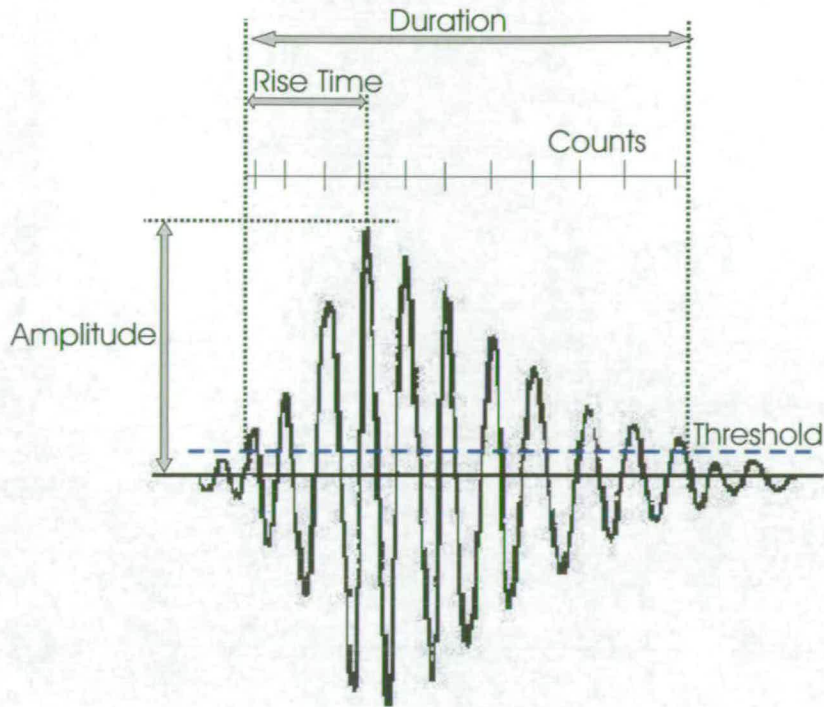
Figure 4.3: Schematic diagram of AE parameters. The diagram illustrates how the different attributes are measured.

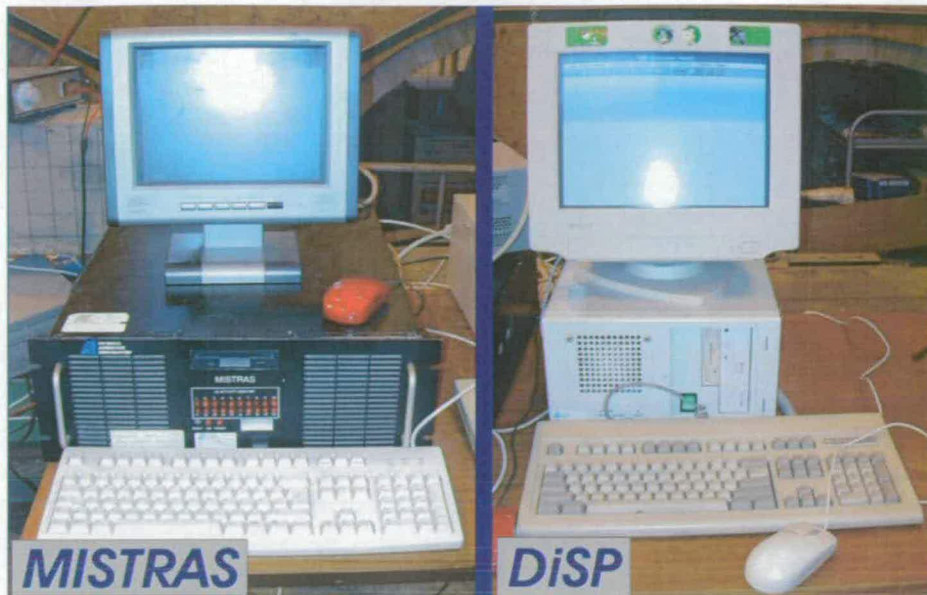
Figure 5.1: MISTRAS and DiSP systems.

The DiSP is the new advanced version of the MISTRAS system and they both work at frequencies above 25 kHz. Both are fully digital, multi-channel, computerized acoustic emission systems that can perform waveform and signal measurements and store and display recording data. The systems mainly consist of a Personal Computer, a circuit board, sensors, preamplifiers and coaxial cables [PAC, 1995]. The MISTRAS

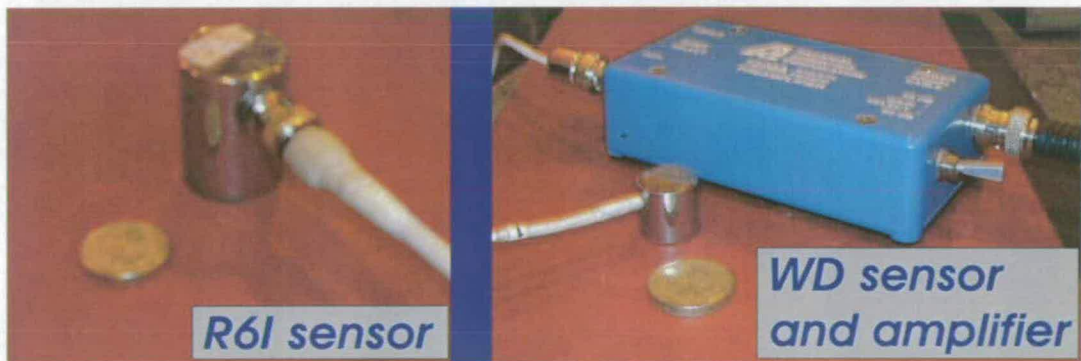
Figure 5.2: PAC's AE sensors.

and DiSP models owned by Edinburgh University have eight channels and four channels respectively. Two sets of sensors were also available at the University: eight broadband sensors (PAC WD) and eight resonant sensors (PAC R6I Resonant 60 kHz Integral sensor) (Figure 5.2). A different broadband model of sensors (PAC UT-1000) was used in Kumamoto University. The resonant sensors have an incorporated amplifier of 40 dB, whilst the broadband types use an external amplifier that can be set to 40 or 60 dB. The 40 dB option was adopted in all the experiments. Further details about the AE transducers are given in section 5.4.

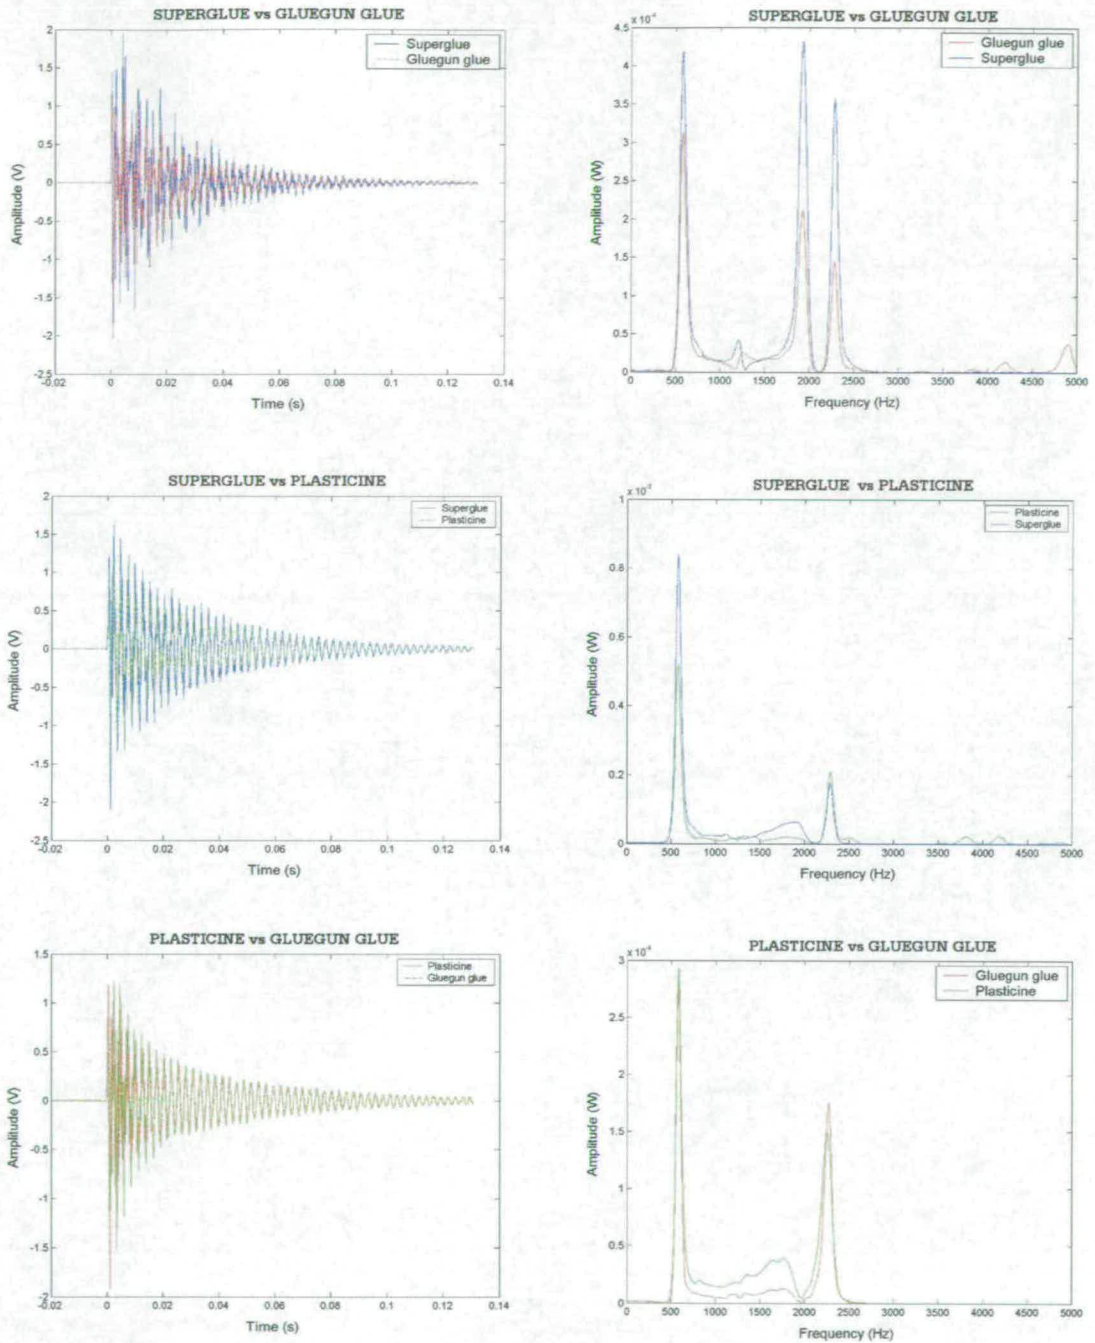
Figure 5.7: Concrete slab results: Time Domain (left) and Power spectral density (right) plots for the different couplant types, shown in comparison with each other.

In the final stage a test on a cast concrete cube (150 mm) specimen was carried out using these couplants. A ball bearing (13 mm in diameter) attached by an elastic band to a frame that sat above the impact point, was used as an impact source. The frame was located such that the ball would strike the surface only once. This system set-up would ensure an adequate, constant and reproducible impact. Only one accelerometer at a time was used and this was mounted on the centre of one of the vertical sides of

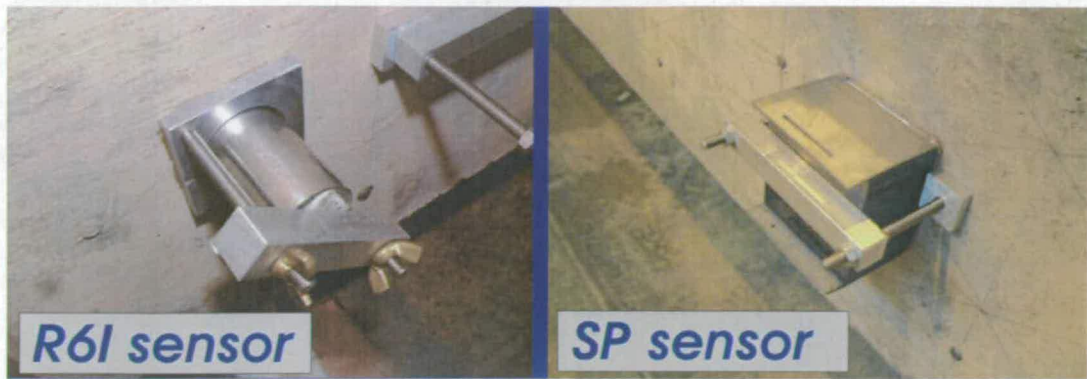
Figure 5.11: Sensor Clamps.

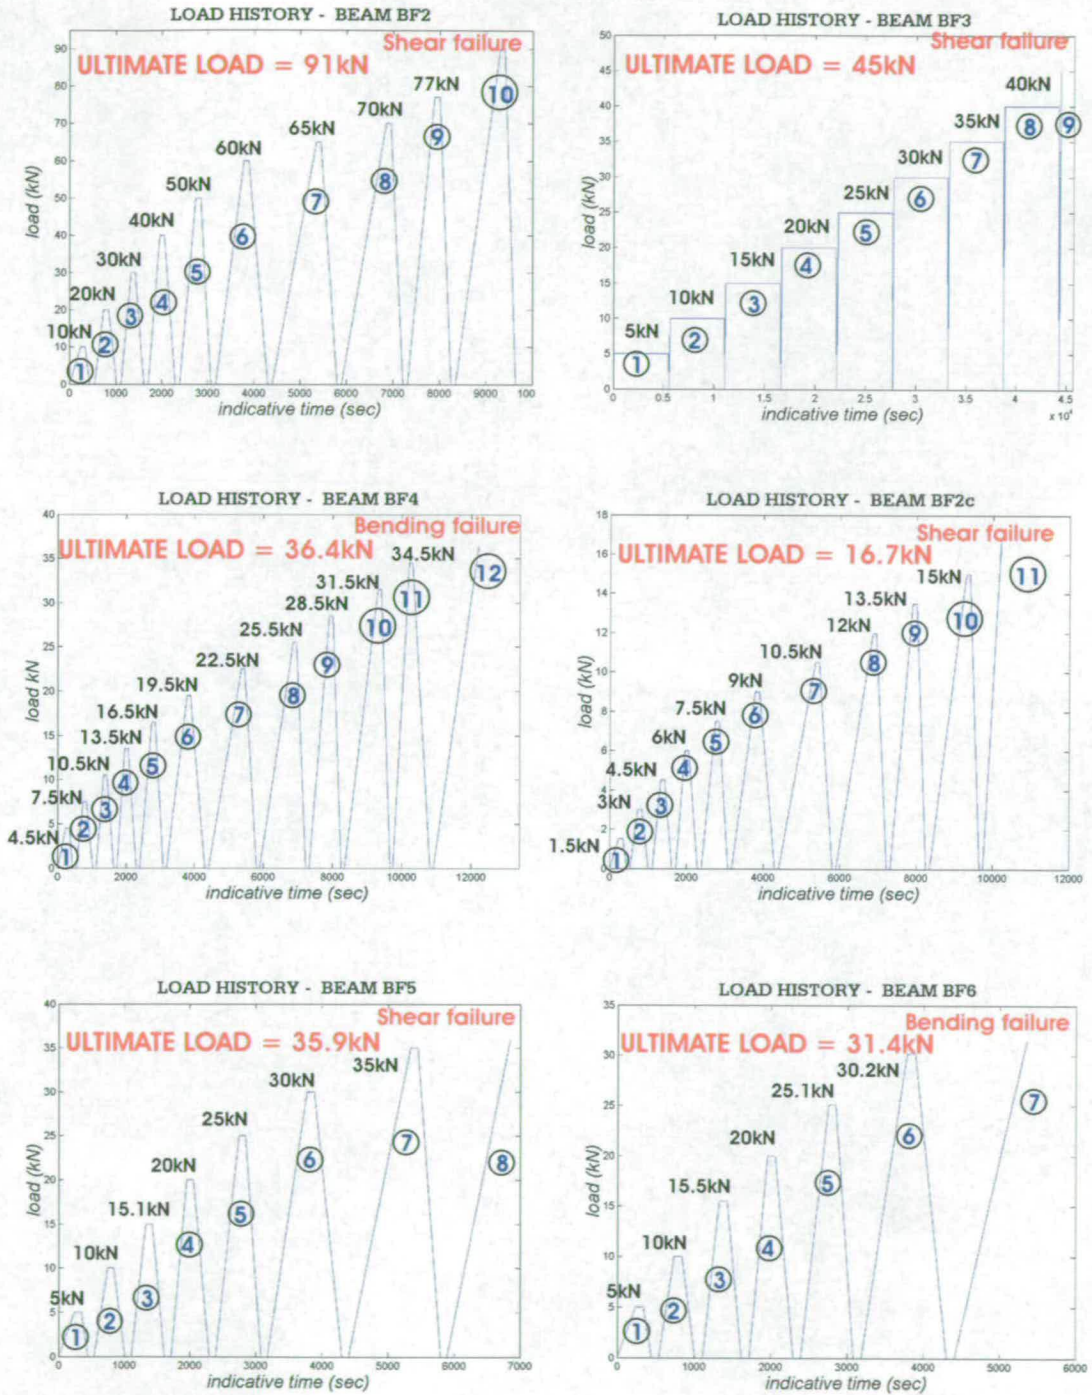
Figure 6.3: Load history of the beams of Edinburgh experiments.

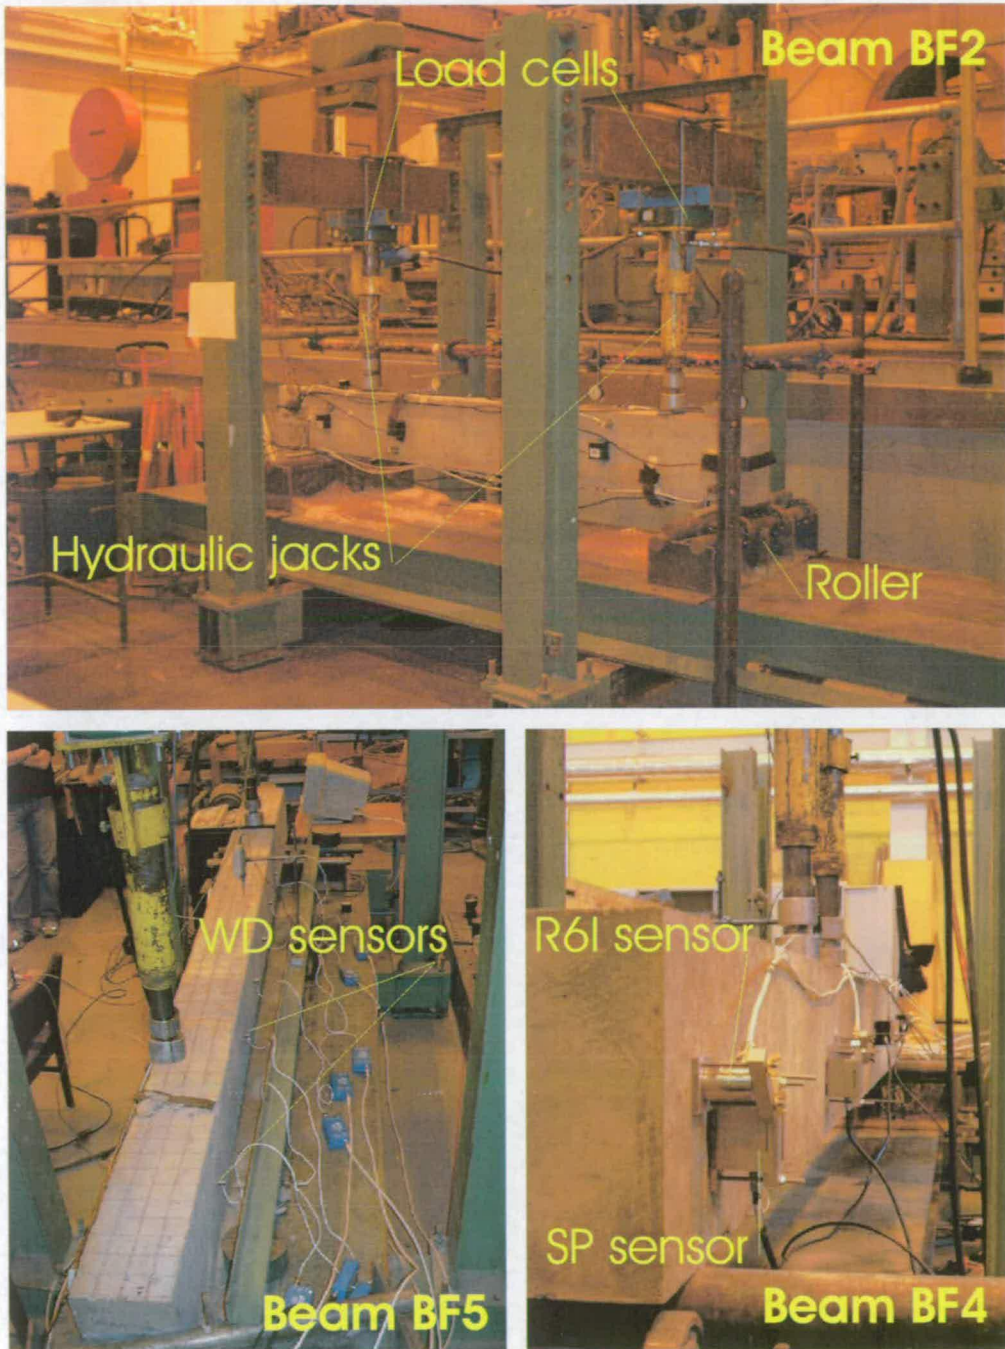
Figure 6.10: Photos of Edinburgh beams.

The beam was 345 mm wide, with an overall height of 305 mm. It was 4.2 m long and reinforced with three 25 mm diameter mild steel bars. After having been cast, the beam was turned over through 180° so that it could be tested upside-down (i.e. with the tension zone at the top), in order to facilitate the monitoring of the cracks. The concrete compressive strength was 32 MPa and the beam was designed to fail in flexure. The velocity of the wave-propagation was calculated using the PUNDIT (see section 5.5) and an average value of 4118 m/sec was obtained. One side and half the top and

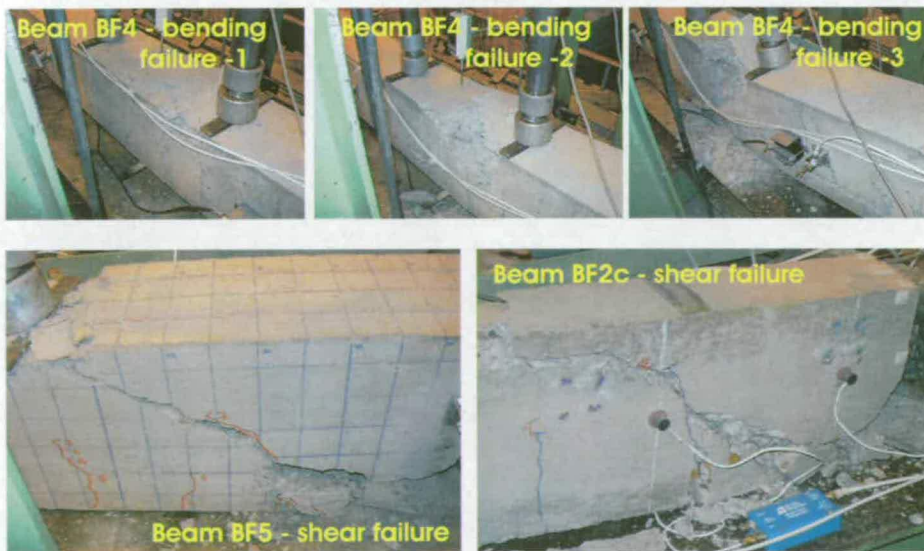
Figure 6.17: Photos of Edinburgh beam failures. Note the visible shear dislocation of the grid pattern for test BF5.

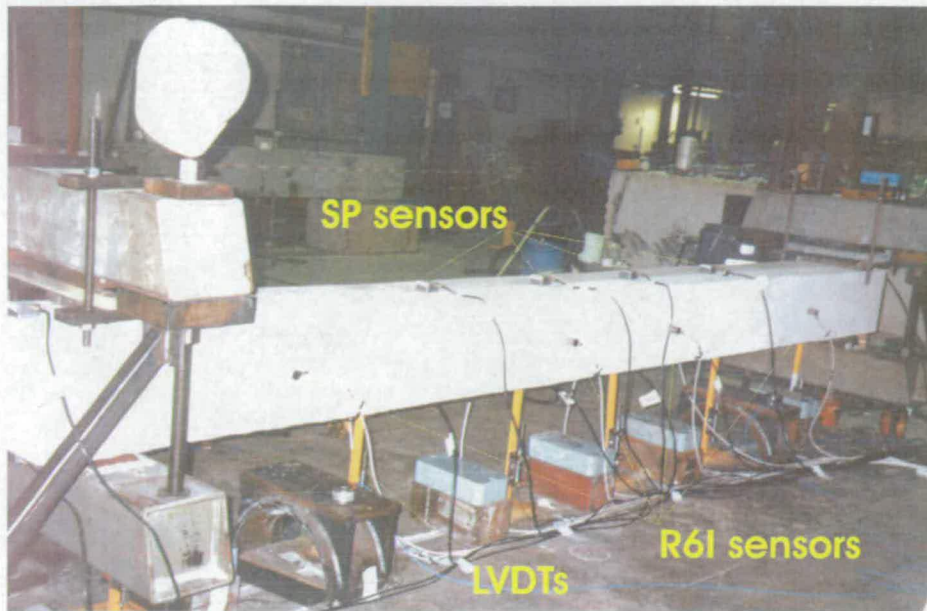
Figure 6.18: Photo of instrumented beam CF1.

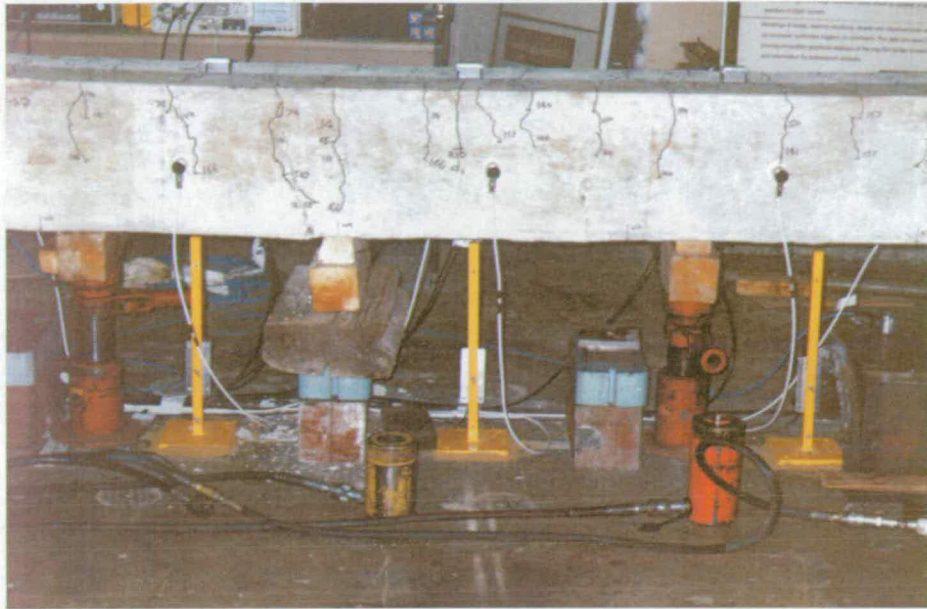
Figure 6.19: Photo of beam CF1 failure.

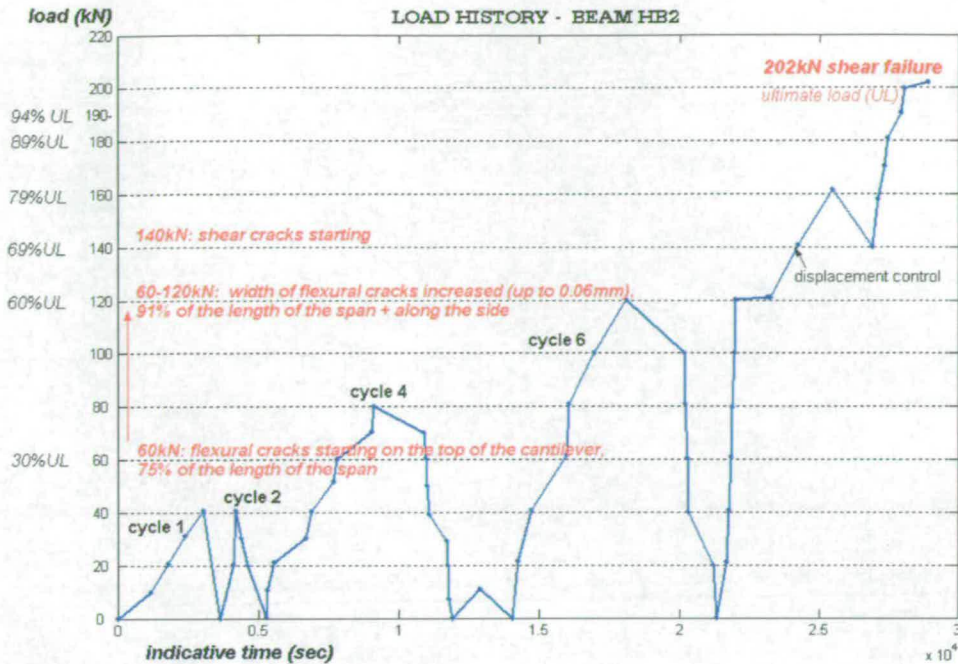
Figure 6.22: Load history of beam HB2.

- cycle 1:
 - loading up: $0 \xrightarrow{t_Q} 40$ kN, in steps of 10 kN
 - unloading: $40 \xrightarrow{t_Q} 0$ kN, in steps of 10 kN
- cycle 2:
 - as for cycle 1
- cycle 4:
 - loading up: $0 \xrightarrow{t_Q} 80$ kN, in steps of 10 kN;
 - unloading: $80 \xrightarrow{t_Q} 0$ kN, in steps of 10 kN;
- cycle 6:
 - loading up: $0 \xrightarrow{t_Q} 120$ kN, in steps of 20 kN;
 - unloading: $120 \xrightarrow{t_Q} 0$ kN, in steps of 20 kN;
- cycle 7:
 - loading up to failure, in steps of 20 kN;

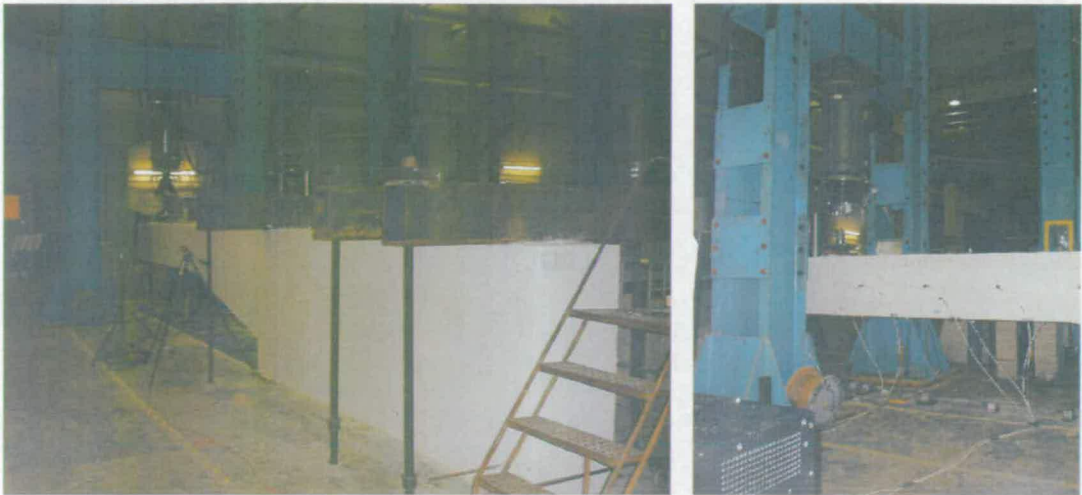
Figure 6.23: Beam HB2. Test configuration and instrumentation.

During the tests the beam was monitored using the MISTRAS system in

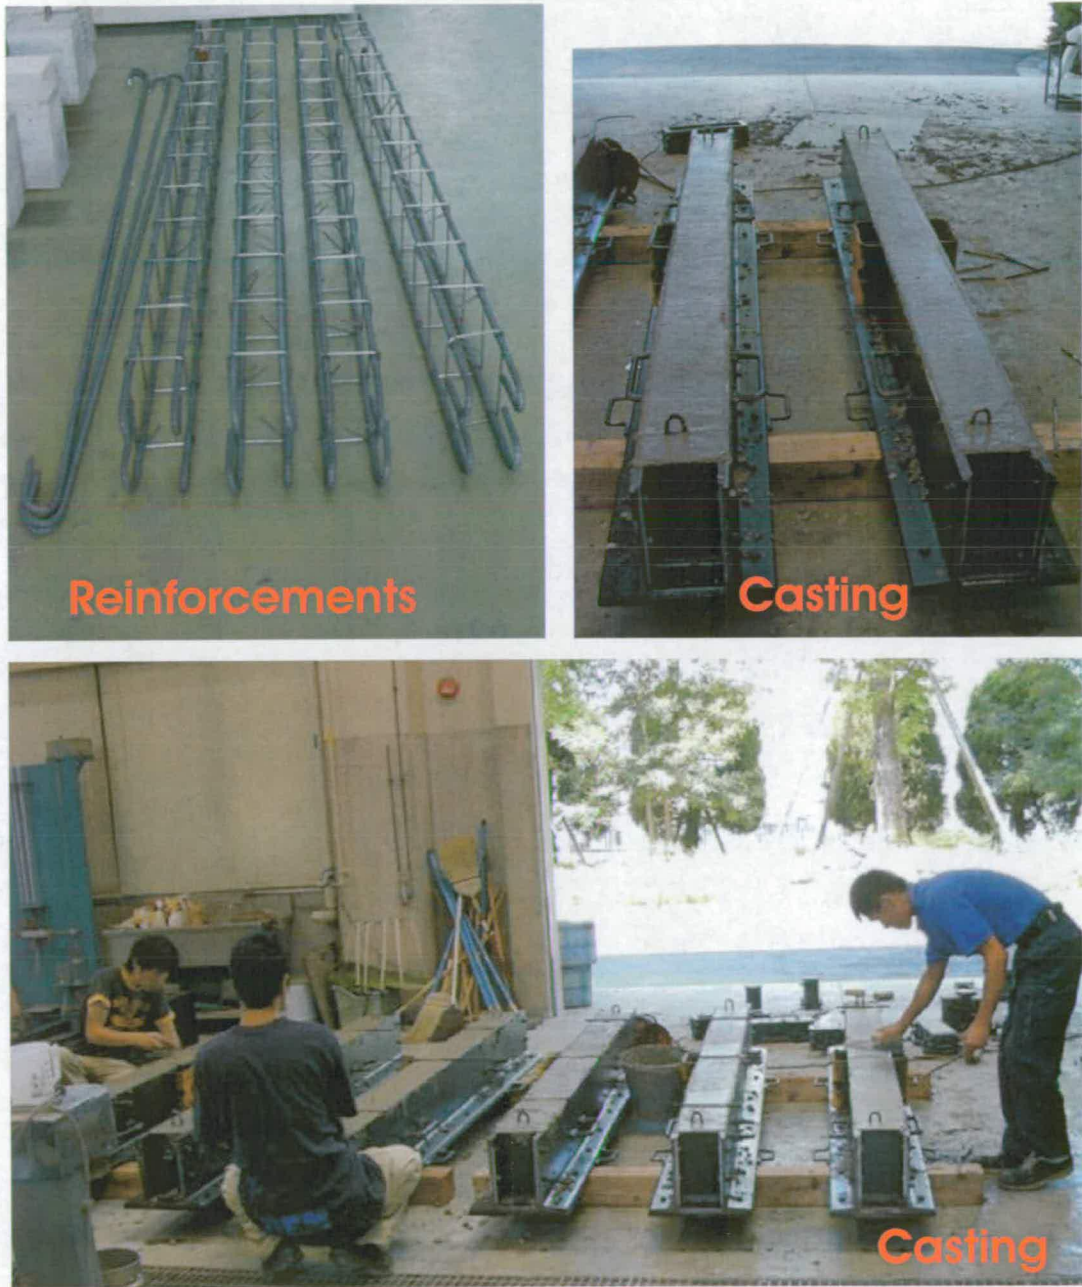
Figure 6.25: Phases of the casting of the beams in Kumamoto Laboratory.

The beams were designed according to experiments previously performed in the laboratory and the dimensions were determined by the existing metal mould that could be used. Two types of beam were made in order to verify the influence of beam design on the results. Four beams were designed having stirrup cages (beams K1, K2, K3 and K4) whilst the remaining two beams were simply reinforced (beams KL1 and KL2). Due to the limited available time, rapid hardening concrete was used and as before the fresh concrete and the reinforcement were ordered from an external supplier. The longitudinal bars and the stirrups were bent and the stirrup cages assembled in the laboratory and the assemblies placed in the formwork (Figure 6.25). The concrete was

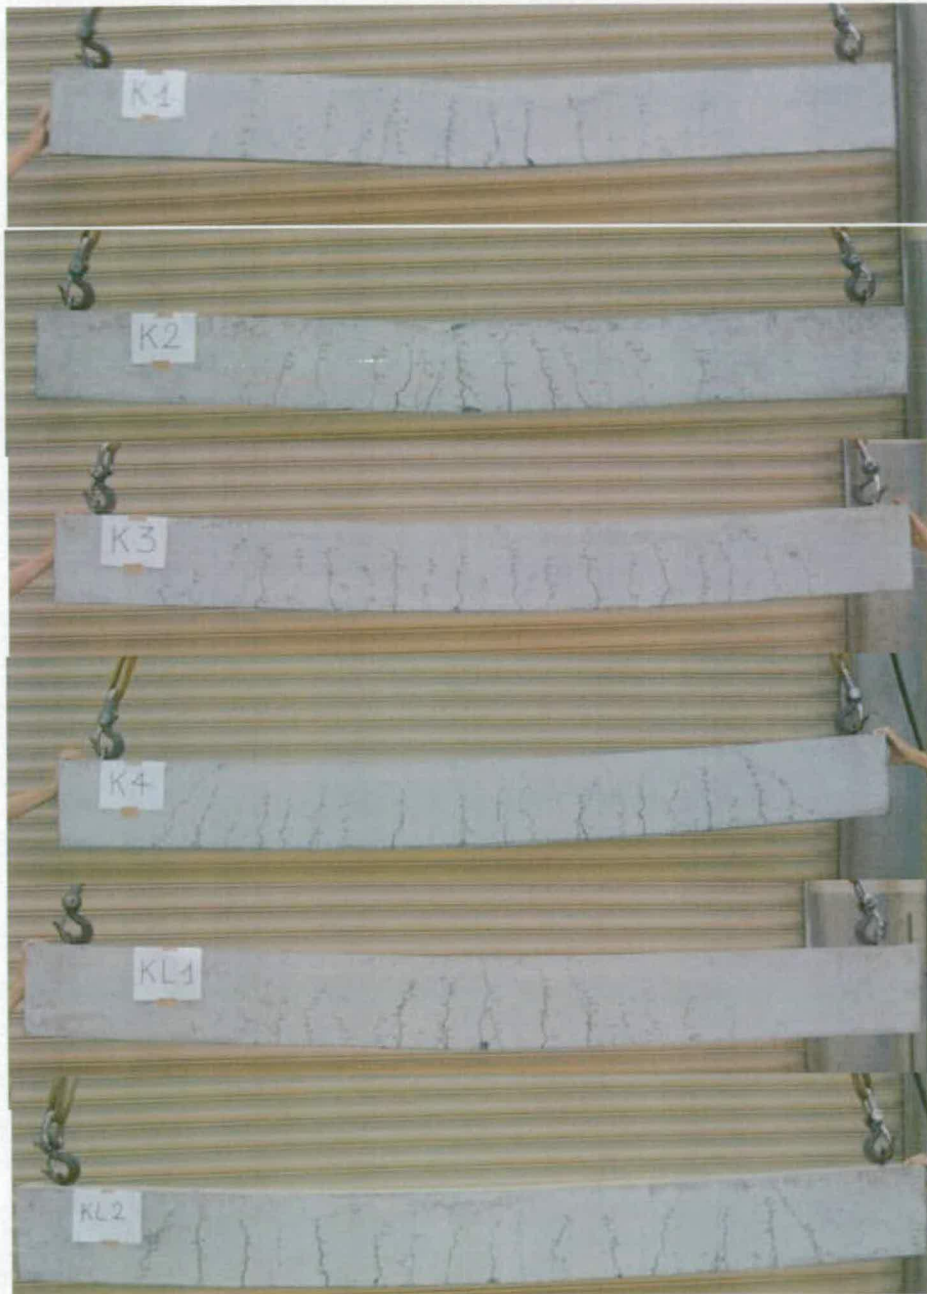
Figure 6.33: Photos of failed beams at Kumamoto Laboratory.

During each cycle the cracks were marked as in the Edinburgh experiments although their exact pattern was of no specific interest for the purpose of these tests and it is therefore not shown here in detail. Depending on the load configuration the crack patterns appeared to be composed of pure bending cracks (beams K1, K2 and KL1) or of a predominance of bending cracks alongside the beam with few shear cracks appearing at the beam ends (beams K3, K4 and KL2). Photos of the failures are in Figures 6.33 and 6.34.

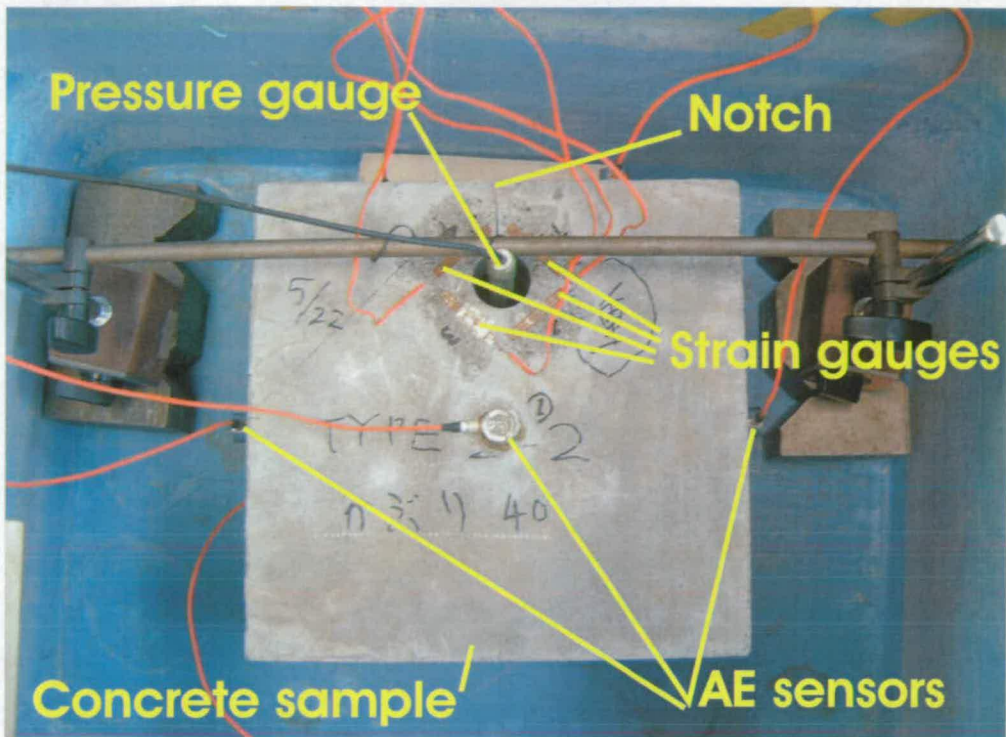
Figure 6.35: Set up of the concrete sample for the Moment Tensor test.

The experiment consisted of pouring an expansive agent (dolomite paste) in the rebar hole of the concrete sample. This agent then expanded (over a period of about 12 hours) simulating the corrosion of a rebar and thus generating the cracking and failure of the sample. The pressure gauge, placed in the rebar hole before pouring the agent,

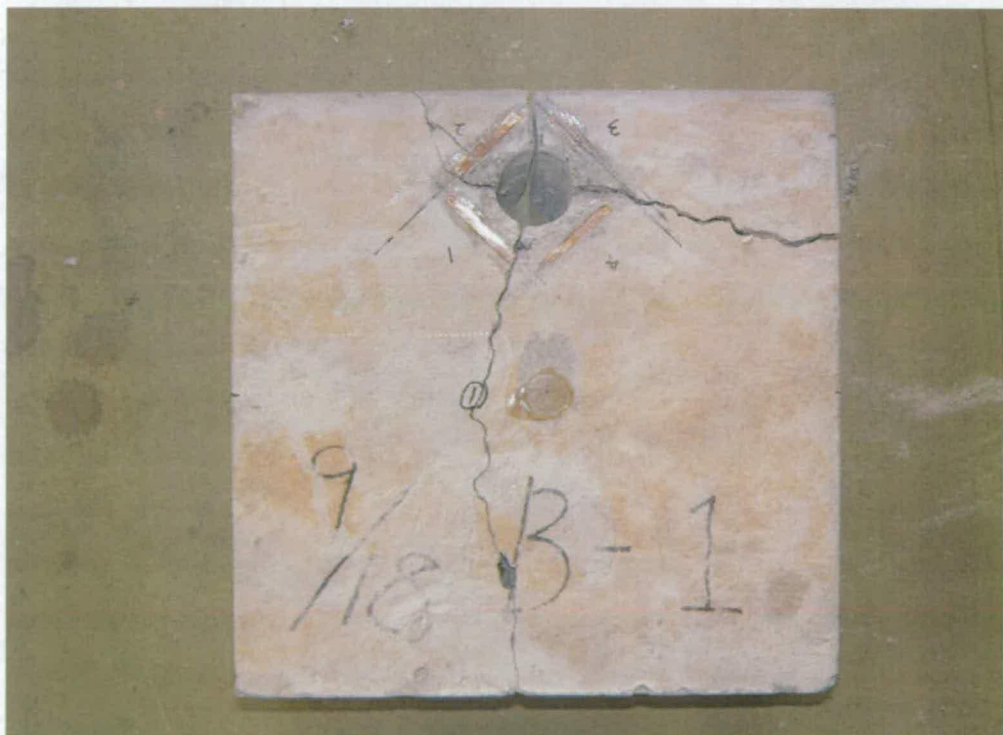
Figure 6.36: Failure of the concrete sample for the Moment Tensor test.

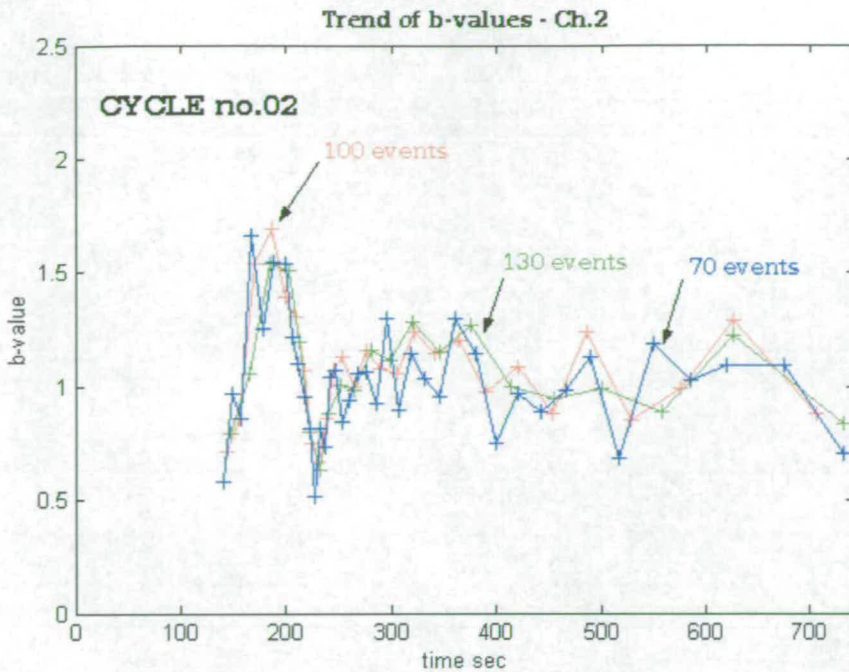
Figure 7.2: b -value over time calculated with using groups of respectively 70 (blue line), 100 (red line) and 130 (green line) events.

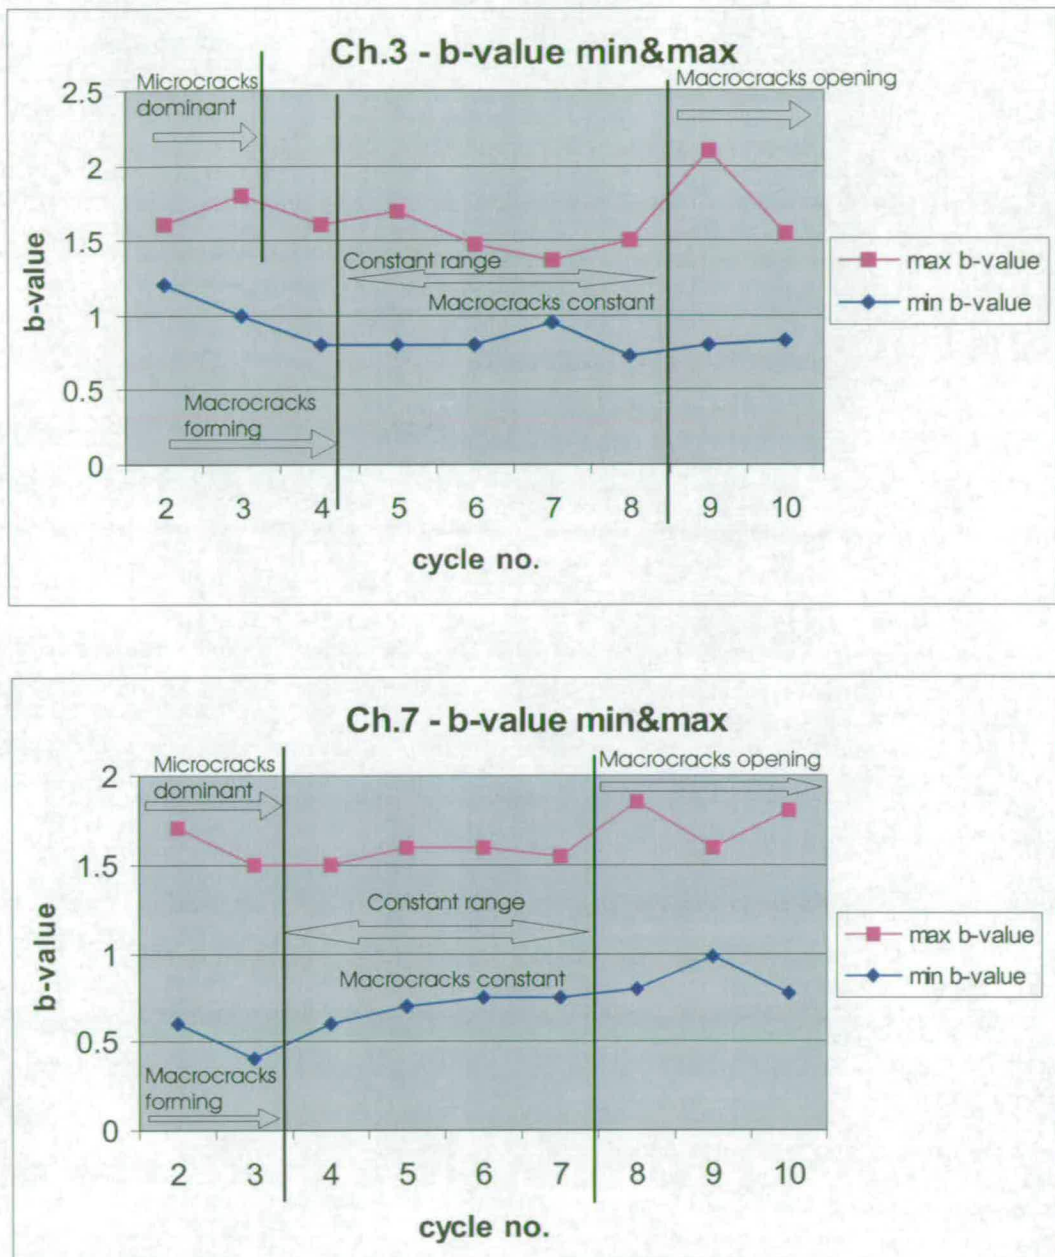
Figure 7.5: Variation of the maximum and minimum b -value for channels 3 (top) and 7 (bottom) during all the cycles of the whole experiment. The vertical lines show the different identified cracking stages indicated by the arrows.

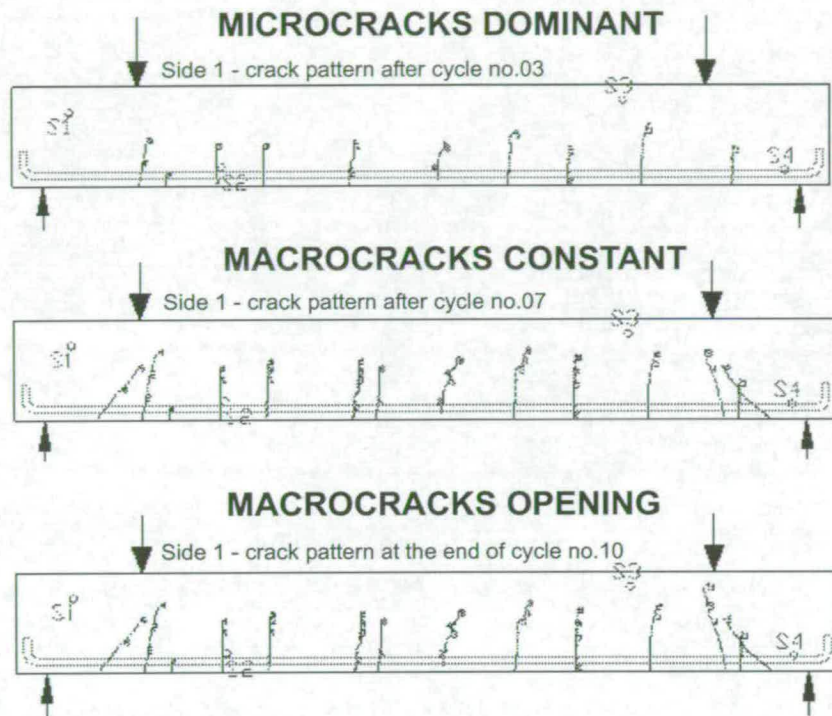
Figure 7.6: A sketch of the fracture process developments during the different stages of the loading. The dotted line outlines the location of the steel reinforcement. Note the inclined shear cracks near the edges of the sample.

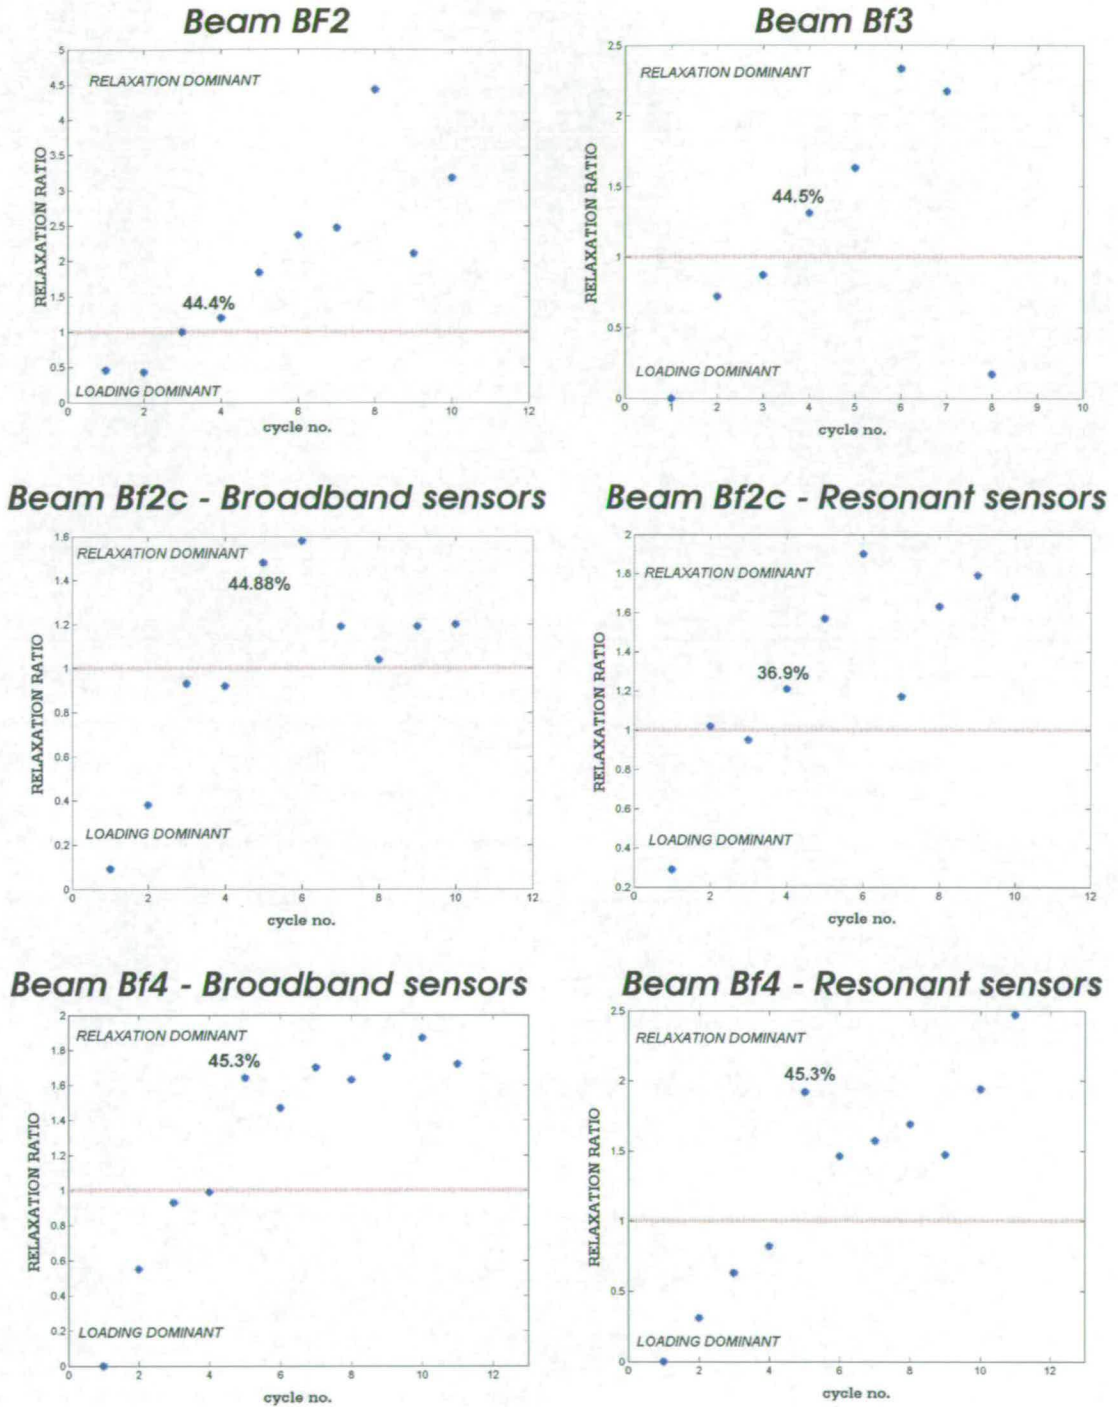
Figure 7.18: Relaxation ratio results of Group 1: beams BF2, BF3, BF4 and BF2c. The red line corresponds to a relaxation ratio equal to one. The dots represent the values of the relaxation ratio (on the vertical axis) for each relative number of cycle, that can be read on the horizontal axis.

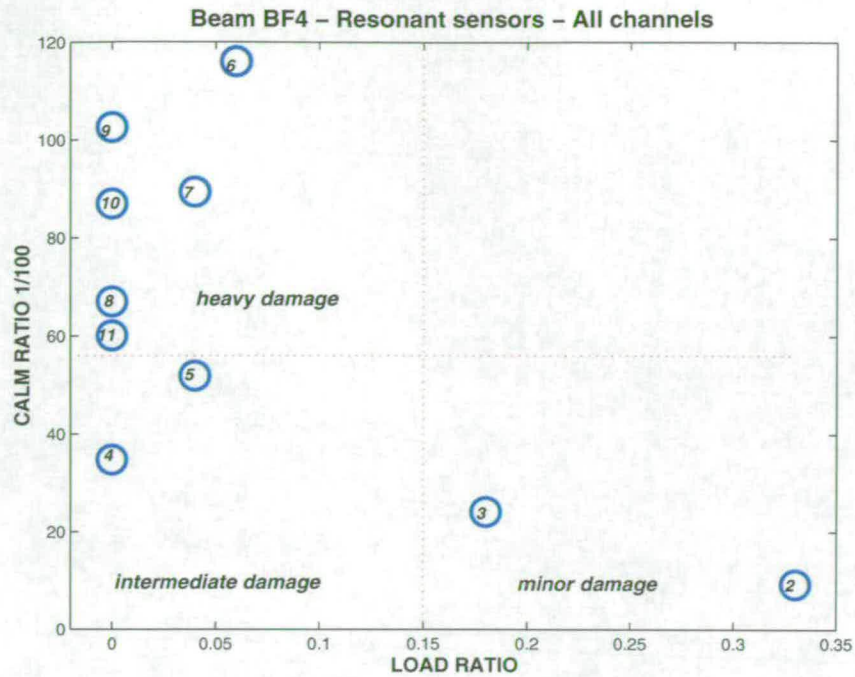
Figure 7.21: NDSI assessment for beam BF4, using all data. The numbers indicate the loading cycle and the red lines define the different areas of damage.

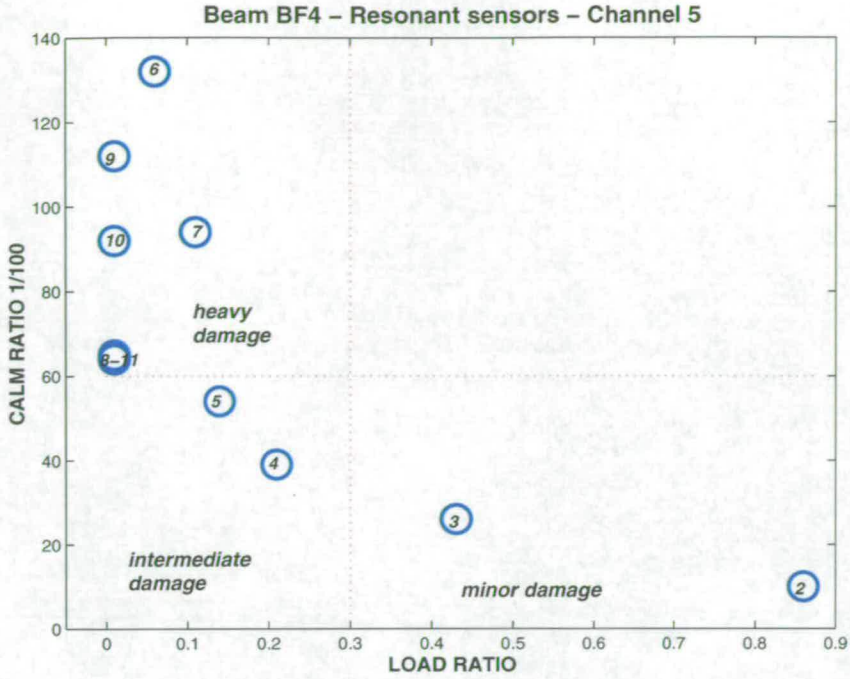
Figure 7.22: NDSI assessment for beam BF4, using only channel 5 data. The numbers indicate the loading cycle and the red lines define the different areas of damage.

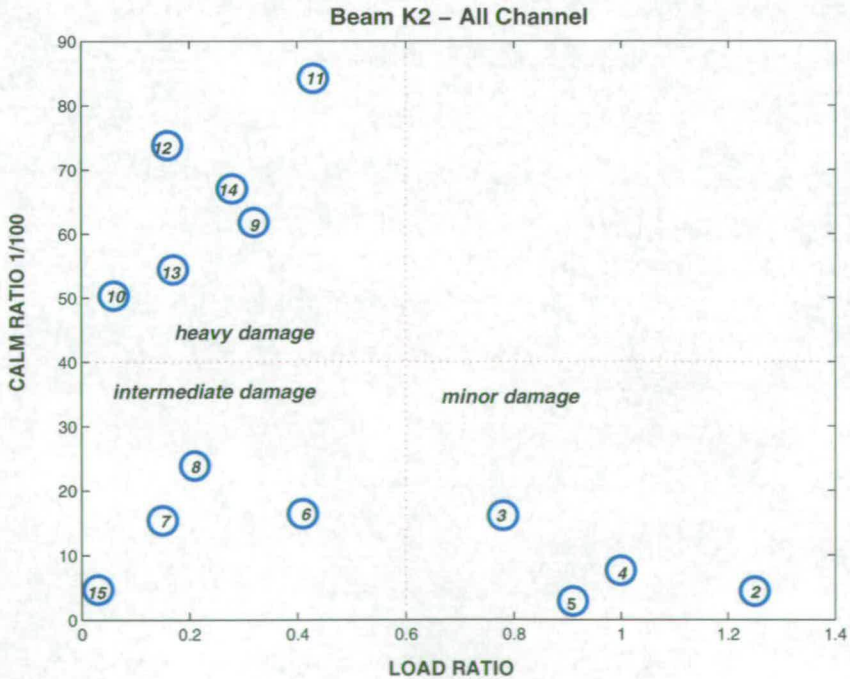
Figure 7.23: NDSI assessment for beam K2, using all data. The numbers indicate the loading cycle and the red lines define the different areas of damage.

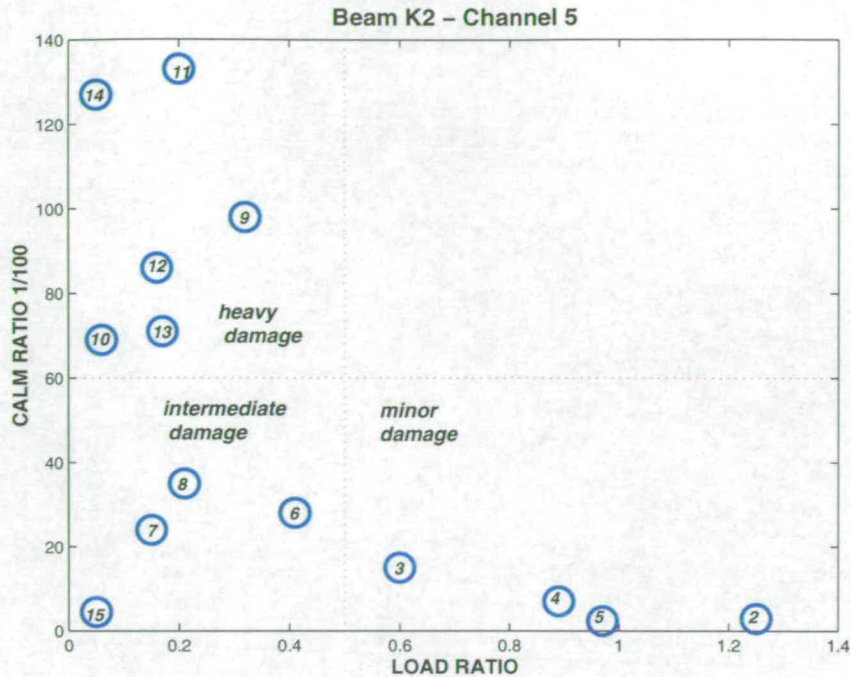
Figure 7.24: NDSI assessment for beam K2, using only channel 5 data. The numbers indicate the loading cycle and the red lines define the different areas of damage.
