**FEASIBILITY STUDY
OF THE APPLICATION OF THE
ACOUSTIC EMISSION TECHNIQUE
TO CONCRETE BRIDGES**

Sabrina Colombo

The University of Edinburgh

May 2003

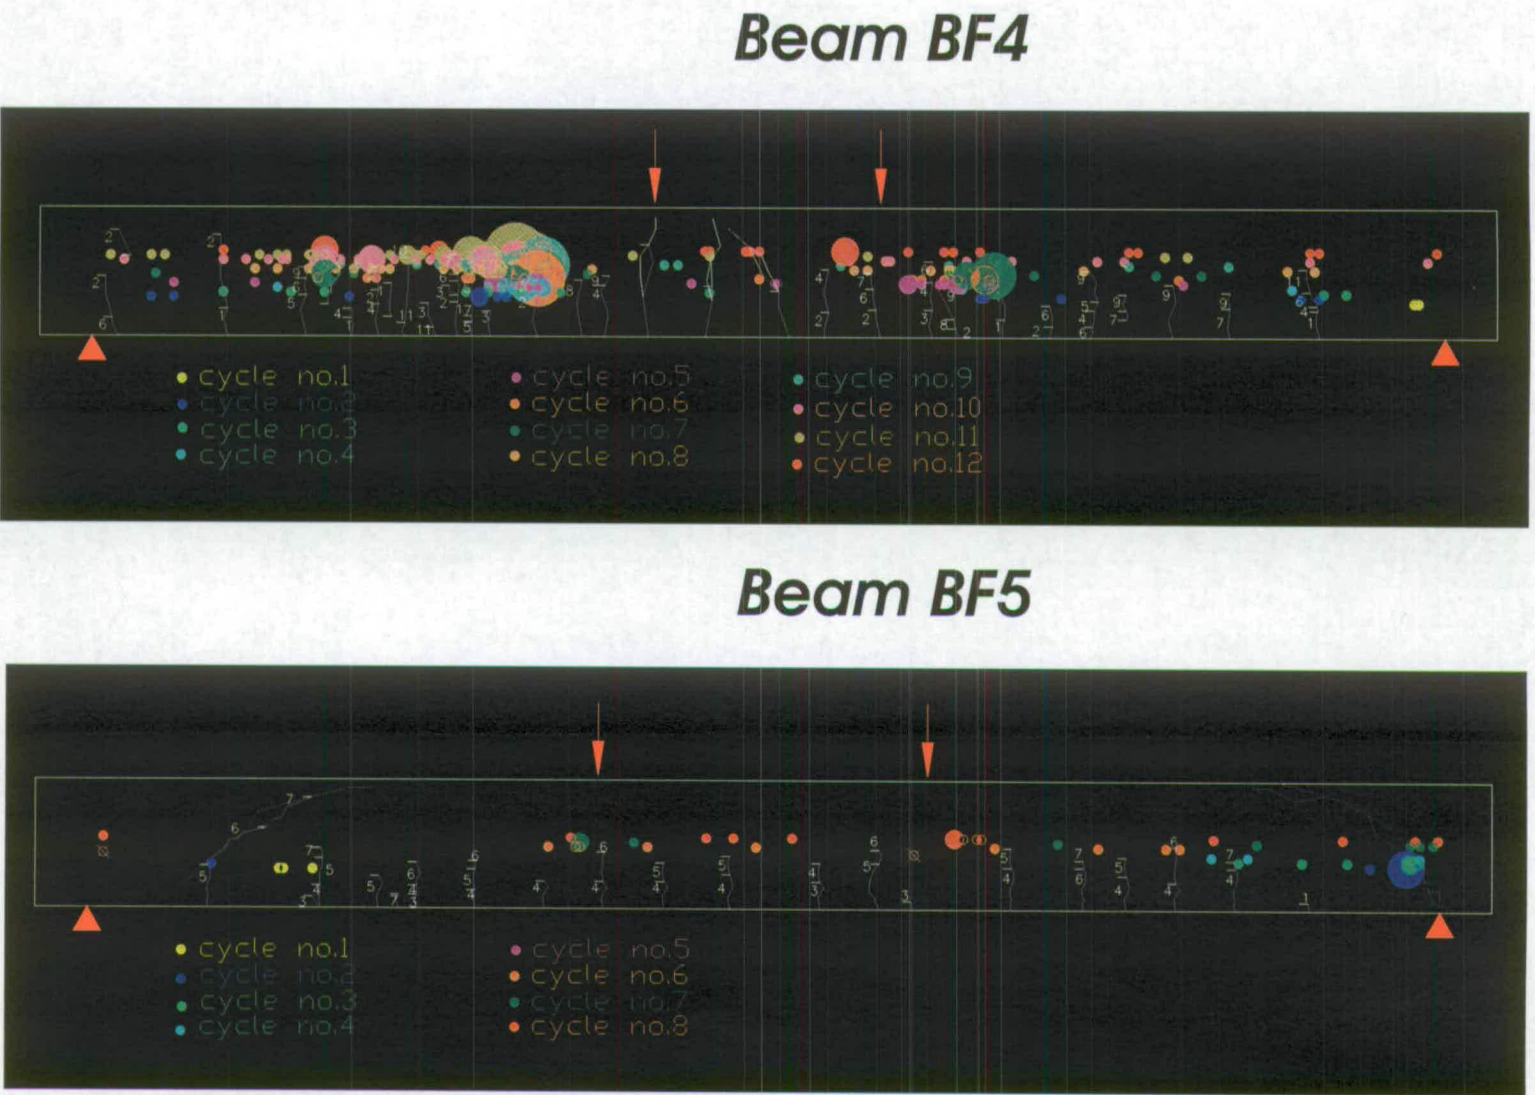
Figure 7.26: Location of events recorded by the SoundPrint system on beams BF4 and BF5. The different colors indicate different loading cycles, whilst the diameter is proportional to the number of events.

On beam BF4 (top of Figure 7.26) two active areas can be identified, corresponding to the region where the bending moment was maximum; very few events were however located in the middle of the beam. The two active areas correspond to the peaks in Figure 7.28, which shows the PAC results.

On beam BF5 (bottom of Figure 7.26) it is not possible to identify a clear pattern. A larger concentration emerged towards the right end of the beam, where the sample

The locations shown in Figures 7.26 and 7.27 include the events recorded during all the cycles and a pattern can be recognized for beams BF4, BF6 and BF2c. It was noted that for these beams, the pattern of AE activity emerged on cycles number 6, 3 and 6 respectively (Figures 7.30). These cycles corresponded to 53.6%, 49.4% and 53.4% of the ultimate load to which each beam failed. The SP activity was then able to give an early indication of where ultimately those beams were going to fail.

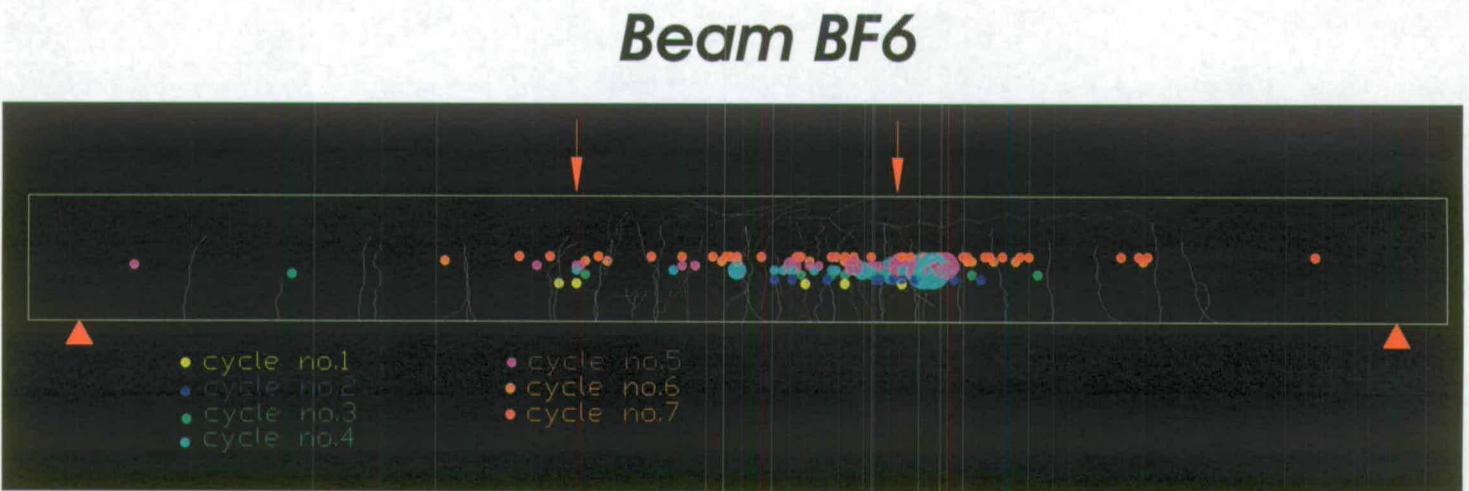
Figure 7.27: Location of events recorded by the SoundPrint system on beams BF6 and BF2c. The different colors indicate different loading cycles, whilst the diameter is proportional to the number of events.

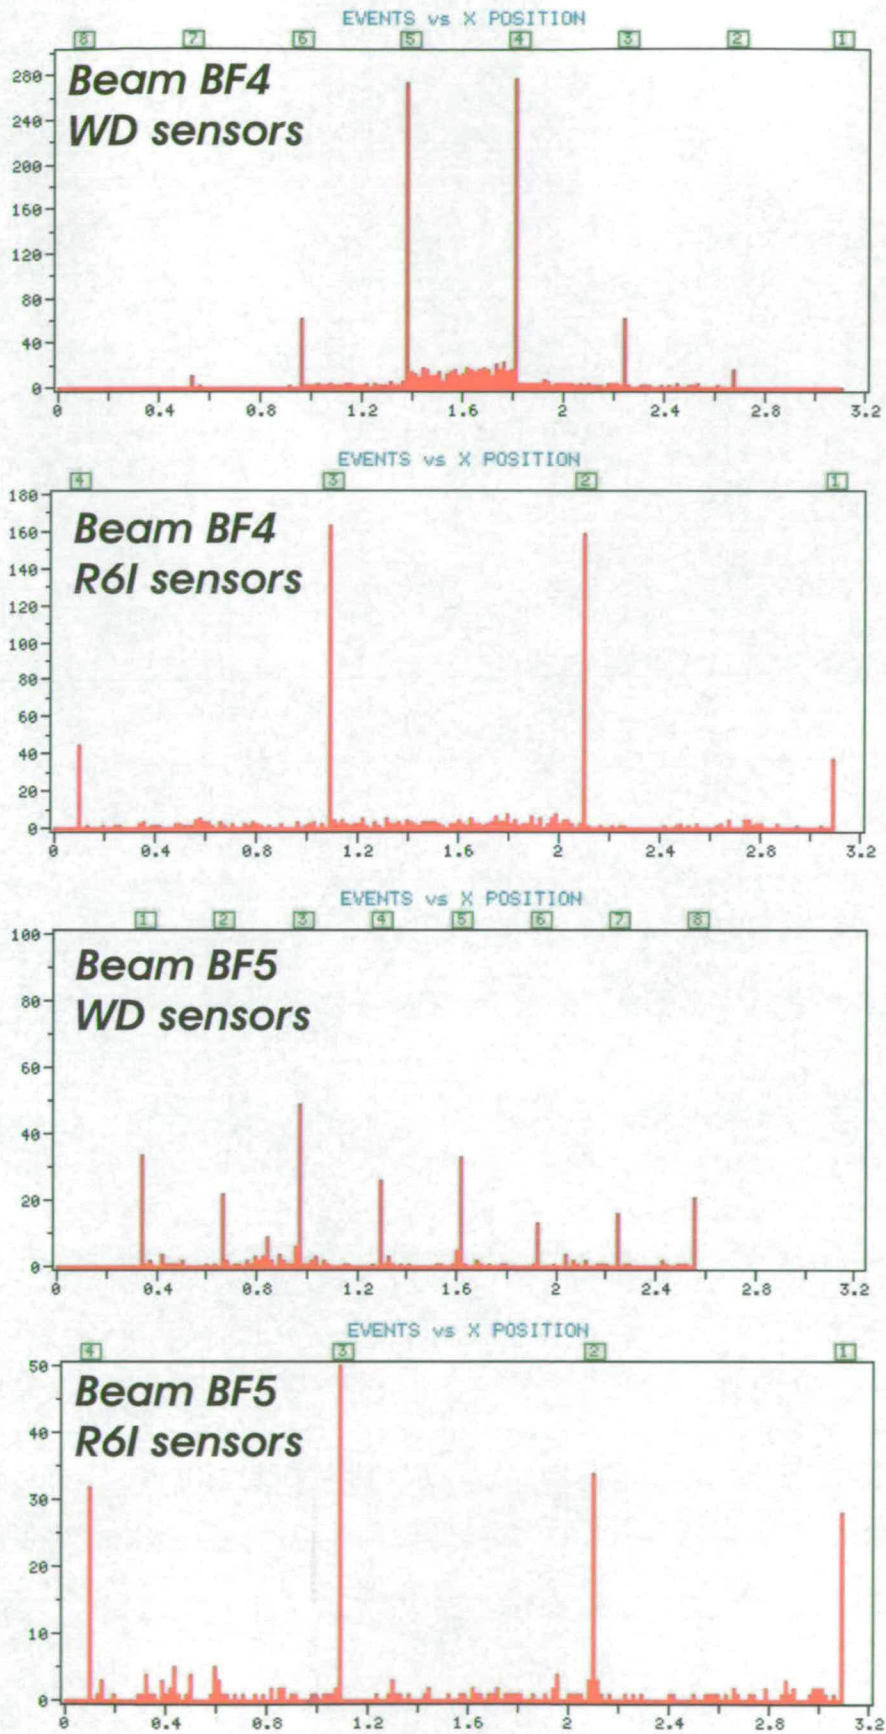
Figure 7.28: PAC AE location for the full test of beams BF4 and BF5.

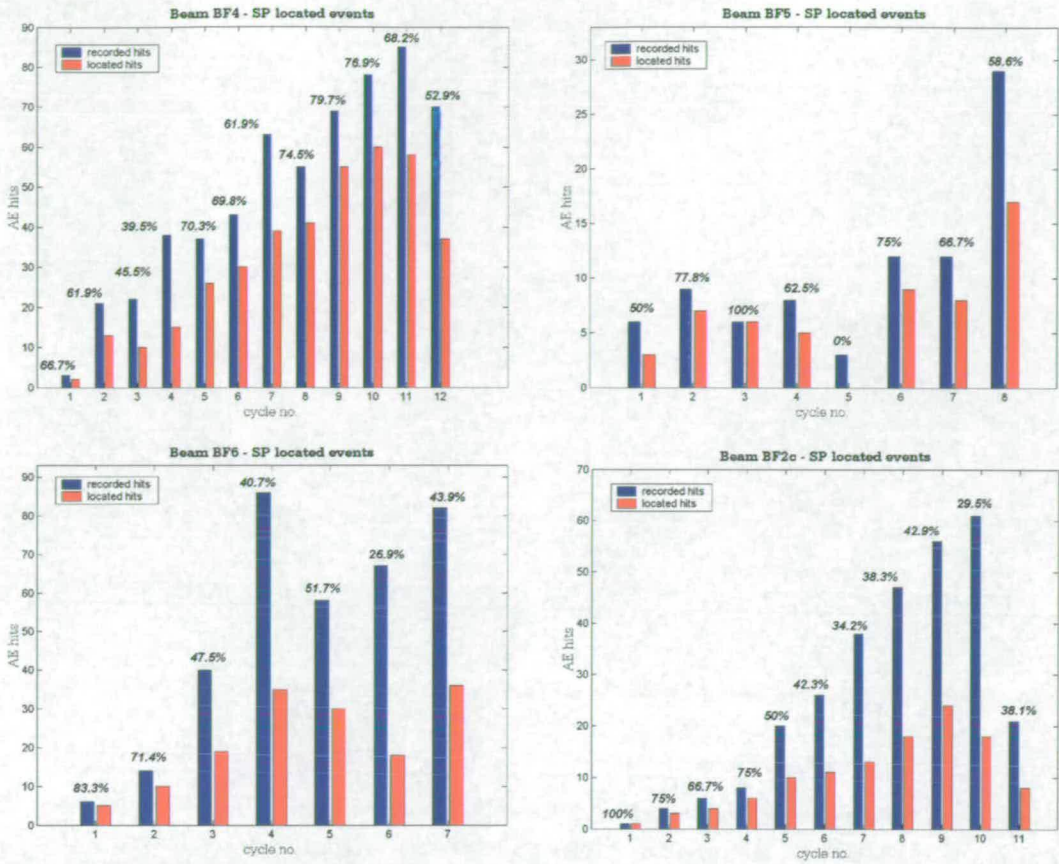
Figure 7.31: Histogram representation of the recorded and located SP hits for beams BF4, BF5, BF6 and BF2c.

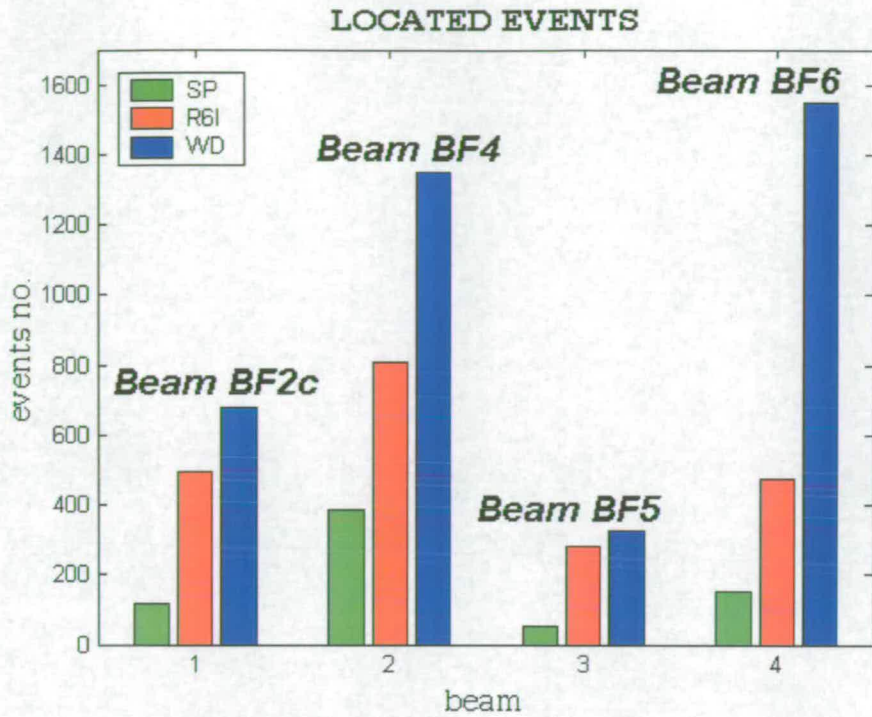
Figure 7.32: Histogram representation of located hits recorded by SoundPrint (SP), resonant (R6I) and broadband (WD) sensors.

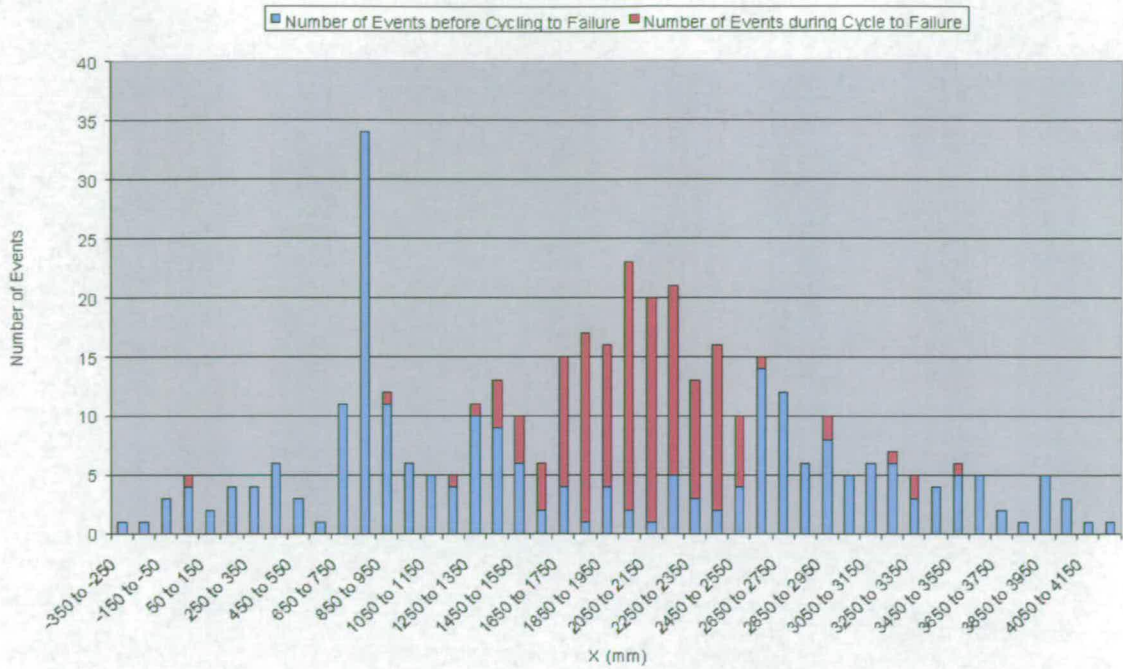
Figure 7.35: Distribution of SP events for beam CF1.

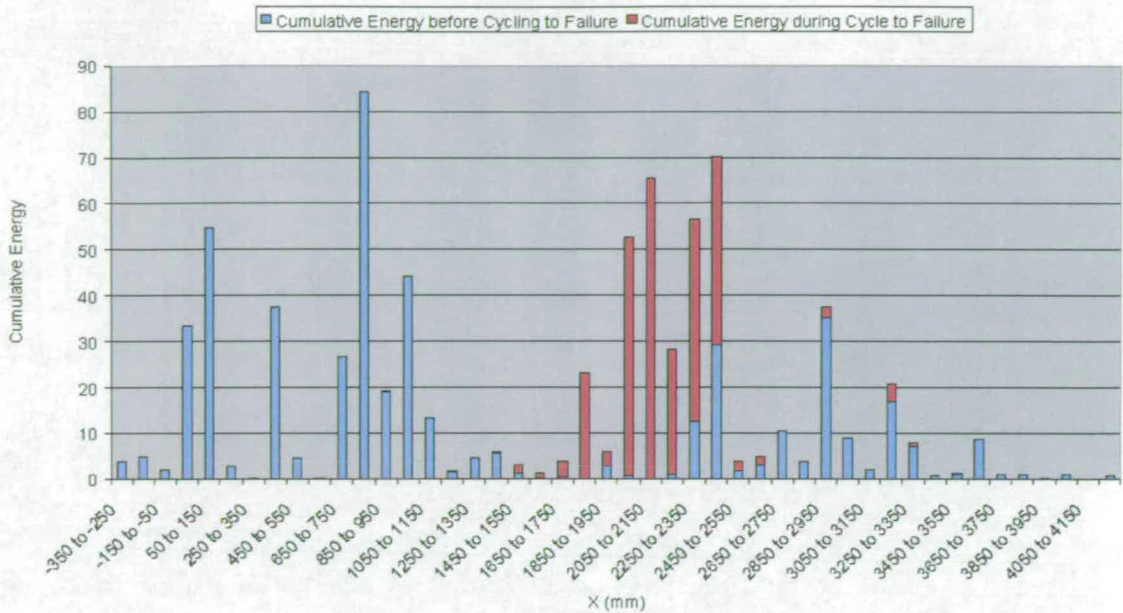
Figure 7.36: Cumulative energy distribution for SP events for beam CF1.

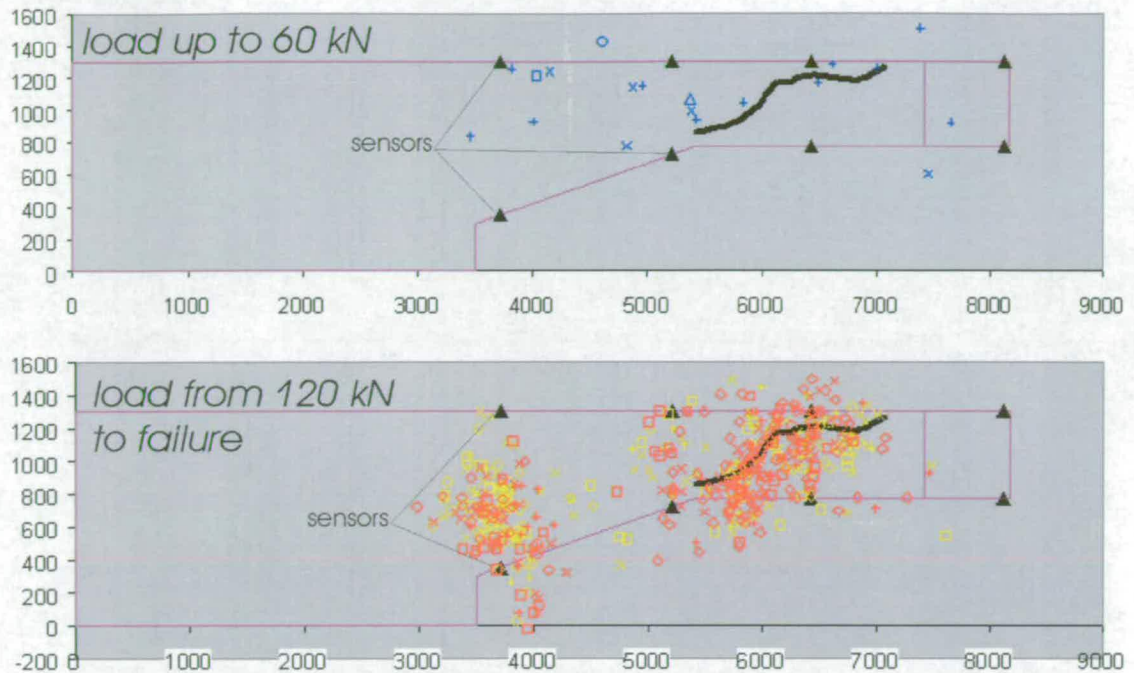
Figure 7.39: Location of SP events during different load ranges for beam HB2.

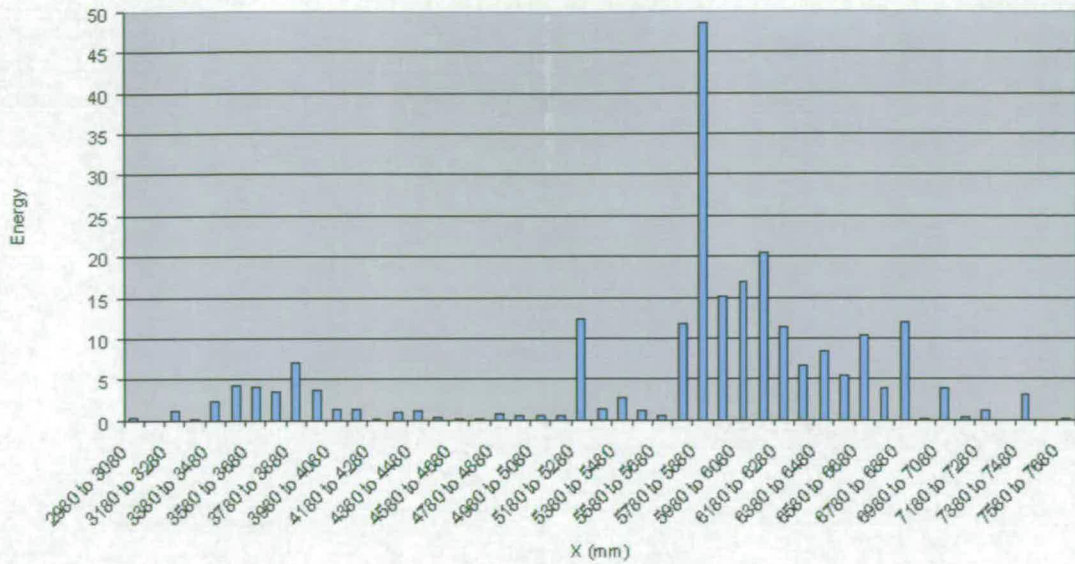
Figure 7.40: Histogram representation of the cumulative energy of SP events for beam HB2.

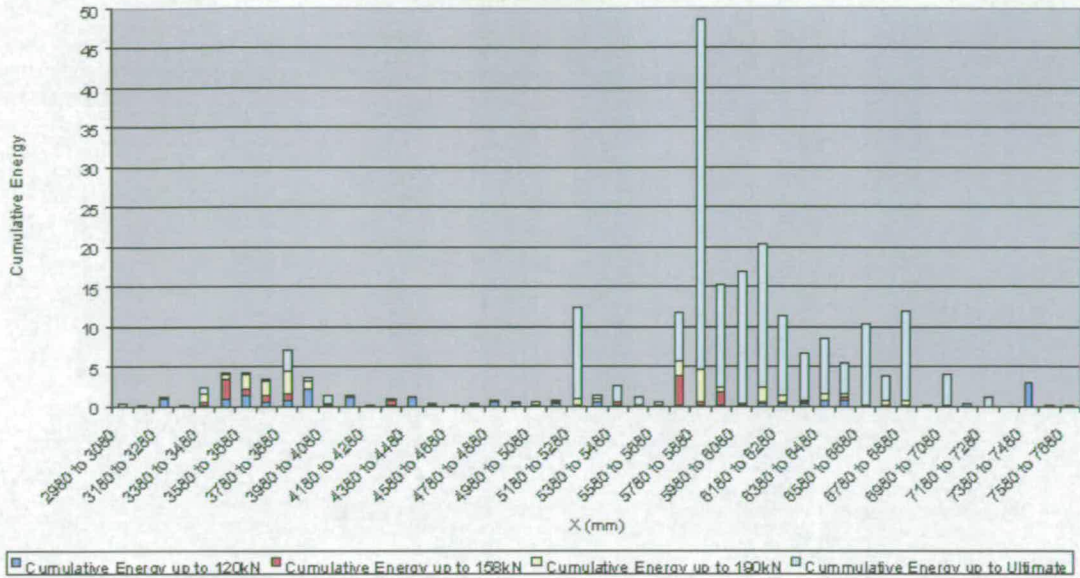
Figure 7.41: Histogram representation of the cumulative energy of SP events as a function of load for beam HB2.

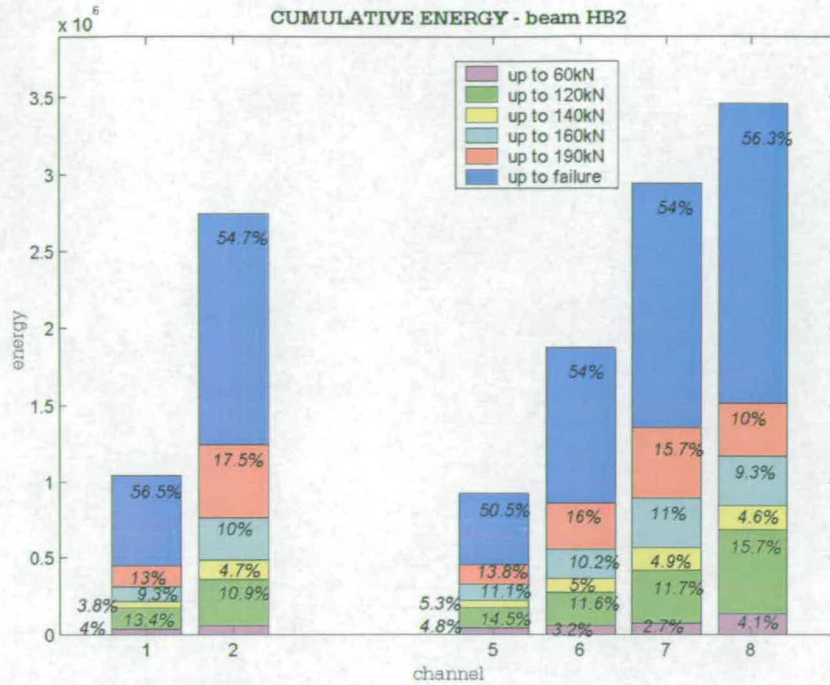
Figure 7.43: PAC energy as a function of load for beam HB2.

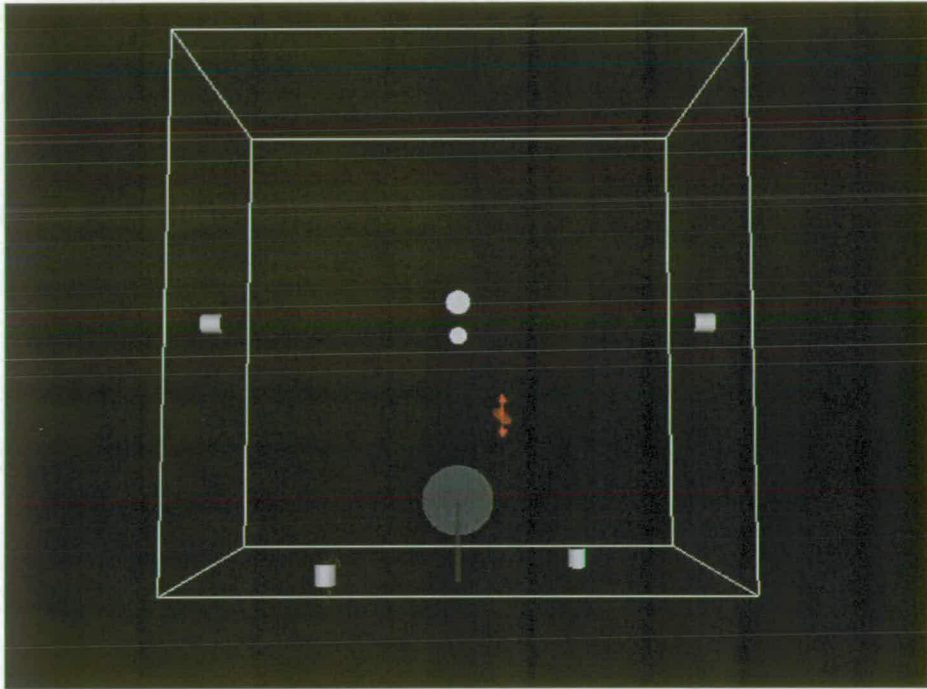
Figure 7.47: Moment Tensor results: First stage of the cracking on the sample. The red symbol represents a mixed-mode crack; the circle represents the crack surface, whilst the arrow indicates the P-axis, i.e. the direction of the crack extension. The white cylinders or circles represent the sensors. The grey circle and line indicates the hole and notch on the sample.

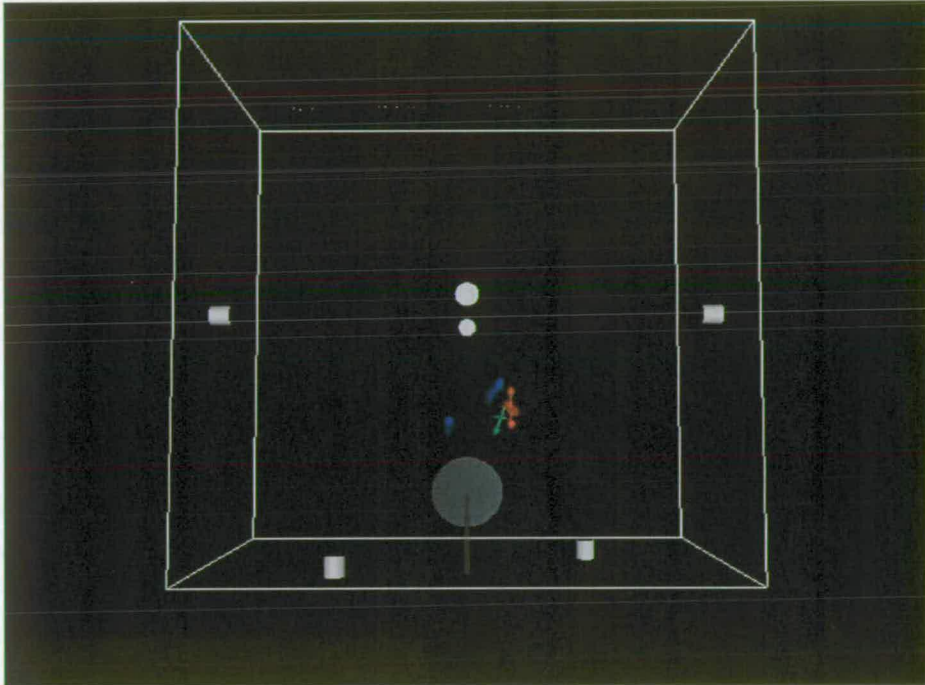
Figure 7.48: Moment Tensor results: Second stage of the cracking, plotted as in Figure 7.47. The different colors (red, green and blue) indicate different crack types (mixed-mode, tensile and shear).

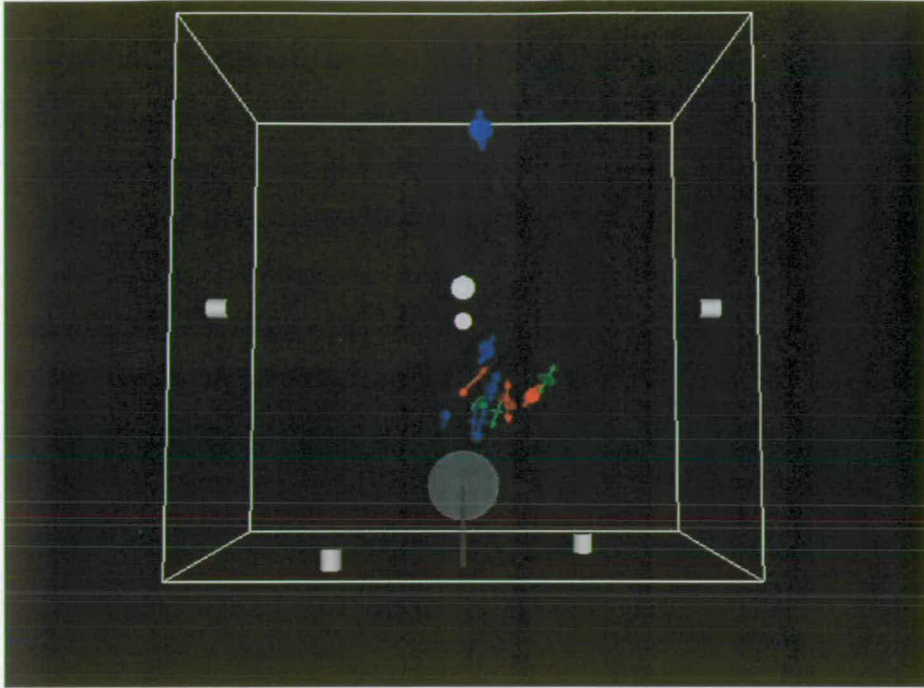
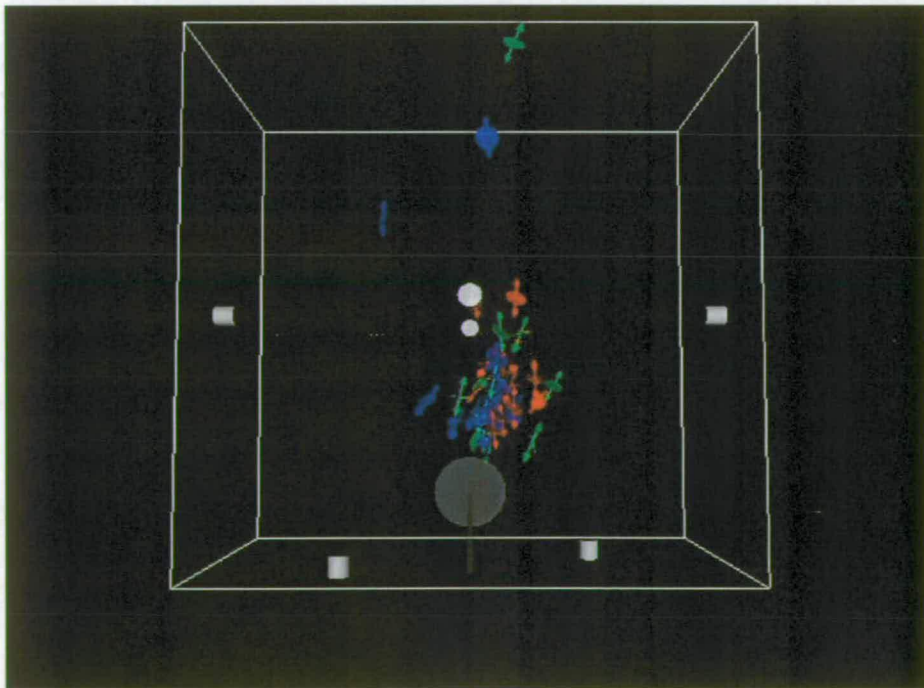
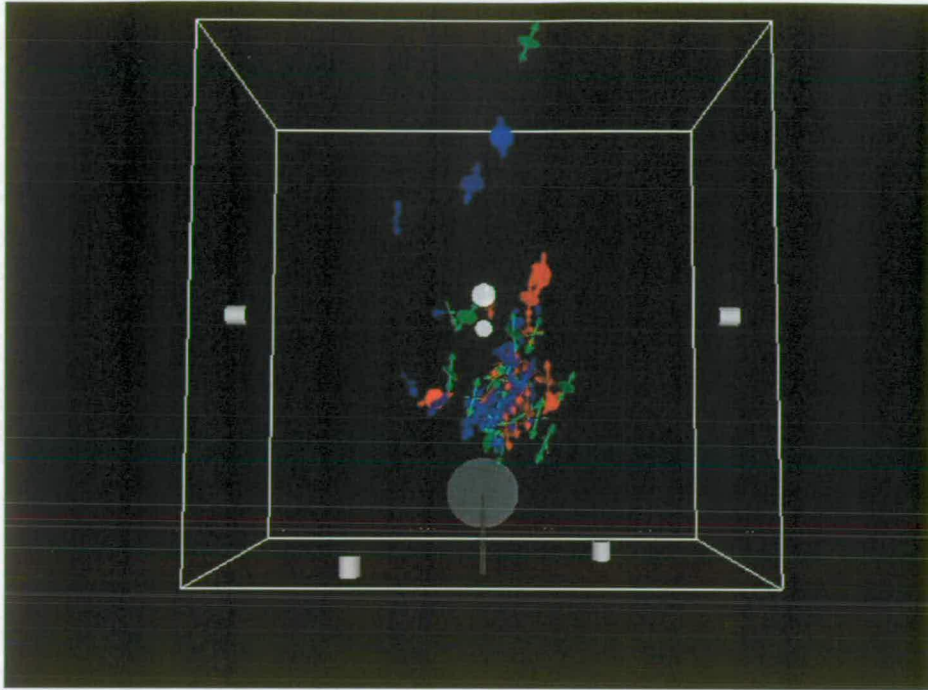
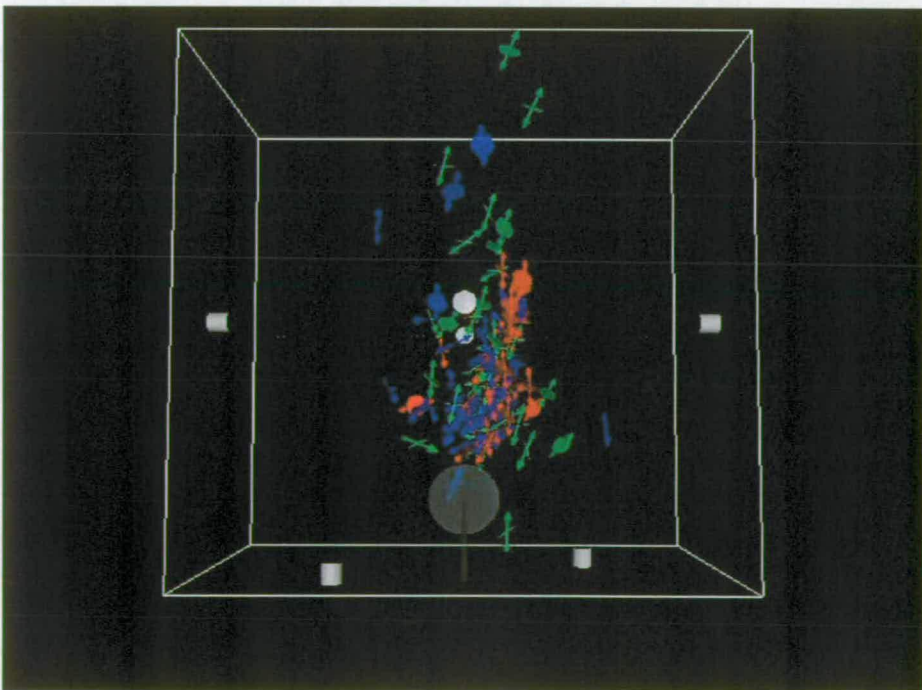
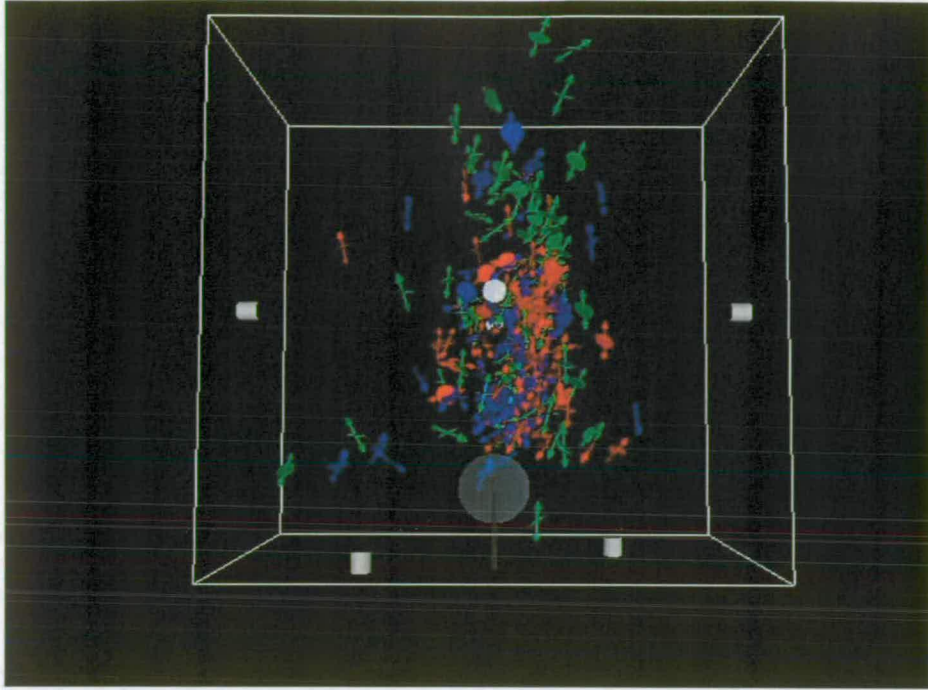
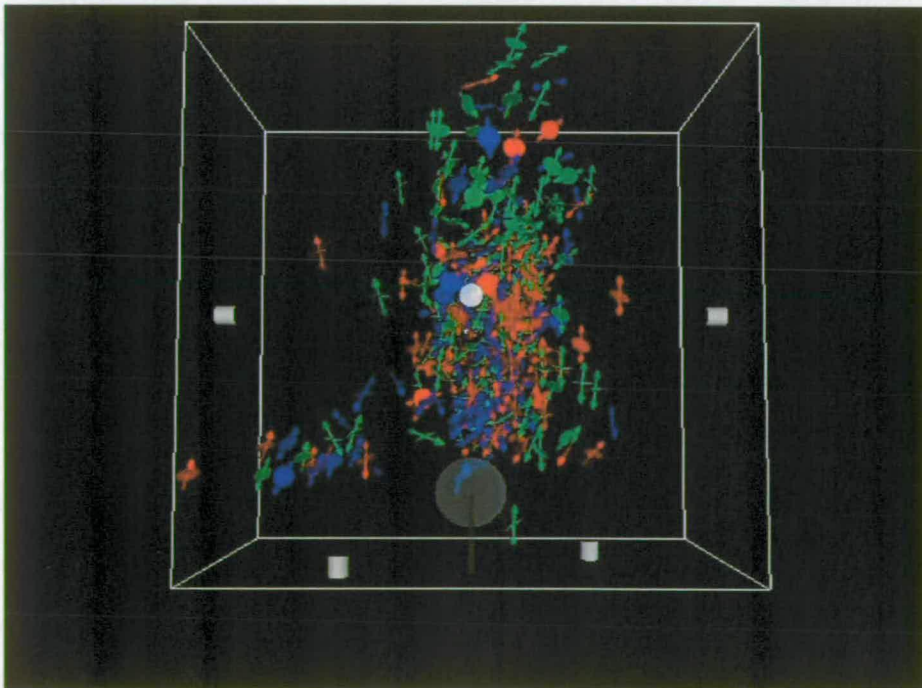
Figure 7.49: Moment Tensor results: Third stage of the cracking, plotted as in Figure 7.48.

Figure 7.50: Moment Tensor results: Fourth stage of the cracking, plotted as in Figure 7.48.

Figure 7.51: Moment Tensor results: Fifth stage of the cracking, plotted as in Figure 7.48.

Figure 7.52: Moment Tensor results: Sixth stage of the cracking, plotted as in Figure 7.48.

Figure 7.53: Moment Tensor results: Seventh stage of the cracking, plotted as in Figure 7.48.

Figure 7.54: Moment Tensor results: Eighth stage of the cracking, plotted as in Figure 7.48.

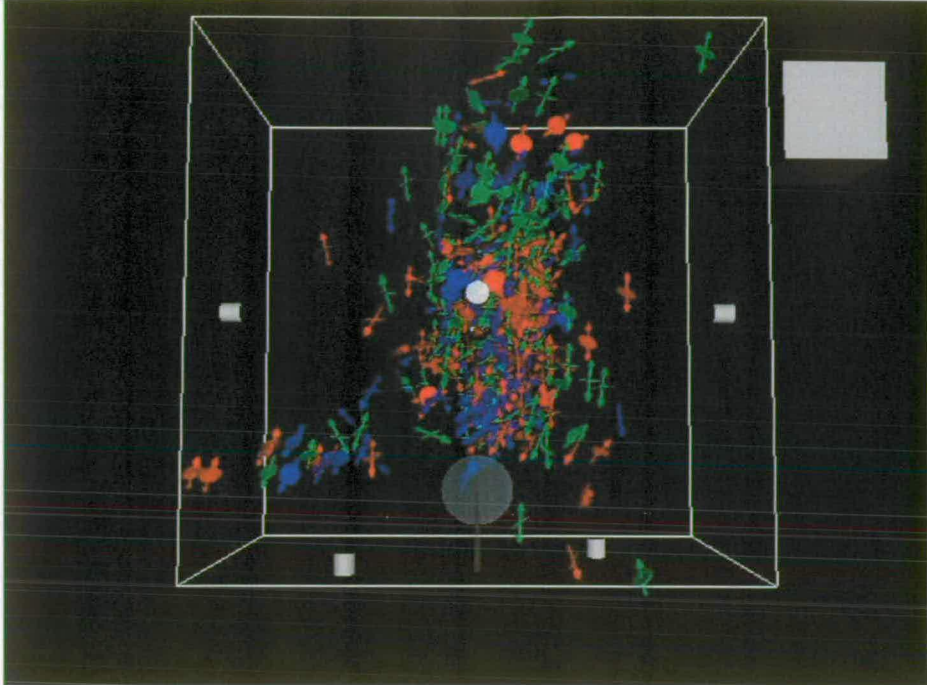
Figure 7.55: Moment Tensor results: Final stage of the cracking, plotted as in Figure 7.48.

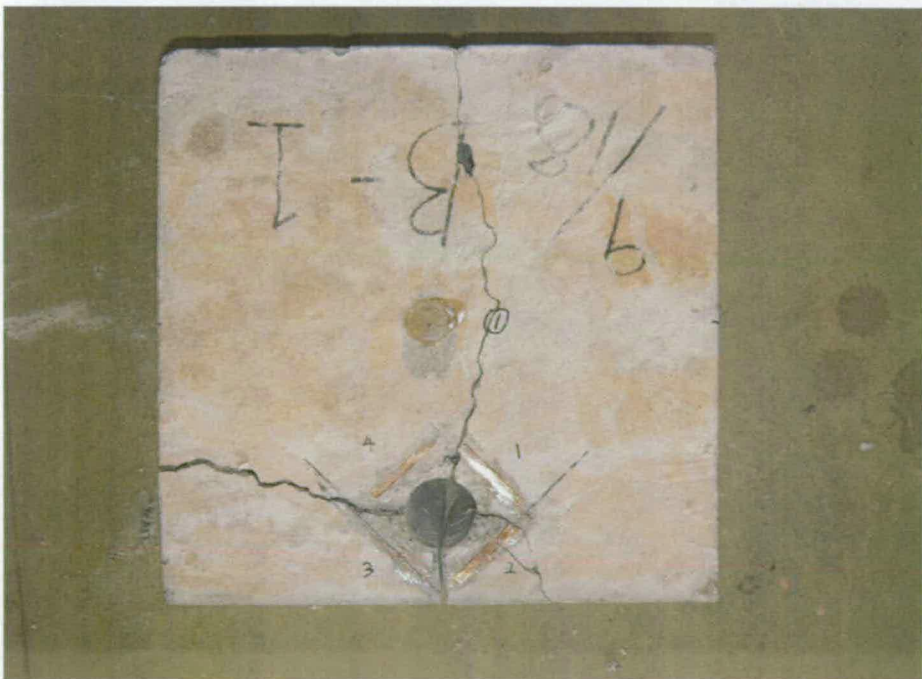
Figure 7.56: Failure of the sample used for the Moment Tensor analysis.

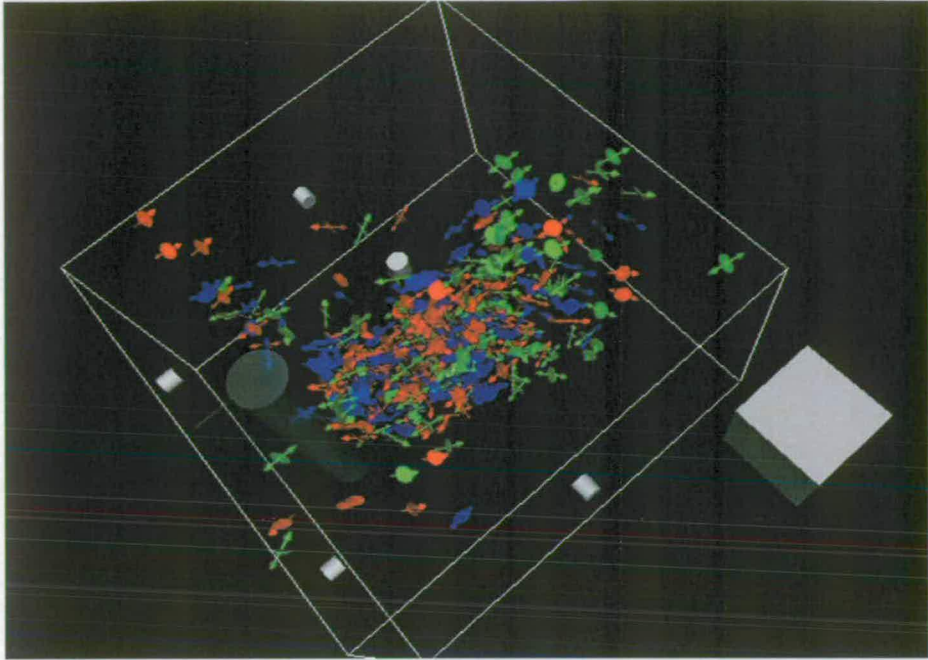
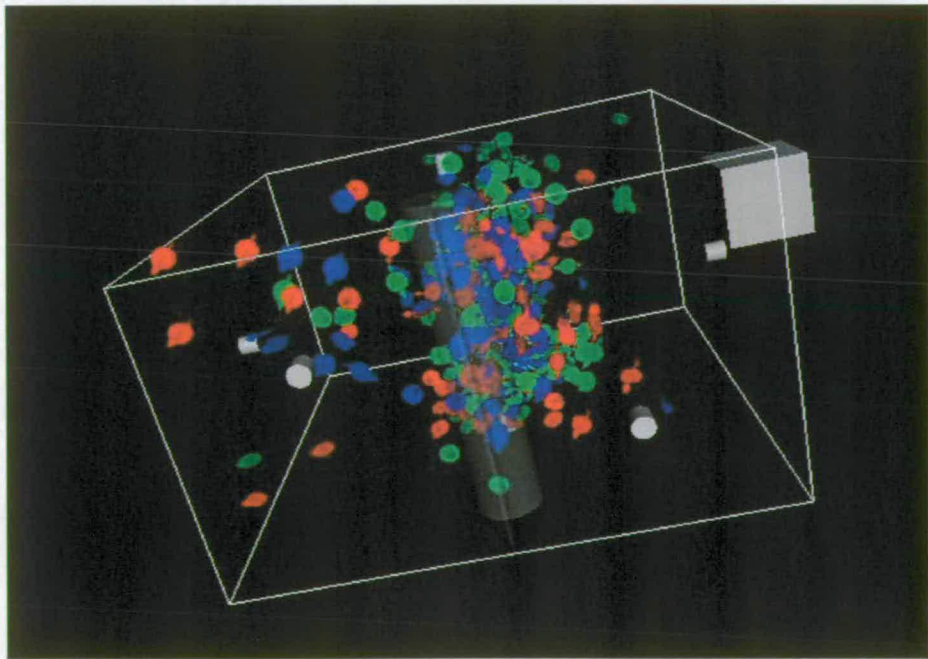
Figure 7.57: Moment Tensor results, first rotated view: final stage of the cracking, plotted as in Figure 7.48.

Figure 7.58: Moment Tensor results, second rotated view: final stage of the cracking, plotted as in Figure 7.48.

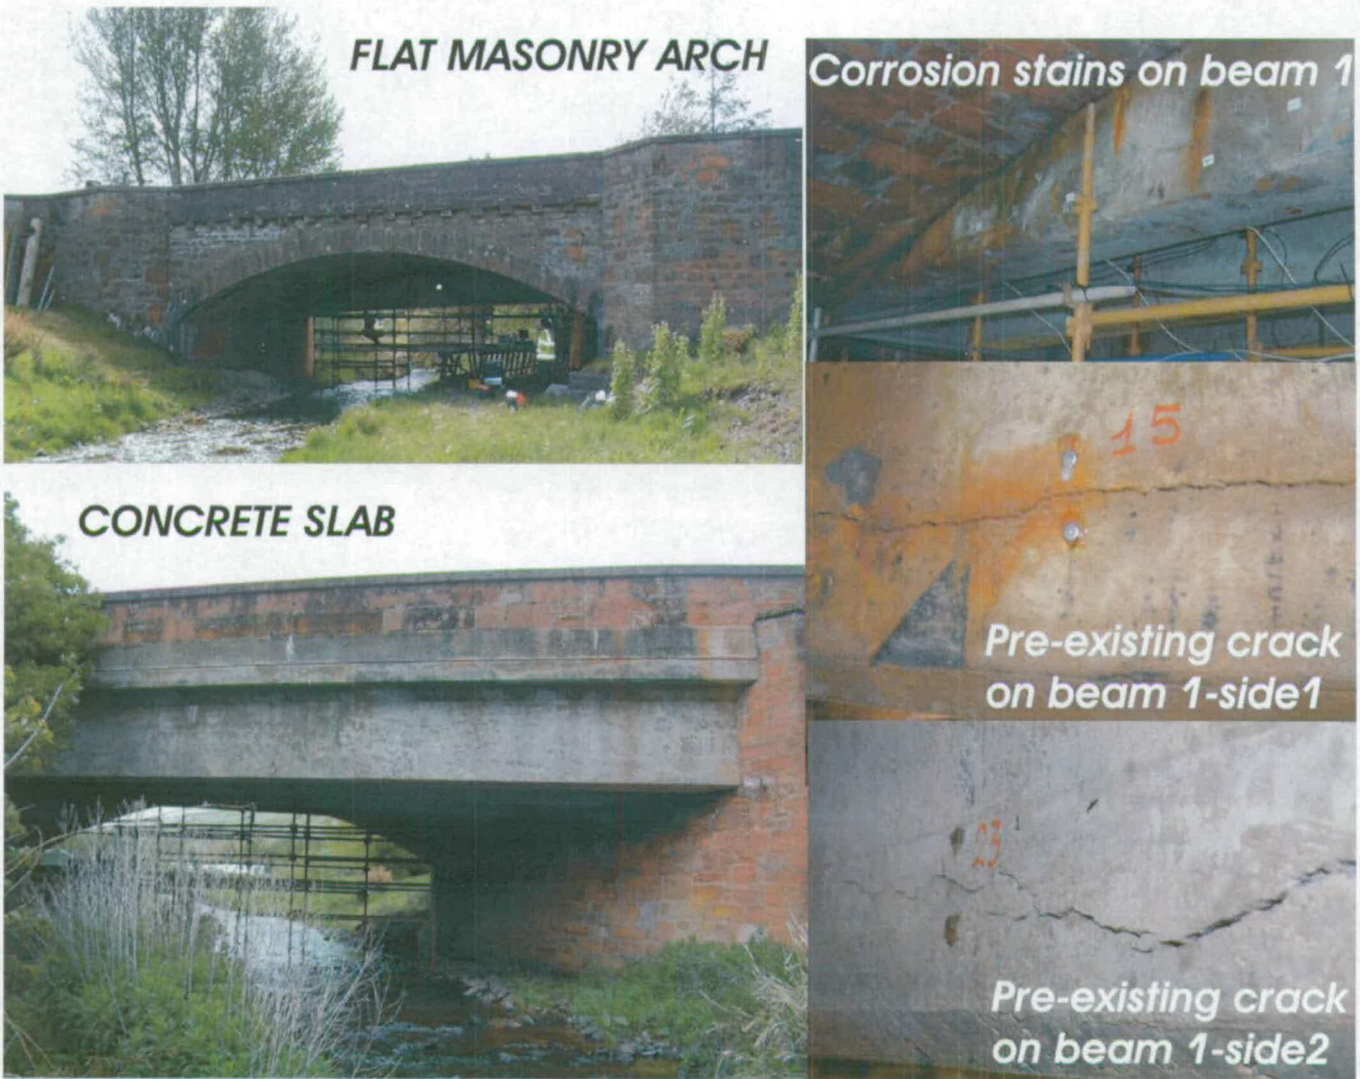
Figure 8.1: Boghall bridge: masonry and concrete side; pre-existing cracks.

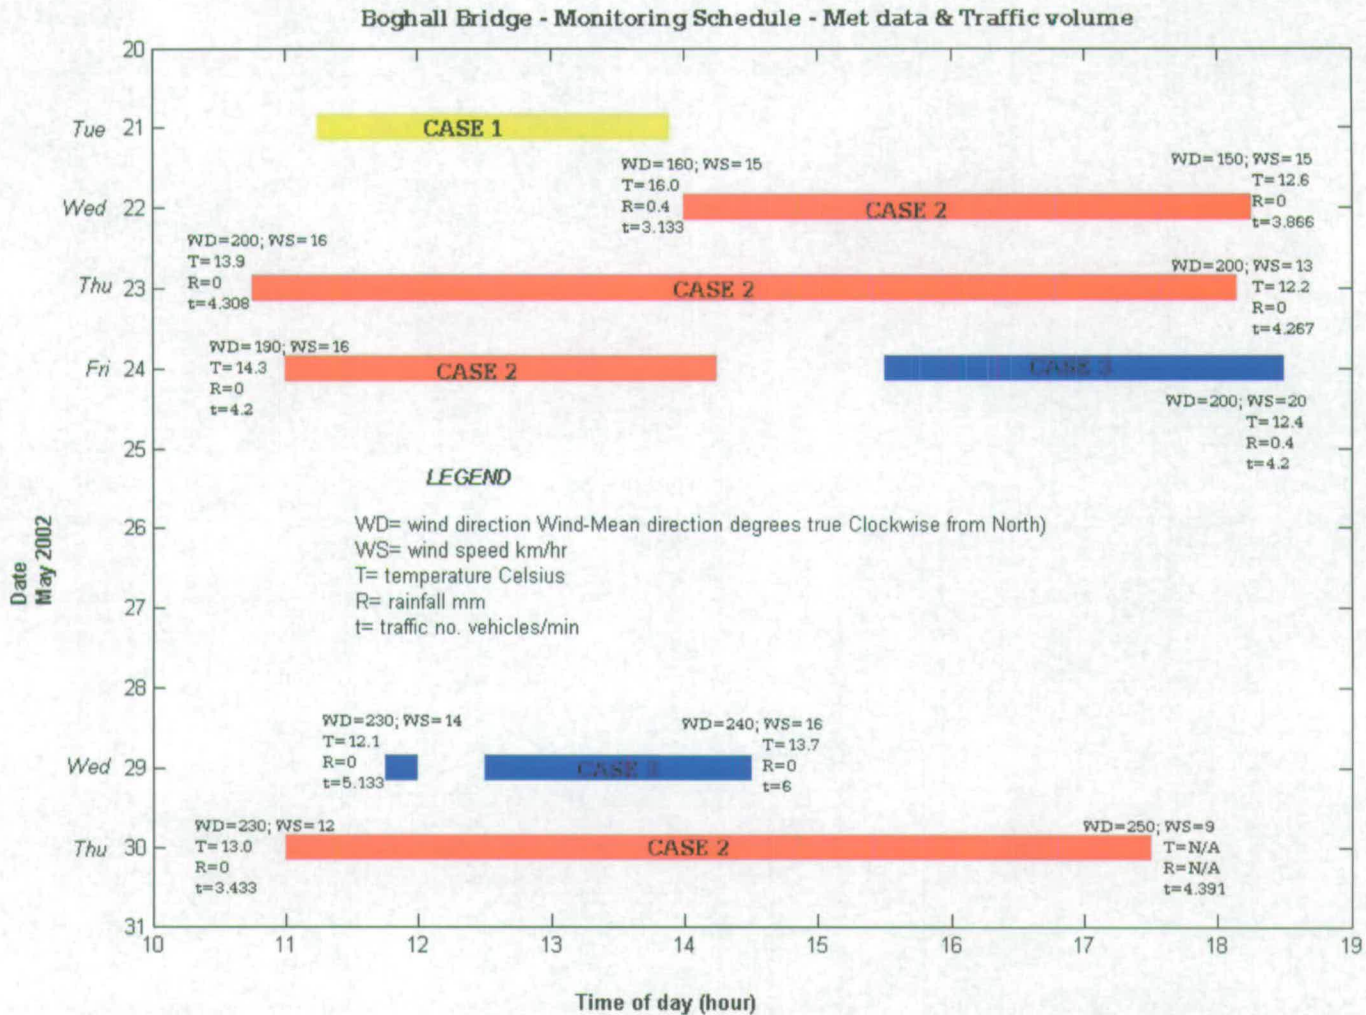
Figure 8.4: Monitoring schedule and meteorological data.

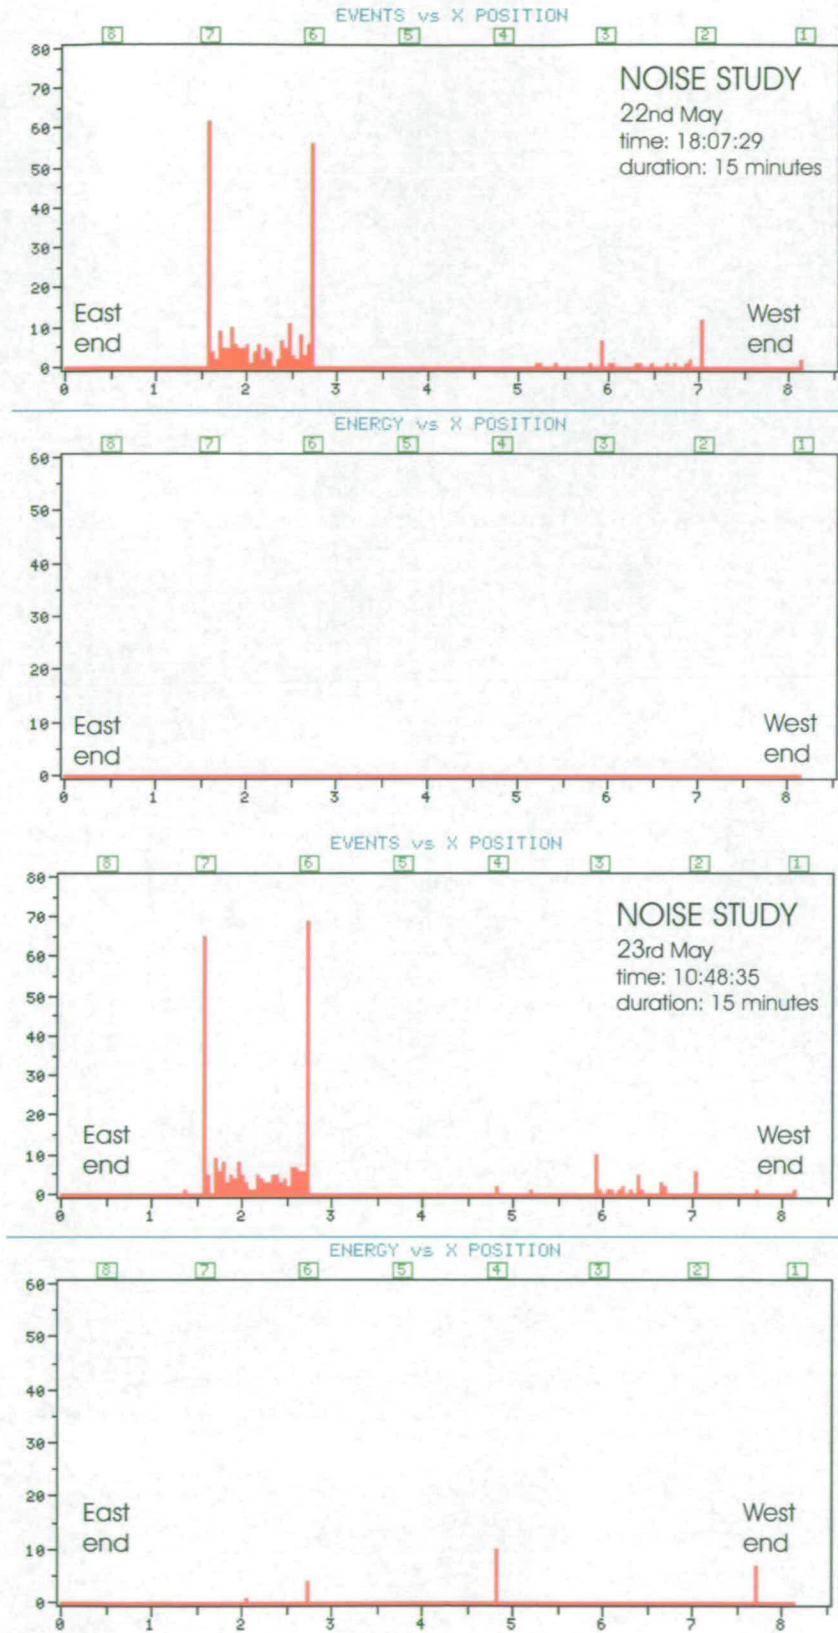
Figure 8.6: AE activity location: Noise study. The location along the beam is indicated on the x-axis in meters, whilst the green squares (on top) indicate the AE sensors.

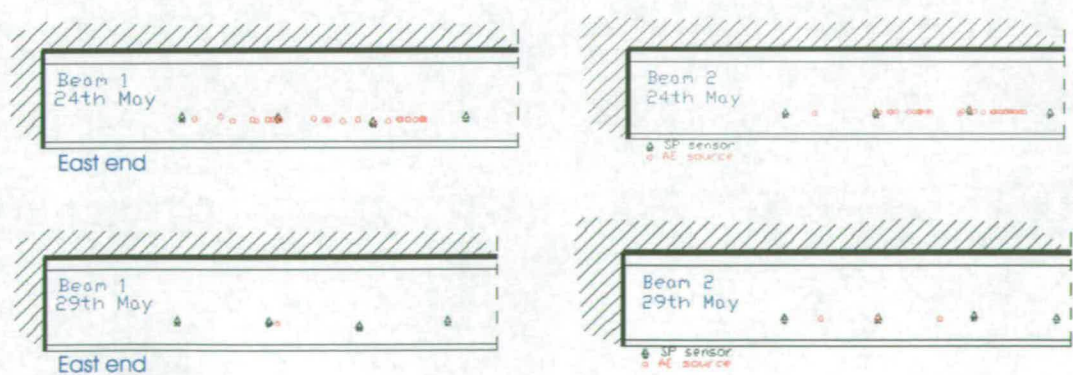
Figure 8.12: Boghall bridge. Location of the SP events, for Case 3, plotted as for Figure 8.10.

Fewer signals were located in relation to Case 3, and the AE sources were mainly coming from Beam 2 (Figure 8.12). Although the presence of low AE activity agrees in this case with the results obtained from the PAC system, it does not agree with the findings of the Case 2 as high activity on the cracked side of Beam 1 would be expected.

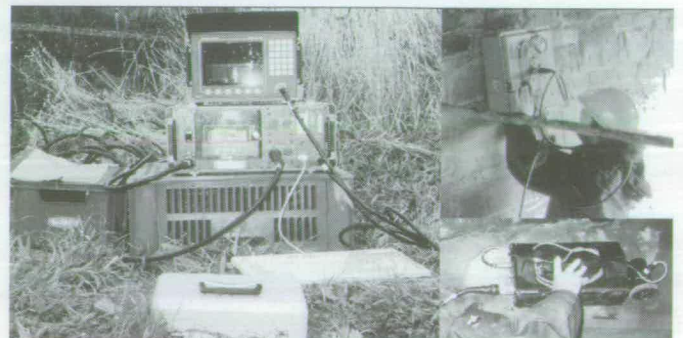
Fig. 7. SIR10A impulse surface probing radar system.

The source location of AE events was used to plan a complementary ground probing radar survey using a GSSI SIR10C at frequencies of 500 and 900 MHz, shown in Fig. 7. It was intended that the radar survey
