**FEASIBILITY STUDY
OF THE APPLICATION OF THE
ACOUSTIC EMISSION TECHNIQUE
TO CONCRETE BRIDGES**

Sabrina Colombo

The University of Edinburgh

May 2003

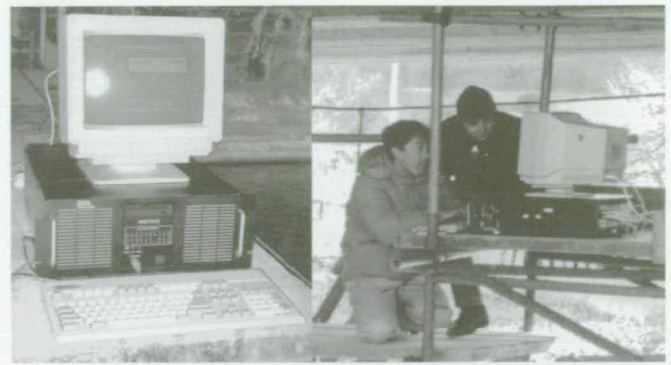
Fig. 3. Mistras data acquisition and analysis system.

using a Physical Acoustics Corporations MISTRAS-2001 (*Massively Instrumented Sensor Technology for Received Acoustic Signals*) fitted with DSP-32/16 signal processing devices (shown in Fig. 3). The parallel processing architecture used for computerised AE was configured to simultaneously perform signal measurement on eight channels. Eight AE sensors of Type R3I were used. These transducers of 30 mm diameter by 40 mm high incorporated a built in pre-amplifier of 40 dB and had a low resonant frequency of approximately 30 kHz and operated in the 100 Khz to 1 Mhz frequency range.

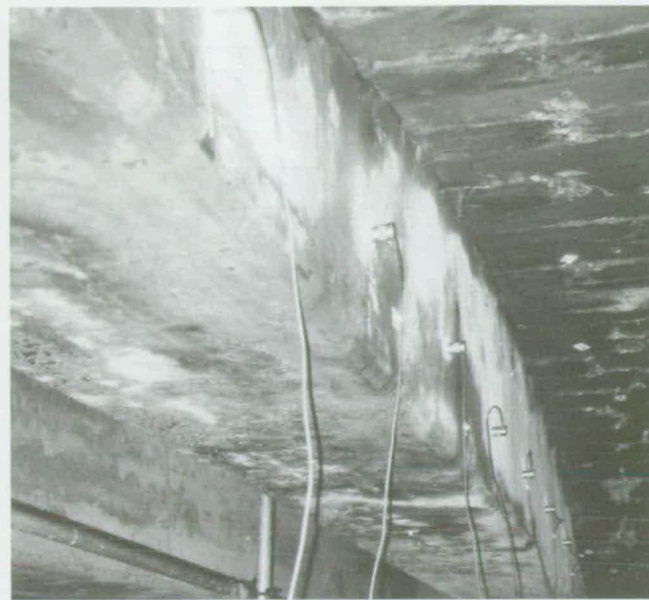
Fig. 22. Close-up of sensors mounted on south side of concrete beam.

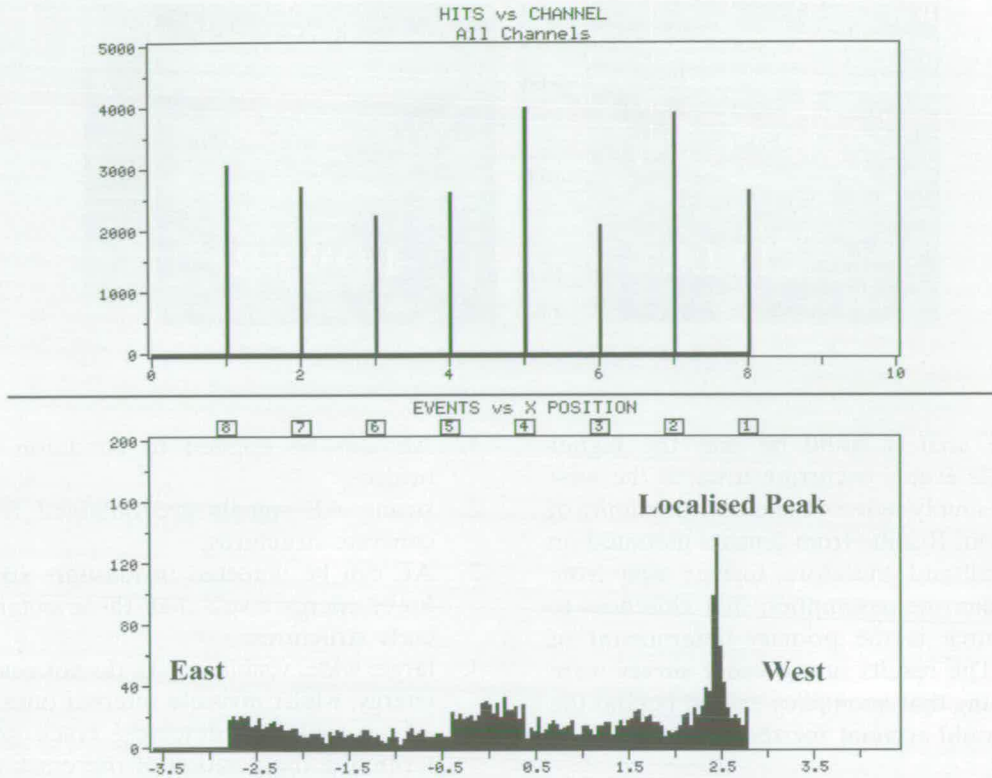
Fig. 26. Case 4: cumulative total hits for each channel and analysis of event location.

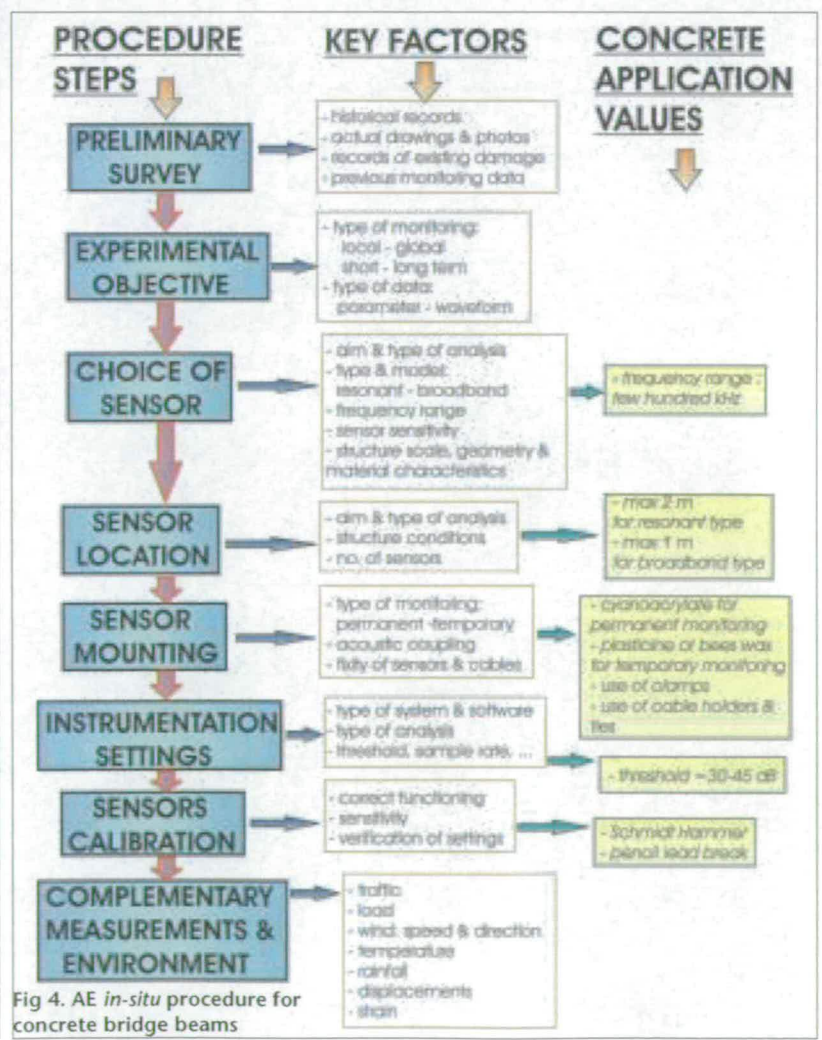
Fig 4. AE *in-situ* procedure for concrete bridge beams

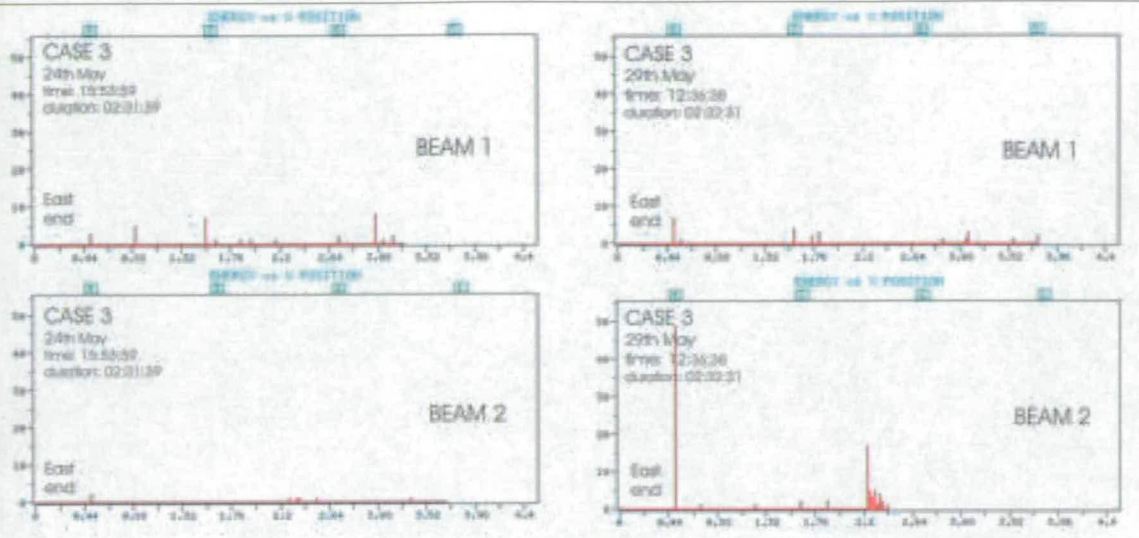
Fig 10. AE energy location – Case 3

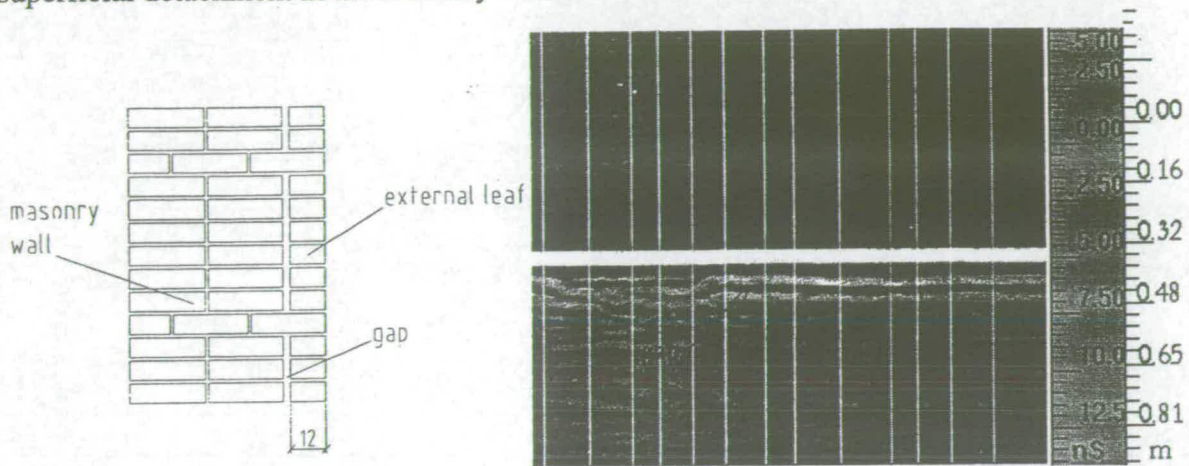
Figure 2. Radar image of a masonry wall [3].

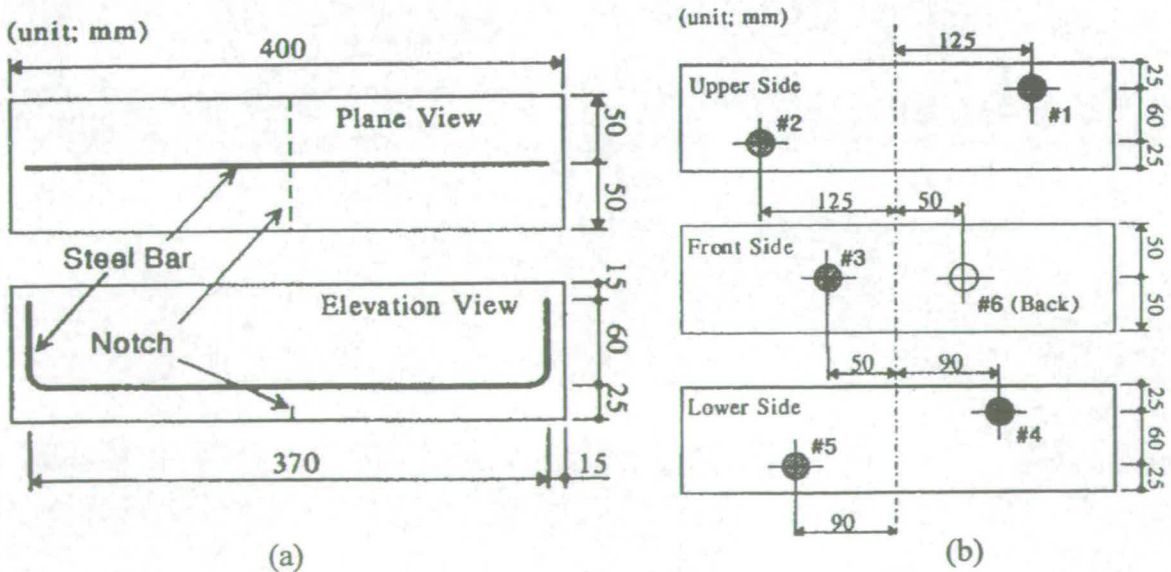
Figure 3. RC beam subjected to acoustic emission monitoring (a) and arrangement of AE sensors (b)[4].

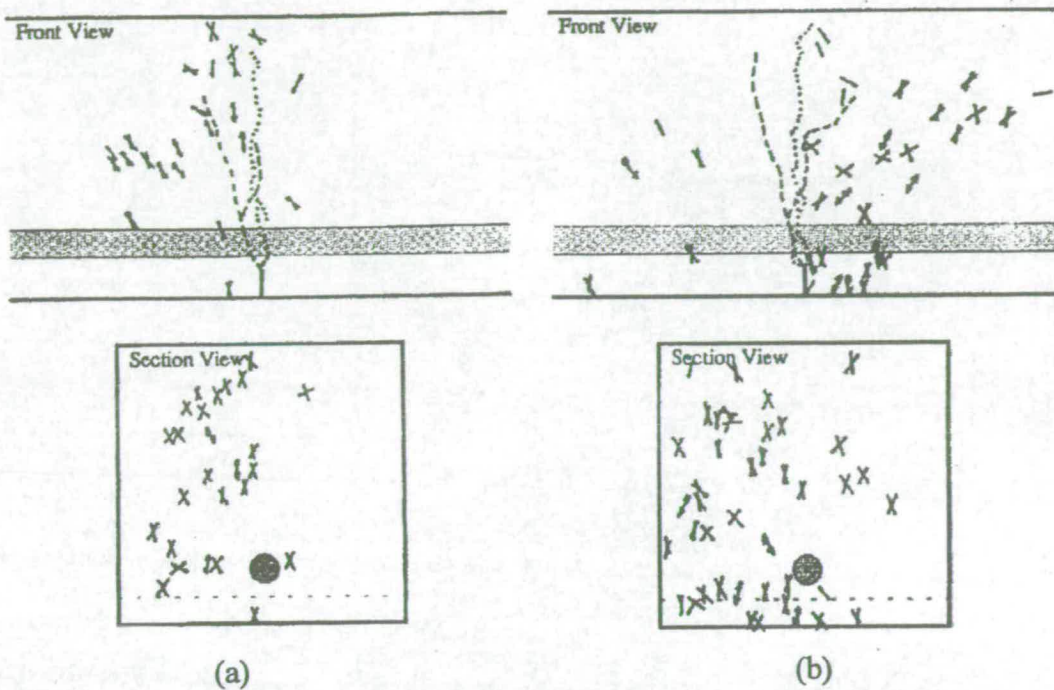
Figure 4. Results from acoustic emission monitoring: microcracks generated by static pre-loading (a) and cycling loading (b) in RC beam specimen "Type B" [4].

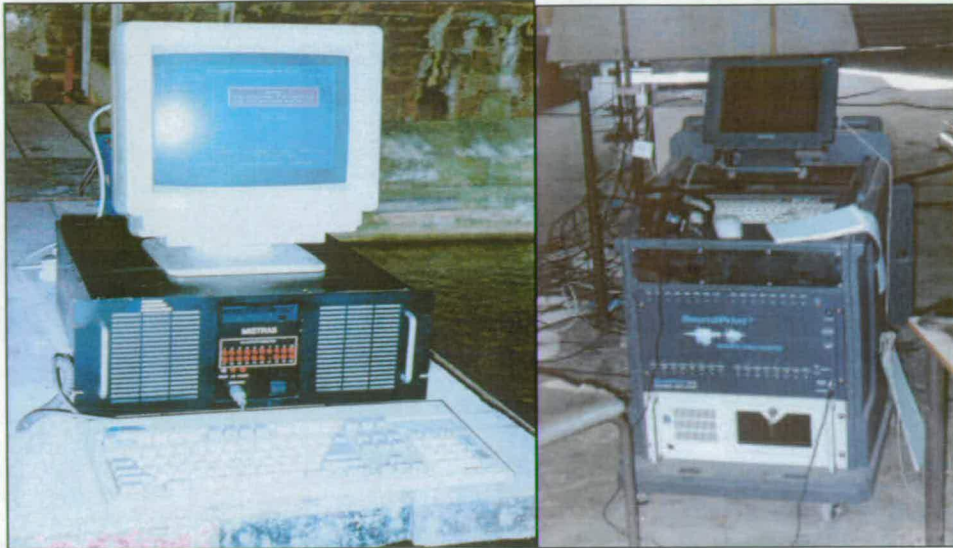
Figure 3. Mistras System (left), and SoundPrint[®] System (right).

The MISTRAS-2001 (Massively Instrumented Sensor Technology for Received Acoustic Signals), PAC’s (Physical Acoustic Corporation) is a DSP-32/16 new parallel processing AE architecture for (2-256) digital channels. The system performs waveform and signal measurement and stores and displays resulting data.

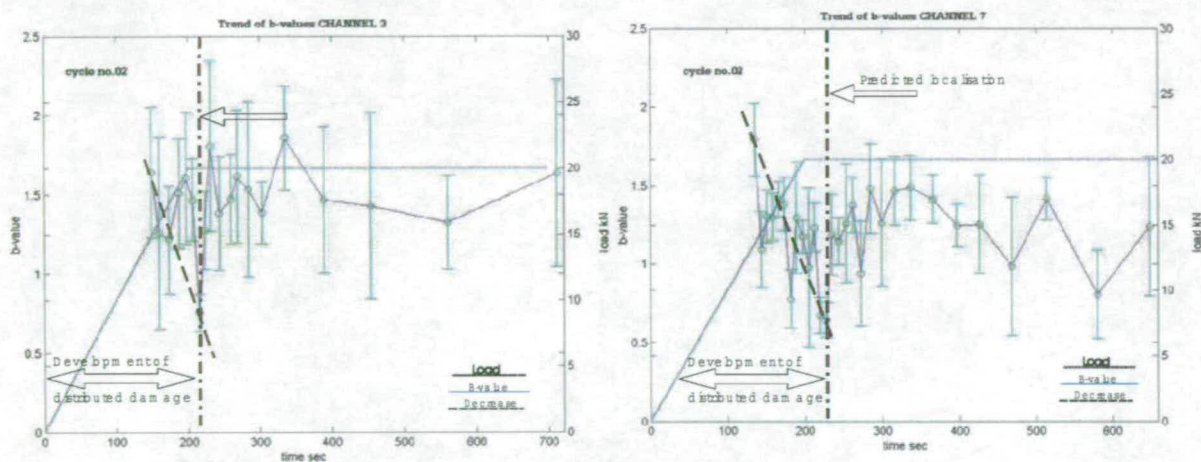
Figure 4. Trend of b -value over time for channel 3 (left) and 7 (right) during the load cycle number 2; the load is shown on the vertical axis on the right.
