# **Approaching the mind of the builder**

**Analysis of the physical, structural and social constraints on  
the construction of the broch towers of Iron Age Scotland**

**John Barber**

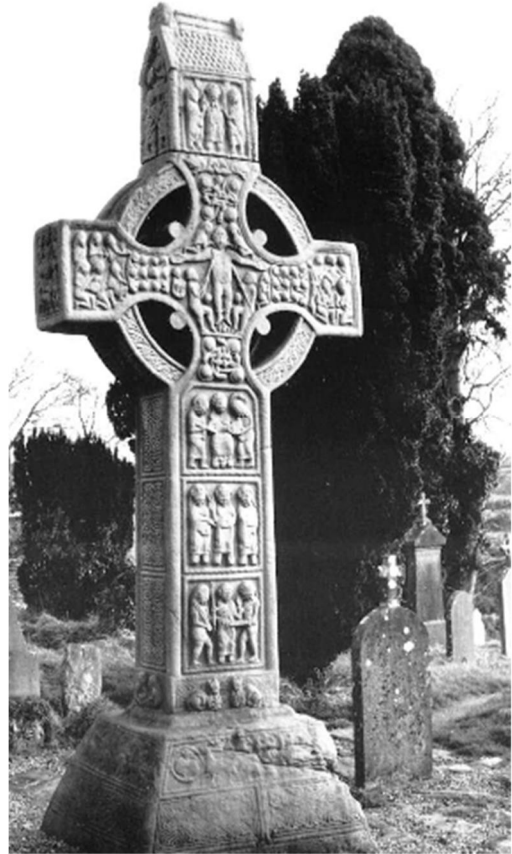
**Figure 2 (right) Muirideach's Cross at Monasterboice, Ireland. The upper arm of the cross represents a wooden house-shaped structure with shingled roof and finial at the crossing of the bargeboards. The ridgepole is external to the roof.**

metal and vellum, and in the archaeological remains excavated at a handful of sites. The stone skeuomorphs are preserved as the finials of high crosses (Figure 2) and in so called

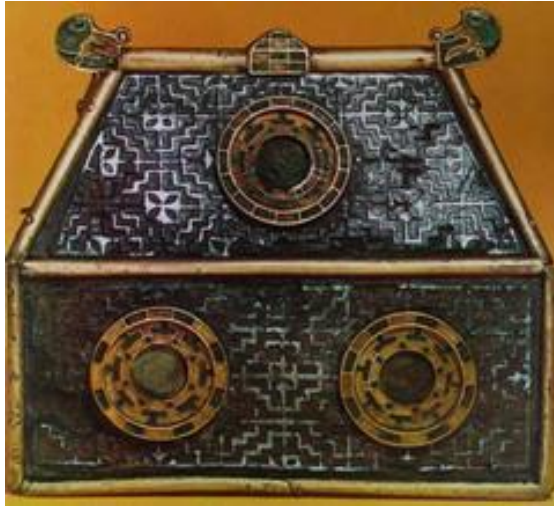
**Figure 4 (left) The Lough Erne Shrine. Although more stylised than the Monymusk reliquary casket this retains the essential forms of a timber frame-built structure**

house-shaped burial shrines, the former rather more widely explored as art-historical subjects (Henry 1964, Stalley 1991, Harbison 1992) than the latter (Wakeman 1975). Fewer than a dozen metal reliquaries, like the Monymusk (Figure 3) (Anderson 1880) and Lough Erne reliquaries (Figure 4) survive and some of those only as fragments, e.g. the Clonard fragments (Floinn 1989, including, perhaps the ridge-piece referred to therein (ibid, 55). The vellum representations are somewhat ambiguous and the most frequently cited, the 'Temptation of Christ' scene in the Book of Kells (200 verso; Meehan 1994; 11: copied here as Figure 5) is possibly best

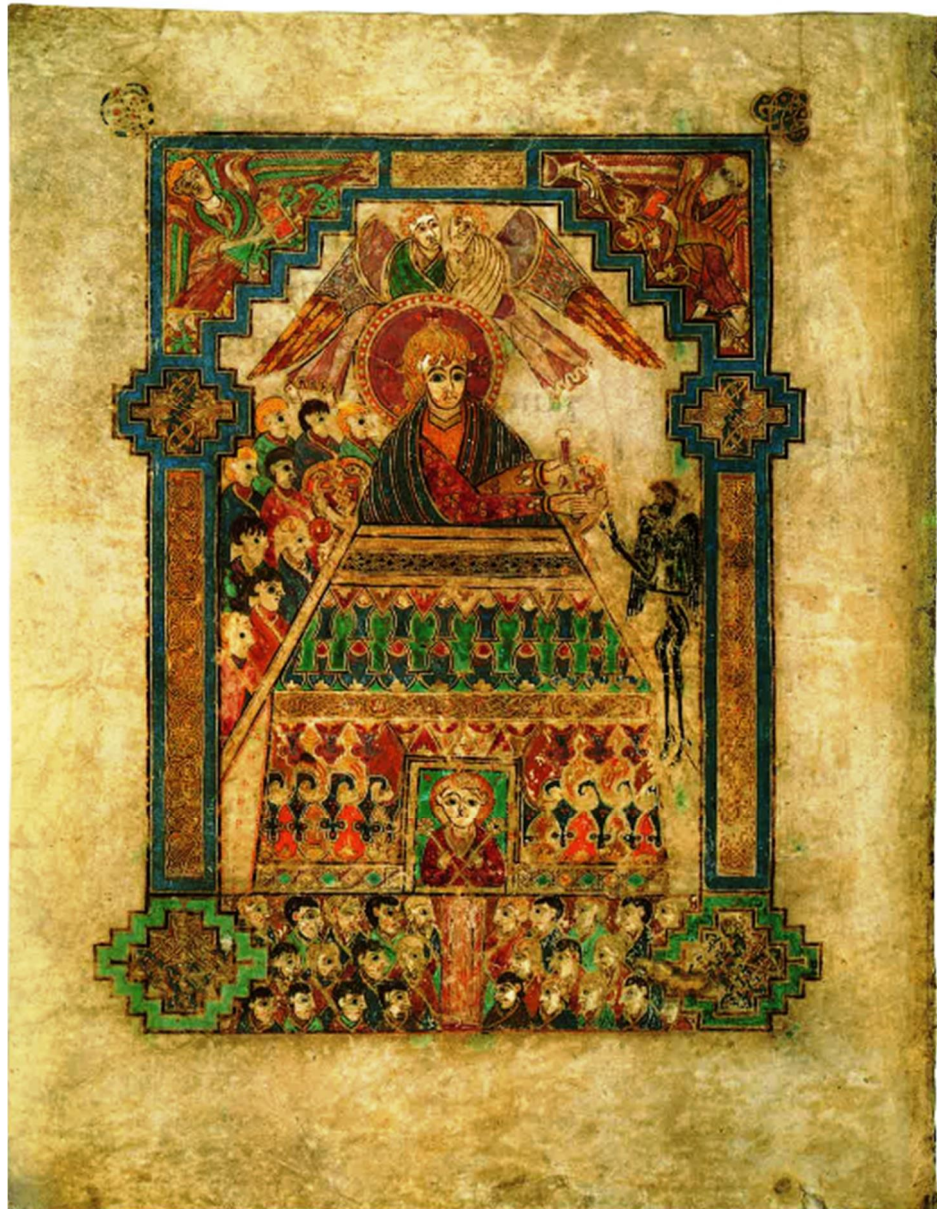
**Figure 5** The temptation of Christ scene from the Book of Kells (200 verso). The image of the temple emulates the characteristics of a timber frame-built structure with external ridge-pole and shingled roof but seems to represent the bargeboards as reaching the ground, an attribute of Anglian not Irish church building. The finials at the crossing of the bargeboards are however conformable with Irish insular art.

The Irish monastery on Lindisfarne was founded by St Aidan, who had travelled from the mother house of Iona at the request of King Oswald in 634 AD to help establish Christianity in Northumberland (Stenton 1984). Aidan's experience of churches is likely to have been that of the simple Irish wooden church. The NE Angles built rectangular or slightly boat shaped timber houses in which the lateral thrust of the roof on the long side walls was counteracted by the use of long rafters whose ends were set into the ground or resisted by lean-to aisles (see Plates 105 and 106 in Hope-Taylor 1977 for images of three-dimensional models of the form). Attempts by Anglian craftsmen to construct to a brief prepared by Irish monks would have produced forms with elements of both traditions. The result would have been the modified version of a canonical Irish wooden church represented in the Book of Kells (Figure 5).

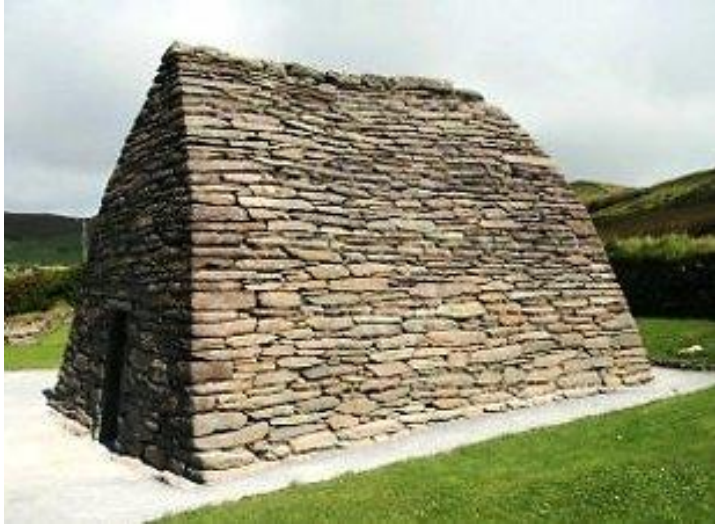
**Figure 6 Gallarus oratory, Dingle, Ireland. A corbelled oratory which may have been built with mortar. Its date is disputed but may lie in the range 800 to 1200 AD although some scholars suggest a much earlier, even pre-Patrician dates.**

The small but exquisite oratories, like Gallarus, in Dingle (Figure 6) were attempts by craftsmen skilled in drystone tholos-building to copy a rectangular wooden church. This runs counter to Conant's description of Gallarus as 'an elegant translation into corbelled stone of the cruck house' – a suggestion that would have been more credible if any evidence existed for cruck houses in Ireland for this period, or for the following half millennium (Conant 1973, 31). In contrast the area around Gallarus contains over 700 tholoi of the *clochán* type<sup>27</sup>. Although Gallarus was corbelled, it is hypothesised that mortar was used, if not in the original build, then in subsequent repairs (Harbison 1970).

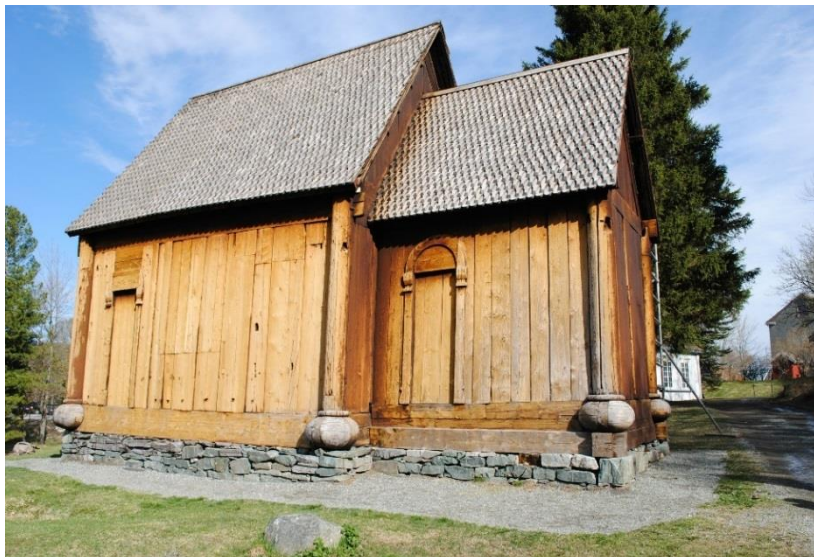
**Figure 8** The simple stave built church of Haltdalen, Norway. Note that the structure is supported on a stub wall, which is all that would survive the decomposition of the church.

none at all, see for example Haltdalen, now in the Tromso Museum (Figure 8). The simpler stavkirken, rotted away to ground level would leave only post hole settings to represent them (see Figure 10, after Lindholm 1969, 30). Even the most complex of the wooden churches (Figure 10) would leave only a few postholes

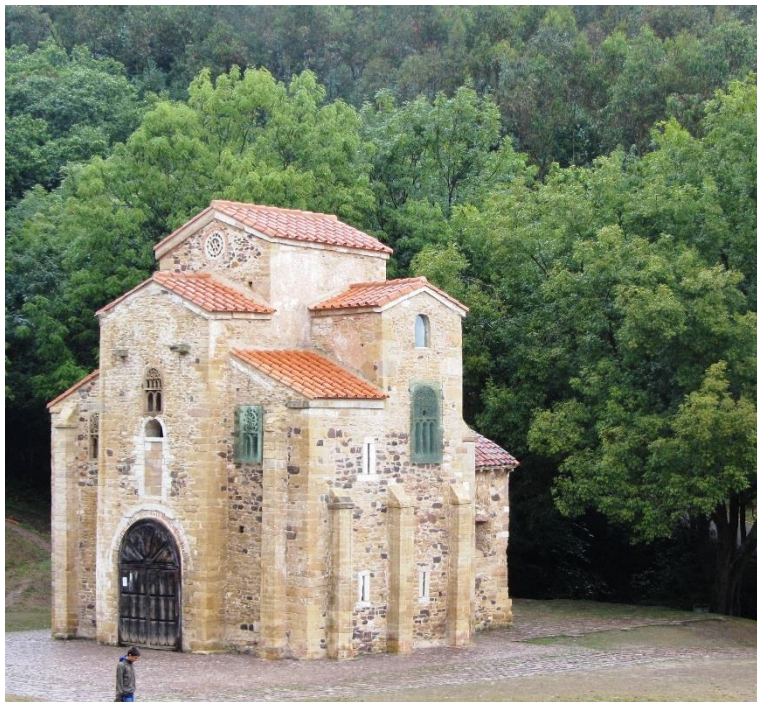
**Figure 14 San Miguel de Lillo, Naranco; surviving fragment. The emergent Asturian cruciform is represented in this church only in the projection of transepts above the line of the side aisles on the exterior. That line was continued into a much larger nave, now lost but represented in cobbling behind the church (visible bottom right in this picture).**

hundred metres from Santa Maria, on the hillside of Naranco, has been described by Barral i Altet as 'a highly compact architecture' (Figure 14), no doubt in part because what survives is the remodelled west end of a larger original structure (Barral i Altet 1998). The footprint of the original basilica with its buttressed nave is

marked out on the ground as a cobbled area behind the truncated chancel and transepts. The church is remarkable for its *transennae* or pierced stone window screens, which became a feature of Asturian pre-Romanesque churches only to be abandoned later.

It should be noted in passing that these structures were significantly modified to the forms in which we now observe them and were extended (San Miguel de la Escalada Figure 17) or contracted (San Miguel de Lillo Figure 14), and presumably only abandoned unmodified where their social or liturgical relevance had fallen below some acceptability threshold (Santa Maria de Naranco Figure 13). Their mutability illustrates both the structures' physical capacity for change and the architectural and engineering responses of their builders to social, religious or liturgical pressures requiring change.

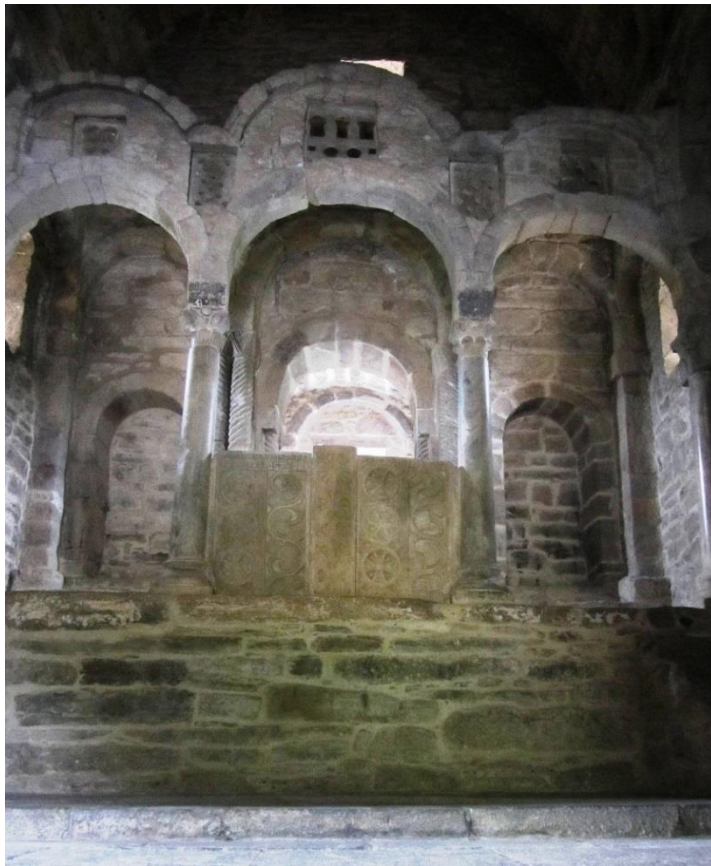
**Figure 15** Sancta Cristina de Lena. The raised chancel with iconostasis-like arrangement of decorated slabs between pillars (above). The apparent depth of the chancel area is an optical illusion; it is less than 1.5 m deep. The narrow access steps are out of shot to the right and left in this image (see plan below).

plane of their facade, a second set of three arches atop a low masonry wall into which five *transennae* have been inset. In all but the name, this is an iconostasis and would not seem out of place on the eastern Mediterranean littoral. The inseting of the upper order in the iconostasis and the positioning of the lateral pillars and engaged

pilasters, together with the blind niches either side of the entrance to the apse, form a series of retreating visual planes which creates an optical illusion of depth in the chancel area which is no more than 1.5 m deep in reality (Figure 15 & 16). With its

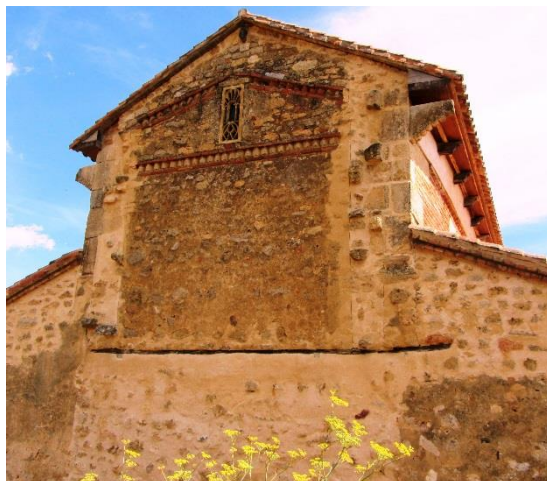
**Figure 18 Evidence for earlier wall and roof lines surviving in the external face of the east elevation of the church at San Miguel de la Escalada.**

The external east gable walls of the church proper displays evidence for a history of significant modification with sealed arches, embedded wooden beams and protruding tussing all indicative of a complex constructional history (Figure 18) which was

continued into the twelfth century with the construction to the west of a tower and church in an emergent Romanesque style, the internal barrel vaults of which were subsequently cut away; not a task for the faint hearted.

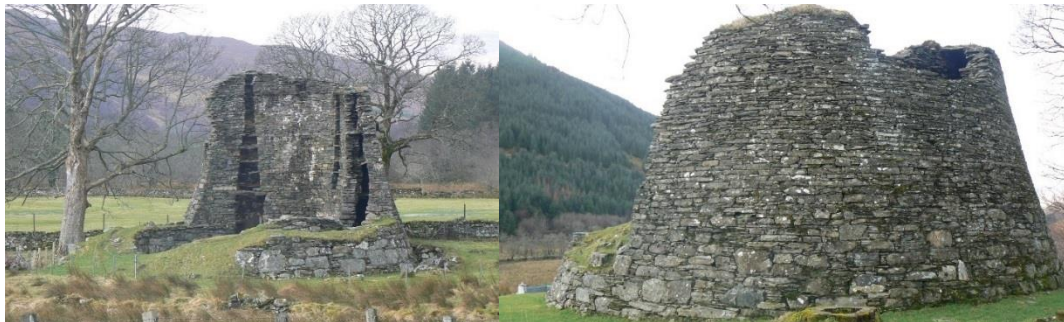
**Figure 24** Glenelg brochs, Dun Telve interior on the left and Dun Troddan, exterior, on the right.

Broch towers (Figure 24) are uniquely Scottish Iron Age structures, possibly built and rebuilt within the interval 400 BC and AD 400<sup>64</sup>, and reused in a variety of roles thereafter. Broch towers occur over much of Scotland (Figure 25) but are concentrated in the northeast mainland, Orkney, Shetland, the Hebrides and the adjacent Atlantic coast of Scotland.

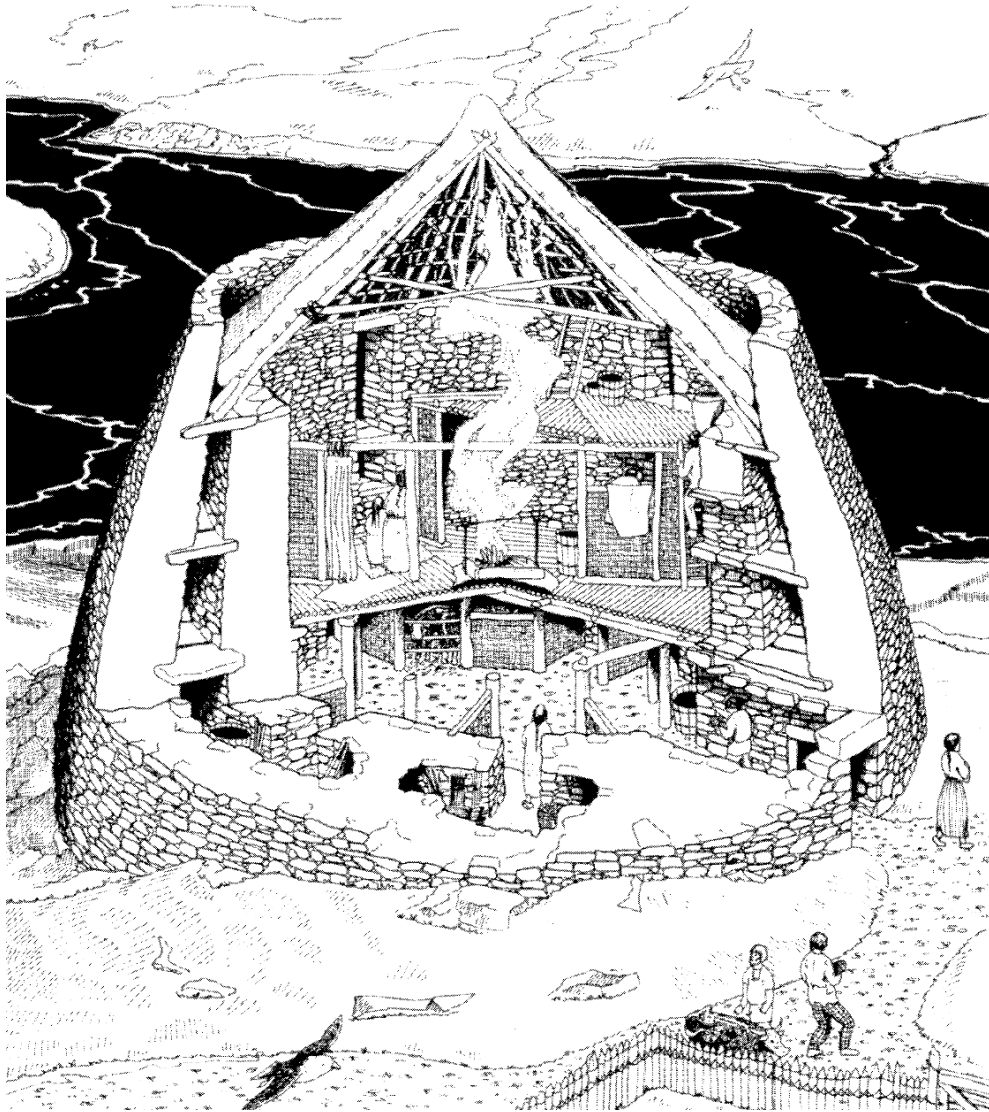
**Figure 26 Alan Braby's representation of the broch tower founded in the 2012 paradigm.**

<sup>70</sup> The term 'SM2012' refers both to the model as drawn by Braby (Figure 26) and the body of knowledge that underpinned it and the paradigm from within which it was generated. 2012 was selected as the threshold year because it is the year in which the literature review for this thesis was completed.

The profile of the outer wallface is highly variable around the circuit of the broch (Figure 65). A generic view of this variation has been fastened upon as a normative feature of broch towers which are thus represented in the SM2012 (Figure 26). Under field observation, these variations in profile seem likely to have resulted from damage to the wall, combined with the effects of losses

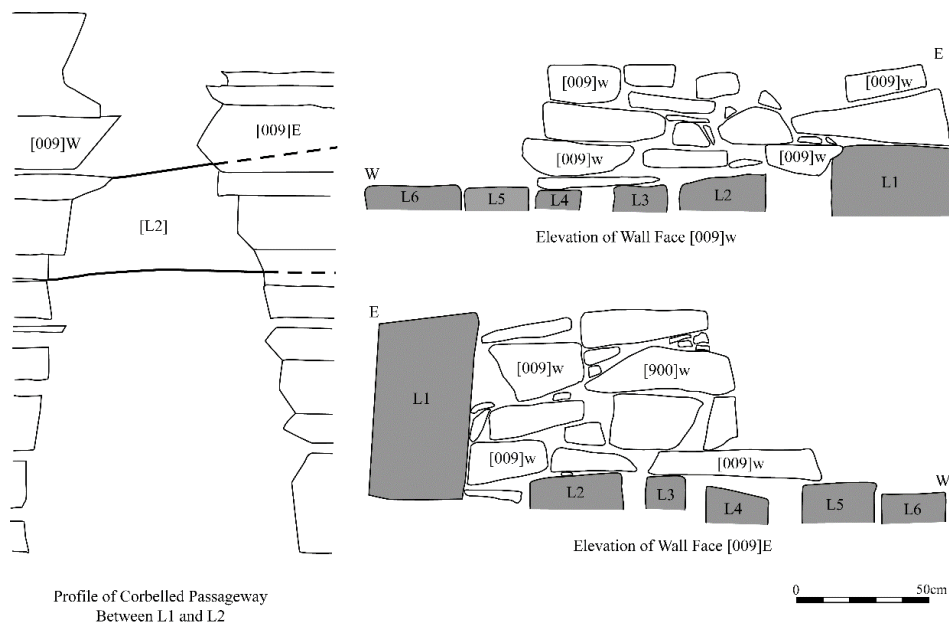
**Figure 28** The sides of the entrance passage at the broch of Clachtoll. Note the relative massiveness of lintels L1 to L4 that carry the mass of the outer wall, the latter visible above the lintels.

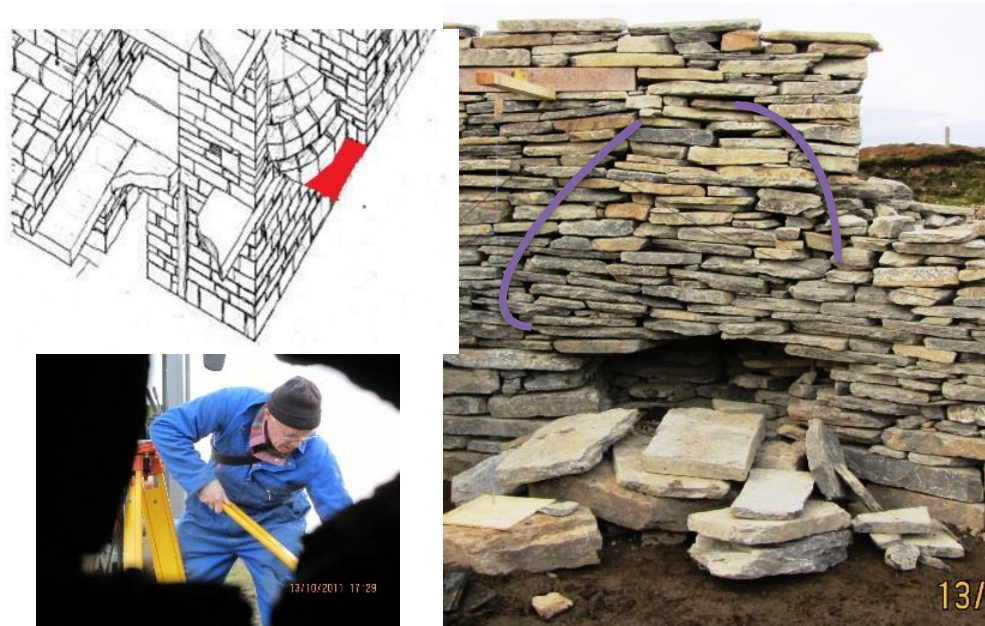
**Figure 31** The sketch (top left) shows the attenuated footprint of the inner wall, shaded red. Any settlement into this footprint would lever the inner wall inwards from the stepped stones of the corbelled guardcell. This was simulated in a 1:1 model of the Clachtoll entrance and forced into failure. However, the stones above simply arched over the breach (curved purple lines). The breach was pushed through the guardcell wall (bottom left) with no further failure of the wall masonry

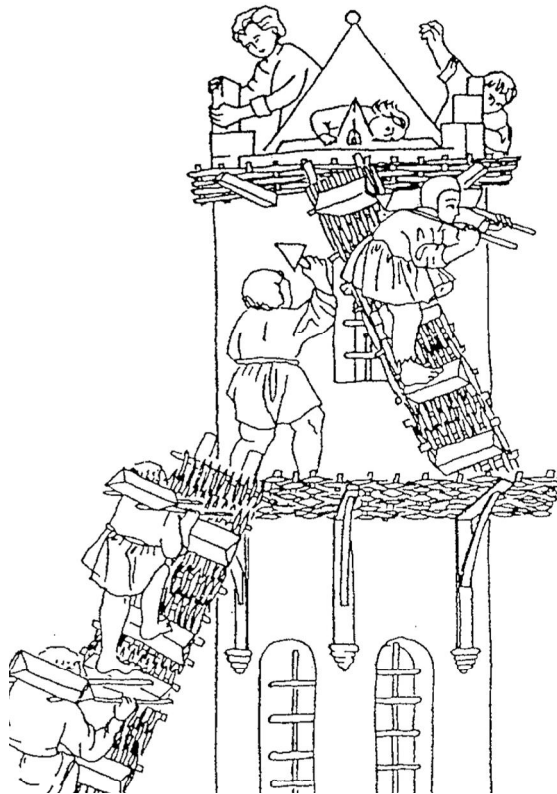
**Figure 33** In this illustration dating to c. AD 1300 the long ladder/ramps have been stiffened behind by stronger poles, but otherwise the ramp-ladder and the hanging scaffoldings are clearly of wattle work. Note also, the little figure at the wallhead levelling with a plumb-level. Save only for the use of mortar – evidenced by the trowel – there is nothing in this illustration that could not be encountered in the Scottish Iron Age. (after the British Museum’s Egerton manuscript, as reproduced in Binding 2004, 87, his Figure 268: creative commons ©).

(at 68.2% probability). Its import here is that it indicates the probable use of wattle screens as flooring for the putative floor resting on the scarcement, a suggestion avoiding the need to imagine the procurement of many timbers in a treeless landscape, and one consonant with Harding’s observation (ibid) that the area ÷ doubtless supported only relatively light birch or hazel woodland.ø quite so. One robust, or two or three lighter layers of wattle screens would construct a floor easily capable of carrying normal household weights, including people. Such screens, apparently used singly, furnished the access ramps and floors for scaffolding in major medieval building projects (Figure 33).

demonstrated by the writer's work in building corbelled curves in Spittal. His concerns about the timber supply for broch building can be tempered by the knowledge of the suspended or hanging scaffolding (Figure 33) which would greatly reduce the demand for substantial timbers.

One timber demand ignored by many scholars to date is the requirement for scaffolding during construction. In general, it is conceived that the tall walls were built, helically in rises that approximate to the comfortable working range of a mason. Given the extreme thickness of the wallhead, the rise may have been somewhat short, perhaps as short as 500 mm. As noted in Chapter 3 (& see Figure 33) this scale and rate of build could have been managed from suspended scaffolding.

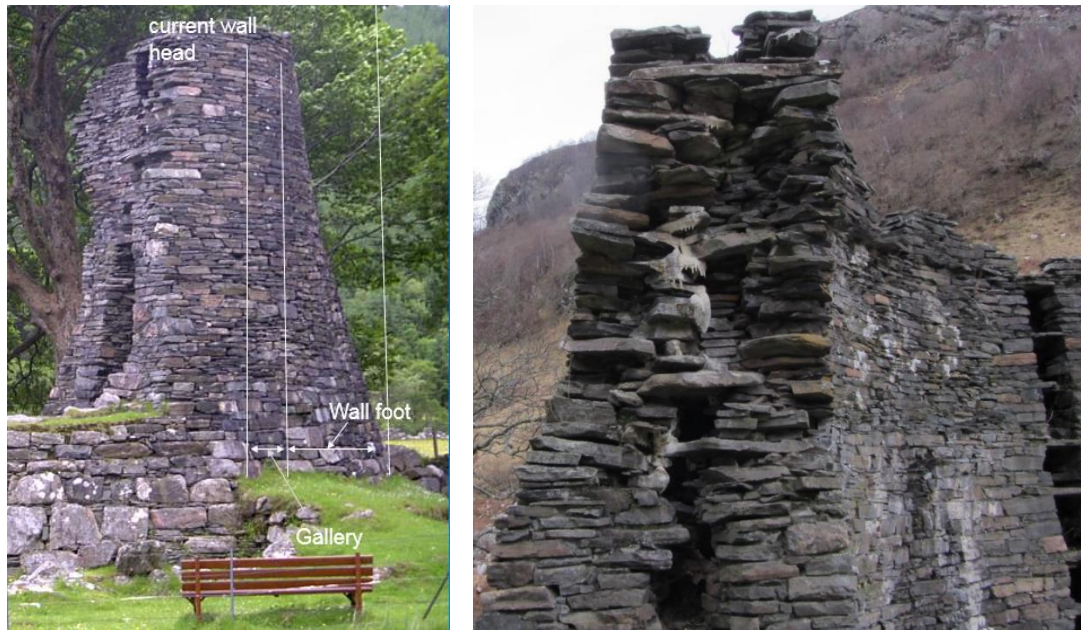
**Figure 35 Dun Telve, Glenelg is illustrated here to show that the outer and inner walls converge with height and meet just below the wallhead. The high scarcement is visible in the right hand image and it is generally speculated that this lies at the wall convergence level and perhaps 1 m or so below the final wallhead. The weeping lime salts probably result from relatively recent conservation, some of the stones of which can be seen just right of the excrecence, supporting the view that the stones filling the intramural space above that level are as originally built**

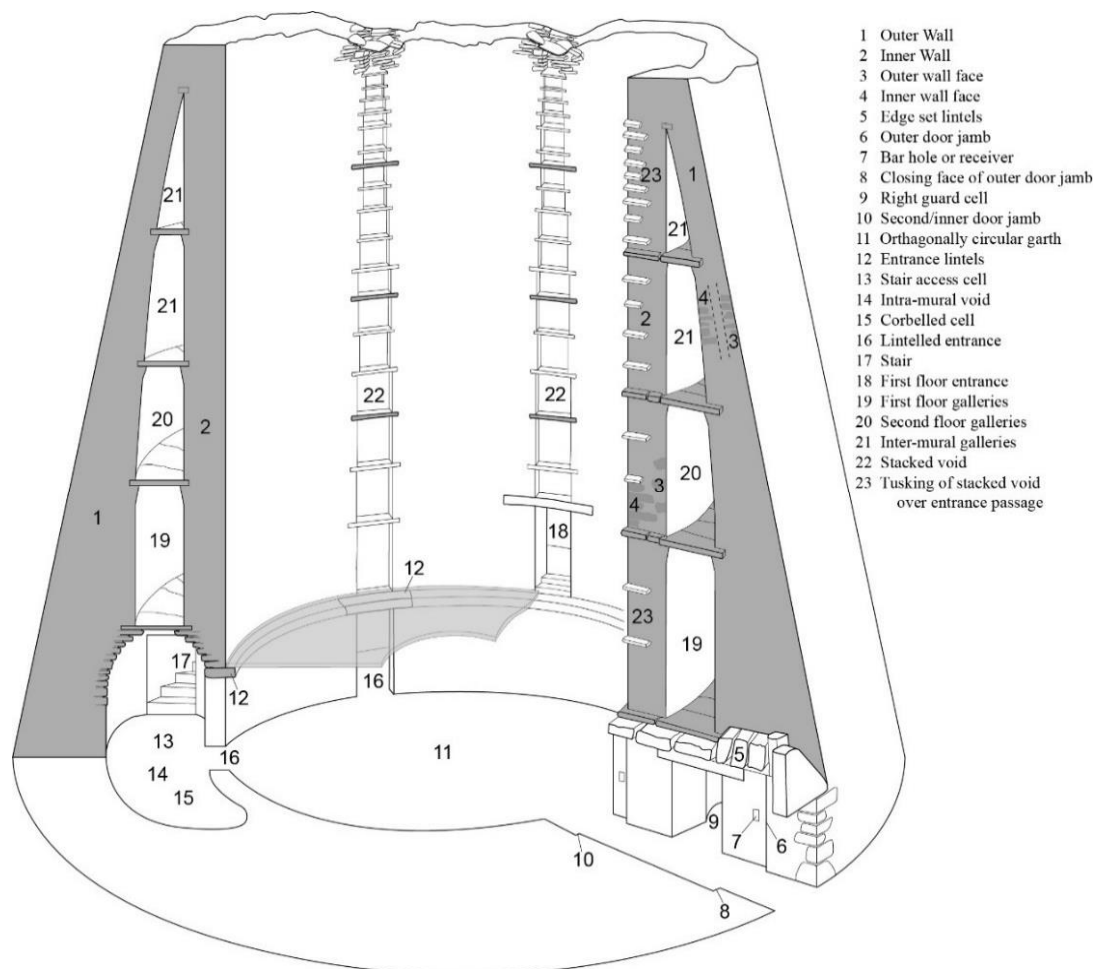
**Figure 36** The form and configuration of the Revised Standard Model broch, the RSM. Only its structural elements have been included in this illustration and the stairfoot cell on the left is included for illustration only, the stair proper would be entered at 16. The relationships between observations and interpretations of these and other features of the SM2012 and RSM configurations are tabulated in Table 3.5.

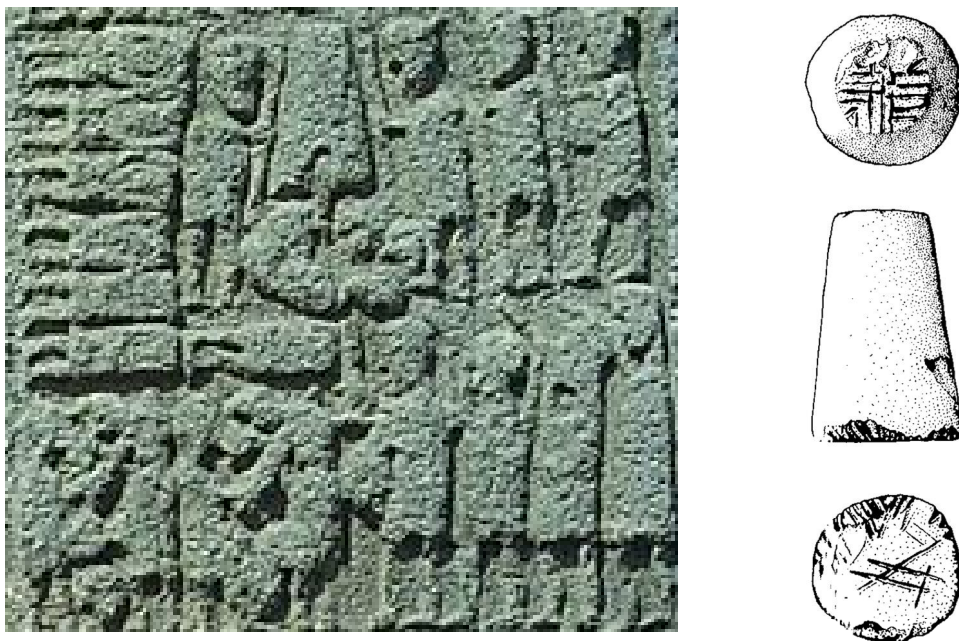
**Figure 37** The central panel on the reverse side of Sueno's Stone, a possibly 10<sup>th</sup> century decorated Pictish monolith, is thought to display the aftermath of a battle with decapitated bodies on the left and apparently armed persons on either side of a truncated cone shape which may have been intended to represent a broch tower. Similarly, the gaming piece from Scalloway may be a three-dimensional representation of a broch tower.

Two putative and near contemporaneous representations of brochs survive to us, the first a sculpted shape on the back of the Sueno's Stone cross slab (Henderson and Henderson 2004, 135) and the second, a gaming piece excavated at Scalloway, in Shetland (Sharples 1998, 173, 175). Both representations are reproduced here as Figure 37). These images are not unambiguous evidence of the forms of original brochs but such evidential value as they possess point to the truncated cone shape deduced from the surviving remains. It should be noted that Sueno's stone is thought, on art historical grounds, to date to c. 900 AD and is more than a millennium later than the initial broch building episode. However, the esteem in which Picts seem to have held brochs is demonstrated by their common reuse of brochs and broch sites and it is not impossible that a notion of a heroic age of brochs may have informed the sculptor of Sueno's stone, albeit that few brochs, more than currently but probably fewer than 20, would have survived to full height at that date. Thus, the uncertainty of the identification is necessarily acknowledged, as is the absence of an alternative credible interpretation.

If the gaming piece excavated by Niall Sharples at Scalloway is indeed a representation of a broch, as is suggested here, then the pattern incised into its upper surface (Figure 37) may represent the panels of an essentially flat roof (Sharples 1998, his Fig 113). Similarly, if the carving on Sueno's stone is representative of a broch, this also is a frustum of a cone in shape (Figure 37, right). Thus, both possible artistic representations of brochs appear to represent truncated cones without conical roofs and while this is a tenuous line of argument, nonetheless these objects had the potential to refute the non-conical hypothesis and they do not do so.

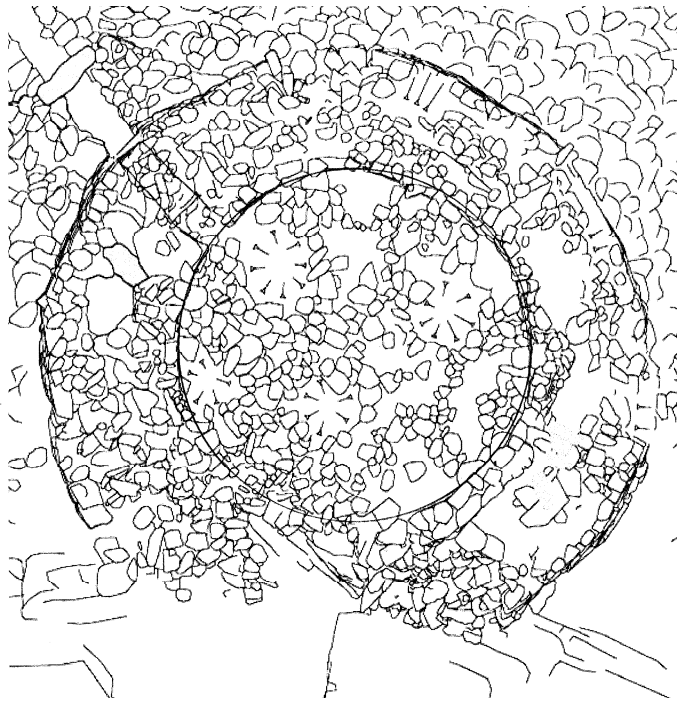
**Figure 40** This outline plan was derived from the laser scan surveys of Clachtoll broch. Onto its inner wallface a circle of best fit has been drafted which indicates a very close approximation to true circularity everywhere except in the upper right quadrant, where the wall head had been both displaced and rebuilt in the recent past.

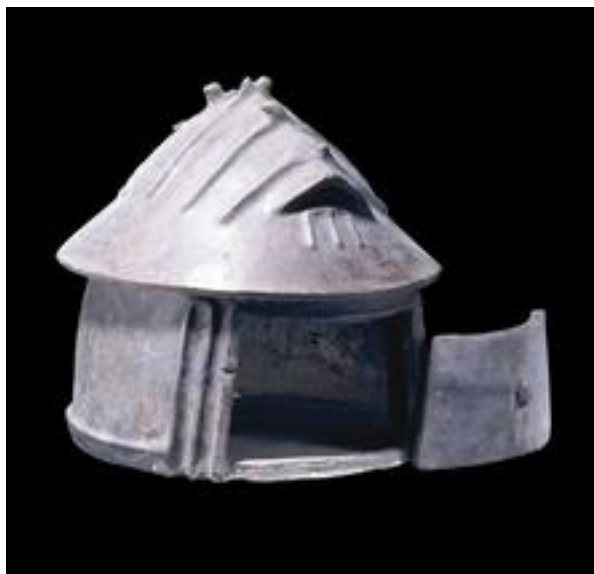
**Figure 41 (left) Skeuomorph of a Villanovian House from the Alban Hills, Lazio, in the British Museum collection. © The British Museum**

It is imagined that the ridgepole is supported on a central ring-beam structure. The house shaped cinerary urns of the Villanovan Period, 900-800 BC

illustrated in Figure 41, comes from the Alban Hills, Lazio. Similar urns, of the same period from southern Germany display many of the same features (Figure 42).

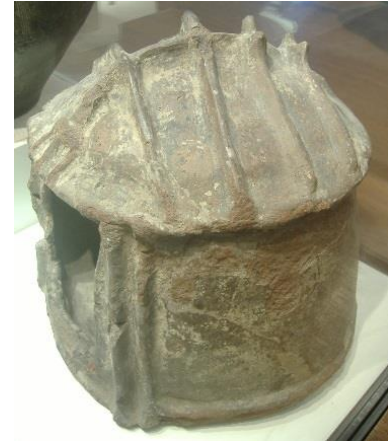
**Figure 42 (right) Skeuomorphic house-shaped cinerary urn from southern Germany on display in the Charlottenburg Museum, Berlin.**

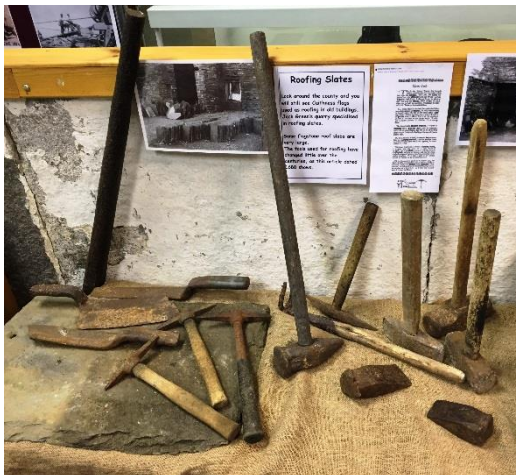
**Figure 44 The toolkit of the 19th and 20th century quarrymen of Caithness; displayed in Castletown Museum. Nothing in this assemblage could not have been in existence and use in Iron Age Scotland.**

traction, together with cordage and timber. Sedimentary stones, common in the NE Mainland and Orkney, were easily quarried. The tool kit of a quarryman in the early 20<sup>th</sup> century had not advanced over that which could have been available to his Iron Age ancestor (Figure 44) for the working of stratified sedimentary flagstones.

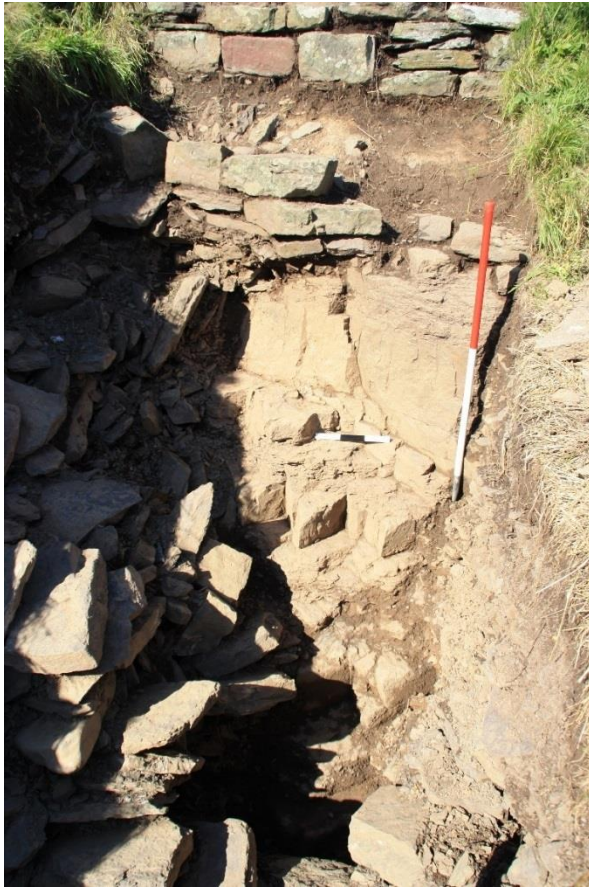
**Figure 45 The rock cut ditch at Nybster. The use of stone pounders for quarrying militates against the production of vertical faces and the sides of the Nybster ditch steps out towards its centre line as it descends. Not a disadvantage in ditch digging, it can be a severe disadvantage at a quarry face. © AOC Archaeology Group**

The promontory fort at Nybster has a rock-cut ditch (Figure 45) and while tool marks are not readily visible on the photographic image, they were observed in the field (I am grateful to my colleagues Drs Cavers and Heald for this information). However, the bulk of the quarrying may have been undertaken using stone tools. The

face visible in Figure 45 was quarried by use of heavy mauls that leave a stepped profile<sup>99</sup>.

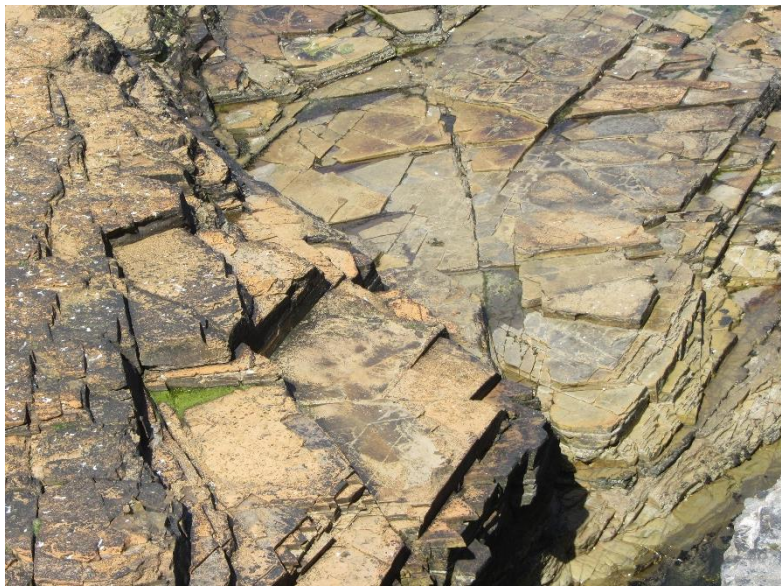
**Figure 46 Typical Orcadian bedrock exposure of flagstone formation with (here) horizontal bedding planes and vertical cleavage planes at 30, 60 and 90 degrees to each other. This produces first class building stones with minimal quarrying cost.**

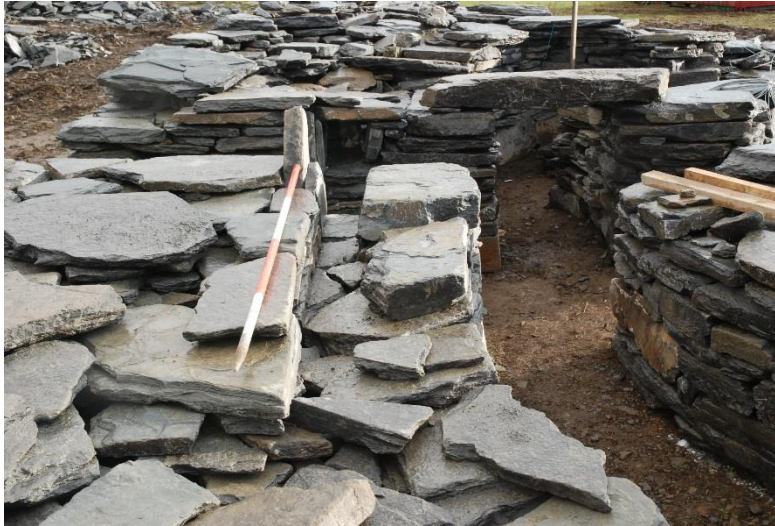
**Figure 50 The barhole and slot under construction in a 1:1 model of the Clachtoll broch entrance area. Given the small cross sectional width and height of the barhole and the narrowness of the entrance, failure to insert the bar at this stage would preclude its insertion later.**

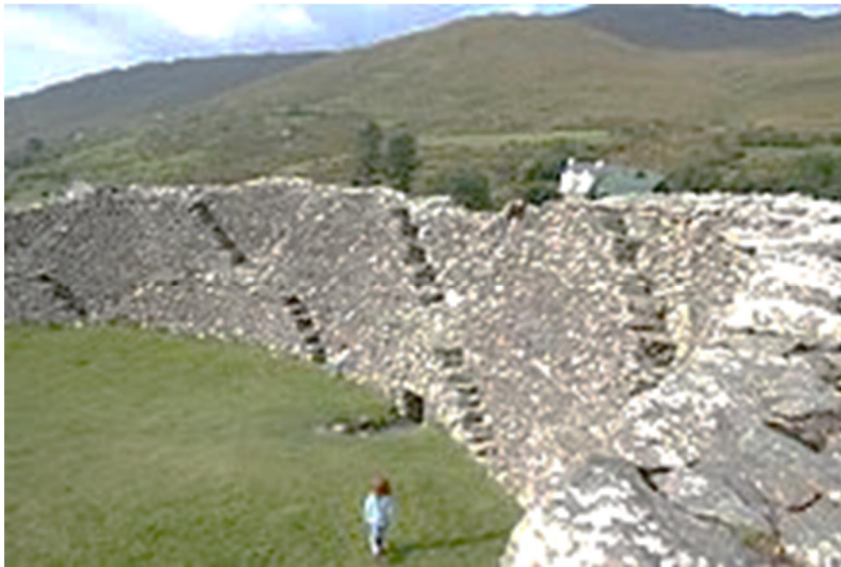
**Figure 51** The Irish stone fort at Staigue, Co. Kerry, comprises a large curtain wall with characteristic X-shaped stairways built into the internal wallface.

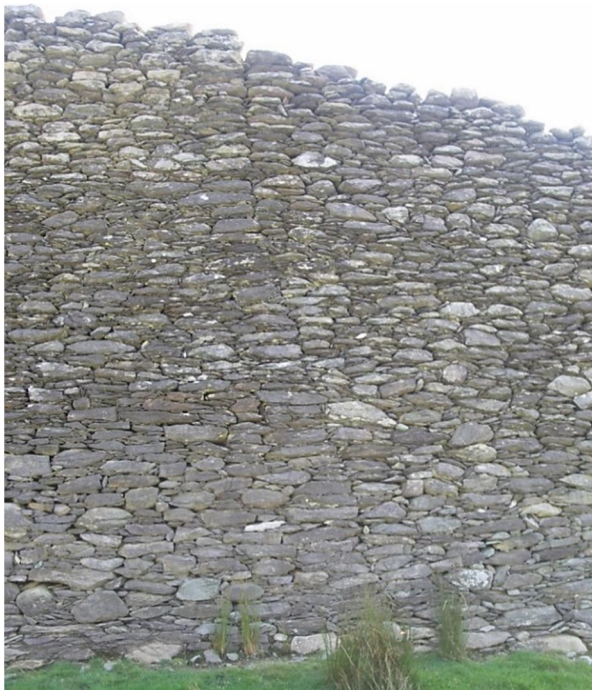
**Figure 52 (left)** Staigue's external wallface presents like a brooch tower wallface. However, a clear building break has been observed in the outer wallface that might support an argument for helical building around the circuit of the fort. No comparable building break has been observed on Scottish Brochs.

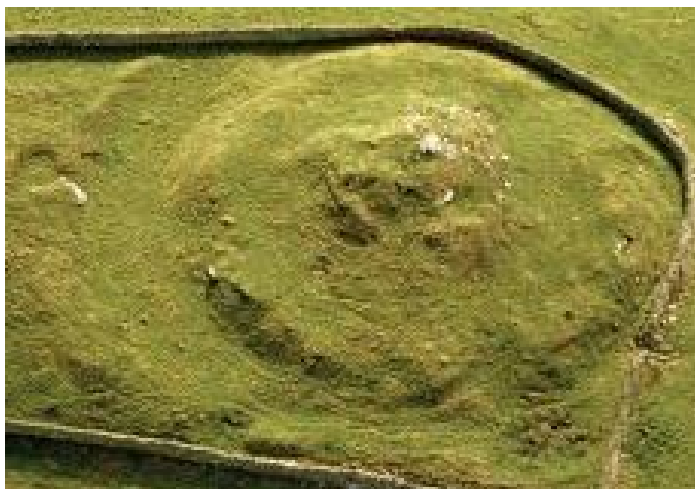
**Figure 54** The residual broch remains at Bruan, Caithness. The central mound (3 m high) is surrounded by the base of the original broch wall. © RCAHMS

many sites (see Chapters 6 & 7) and created some chimerical monument forms. At Bruan (Figure 54) removal of the good building stone of the broch wall was initially accompanied with dumping detritus into the garth area. Eventually the wallhead was reduced below the level of the dumped material which now stands proud of the vestigial wall foot, and the monument is now shaped rather like a Mexican sombrero. It is highly probable that original and possibly relatively undisturbed archaeological deposits survive within this bizarre monument.

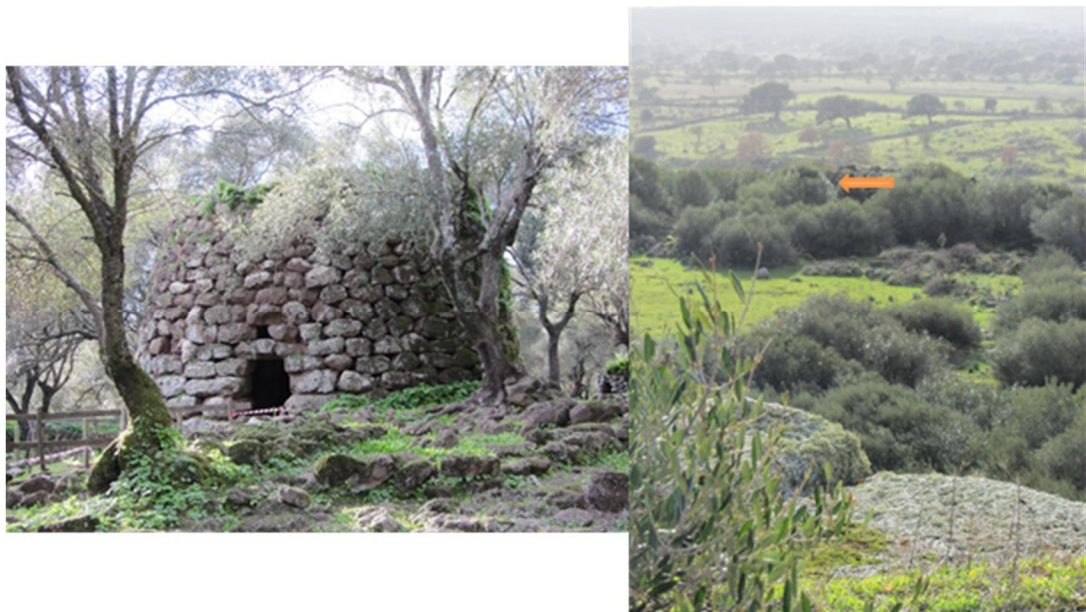
**Figure 57** The Sardinian nuraghe of Sta Christina at Paulolatio (above left) survives to half its original height and is quite fully masked by the surrounding olive trees. Even at full height it was never easily discernible. On the right, a nuraghe indicated by the arrow lies hidden in trees, barely discernible from the wallhead of the example from which this image was taken.

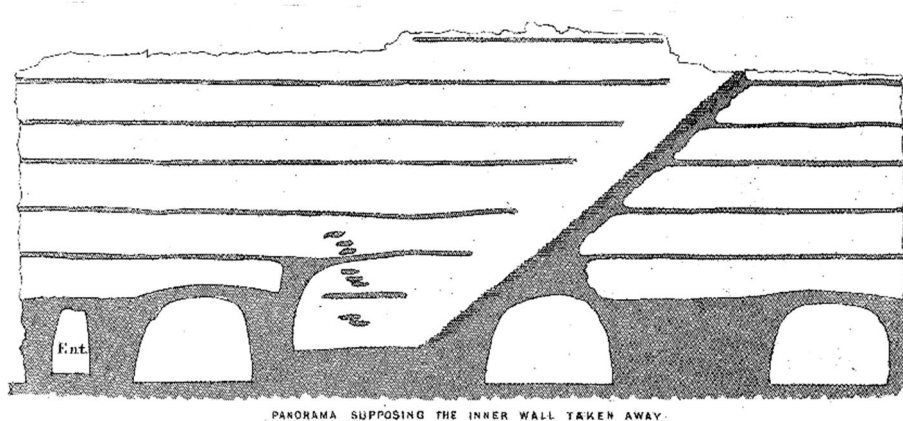
**Figure 58** Dryden's sketch of a circumferential section through the plane of the galleries, revealing the helical stairway.

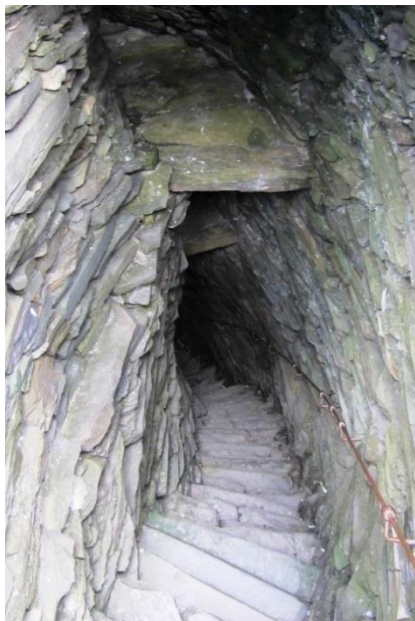
**Figure 59 (left)** View down the helical stairway, revealing two gallery floors. Note the several adjustments to the curvature and location of the left hand wall, i.e. the wall abutting the interior of the broch. This wallface has been stepped back from the stairwell in three stages and follows a recurved footprint in the uppermost. It is probable that this is associated with the secondary insertion of the helical stairs.

by leaping back across the stair hole to the nearest lintel of the gallery floor, some 3 to 4 m distant (Figure 59 and Figure 59)<sup>133</sup>.

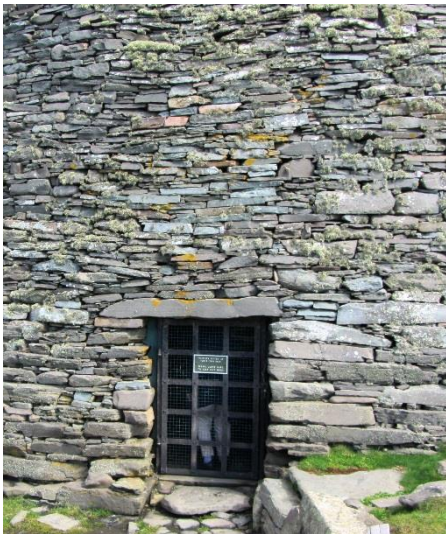
**Figure 63 (left) The outer wallface above the current entrance at Mousa. The edges of the inserted masonry are indicated by a proliferation of small slabs and an extensive rispains joint on the right.**

The high breach above the original door ope is illustrated in Paterson's paper, in a photograph of the entrance (Paterson 1922; 178: Figure 62 above). The wallface masonry above the current entrance is clearly built in a different plane from that of the adjacent masonry with relatively clear differences in the masonry build (Figure 63). This is similar to the wallface configuration above the entrance at Dun Telve,

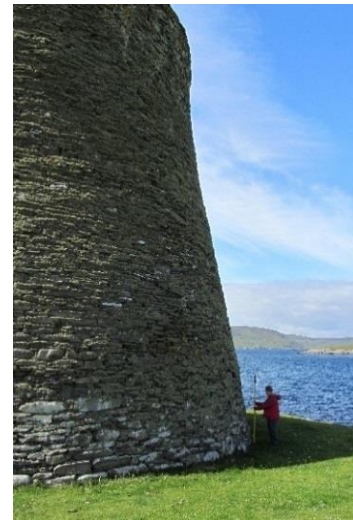
**Figure 64 (right) Profile on the north east of the monument is steeply battered and linear in section to about mid-height above which it becomes vertical, in two stages.**

from the wallhead, on the one hand and rebuilding on the other. In Figure 64 The linear wall slope of the lower half of the wallface on the NE side is probably close to the original profile of the monument, some 11.58 degrees (this is the left-most image in the composite in Figure 65).

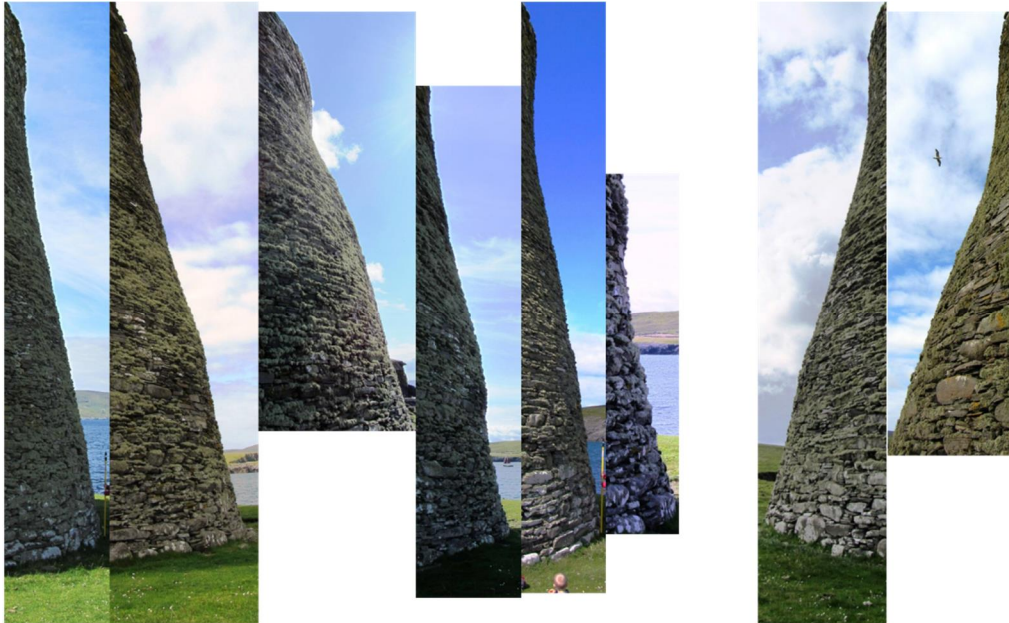
**Figure 65 Outer Wall profiles at Mousa. The LHS image probably best preserves the original battered profile of the broch wall in its lower half. The various bulges and out-thrusts, in places beneath slightly overhanging upper part is most probably Viking in date. (These images are only approximately correctly aligned for height relative to each other).**

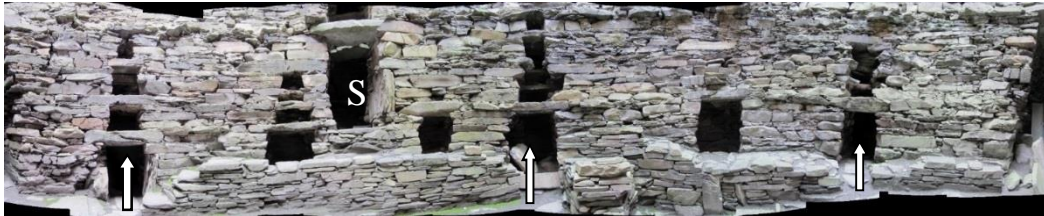
**Figure 66** The internal wall foot at Mousa. The broch entrance appears at both ends of this panorama. Short stacked voids are positioned over the entrance lintels of the wall cells and some aumbries. The wall between the entrance, on the left in this image, and the stair access ‘S’ seems extensively rebuilt.

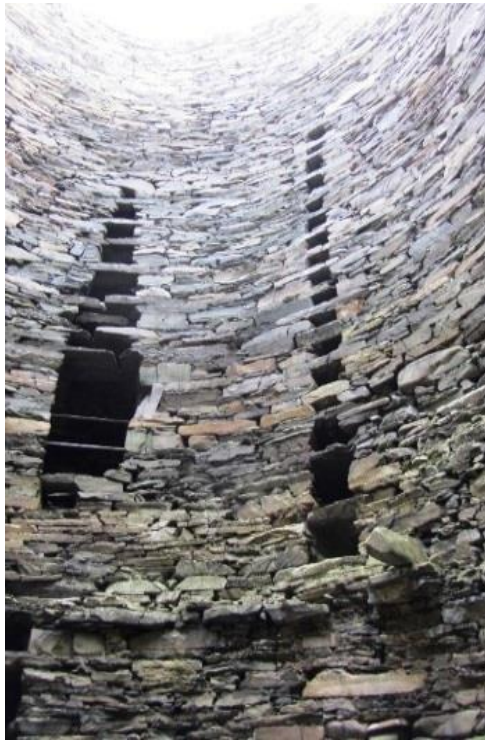
**Figure 71 (above)** Stacked voids above the stairway entrance.

The inner wallface of the broch at Mousa bears three long stacked voids, one rising above the broch entrance, one associated with the stairway entrance and a third that probably rose from a doorway above the scarcement (on right in Figure 71). The latter is set above, but offset from the line of one of the aumbries and it is unlikely to have been intended as a relief mechanism for the aumbry. If, however, the aumbry is a relict entrance to a now lost gallery or wall-cell, the presence of this relieving structure would be explained; it is a relict feature from an earlier configuration. This

contemporaneous but they are likely to have been so. The quality of the masonry build at mid-height in the inner wallface is especially poor (Figures 71-3) whilst that above it is quite serviceable. This is consistent with a reconstruction above a wall weakened by collapse.

<sup>135</sup> **It seems clear from Figure 71 and**
