# **Approaching the mind of the builder**

**Analysis of the physical, structural and social constraints on  
the construction of the broch towers of Iron Age Scotland**

**John Barber**

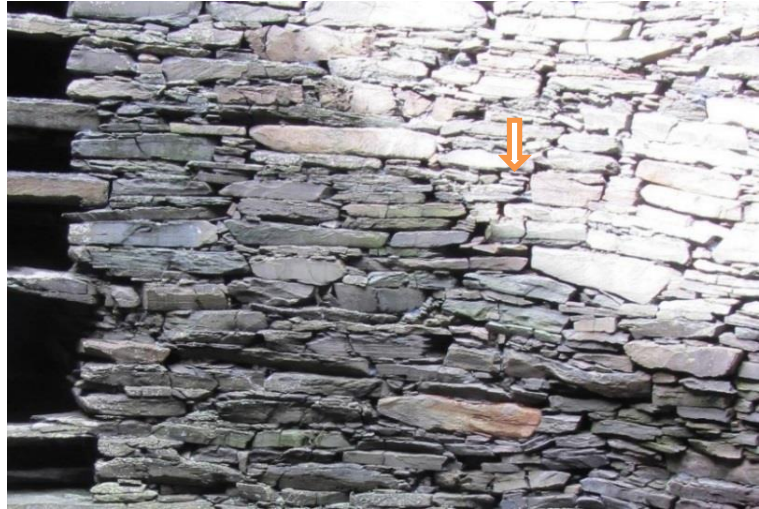
**Figure 72 (right) The quality of the built wall at mid-height is very poor, with few or no panels of pinnings used to consolidate the masonry. The indicated panel sits within a structural crack and is therefore not original.**

contemporaneous but they are likely to have been so. The quality of the masonry build at mid-height in the inner wallface is especially poor (Figures 71-3) whilst that above it is quite serviceable. This is consistent with a reconstruction above a wall weakened by collapse.

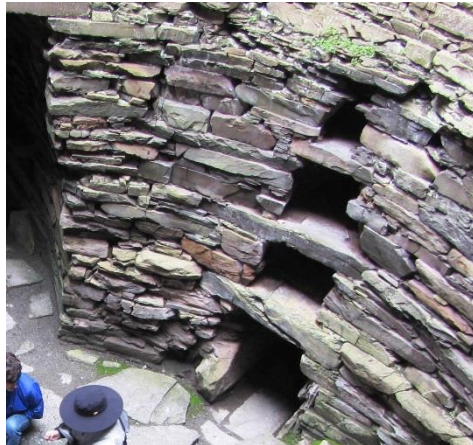
**Figure 73 (left) The masonry of the inner edge of the entrance passage within the garth is, at best, shambolic and contrasts strongly with the build of the surviving inner wallface. The possibility that these are contemporaneous constructions is minimal. The lower scarcement can be discerned all the way to the arras, with a little faith.**

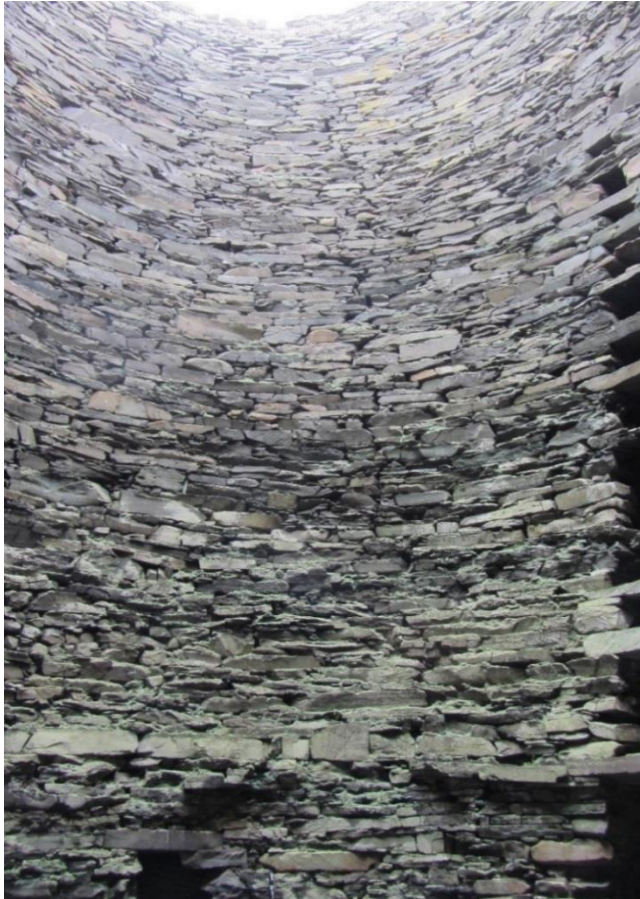
**Figure 74 Major structural cracks are clearly visible in the inner wallface. Note apparent displacement of the LHS wall of the second void in comparison with the lowest.**

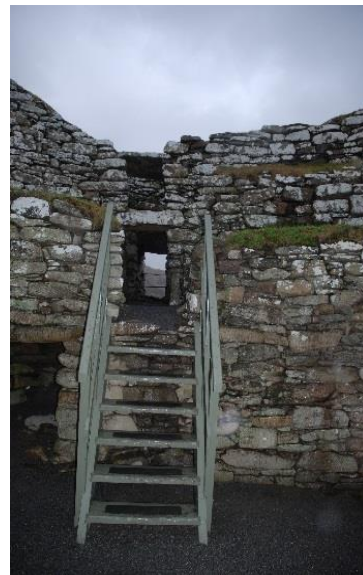
**Figure 77 (right) Modern wooden stairway access to the elevated ope and stairway.**

solum and accessed by a wooden ladder (Figure 77).

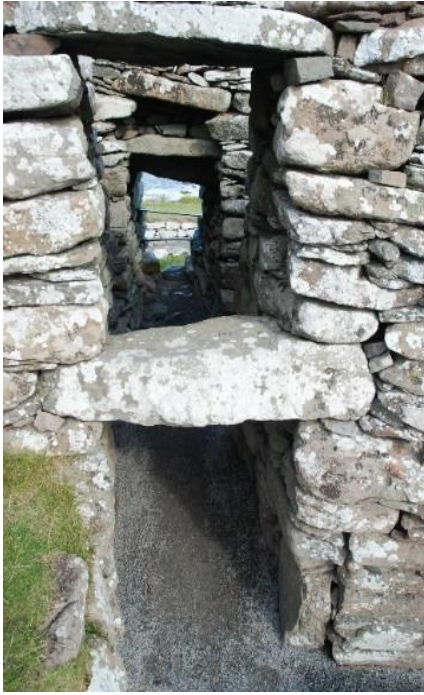
**Figure 78 (left)** The reuse of a stacked void, probably the original stair landing stacked void, to form an entranceway through the inner wall. The entranceway passage cut through the wallhead for about 600 mm and crossed the first level gallery void to exit the broch by a new ope slapped-through the outer walling of the monument.

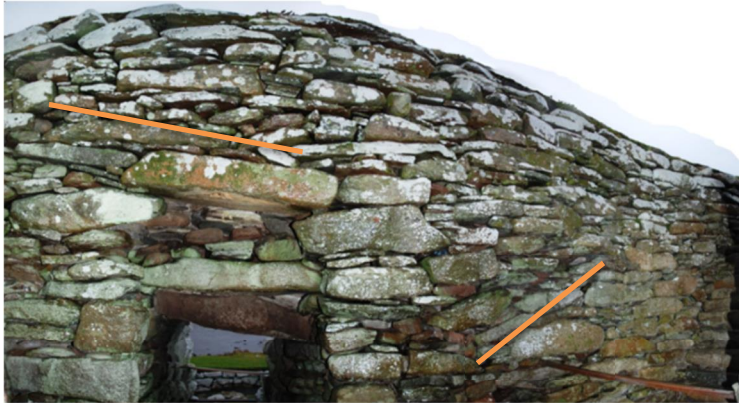
**Figure 80 (above)** The inner wallface of the outer wall at the secondary door. The lines indicate the more obvious fracture planes through the masonry which is clearly heavily reworked in this area.

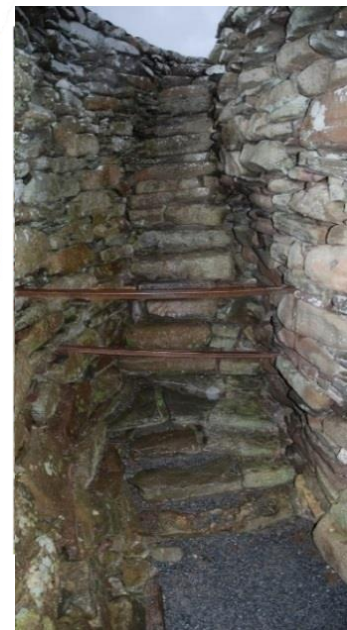
**Figure 79 (right)** The stairway clockwise of the secondary entrance. Note the significant bulge outwards in the LHS sidewall of the stairway. The stairs are not all of one build.

all displaced. It would have been impossibility to form this cell in drystone masonry. It is a built structure frozen in the process of decomposition and bodged into a cell by subsequent builders.

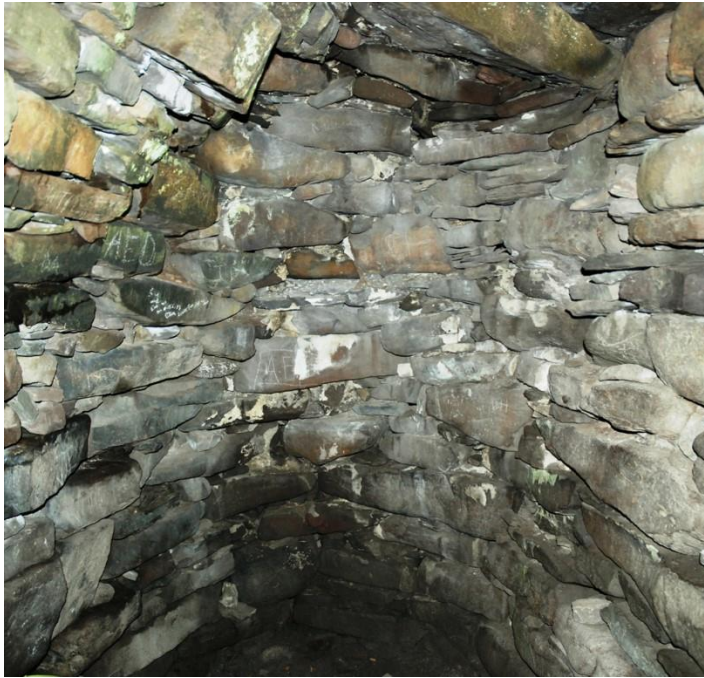
**Figure 81 (left) Cell A. The wall on the right is probably an original gallery wall. The LHS wall is topped with what has been called corbelling. However, this masonry has simply fallen inwards and wedged in place now apparently stabilised with mortar. It is not a drystone built feature and cannot have been one, given the sloping joint planes.**

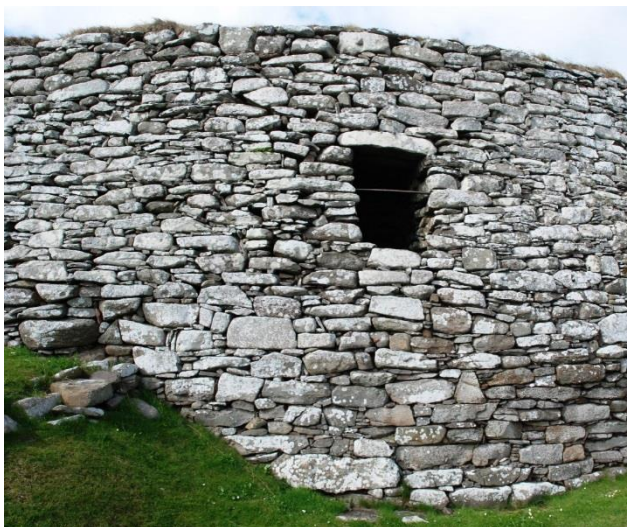
**Figure 82 (left) The tertiary entrance at Clickhimin. Rispain joints isolate the block of masonry immediately below the entrance, which may have extended down to the level of the masonry abutting the broch left of the ope; but note earlier repairs below this level.**

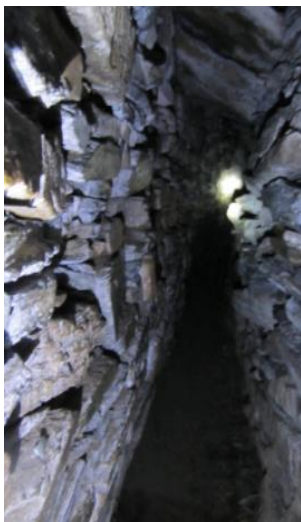
**Figure 87 View along the ground gallery from the LHS guardcell**

This is illustrated in sections and plan in the excavation report (reproduced here as Figures 88 & 89) and illustrated in photograph (Figure 87). Currently its wallfaces, outer and inner, bulge significantly into the passageway and some of its lintels are displaced or broken with fresh stone fallen onto the current passage floor (in 2015). This gallery encircles the broch at ground floor level, albeit apparently now unconnected to the RHS guardcell from which it is said to end 1.5 m distant (see  $\varnothing$  on Figure 89). There is no doubt that this, the lower void, is a ground gallery.

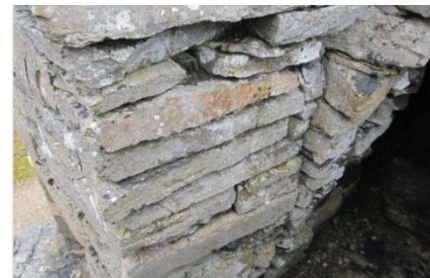
**Figure 91 (above) The back of the left edge of the stairway ope. Note the building break between the vertical masonry pier and the inward leaning side wall of the gallery.**

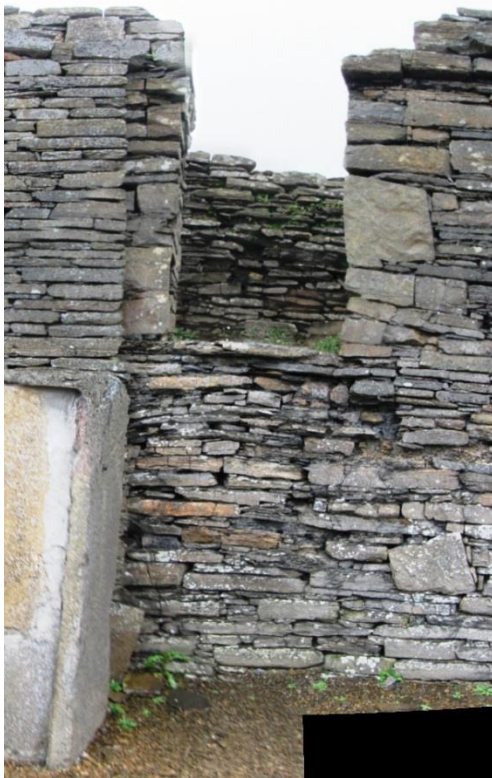
**Figure 92** The masonry directly under the ope is badly disarranged and it is likely that it blocks a door ope that gave access to a ground floor gallery or a ground floor stairway, possibilities that can only be tested by excavation.

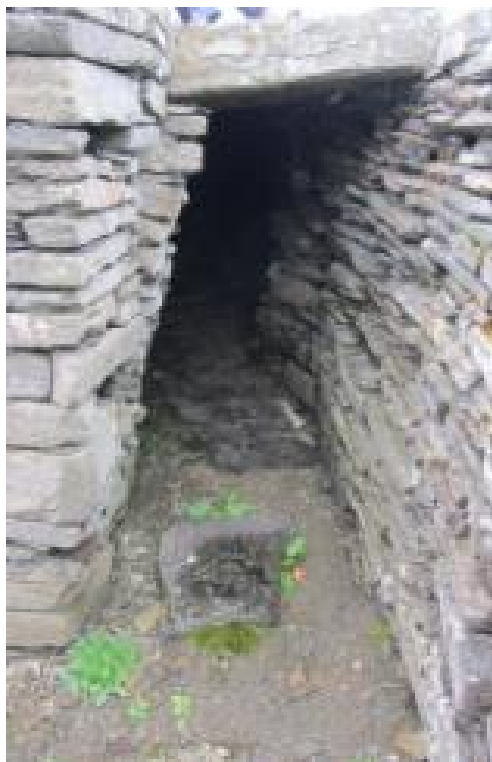
**Figure 93 (left)** Entrance to the intermediate gallery, now inclined to the outside of the broch by an average of approximately 15 degrees.

**The 'pear-shaped' cell of the mid void**  
The void opposite the stairfoot (

Figure 93) opens into a pear shaped cell (shown in hyphenated outline on North, i.e. right side of Figure 94). It is up to 1.5 m high. The pear-shaped cell is not concentric with the original gallery on this level and it

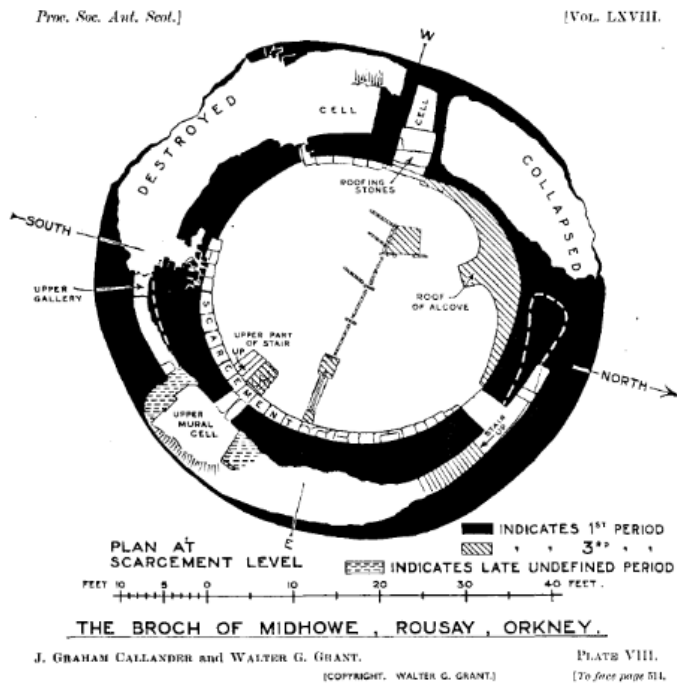
Figure 94 Plan of second and third floor features at Midhowe, after Callander & Grant 1934. The 'pear-shaped cell' is marked by a broken line, below centre right of the image.

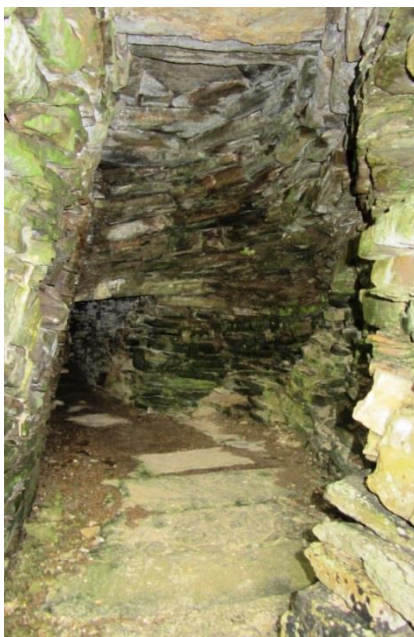
Figure 95 (left): The entrance to the pear-shaped cell from the stairfoot showing divergence of the left hand wall from the floor lintels of the original gallery.

These floor lintels are also the roof lintels of the ground gallery and would have been the floor of the original first level gallery. The first level gallery side wall should then overlap the edges of these lintels. The pear-shaped mid-void is therefore not a broch gallery and is a non-canonical form. It is very roughly corbelled and re-joins the original gallery further anti-clockwise,

via a crawl-way (just visible in Figure 95, left of centre) that runs on towards the entrance. This continuation of the gallery is not represented in the excavation plan (extracted here in Figure 94).

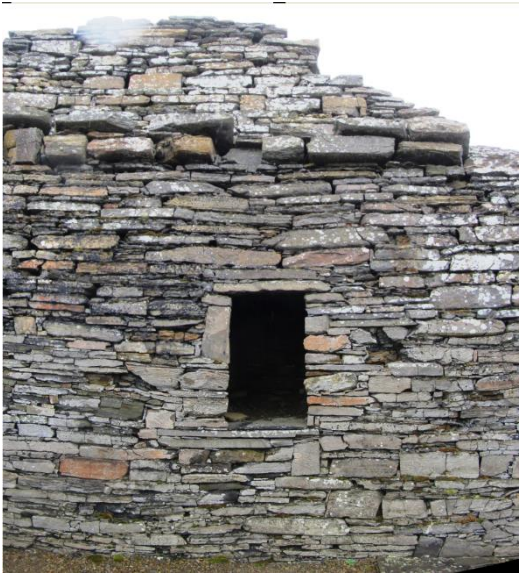
Figure 98 (left) The 'Entrance to galleries'

In contrast, the galleries on the north side of the broch (see Figure 88) although distorted, were regularly built and clearly set one above the other. Taken at face value, this section seems to demonstrate that the 'Entrance to Galleries' accesses a volume of traumatically failed fabric within the wall, rather than a built gallery. This is consonant with the outward tilt of the second level masonry above it to the right, and consonant also with the general condition of the lower gallery which indicates major deformation of the wall.

space suggests that it has been capped off below the extant high-level scarcement (see Figure 85 & Figure 100). It is clear from Figure 98 that the masonry around the void ope was very heavily cracked and broken and its down-taking would only have required a local intervention. However, this further implies that the high-level corbelled scarcement here cannot have predated the resurfacing of the IW in this area. Thus, the high-level scarcement was not a feature of the original broch tower. It

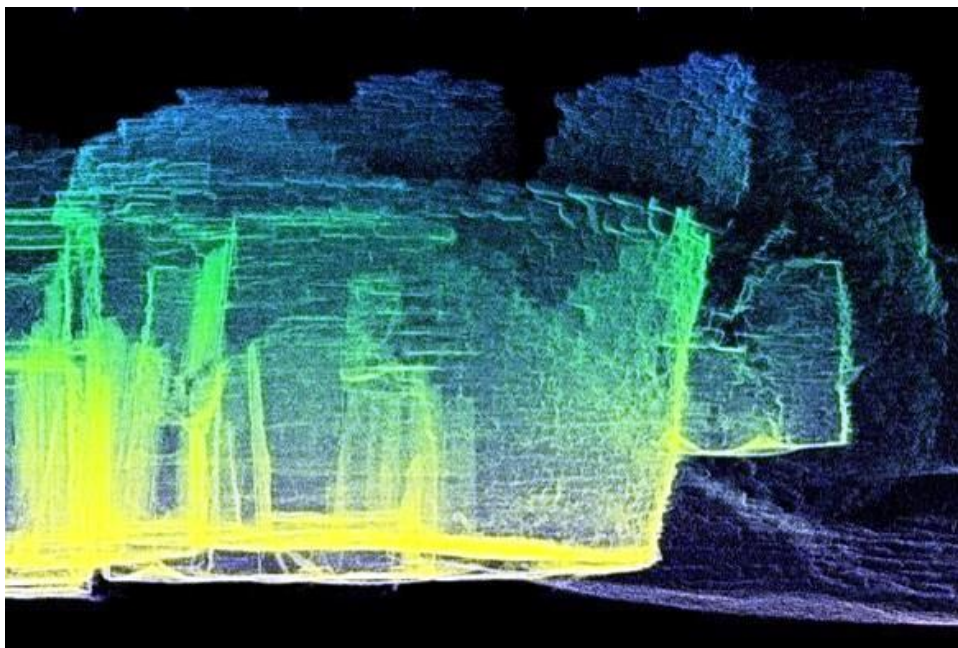
**Figure 100** Point-cloud image; the aumbry on the right enters the wall horizontally and rises vertically within the intramural void. Note the high-level scarcement, dipping towards this side and built into the masonry overlying the intramural void.

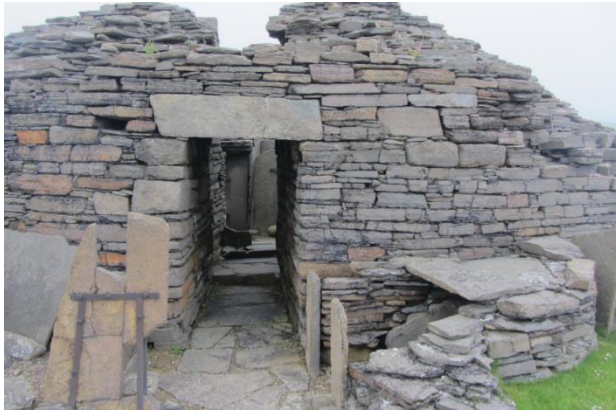
**Figure 101 The entrance façade**

As discussed in Chapter 3, the engineering and architecture of the entrance is the most complex part of a broch and its masonry is subject to the greatest stresses. The external face of the Midhowe entrance is well formed and apparently unaltered by the failure of the outer wall on either side of it. The entrance ope and its enveloping masonry are centered within the area of greatest structural deformation.

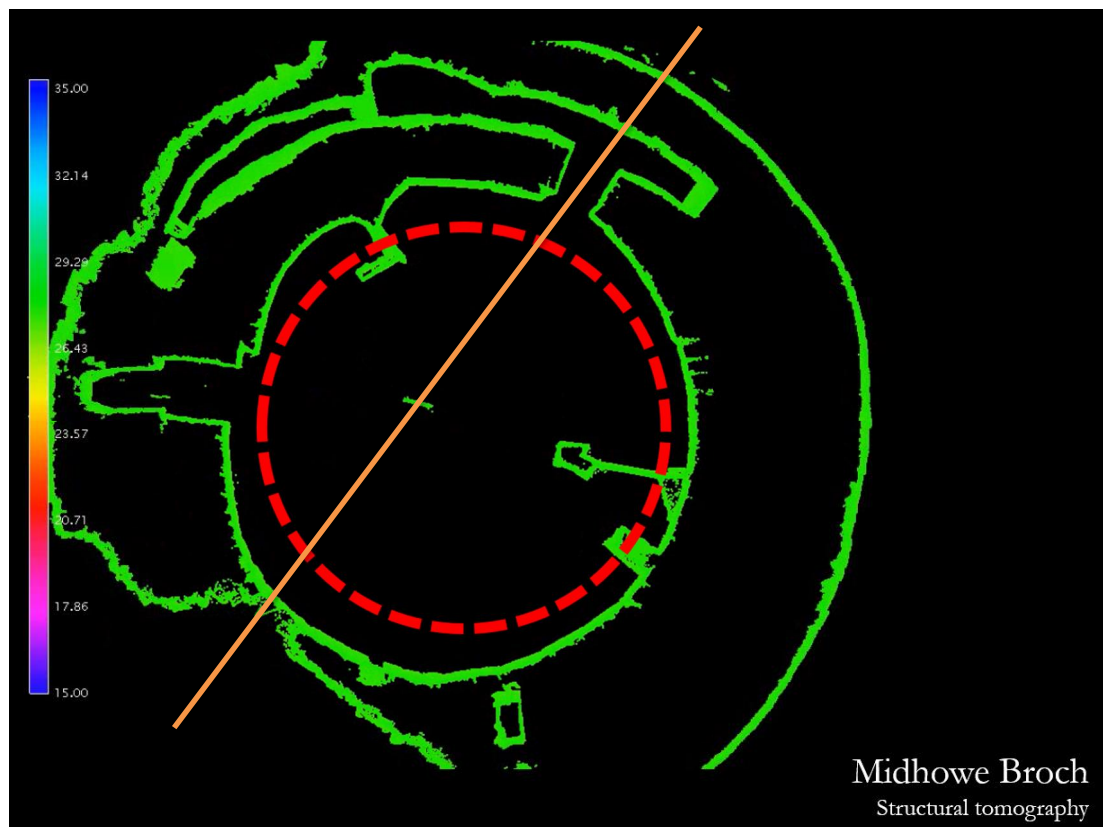
**Figure 104** This image comes from the tomographic analysis of the structure and represents a horizontal segment of the structure some 2 m above the central solum. The green lines trace structural margins and the red broken-line marks the relative position of the wallfoot. The diagonal line is the axis of maximum distortion by out-throw.

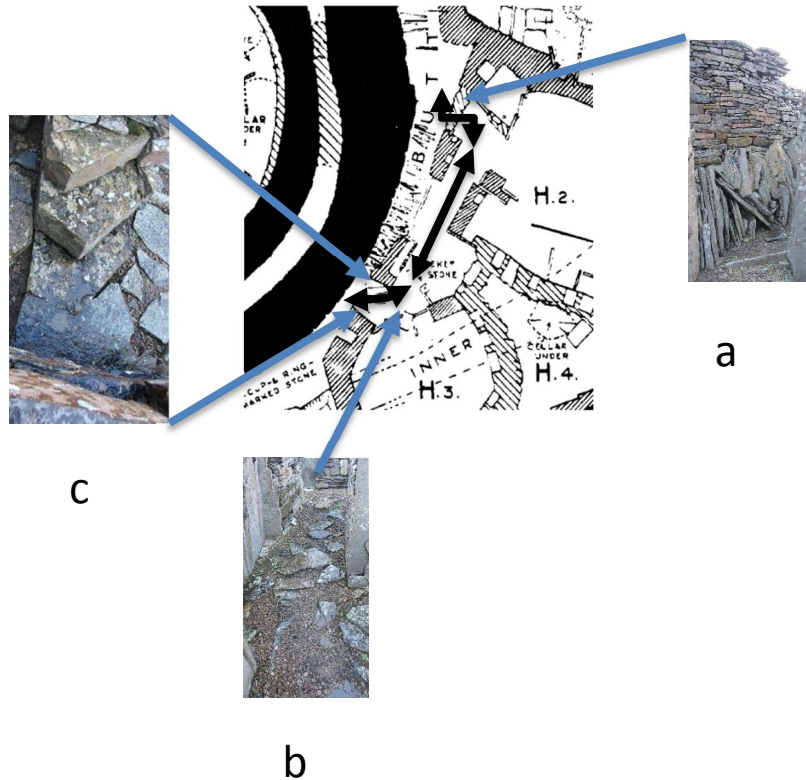
**Figure 107** Circulation along the passage bordering the broch's outer wallface was blocked by the insertion of the stacked slabs (a) requiring the formation of a 'corridor' within structures H2 to H4 (b) and the breaking out to wallfoot level of an exit at (c); all undertaken to form the new circulatory path indicated by the black arrows.

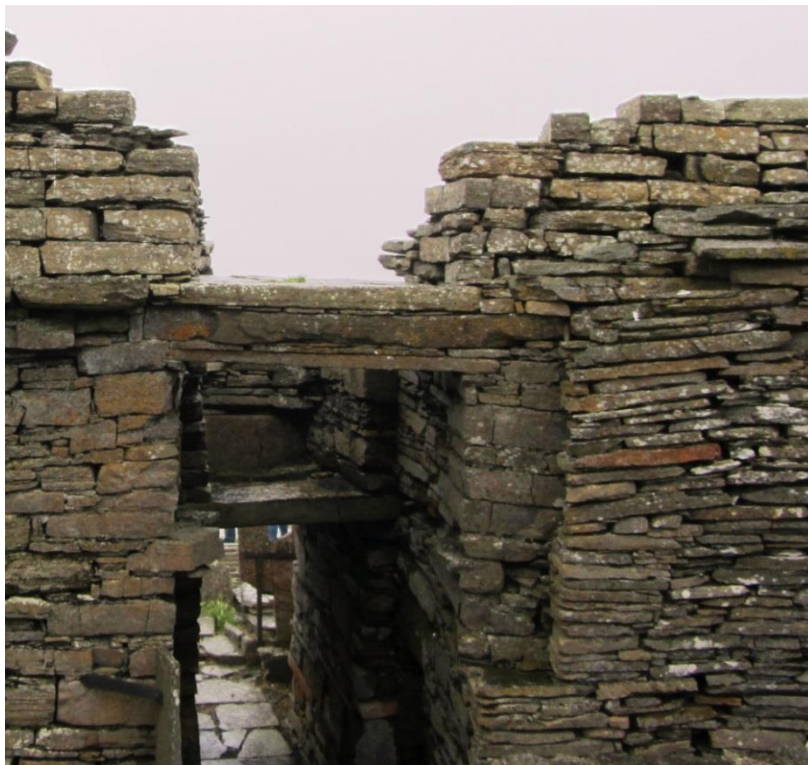
**Figure 108** View of the entrance passage from inside the broch.

The entrance passage was originally lintelled along its full length at about 1.9 m above solum, but the innermost lintels have been slapped out at some stage leaving tuskings (projecting stumps) on one side and gaps with broken stumps on the other (Figure 108). The three outermost lintels formed a composite beam to carry the mass of the outer wallface and were either massive (the first one) or set on edge (the inner two). This and the thin slabs of the rest of the lintel table are illustrated in the excavation report, from which Figure 109 is an extract. This also illustrates the upper lintel table, level with the top of the triple-decker stone beam. However, it does not record the socket or the opposing tuskings of the lost lintel/s that had filled the gap between the illustrated ones and the doorjamb rebate at this higher level (compare Figure Figure 108 with Figure 109).

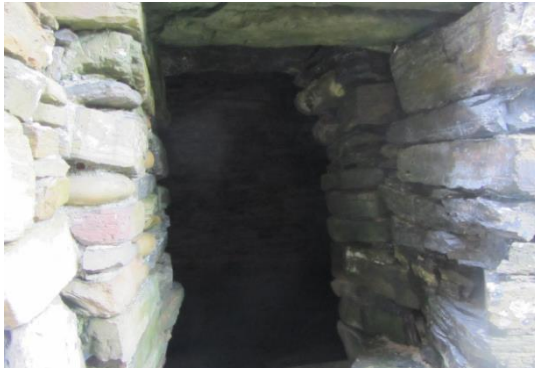
**Figure 110** The short access passage to the LHS Guardcell. Note the building join in its right hand side wall.

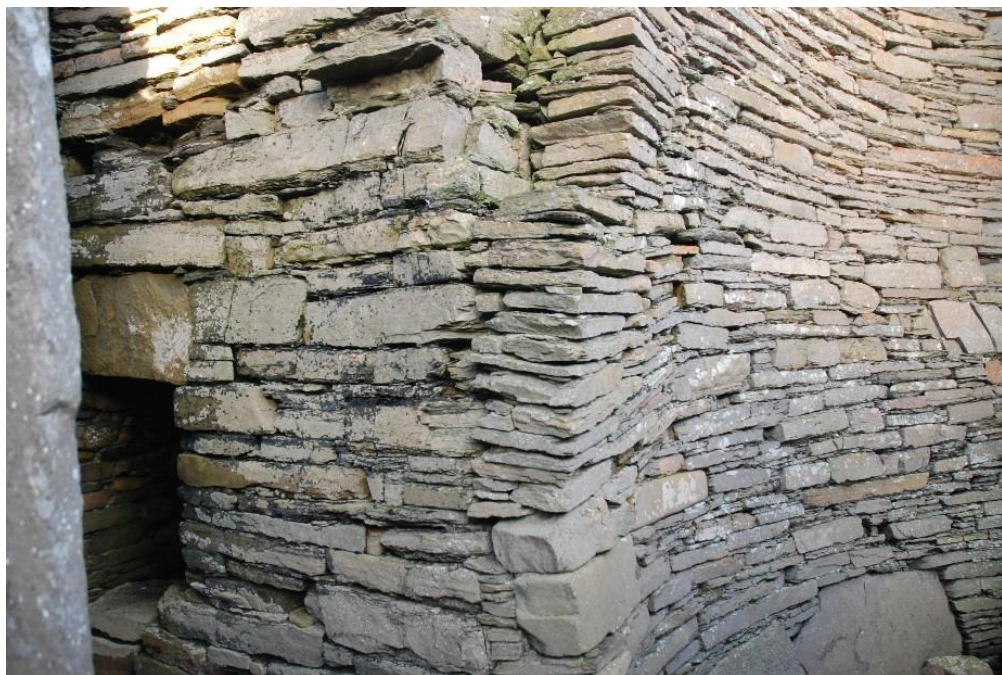
**Figure 111** The ILW at the entrance passage (LHS) The deep concavity of the wall is indicated by the sweep of the masonry lines. The stumps of the original passage lintels are visible top left of the image where the innermost lintel, now lost may have lain in a scarcement at this level. It is probable that the broch wall was substantially rebuilt above this level.

The outer edge of the LHS of the broch entrance passage, the doorjamb with its ascending rebate and the inner edge of the passage sidewall are all truly planar masonry faces. Comparison of the inner edge with the Inner Lining Wall (ILW) illustrates the point that this linearity is incompatible with the fate of the Inner Wallface, as reflected in the vertical curvature of the abutting ILW (Figure 111).

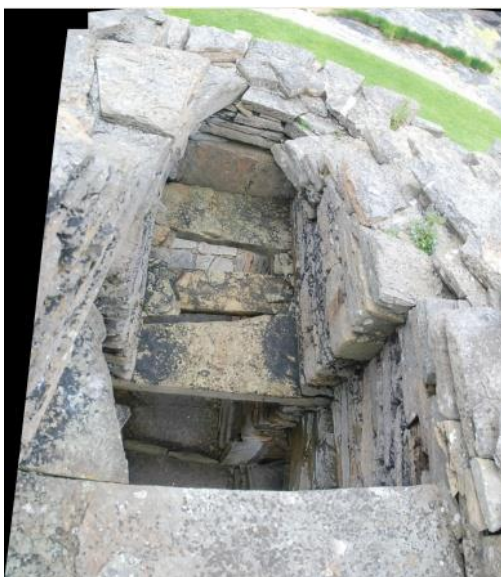
**Figure 112 The supra-entrance cell viewed from the upper lintel table; note tussing (on left) of a lost innermost upper lintel which had extended this lintel table to the line of the doorjamb.**

The differentiation of the passage lintels demonstrates the principle of strengthening the outermost for load bearing under the outer wall. The current Supra-Passage Cell (Figure 112) continues the vertical line of the passage sidewalls and it ends at the doorjamb rebate. At the outer end, the outer wallface runs over the massive first and

vertically set second and third lintels, the third lintel is visible in the photograph. Its side walls begin to corbel in over the lintels, to form the cell, which would have covered the three mid lintels and supported the mass of the core of the outer wall. Caution is required here because it is not clear how much of this arrangement was manufactured in conservation. It is unlikely that a conserving architect or mason would spuriously invent a chamber here and some comfort may be taken in the idea that the configuration has a basis in fact.

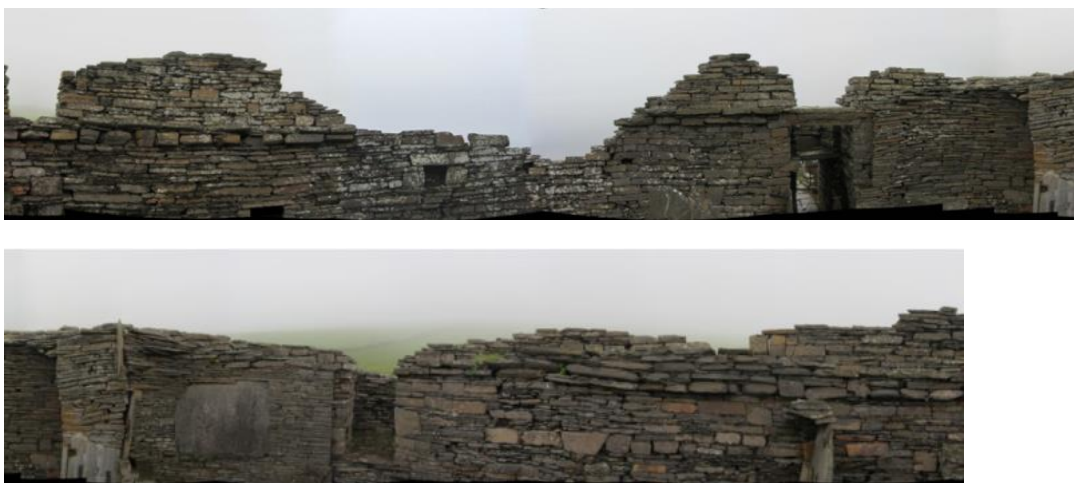
**Figure 113 The surviving scarcement. Note that these montages distort distance and proportion.**

The Scarcement is not visible behind the ILW on the other side of the entrance and it is absent between the end of the ILW and the first level stairway ope. It reappears again clockwise of the stairway ope but there is enlarged by the addition of up to 5

courses of corbels centred left of its junction with the stone packing on the septum filling the gap between it and the bottom of the scarcement (see bottom right in Figure 113). Thus, the scarcement is later than the stair ope, later than the formation of the aumbry and earlier than the local ILW. The corbelling on the scarcement had some function in common with the septum, and is thus, functionally coeval with the septum for a period, but the scarcement may predate the septum.

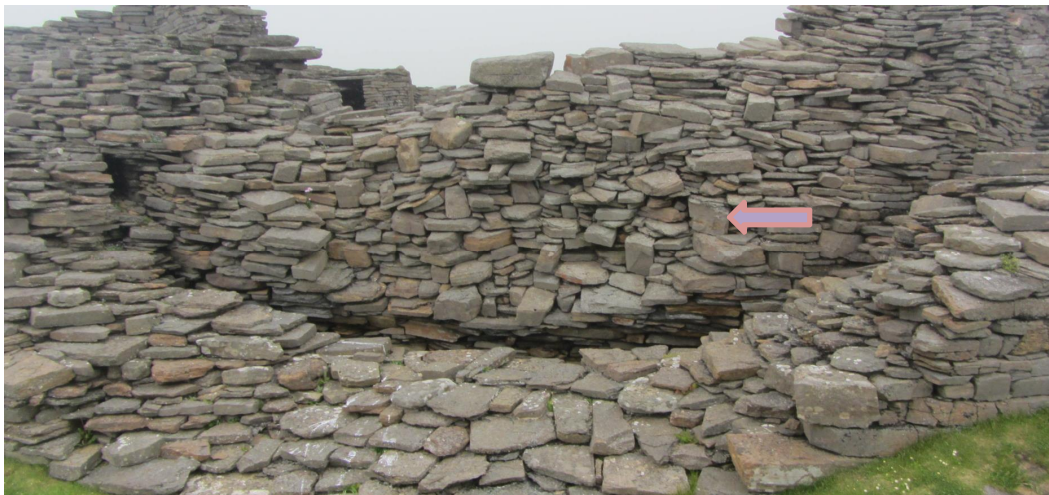
**Figure 114** The breach of the south wall. The apparently vertically set stones, like the one indicated, have their horizontal bedding-planes set in the horizontal building plane and their 30o/60o cleavage-planes in the vertical, the better to resist compressive forces.

apparently edge-set blocky stones may have been thus positioned so that the parallel bedding-plane faces are in the horizontal plane, thus the stone indicated in (Figure 114) has its  $60^\circ/30^\circ$  cleavage planes set vertically. This arrangement maximises the

stone's ability to resist compressive forces and the consistent placement of stones in this fashion indicates a conscious, rational appreciation of the best use of materials in the novel tower structure. Of course, this assumes that the exposed face is not a

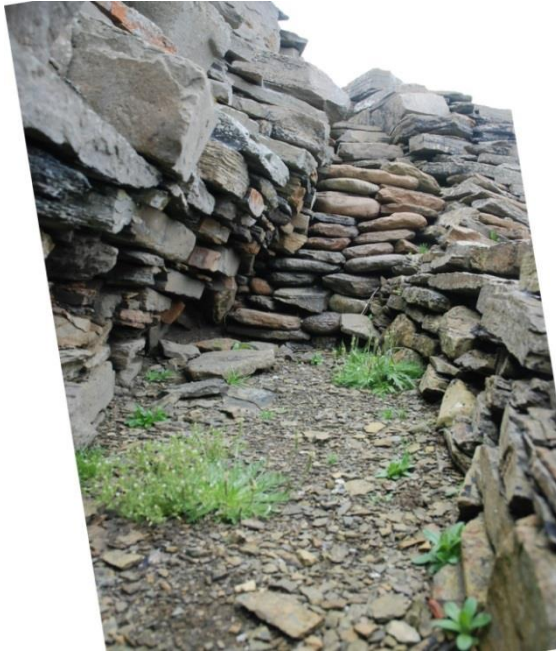
**Figure 115 View along the exposed gallery foot in the south breach**

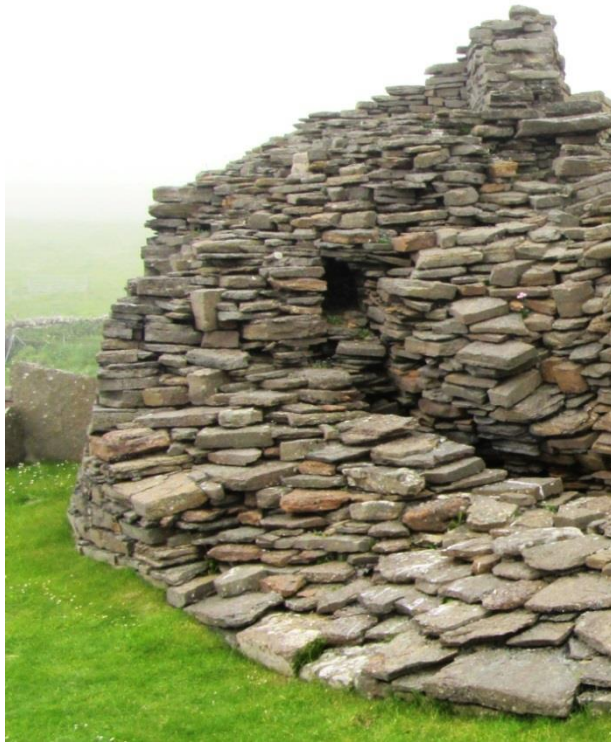
**Figure 116 (left)** The West end of the breach in the outer wall. Note how the entrance masonry, visible top left, is horizontally set above the tilted masonry of the edges of the breach in the wall

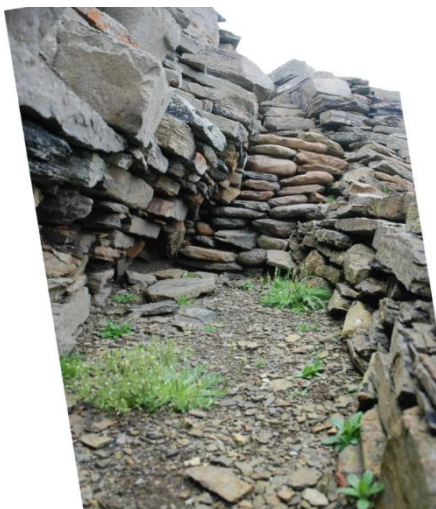
**Figure 117** View along gallery floor towards the south end of the outer wall breach

The neatly stacked arrangement of stones within the gallery void near the top of Figure 117 is assumed to be an artefact of conservation. The stair steps formed near its top seem aligned on the upper gallery and are contained between the built wallfaces, not keyed in. They rise anticlockwise to the monument, uniquely in the broch *oeuvre*.

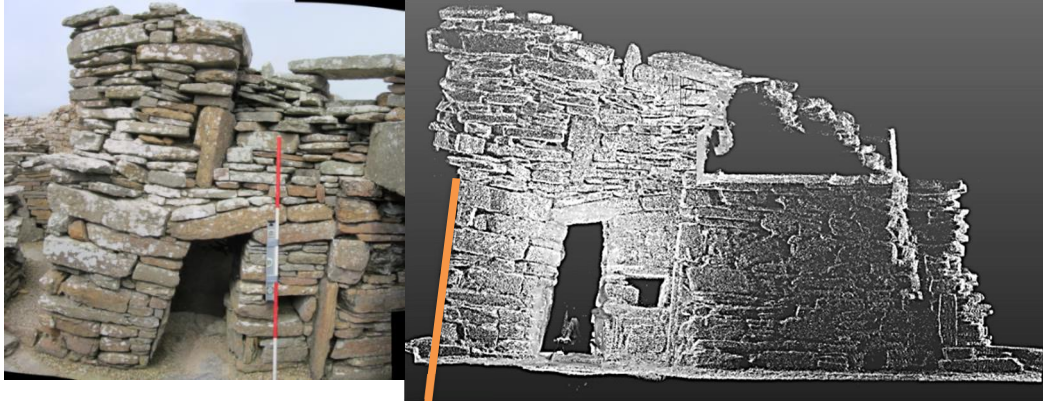
**Figure 122** The photographic panorama of the entrance area of the broch (left) exaggerates some of its proportions, but the laser scan (right) is metrically precise.

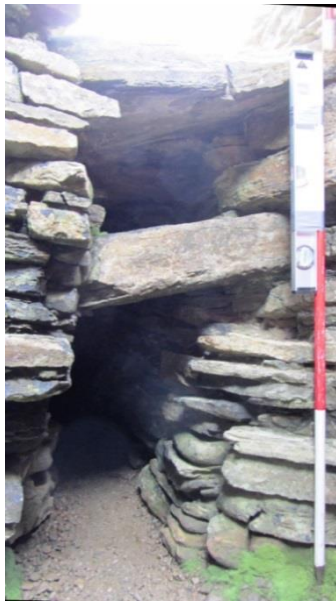
**Figure 125 (left) Entrance from the RHS Guardcell to the ground gallery and an overlying void apparently interpreted as a gallery by both Hedges and MacKie.**

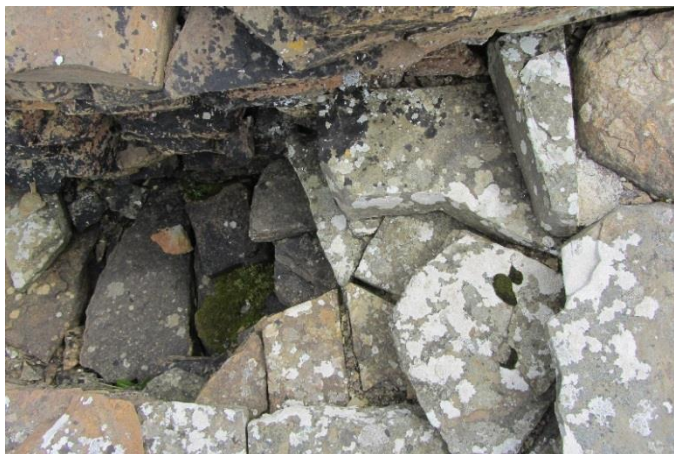
**Figure 124 Slab-on-slab secondary paving inserted between gallery walls.**

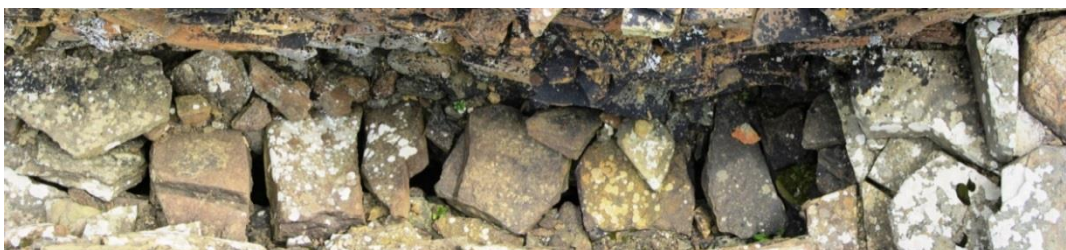
**Figure 123 (above) Original roof lintels of the ground gallery, many broken and displaced, under levelling deposit of slabs and upper slab pavement (on far right).**

Beneath this slab-on-slab foundation for the current surface paving, cruder structural lintels can be seen, under debris. These lintels are embedded in the gallery walls and once formed the roof of the ground gallery (Figure 123). They are now crushed, broken and displaced, presumably by the forces that deformed the lower broch wall throughout.

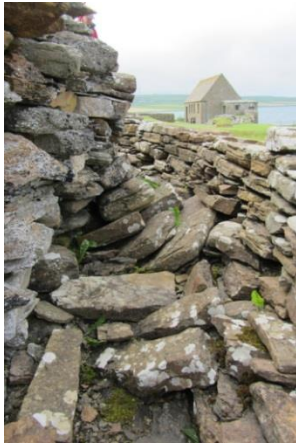
**Figure 127 (left) Gallery void south of the high wall cell with slabs fallen from the RHS now pinned under the outward bulge of the inner wallface.**

The gallery walls are clearly visible beyond the 1 o'clock, high level cell and there the gallery is choked with slabs (Figure 127) lying in the disposition characteristic of a fallen wall, as demonstrated by the writer's experimental work at Spittal, in

Caithness (Figure 126). They have fallen from the outer wallhead into this gallery space and have not been disturbed thereafter, possibly because the outward bulge of the inner wall has trapped them in place (Figure 127).

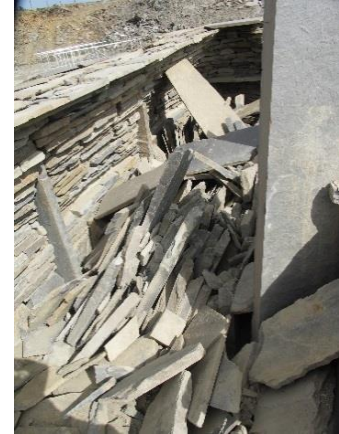
**Figure 126 (right) Cascade of corbel slabs experimentally built and forced into failure at Spittal Quarry experimental centre 2006**

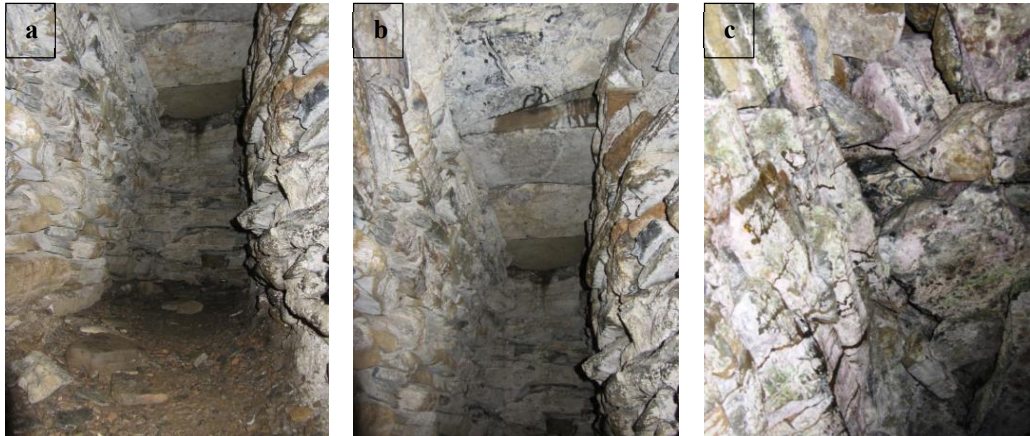
**Figure 129 a, b and c** The anticlockwise end of the LHS ground gallery at its blocking at 9 o'clock (a). Here its roof lintels are intact (b) but closer to the guardcell, the roofing lintels have failed and chaotic structural debris has bridged the gap (c)

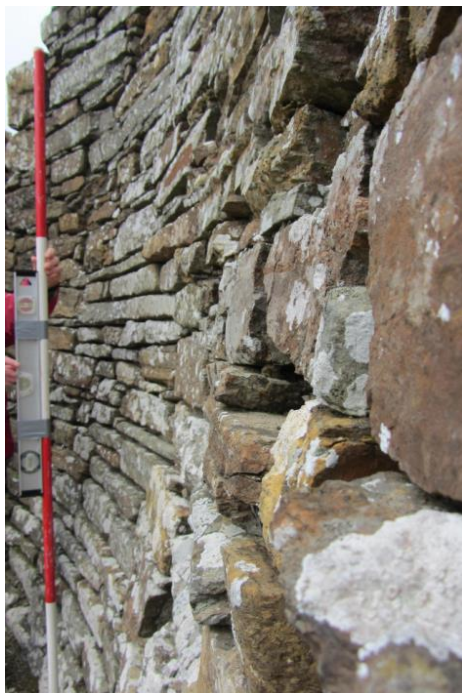
**Figure 128 (left):** The profile of the Inner Wallface adjacent to and below the 1 o'clock high cell. The ranging rod is vertical.

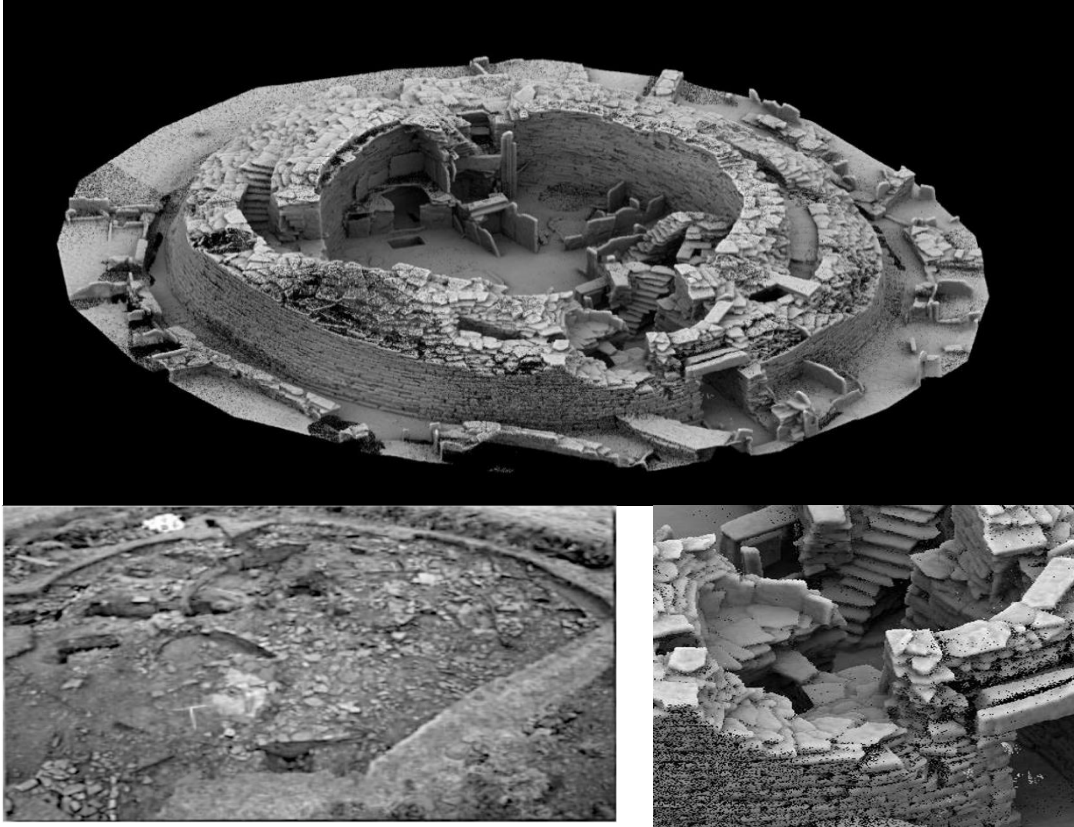
**Figure 131** The end-cell of a cellular structure can be seen above and left of the entrance lintel, cut into the wallhead (upper image). The in situ side slabs of the cell can be seen (bottom right) and the scar left in the broch masonry by its adjacent LHS side cell. In the bottom left frame, Excavations at ‘The Cairns, South Ronaldsay, Orkney, revealed cellular and circular buildings in the foreground, overlying the infilled remains of a broch (bottom left) thought to be 4th century AD. The rectilinear house forms (top right) are Norse and date to the 12th century (this image © Martin Carruthers, UHI).

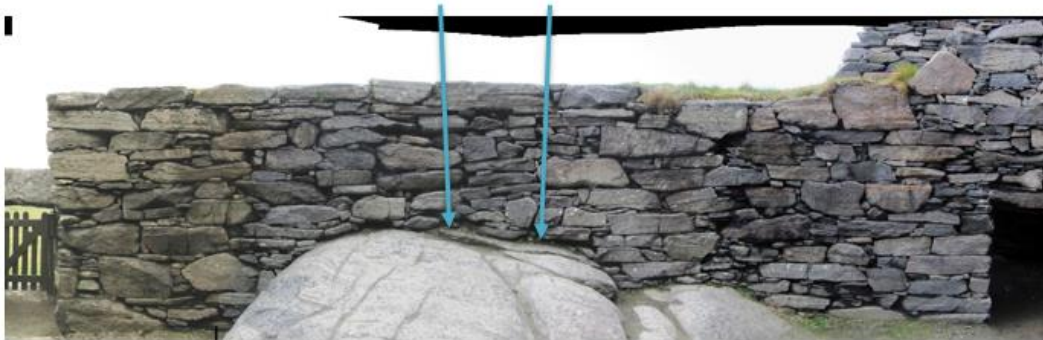
**Figure 134** Inner wallface elevation panorama (2a) with detail of possible cell entrance at the 7-8 o'clock position (2b).

At the time the Inventory report was compiled, the entrance to the 9 o'clock cell was blocked with rubble and another area of rubble on the north of the garth, above the exposed bedrock, was believed to house an additional entrance (Figure 134). The

inventory plan suggests both of these entrances accessing a single gallery. The 9 o'clock cell and its entrance have now been exposed and the cell interior has been excavated (Tabraham 1977) but no entrance to the northwards limb of the chamber has been discovered. The low level wallface is illustrated in Figure 134, and just right of the high point of the bedrock outcrop, the masonry between the two arrows does suggest that an erstwhile opening has been sealed off<sup>151</sup>.

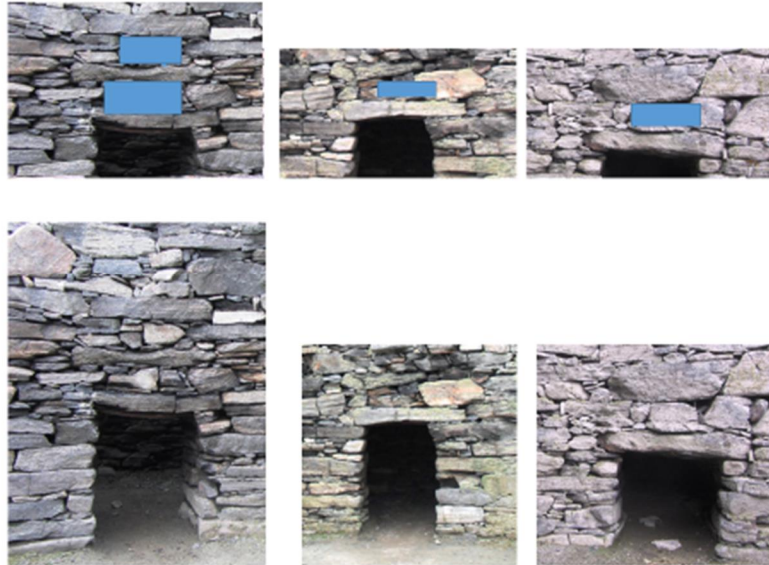
**Figure 135 (above)** Sealed voids of relieving structures over cell entrances: the blue rectangles mark the void locations in the thumbnails above the main images.

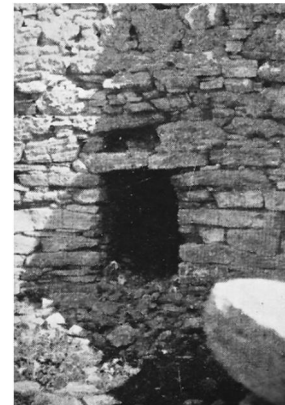
**Figure 136 (right)** Extract from the RCAHMS 1928 record (their pPlate 50) of which the 2015 view is central above.

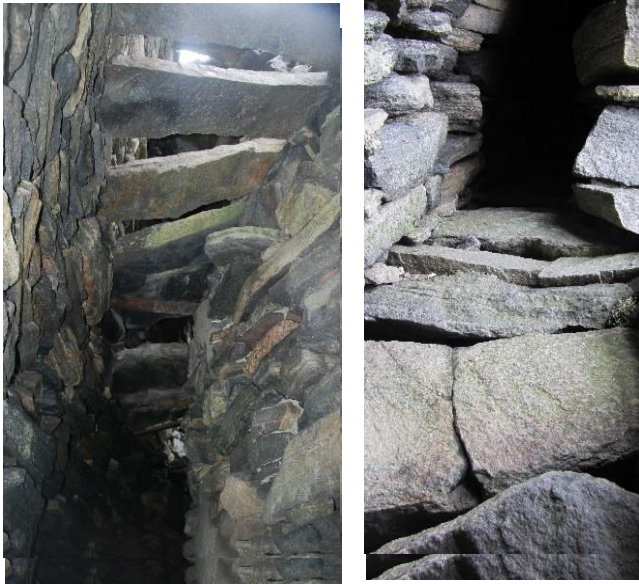
**Figure 137 a (far left) The broken and displaced lintels of the third level. Their displacement and the buckling visible in 137 b (left) confirms that the intramural void is now narrower than it originally was. These indications suggest that the outer wall has also slipped downwards and inwards and moved slightly, anti-clockwise relative to the inner wall.**

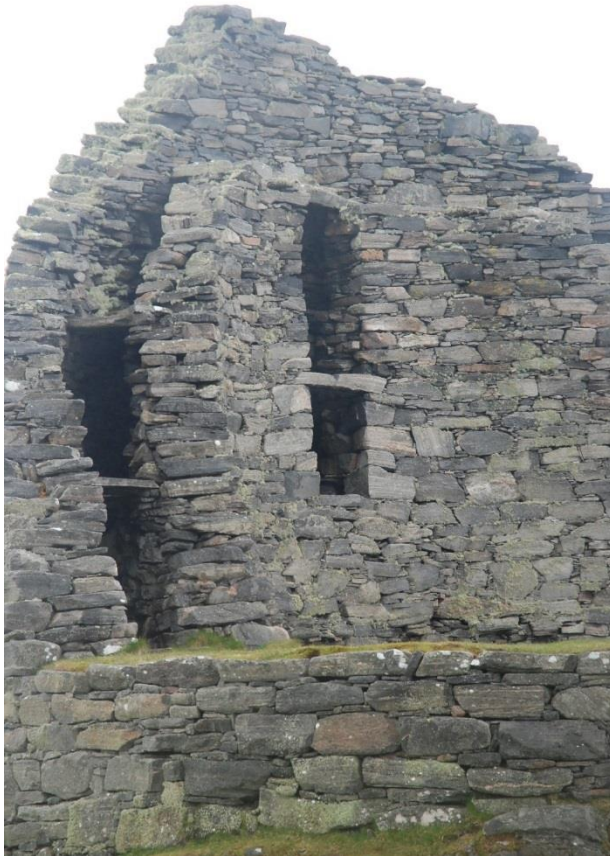
**Figure 138** The edges of the inner wall curve inwards to produce a conch-like form, a consequence of the failure of its surrounding wall, which pulled the remaining edges with it as it fell.

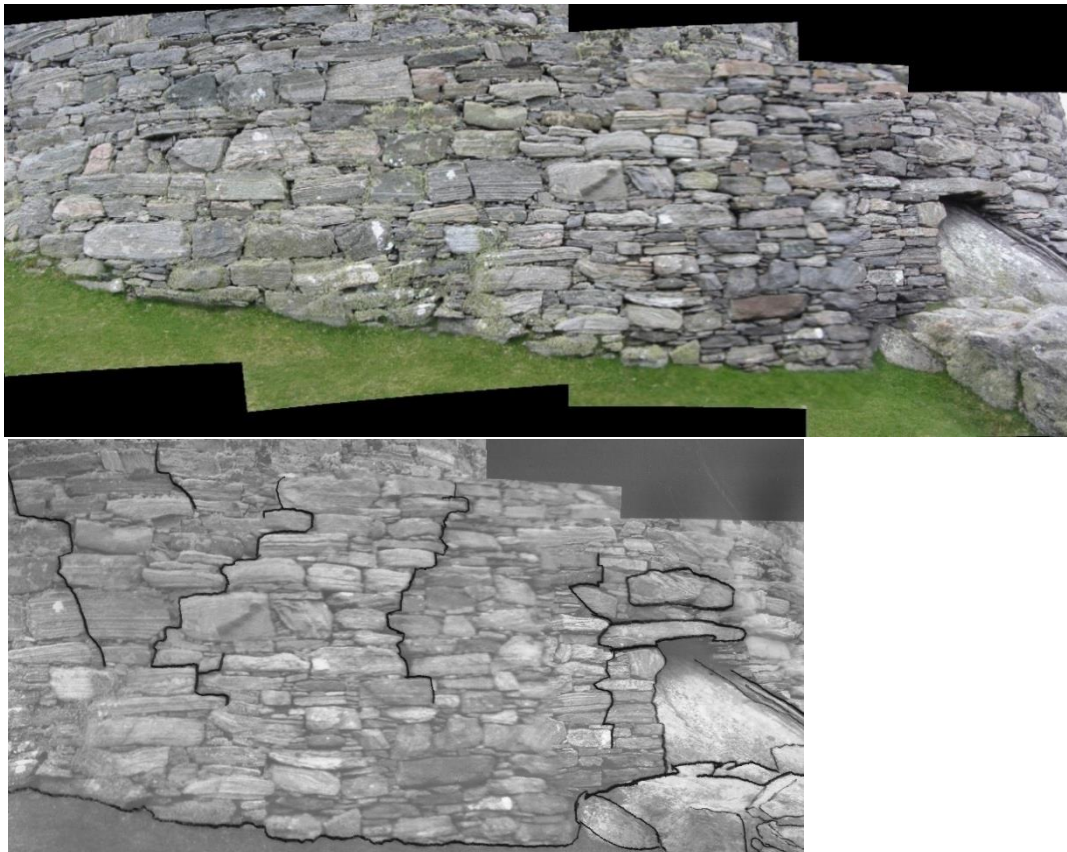
**Figure 139 (above) The outer wallface of Dun Carloway on the southwest side (entrance just off the image to the left). A proliferation of fabric replacements is visible above and left of the bridging slabs over the bedrock. (below) A field sketch shows divisions between apparently different masonry masses**

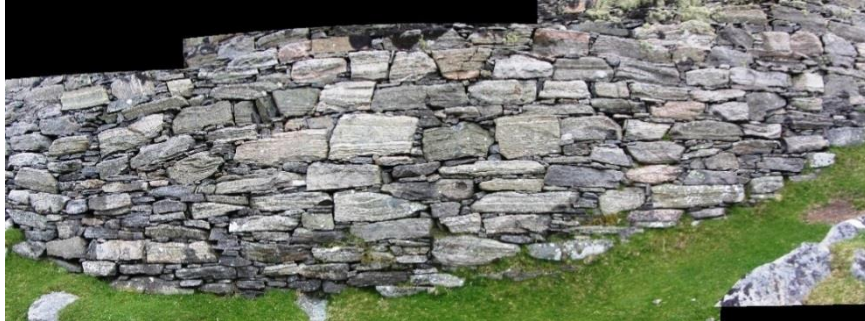
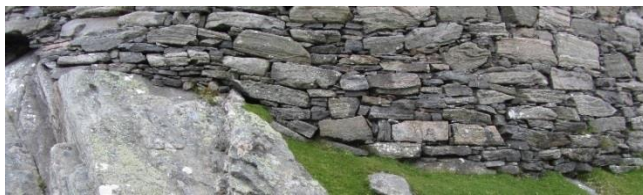
Figure 140 a (top) & b (upper middle) Wallface masonry right of the bridged bedrock.  
Figure 140 c (lower middle) & 140 d (bottom) Field sketches illustrate the main apparent discontinuities in the wallface on the southeast of the monument.

The broch's outer wall, overlapping the edge of the knoll, was apparently built onto a challenging foundation (Figure 133) being, in the southwest quadrant built directly onto sloping bedrock (Figure 140 & Figure 140). Failures in the masonry on this side

Pinnings in unmodified brochs invariably lie between adjacent building stones and do not extend between courses. Examples in the Carloway wallfaces (dark patches in Figure 140) that span courses may be identified as modern 'window dressing'

Masonry discontinuities have been observed also on either side of the bedrock exposures just south of east under the outer wall (see Figure 139 & Figure 140).
