# **Approaching the mind of the builder**

**Analysis of the physical, structural and social constraints on  
the construction of the broch towers of Iron Age Scotland**

**John Barber**

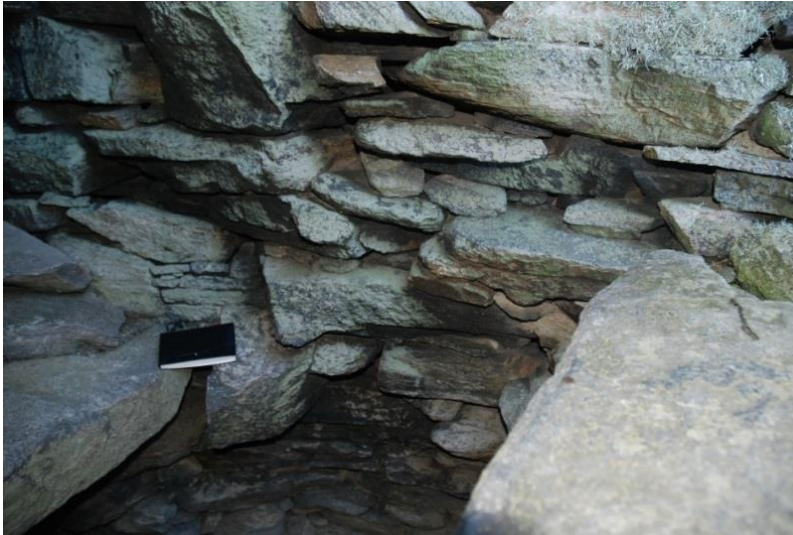
**Figure 141 (left) Tusings from broken lintels of the 3 o'clock cell.  
The lintel visible bottom right is a new insertion.**

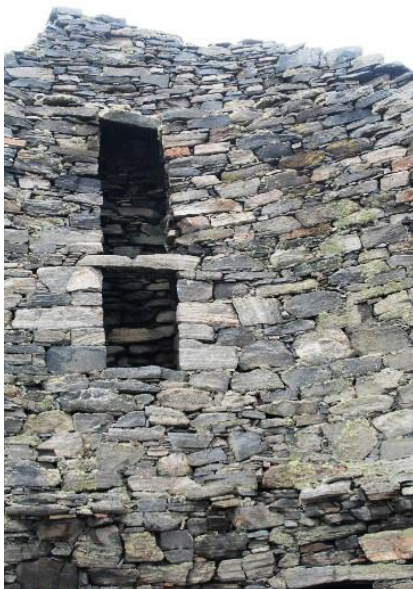
**Figure 143 The relict stacked void fragment above the scarcement at Dun Carloway.**

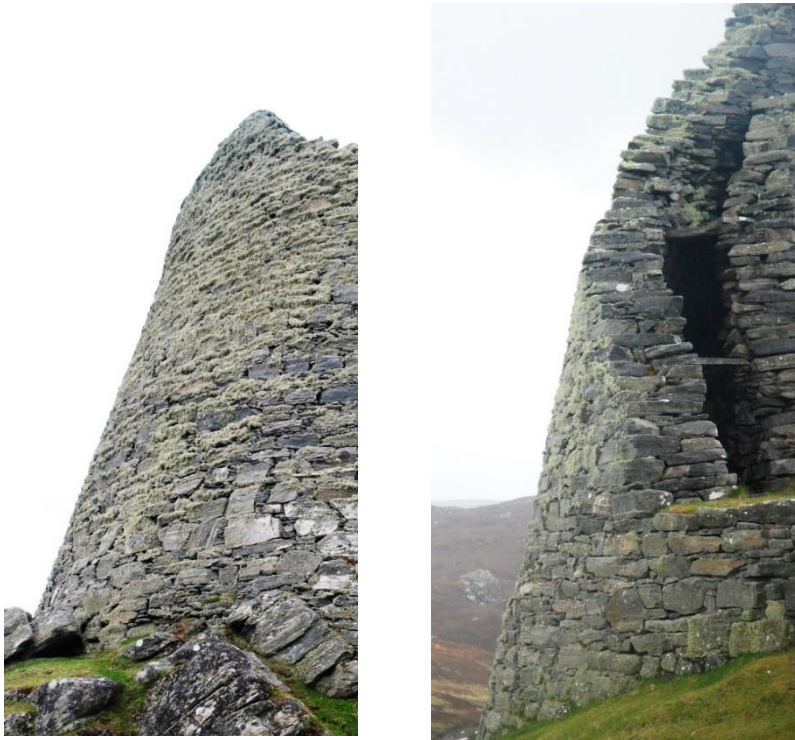
**Figure 144**  
Comparison of outer wallface profile outwith the stacked void (left) with that at right angles to it (right). The former is kinked and faceted, the latter linear (in the vertical plane) and smoothly curved (in the horizontal).

The inward displacement of the outer wall can be appreciated by comparing the outer wallface profile outwith the stacked void with that at roughly right angles to it (Figure 144). The former is kinked, inwards then outwards as it rises while the latter is a smooth conical surface throughout. The RCAHMS 1928 survey represents this position (Figure 133) quite clearly. The outer wallface, seen in the profile view, bends inwards close to the top of the second level gallery and recurves outwards, at least in its highest parts (projected onto the survey plane). In addition, the inner wallface tilts inwards from about the same level.

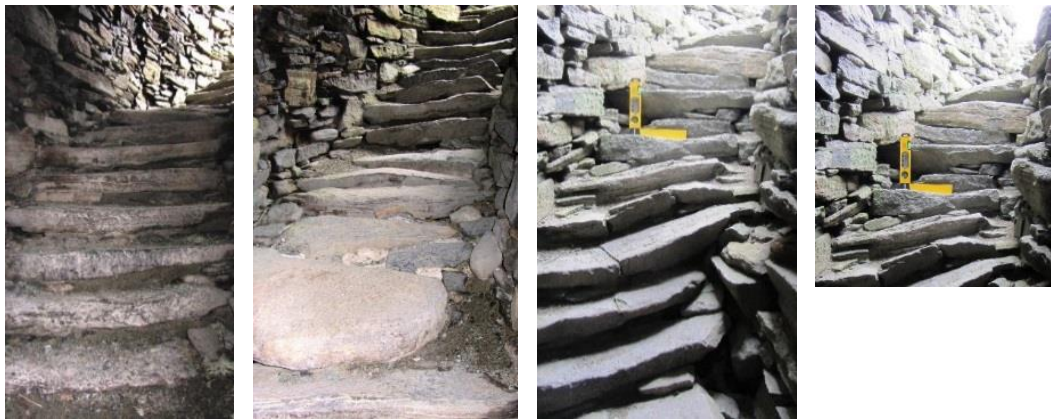
**Figure 145 a, b, c and d; left to right. The intermural stairway in Dun Carloway.**

illustrated in Figure 145 a to d): the lower 7 steps (Figure 145 a); an apparent landing comprising 5 approximately level slabs Figure 145 b); a set of 9 steeply dipping and broken steps terminating at a build up to a higher level (Figure 145c); an upper set of

4 approximately horizontal slab steps completing the stairway (Figure 145 d). Stairways, in RSM tectonics, were designed to articulate between the ground level and the first two gallery floors (G/1 and 1/2). In the surviving section of the Dun Carloway wall, these two lintel levels are clearly visible (Figure 146), as are another two higher levels, albeit less clearly because less accessible, and more disturbed (above). These were the gallery floors, and in the text that follows, are contracted to (GF G/1), (GF 1/2), (GF 2/3) to represent between ground and first galleries, or first and second, or second and third, and so on.

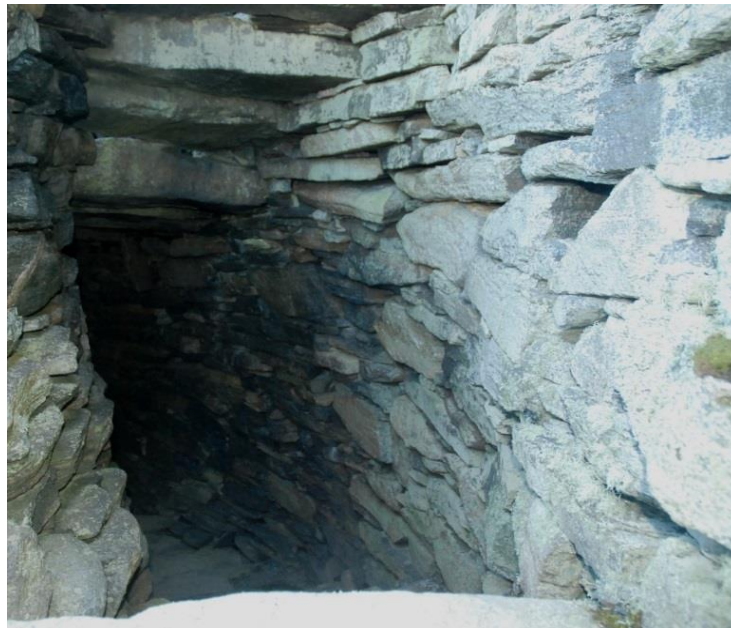
**Figure 146 A view down the composite stairway with the stepped risers visible at the top of the image.**

over the 3 o'clock cell, at 1570 mm does not correspond closely with either of the first two gallery floor levels, but flagged over might match the lower. The plane of a gallery floor is just visible beneath the stepped risers in Figure 146. These risers

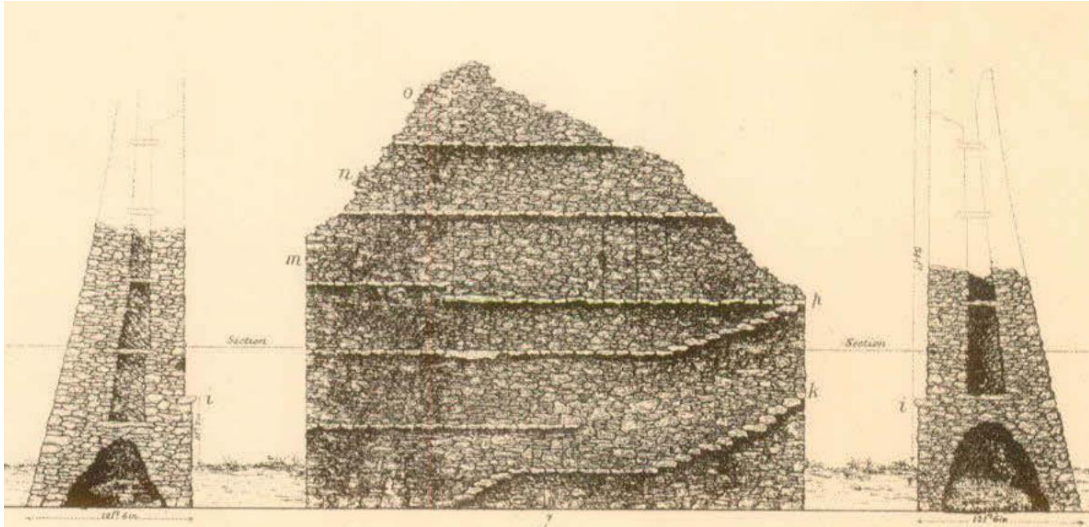
**Figure 147 Vertical and circumferential sections through Dun Carloway, from a survey by Captain Thomas published in 1890.**

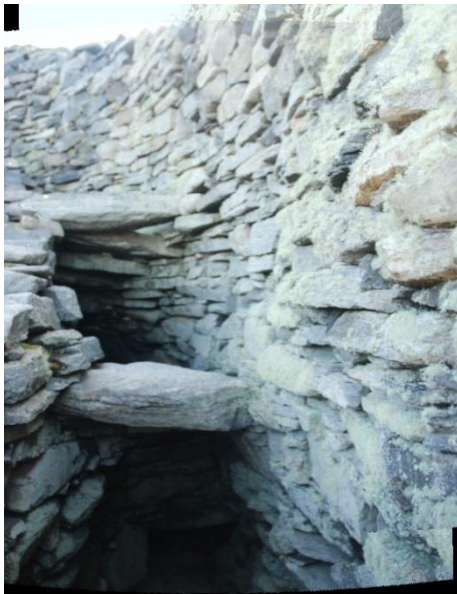
**Figure 148 (far left): The highest cross void lintels are the floor of the 1/2 gallery. The highest stepped riser lies just below centre (in the far left image) and is aligned with its depiction in the left image. A poorly built transverse wallface can be seen below the risers. It rests on a lintel over the sub-stair void. Just above the bottom of the image, a capstone of the ‘tail’ of the 3 o’clock cell accesses a crawlway that apparently ran to the back of the stairfoot (Figure 133).**

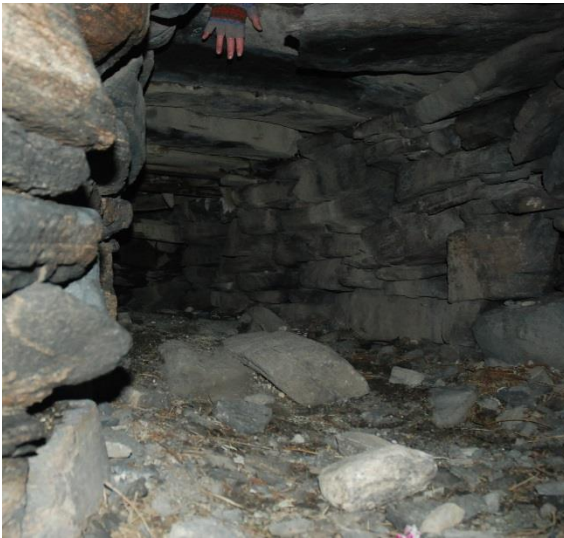
**Figure 149** A view along the intramural void entered from beneath the blocking wallface. The hand visible top left has been inserted from the landing element of the stairway.

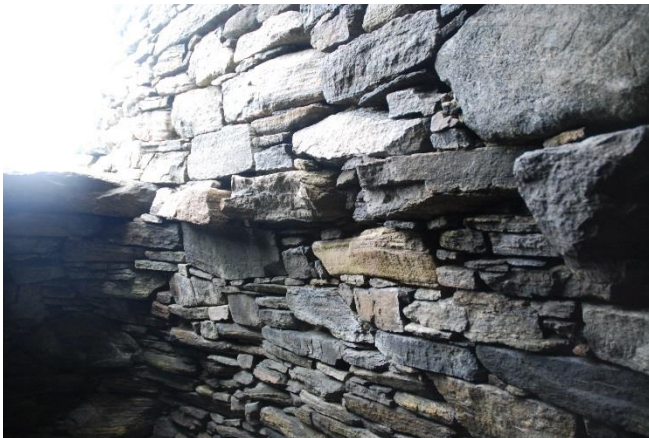
**Figure 150 (left) The stumps of broken roof lintels of the 9 o'clock cell visible in the inner wallface of the outer wall.**

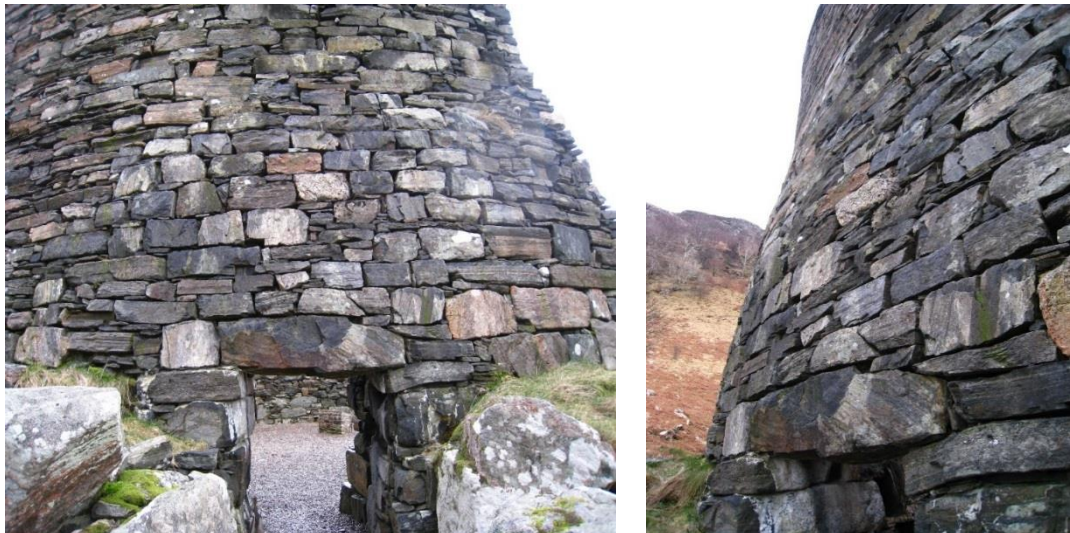
**Figure 152 a & b The bulge of restored masonry over the entrance at Dun Telve. In the frontal image the rebuilt occupies the greater part of the image area but differences are obvious between the rebuild, mainly of large squarish blocks of stone, and the original, mainly of the relatively thin flat slabs visible in the upper left and right corners of the image. Image b (right) shows the bossing of the inserted masonry, out of line with the smooth conical surface of the outer wallface behind it, as viewed here.**

MacKie claims to the contrary notwithstanding, the entrance to Dun Telve gives clear evidence of having been refashioned. A neatly built bulge of blocky stonework above the entrance extends to either side of the current outer lintel and upwards for about 12 courses; perhaps a little less than 3 m. This is clearly visible in photographs taken tangentially to the broch, but is also discernible in frontal views of the masonry (Figure 152 a & b).

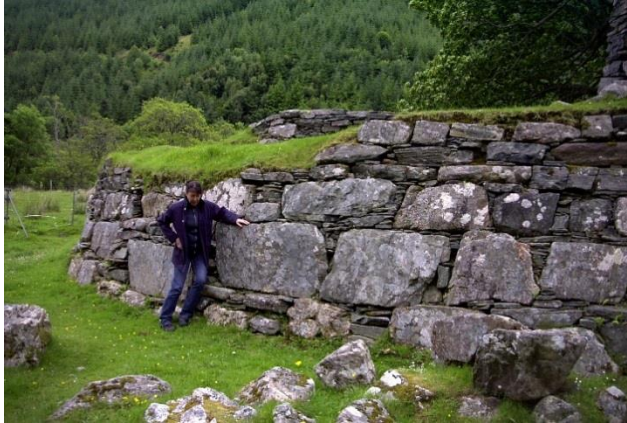
**Figure 153 The outer wallface at ground level includes many very large stone blocks and slabs.**

The build quality of the outer wallface is uniformly high, and rendered especially impressive at ground floor level by the inclusion of many very large stones,

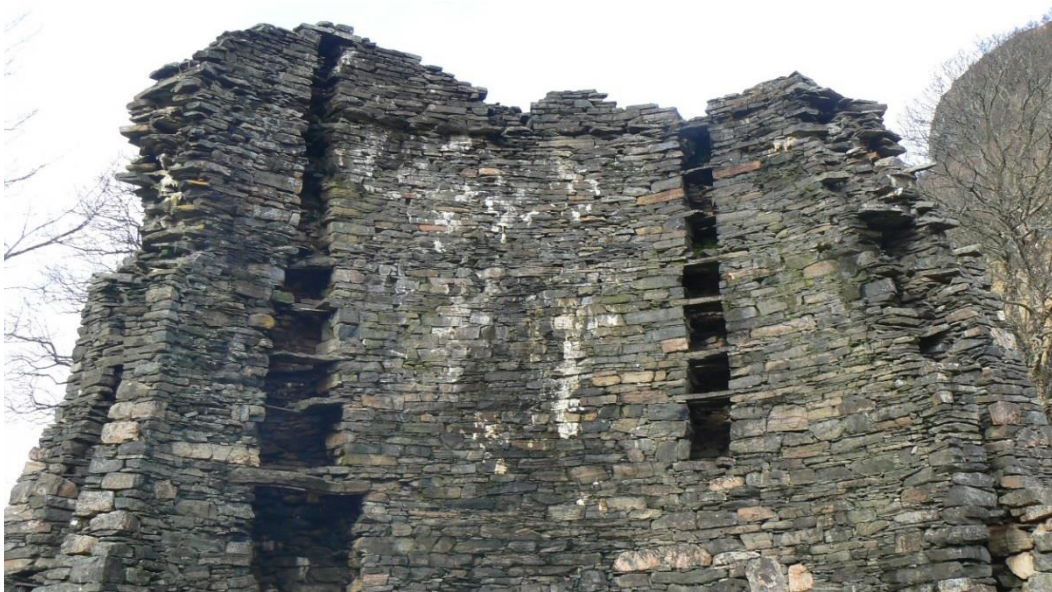
**Figure 154 The inner wallface, like the surviving outer wallface is extremely well built and has preserved in relatively good condition throughout. The quality of the build is indicative of Iron Age construction rather than overactive modern restorative conservation.**

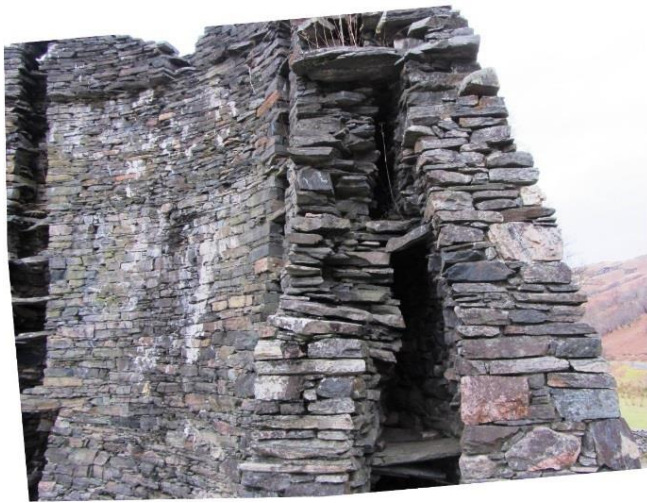
**Figure 155** A localised defect in the inner wall on the northern edge of the high masonry at Dun Telve. The squared return at the foot of the image marks the line of the edge of a stacked void (subsequently conserved), beyond which the wall fabric bulges inward, breaking and displacing lintels, above and below. The neatly squared return on the lower outer wall is wholly an artefact of conservation.

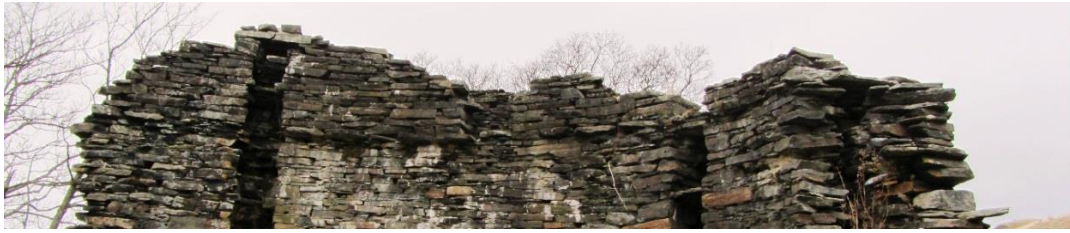
**Figure 157 The high scarcement**

The high scarcement, c. 9 m above the solum, comprises one or locally two layers of stone slabs projecting from the wallface by 300 mm an average, albeit that several are broken. Both of the surviving stacked voids rise through the upper scarcement, the over-entrance stacked void rises at least two segments higher. A further, high-level opening pierces the inner wallface about midway between the stacked voids with its threshold set at the level of the higher scarcement (Figure 157). It is possible that this ope provided access to whatever structure was formed on the high scarcement, or more correctly, access from it since there was no other structural means of accessing the wallhead.

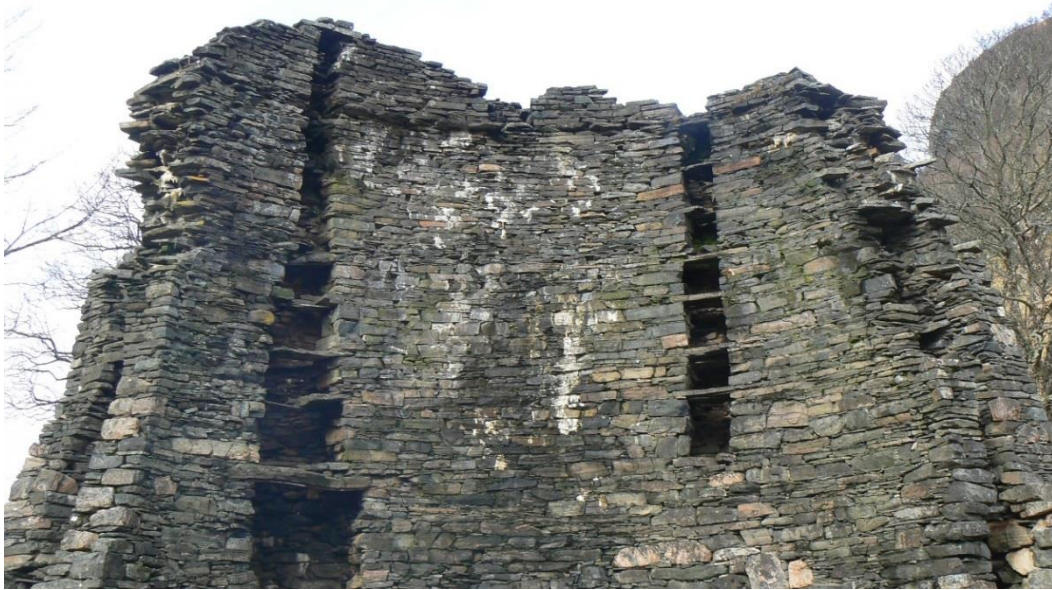
It should be noted however that the gallery floors are largely level and with very few exceptions the individual lintels are intact. There are signs of significant compression

damage in the masonry above the fifth transverse lintel in the stacked void (see

Figure 154) which is consistent with the compression arising from the inward tilt and concave curving of the surviving inner wall.

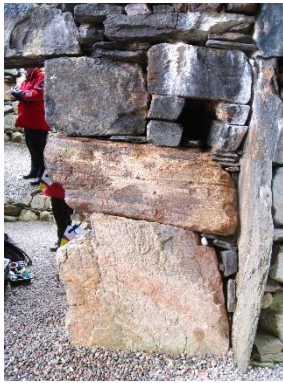
**Figure 160 (left)** The bar receiver and jambstone, adjacent to the guardcell entrance.

**Figure 160 (right)** The guardcell entrance, above the entrance lintel of which, the lintels of the guardcell roof can be seen stepping up to its full height.

Dun Telve has a single guardcell on the right hand site of the entrance passage. It is c 5.5 m long and entered via a low doorway ope from the entrance passage. In plan, the cell is somewhat lobate and although the innermost end is corbelled, the cell was roofed with lintels. The stepped lintels of the outer end and entrance passage of the guardcell can be seen in the intramural void above the cell from within the broch entrance passage (Figure 160)<sup>160</sup>.

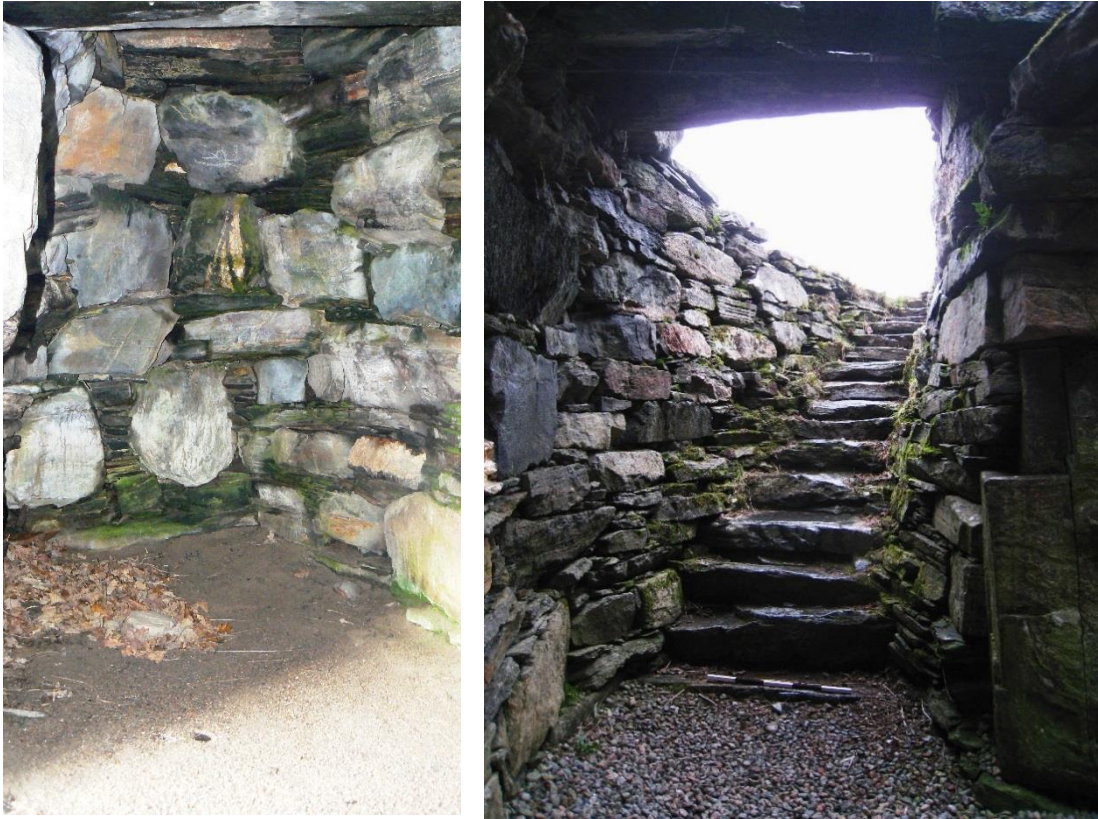
**Figure 161 a & b. Dun Telve, the stairfoot. The counter stairfoot cell (left) and the ground floor stairway (right).**

The entrance to the cell has been commented upon above for the slight remaining traces of a stacked void above the entrance. The counter-stairfoot cell (Figure 161) is well built from large square blocky stones and is lintelled over. The sidewalls of the stairway diverge as they rise but their current condition militates against this being other than a design characteristic. If the fine finish of these sidewalls has been embellished by modern conservation, it has masked any evidence, like opening of the joints, etc, for early traumatic changes.

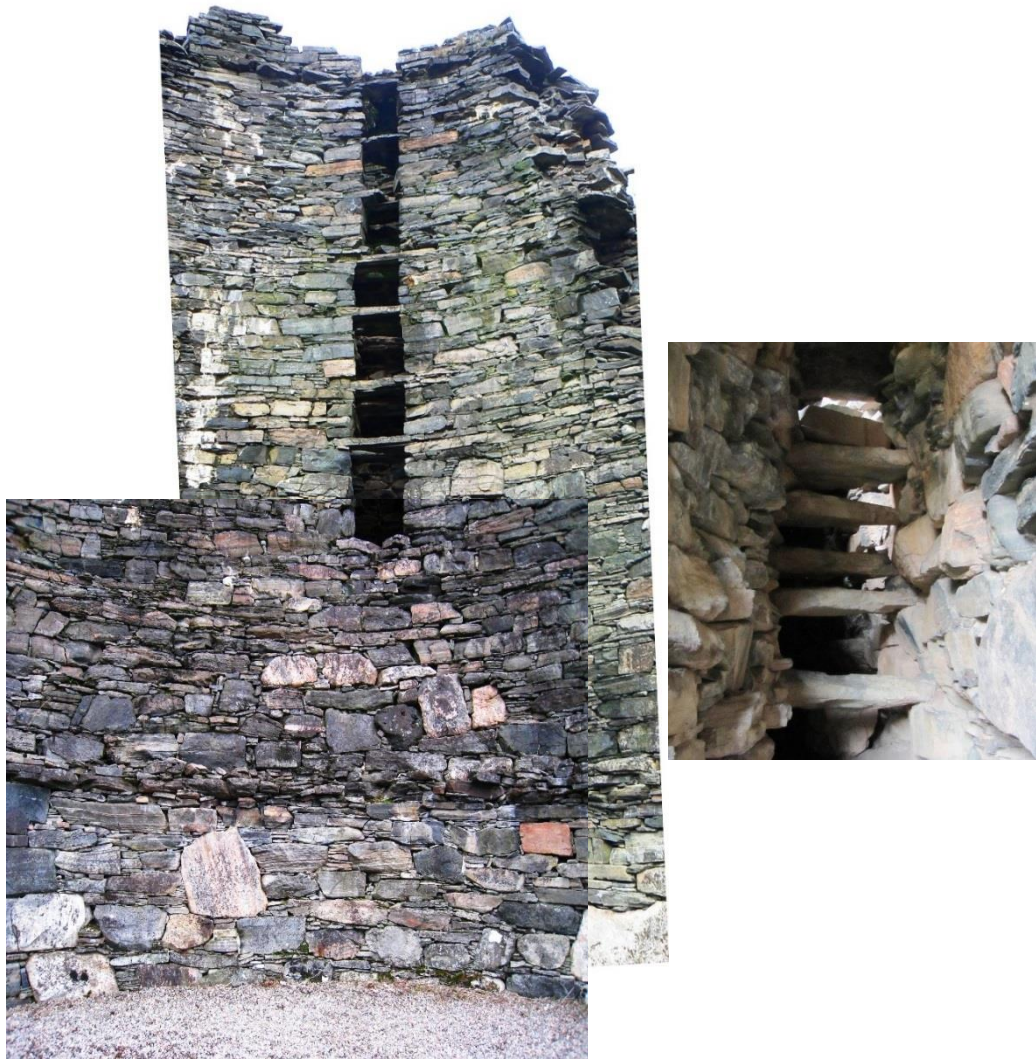
**Figure 162 a Dun Telve, (left) the stacked void at the 8 o'clock position in the inner wallface at Dun Telve. b (right) The inter-mural struts that propped the edges of the now closed-off stacked void segments below the surviving elements.**

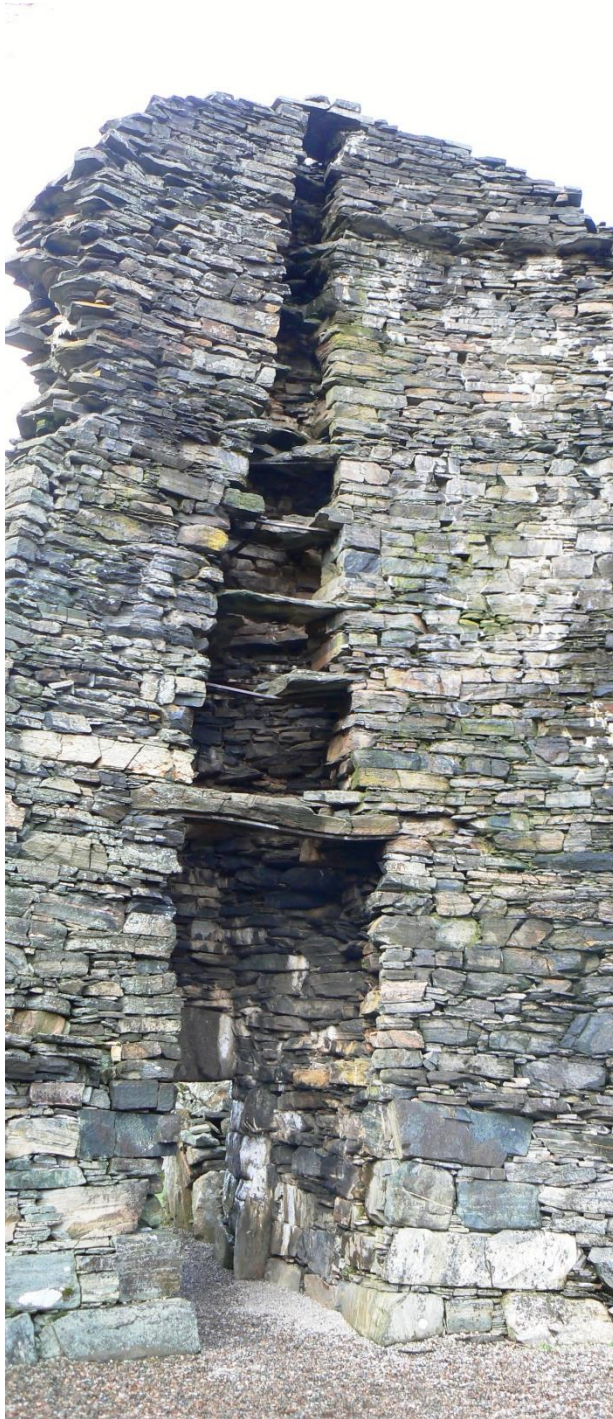
**Figure 163** The entrance stacked void (left). It is clear that several transverse struts have been lost and many of the surviving struts are broken. The image below illustrates the poor condition of many of the remaining struts in this view up through the entrance stacked void.

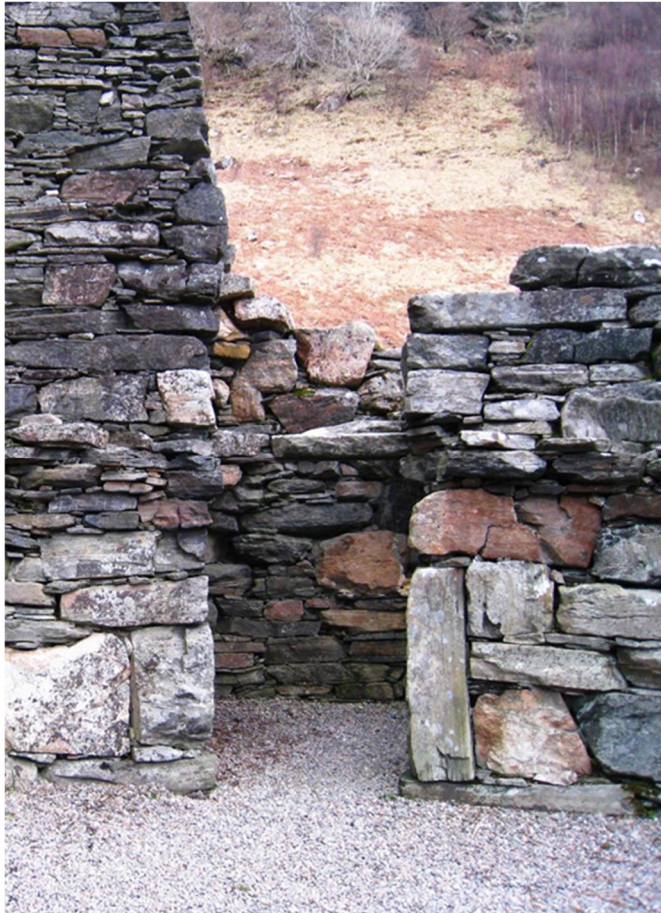
**Figure 164** The first four courses above the left hand edge of the stair entrance ope in the inner wall, on the basis of the 1916 survey, forms part of a lost stacked void return. The right hand edge seems to confirm this identification but may have been rebuilt.

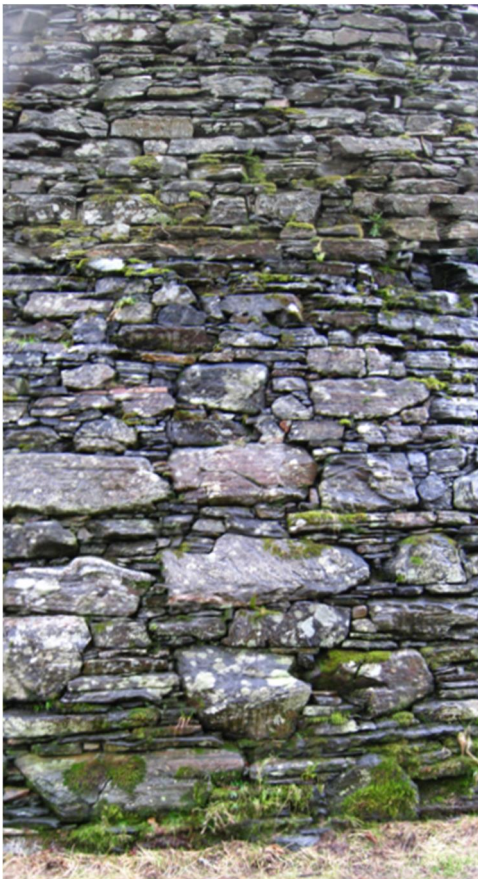
The use of larger stones closer to ground level is illustrated in Figure 166, in which can also be seen the finely fitted panels of pinnings between the main structural

stones. This image also gives evidence for the bringing-to-level of the ascending wall.

**Figure 166** This c. 4 m high section of the outer wall at the 9 o'clock position illustrates the transition from large stones ( $\approx 250 - 500$  kg in mass) at the lower level to a relatively standard smaller ( $< 25$  kg) stone size above c. 2 m high.

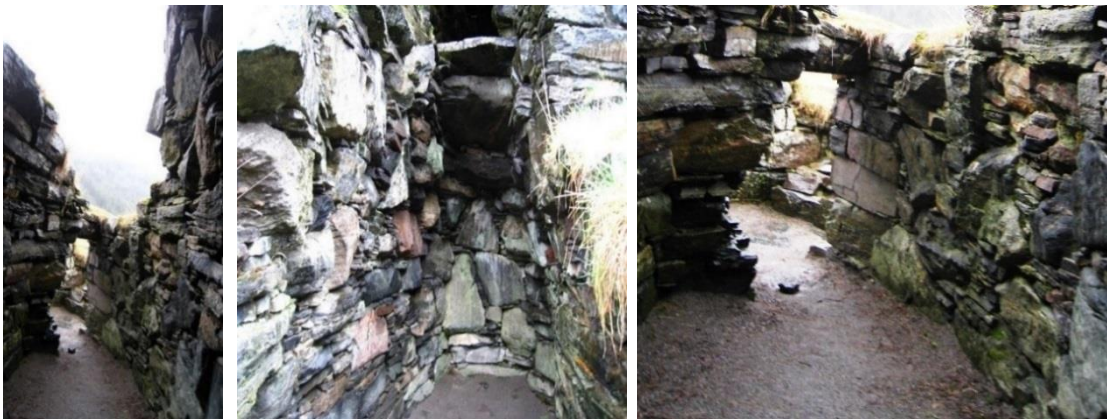
**Figure 168 a & b** The LHS guardcell, (a, left) looking towards the entrance and (b, middle) back of cell and (c right) The guardcell entrance.

The guardcell is well built, indeed rather massively built with steeply inclining sides and with lintel roofing surviving only at the rear (Figure 168 b). A clear rispain joint exists on the right, looking out from the cell, between the rather craggy masonry of the cell wall and the rectangular and blocky face of the entrance passage wall (Figure 168 c). In addition, the cell wall to the right of the image in Figure 168 b is absurdly formed, with vertically set slabs embedded in the wallface. If this is not a modern conceit of conservation, then it is further evidence of earlier failure and repair of the wall fabric at the entrance.

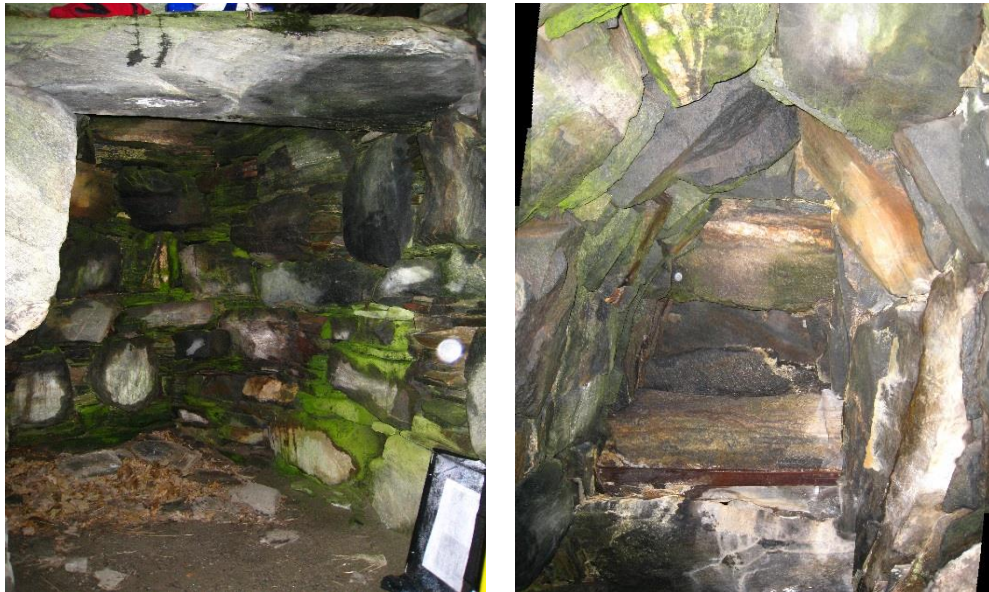
The side walls of the stairfoot cell curve inwards to form a somewhat keeled rear end which gives the impression of corbelling but it is not in fact corbelled. It is roofed with the lintels that form the floor of the gallery above (Figure 169). No credible evidence could be observed for a breach through the outer wall's inner wallface

Figure 169 the stairfoot cell, (left) viewed from the entrance and (right) its roofing.

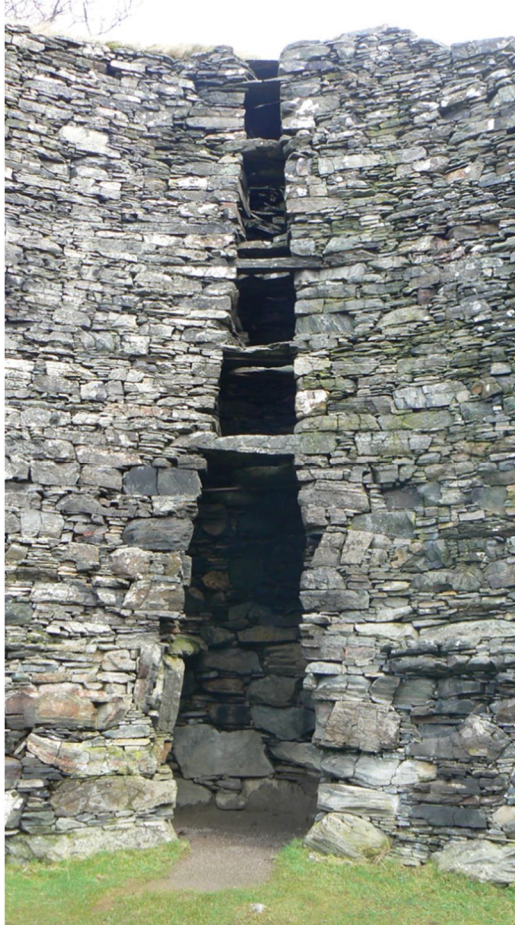
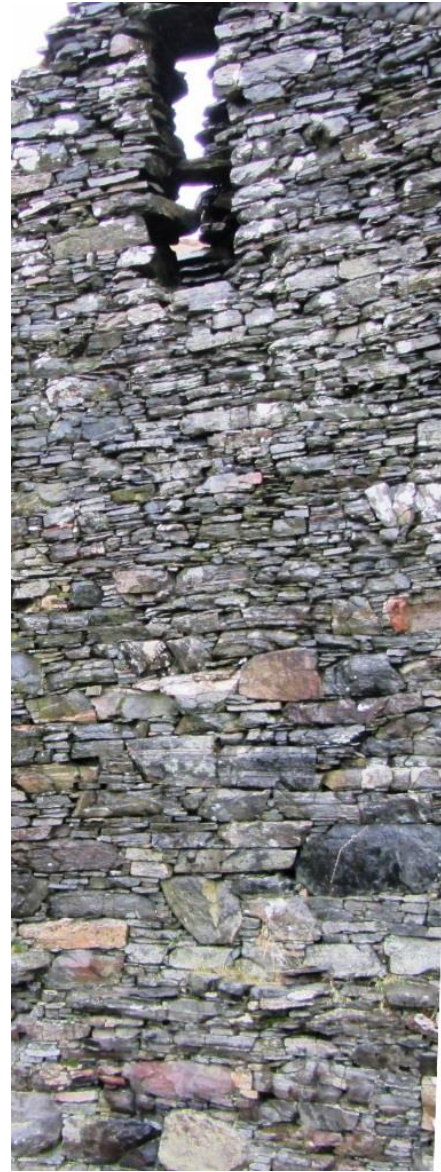
**Figure 170 a & b The stacked voids at Dun Troddan, a (above) the voids over the stair entrance and b (right) the high level stacked void and the masonry beneath it.**

The stacked void at the stairway entrance (Figure 170) is now asymmetrical in the vertical plane, its transverse struts are fragmented and some are missing, especially those at the lower level. It is obvious that it has undergone significant structural trauma which will have originated in circumferential stress in the structure. However,

it is probable that human intervention, partly in removing struts and later perhaps in conserving the stack edges, have complicated the surviving remains.

The masonry under the high stacked void is replete with large panels of pinnings many of which atypically cross building levels. The scarcement is absent from under the high void and rispain joints extend from the scarcement level to the current solum. Even accepting that much of the pinning may have been inserted in the recent past, what remains is consistent with the loss of a large area of the inner wall or, at least of its inner façade. Again, the evidence is not unequivocal and the hypothesis

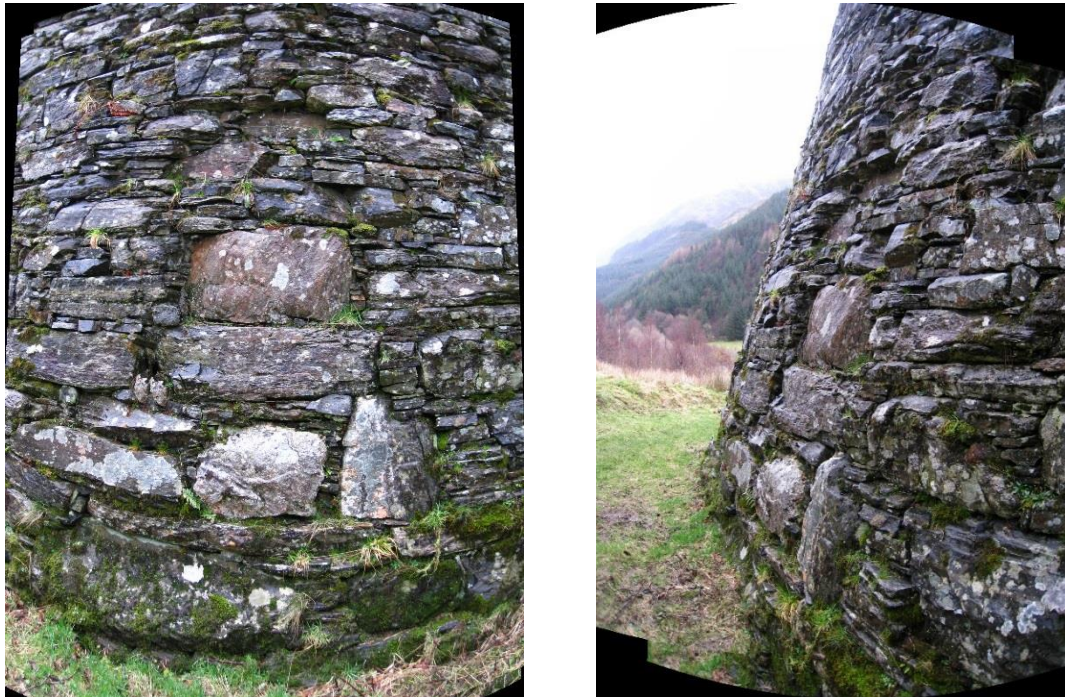
**Figure 171 a & b. An infilled breach in the outer wall outwith the stair cell entrance. Both images are panoramas and parallax distortion is obvious but the inseting of the wall is clear and is real.**

At a point on the outer wallface outwith the locus of the stairwell entrance, an area of recessed stonework can be observed (Figure 171 a & b). The stones used to infill the space include atypical rounded boulders and are inset behind the inclined and curved plane of the wallface. This is interpreted here as an infilled access point into the broch. It is not clear that it had been formed into a structured entranceway. It may have formed an informal access to a monument already in ruins. However, as noted elsewhere, some brochs had a secondary entrance forced through the outer wall at the stairfoot, and it is not impossible that this is a further example, despite the apparent lack of formal framing. Such entrances have been argued to be substitutes for the original entrance following its damage or loss. However, the broch was fairly complete in the eighteenth century and this requires that the loss of the entrance and its rebuild and sealing off of this secondary entrance had taken place before then, i.e. in antiquity.

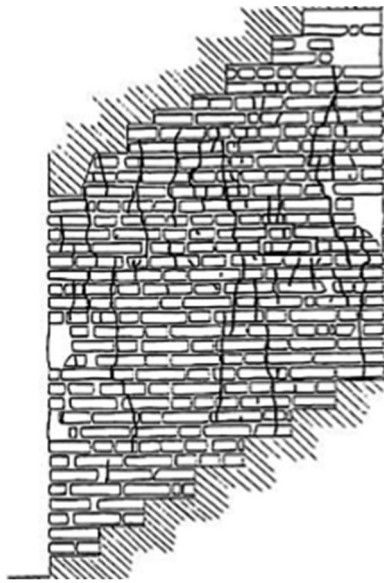
contain interspersed undamaged stones. The bell tower at Monza exhibits similar patterns of fracturing that pierces the full thickness of the brick-built tower wall (Figure 172). It is believed that a combination of compressive forces and vibration

from heavy traffic on the adjacent road have caused this to develop (Valluzzi 2006, 737-8). Vibration is not an obvious threat to brochs most of which are sited far from modern roads or other sources of mechanical vibration.

**Figure 172 Vertical crack swarm in the brick masonry of a tower in the 16th century Cathedral of Monza. The cracks were caused by a combination of compressive overload forces and vibration. Together they slowly widened and deepen the cracks, many of which pierced the full thickness of the wall (after Modena, Valluzzi et al. 2002, Figure 4).**

Following careful down-taking at Thrumster and again at Clachtoll, the writer observed panels of masonry on one or both sides of an entrance passage that exhibited crack-swarms similar to those noted in the masonry of Monza bell tower (Figure 172). Believing that such extensive damage would have required a catastrophic origin<sup>174</sup>, it was initially hypothesised that in their collapse, vertical segments of the broch tower wavered or rotated out of line from their original positions. In consequence, the area of wall masonry bearing the mass in question could be substantially reduced and the pressures on the stable masonry beneath, would locally climb towards infinity, however briefly. At Clachtoll the evidence for a major collapse was compelling (Figure 173) and seemed to verify this operational hypothesis. Distributed unequally through the underlying masonry mass, the forces

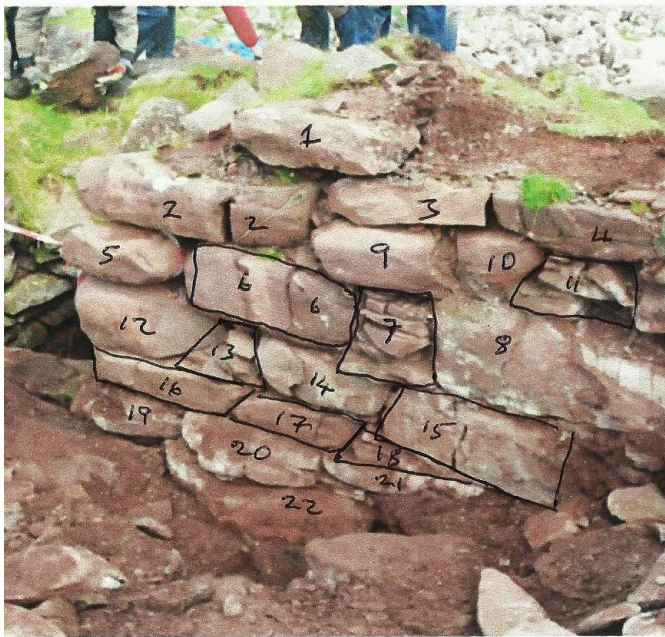
**Figure 173** A crack swarm in masonry right of the stacked void over the entrance passage at Clachtoll. Stones 2, 9/10, 11, 6, 7, 14, 15 and 21 were broken when revealed. In the wall core virtually every stone was cracked or broken.

generated by the falling structure would have been sufficient to crack or fragment many stones in the wall (see

Figure 173). The compression forces locally and irregularly exceed the capacity of the *in situ* stones to bear them and crack swarms resulted in which, for example, a given stone might be completely fractured whilst those above or below it would be sound.

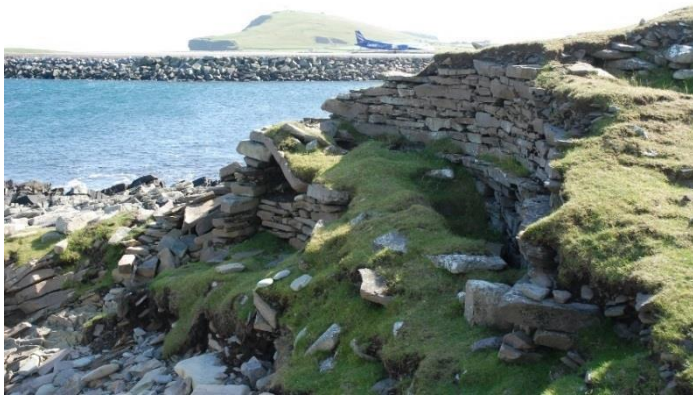
**Figure 175 Broch at East Shore, Pool of Virkie, Shetland. The inner wall and its scarcement are visible on the right and tumble and collapse near the centre fall away to the foreshore sloping down some 3 m below, to the left. The LHS of the broch had been built on unconsolidated material**

Differential settlement can result from building across variable substrates and certainly this was the case with several brochs, and is clearly visible at the eroding broch of Eastshore, Shetland (Figure 175 and see Carter et al, 1995, 452-3 for discussion of midden under parts of the broch wall) and excavation at Dun Vulcan revealed that it was built partly on bedrock and partly on sand (see MacKie 2007b, 1117 for discussion).

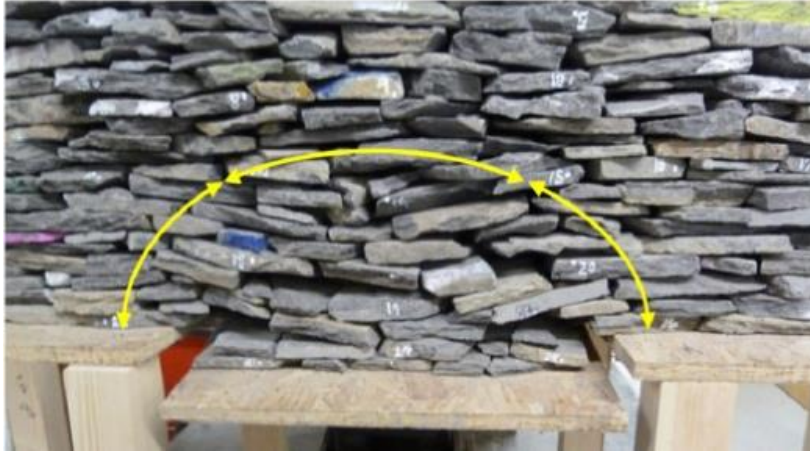
**Figure 176**  
**Experimentally induced arching over ‘subsidence’ hollow (Gilbertson 2013, her Figure 41).**

However, localised subsidence does not necessarily lead to general collapse. This is one important result of experimental work led by Theodossopoulos at the University of Edinburgh's architecture School and of the writer's ongoing experimental work in Caithness. It has been the demonstration that drystone built masonry forms arches over quite significant holes (Figure 176) forced through the inner or outer walls at ground level (Thew, Sutherland *et al.* 2012; Reutter 2012, Gilbertson 2013; Primavesi 2013). These works variously demonstrated that reduction in the substrate of many meters would be required to imperil a broch wall, and that moderate but not insignificant stone loss would arch or bridge over without immediately imperilling the rest of the structure. These results are consonant with field observation and have been applied in the temporary propping of an area of stone loss beneath the south wall at Clachtoll (Theodossopoulos and Cavers 2014). Moreover, steps in the substrate have the potential to form cracks in the masonry above and along the line of the step (Gilbertson 2013 51; Primavesi 2013, 49).
