UNBONDED POST-TENSIONED CONCRETE STRUCTURES IN FIRE

John Gales

A thesis submitted to the College of Science and Engineering in conformity with the requirements for
the degree of Doctor of Philosophy

July 2013

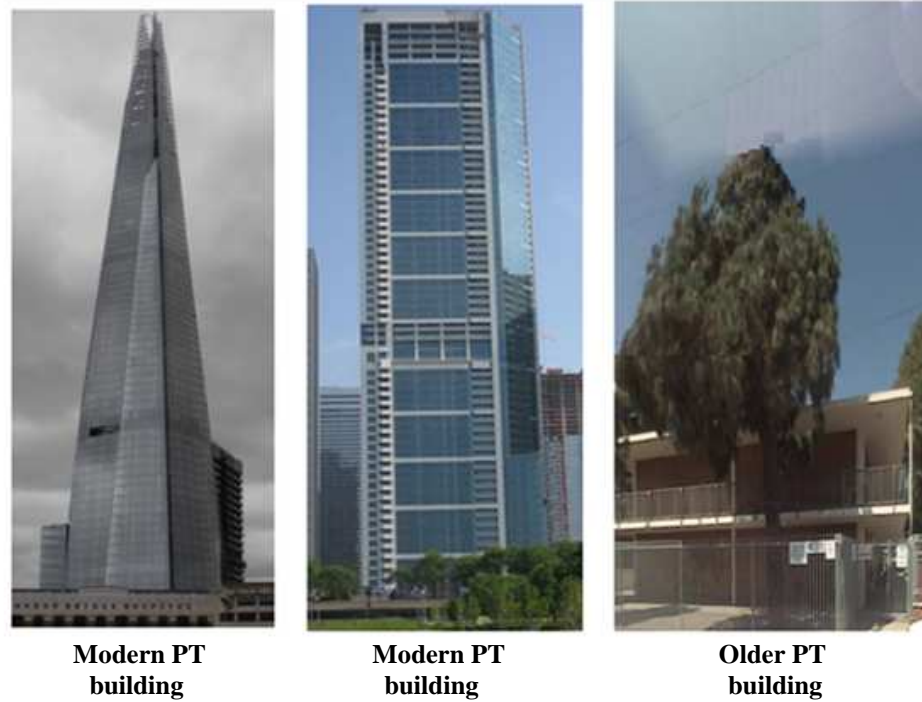
Figure 1.1: Modern versus older PT concrete buildings.

Post-tensioning has been used since the 1950s. In modern construction, however, aided by higher strength concretes and computer aided structural optimization in design, PT construction has become increasingly complex – with buildings of 60 storeys or more becoming common – as compared with their historical low-rise counterparts (see Figure 1.1).

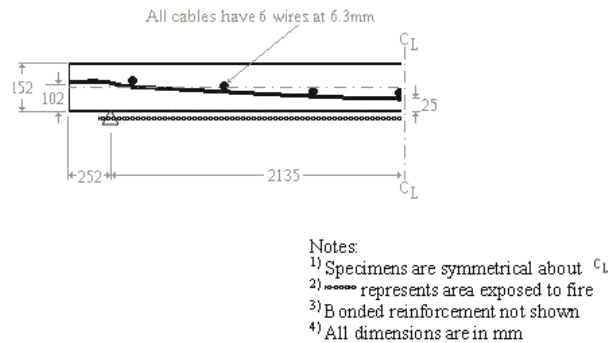
Figure 2.3: Fire Prevention Research Institute slab (after Troxell, 1959b).

In 1959, FPRI conducted a second fire test of a similar two-way unbonded PT slab panel without beams (see Figure 2.3). The original testing report is not readily accessible (Troxell, 1959b), although general descriptions of the test are available elsewhere (Troxell, 1962; PCI, 1972; Gustafarro, 1973). Figure 2.3 illustrates the tested assembly, which consisted of a 152 mm deep siliceous aggregate concrete flat slab panel spanning 3910 mm by 4270 mm and supported on pins at its corners.

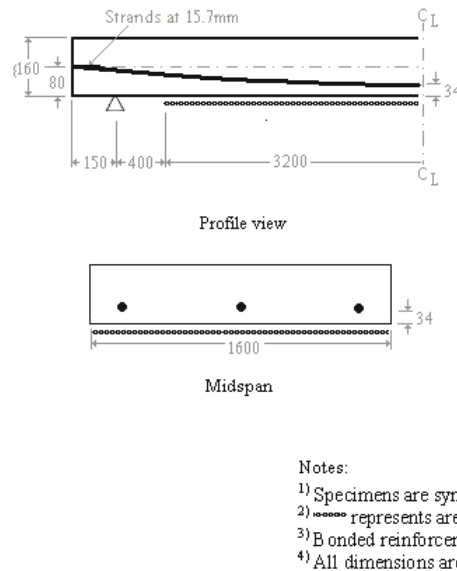
Figure 2.12: Bailey and Ellobody's slab (after Bailey and Ellobody, 2009a).

method and location of moisture measurement are not known). The applied loading was selected as 50% of the capacity of an identical slab tested at ambient temperature, resulting in a fire test load ratio of about 0.65. The slabs were exposed to the BS EN 1991-1-2 (CEN, 2002) fire until collapse (first test) or until the test was halted (three subsequent tests). The heated length was greater than 85% of the total length.

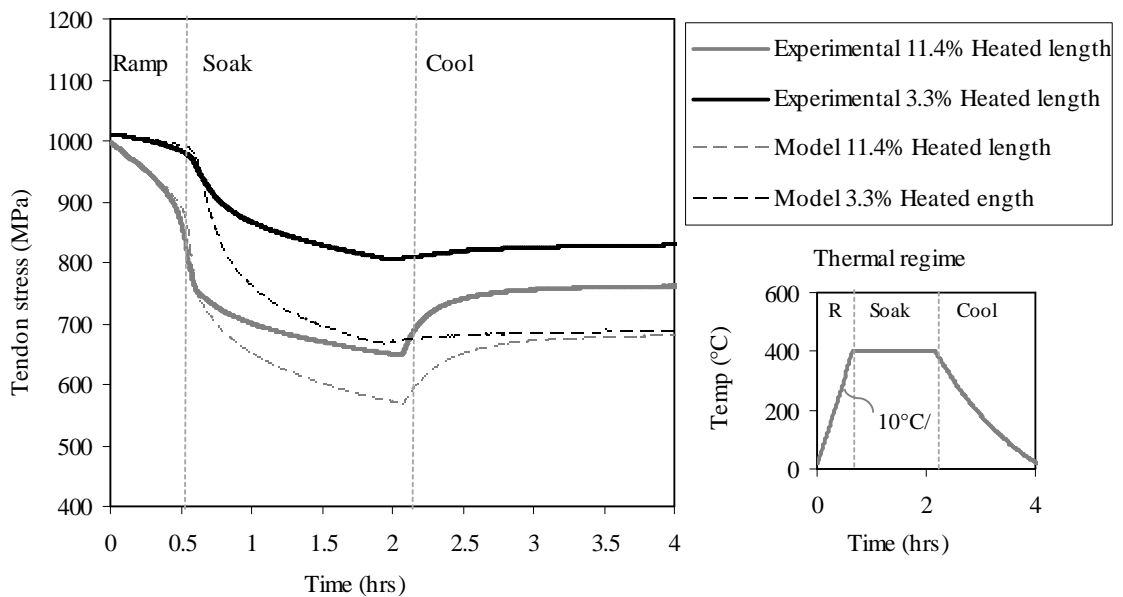
Figure 3.3 shows the effect of the heated length ratio on the variation of tendon stress with heating by comparing tests performed by MacLean at 11.4% heated length and Gales at 3.3% heated length for a 10°C/min ramp, a hold of 90 minutes at 400°C, and passive (air) cooling to ambient.

Figure 3.3: Measured and predicted variation of tendon stress for tendons with different heated length ratios heated to 400°C for 90 minutes and subsequently passively cooled to room temperature.

overall stress level but experienced greater irrecoverable losses. The predicted and experimental stress-time histories for selected cases are illustrated in Figure 3.3. The resulting predictions are generally consistent with the observed trend response; however the model tends to over-estimate the prestress loss for both heated length ratios due to an over-prediction of creep during all heating phases. To address this problem additional creep tests are needed to provide the necessary model inputs at stress levels above 600 MPa (see Purkiss (2008) and Gales et al. (2009)). This point is highlighted by examining tests 4 and 5, which had different initial prestress levels. Test 5 used an initial prestress of 600 MPa, in comparison to approximately 1000 MPa used in Test 3. Modelling inaccuracy was a maximum of 3% for Test 5 and 18% for Test 4. Figure 3.9 illustrates the results of both tests in comparison with the predicted results.

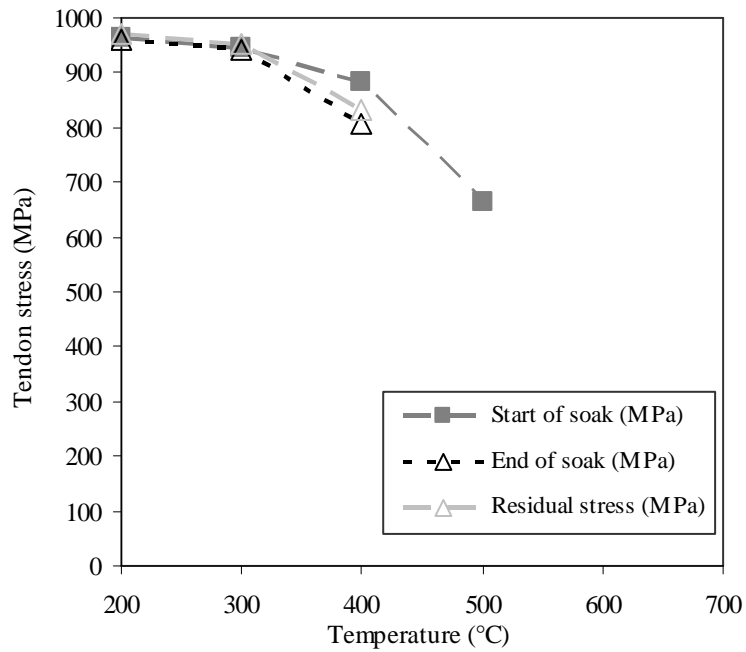
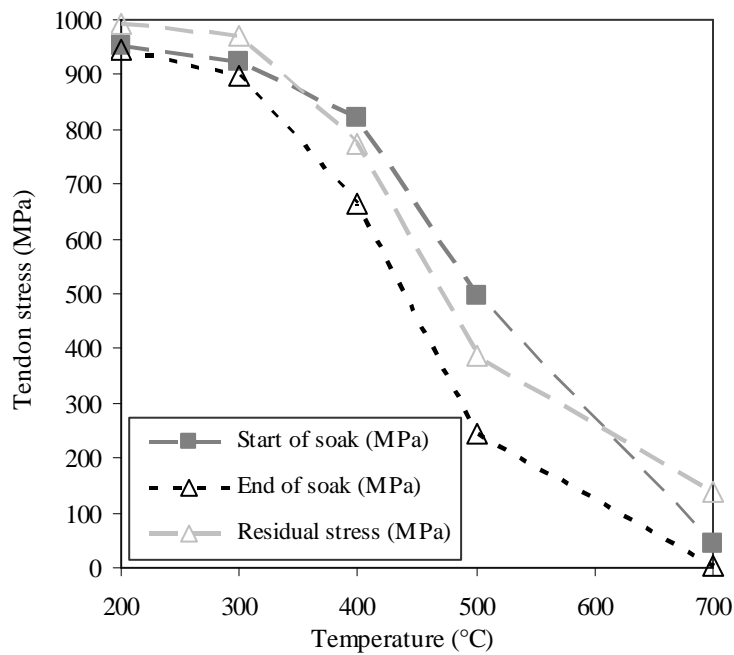
It is clear from Figure 3.4 that reductions in tendon stress are apparent at temperatures above 300°C, and that the effect of creep deformation becomes important between 300°C and 400°C.

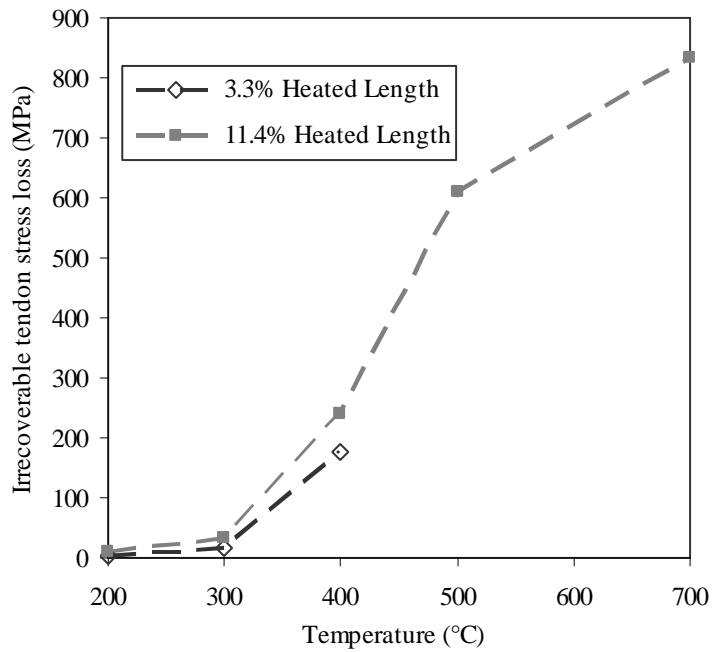
Figure 3.5 shows the irrecoverable prestress loss exhibited for tendons with different soak temperatures and heated length ratios. The acceleration of irrecoverable prestress loss at temperatures above 300°C is clear.

Figure 3.5: Experimentally measured irrecoverable tendon stress loss for different heated length.

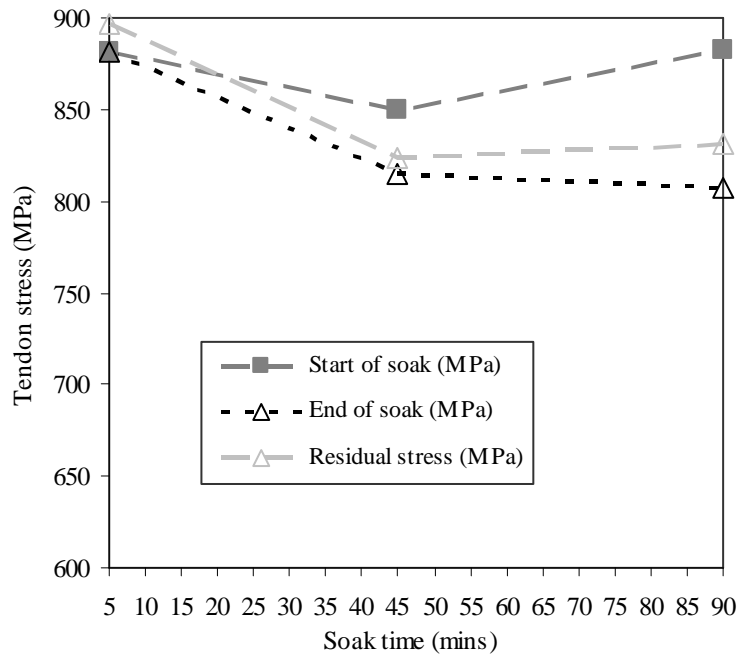
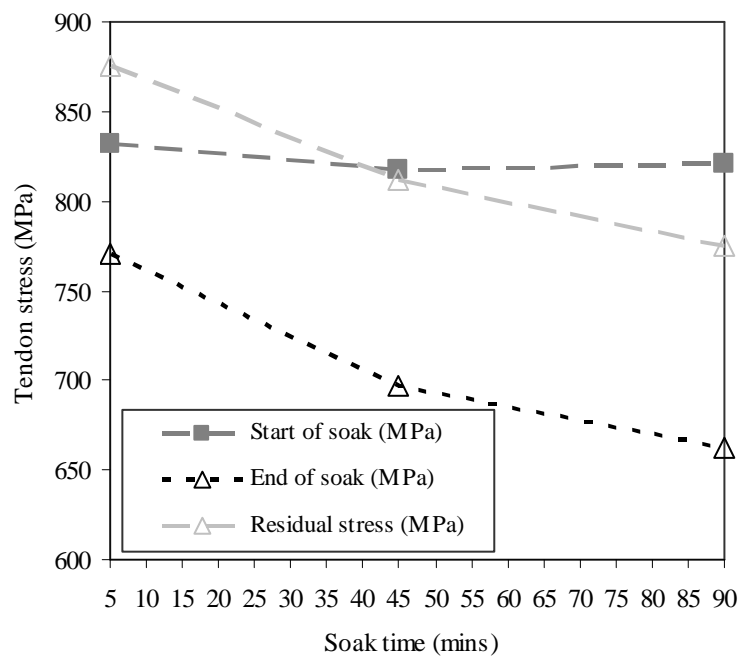
Figure 3.6 shows the effect of soak duration for tendons with 3.3% and 11.4% heated length ratios, again by comparing tendon stress levels at the start and end of the soak period and after cooling to room temperature. This figure shows the time dependency of creep strains, since longer soak times tend to cause lower residual prestress values and larger prestress changes during the soak period (which can be considered a steady-state “secondary” creep phase at elevated temperature). This is particularly evident by comparing the “start of soak” and “end of soak” trends. Figure 3.6 demonstrates that the time dependency of creep strain is significant within minutes and occurs at temperatures well below those considered the critical temperature of prestressing steel in North American guidance; i.e. 426°C (PTI, 2006; CPCI, 2007).

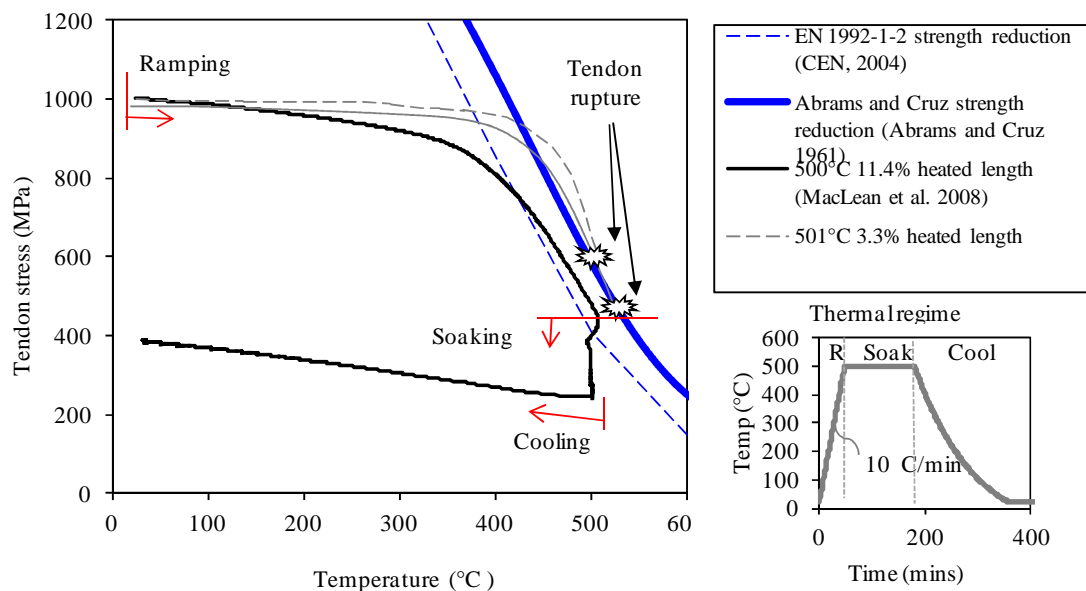
Figure 3.7 compares observed tendon stress variations versus heated region temperature profiles for tests 10 and 11 (3.3% heated length ratio) and Test 18 (11.4% heated length ratio). The Eurocode's (EN 1992-1-2 (CEN, 2004)) recommended tensile strength reduction curve for prestressing steel at elevated temperature is also shown (taken from Table 3.3 of EN 1992-1-2 (CEN, 2004)) along with a less conservative tendon strength reduction curve suggested independently by Abrams and Cruz (1961). It is worth noting that tendon strength reduction factors presented by Abrams and Cruz (1961), show 50% loss of ultimate tensile strength at 426°C (800°F) these curves are therefore responsible for the 426°C critical temperature currently assumed for prestressing steel in North American design guidance, and thus also for the prescriptive concrete covers imposed in North America for fire resistance ratings for unrestrained unbonded PT concrete slabs (PTI, 2006).

Figure 3.7: Strength-stress-temperature-time dependency of tendon stress levels during transient high temperature relaxation tests of various configurations.

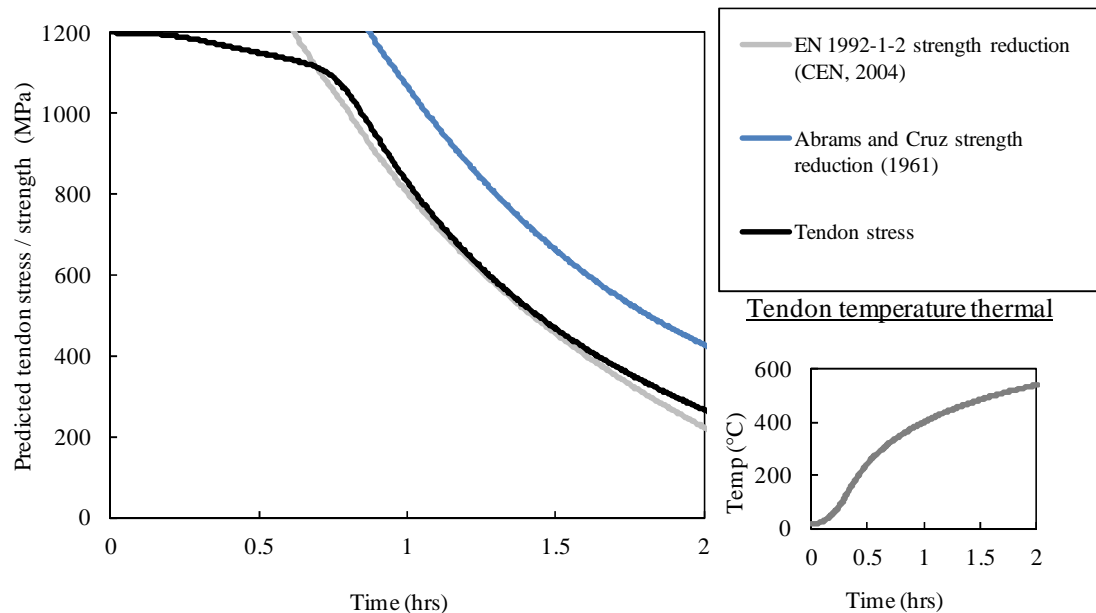
Figure 3.11: Predicted tendon stress variation with time for the default analysis of the two hour fire-rated example slab with 19 mm concrete clear cover (28 mm axis distance) in the central bay (refer to Figure 3.10).

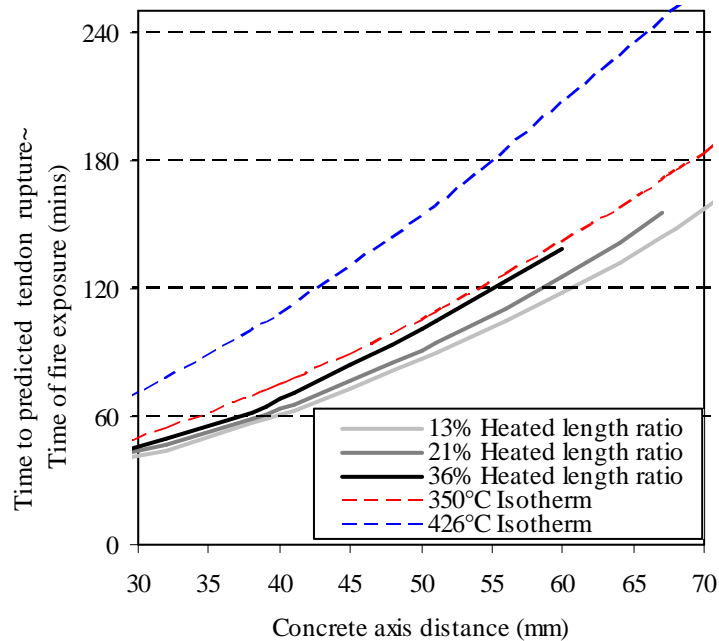
Figure 3.12: Calculated axis distance to prevent tendon rupture versus fire resistance time.

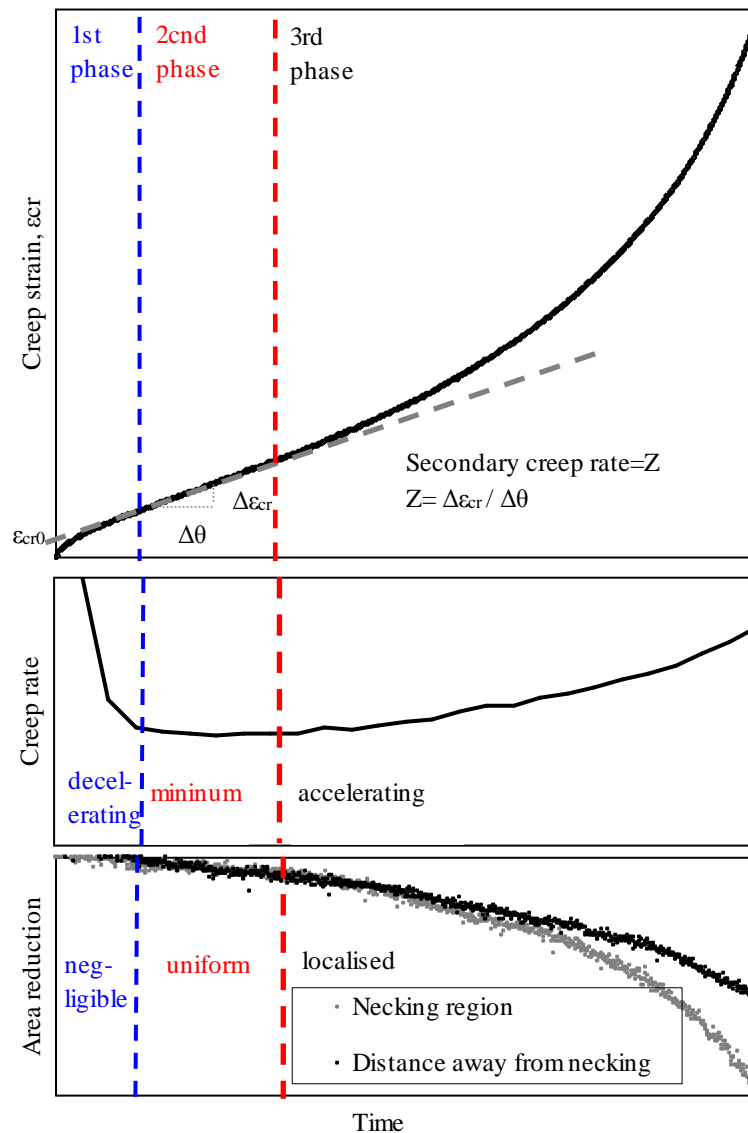
Figure 4.1: Creep theory applied to prestressing steel.

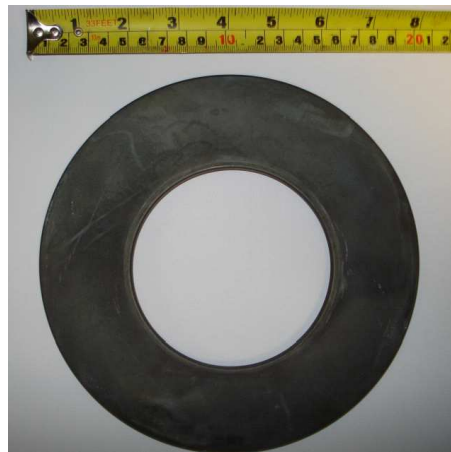
Figure 5.8: (a) Full spring assembly bearing on slab end, (b) spring stack, and (c) individual spring disk.

To simulate a smaller heated length ratio without exceeding the dimensions of the strong floor an industrial spring mechanism was built and installed at the dead end anchorage for Slab C. The anchorage system (shown in Figure 5.8) was constructed with 36 disk springs (200 mm outer diameter, 102 mm inner diameter, and thickness 5.5 mm with an uncompressed height of 12.5 mm) stacked in series and enclosed within a cylindrical steel shaft. The spring assembly was connected to a fixed bearing plate which rested against the end of the slab. A second ‘free’ plate acted on the top of the spring stack inside the sheath. A hole through the spring assembly allowed the tendon to pass through its centre. Thus, when the prestressing tendon was tensioned the free bearing plate compressed the spring stack.

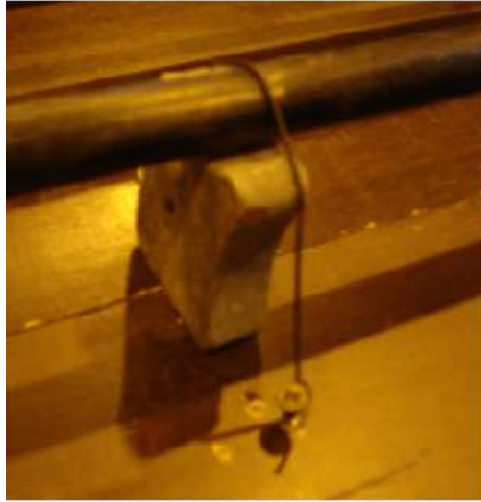
Figure 5.17: Unbonded tendon on a concrete chair tied down to form work.

To guarantee the as-designed tendon drape and concrete cover to the reinforcement, hand cut concrete chairs of variable size were installed below the reinforcement. A total of 15 blocks were used to support the prestressing steel and plastic ducting along the length of the slab. Twelve concrete chairs were used to support each non-prestressed reinforcement bar. Ten reinforcement links were added to support the negative moment tensile reinforcement. Steel wire (diameter 2 mm) was then used to guarantee fixity of the steel and chair to the film-faced formwork (Figure 5.17) and to prevent reinforcement from floating during concrete casting operations. Embedded thermocouples were fixed at the appropriate locations. Two vertical anchor tubes were cast at each column location. Lifting hooks were also installed at the slabs' quarter points. These were placed outside of the heated region.

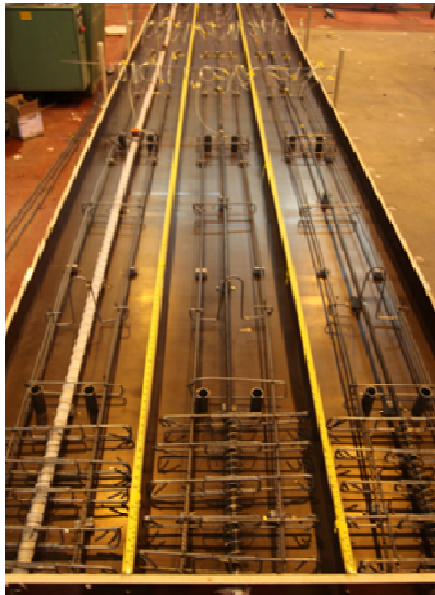
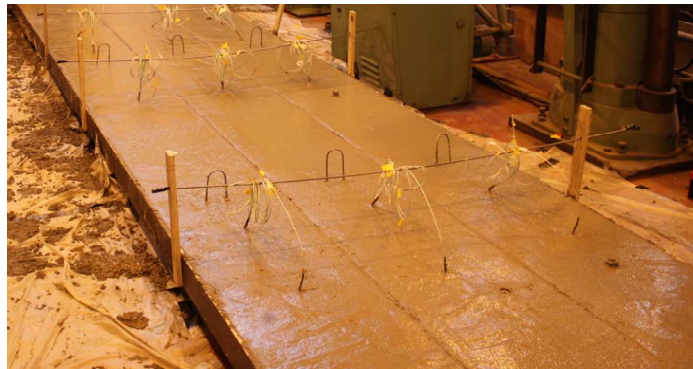
Figure 5.18: (a) Slabs before casting and (b) slabs after casting

All three slabs were cast using ready mix RC40/50 concrete (see Figure 5.18). The specified maximum aggregate size was 10 mm. Additional cubes (100 mm × 100 mm) and cylinders (100 mm diameter × 200 mm tall) were cast concurrently and cured next to the test specimens. Three cubes and three cylinders were tested at 28 days in accordance to BS EN 12390 (2000) parts 1 to 8. The cubes had a compressive strength of 41 ± 2 MPa (average ± standard deviation), whereas the cylinders had a split cylinder tensile strength of 2.8 ± 0.5 MPa. The non-prestressed 8 mm diameter reinforcement tested to an ultimate strength of 658 ± 7 MPa (this is inline with similar reinforcement described in Elghazouli et al., (2009) tested to 624 MPa), and the prestressing tendon's centre wire was tested to 2033 ± 11 MPa ultimate strength. The slabs were left to cure for more than six months (being cast during November 2011 and tested beginning June 2012).

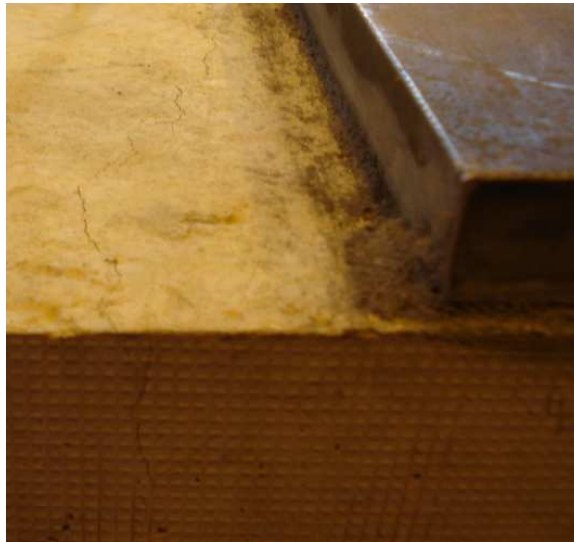
Figure 5.33: Discrete transverse cracking at column location (Slab A, Test A.1 shown).

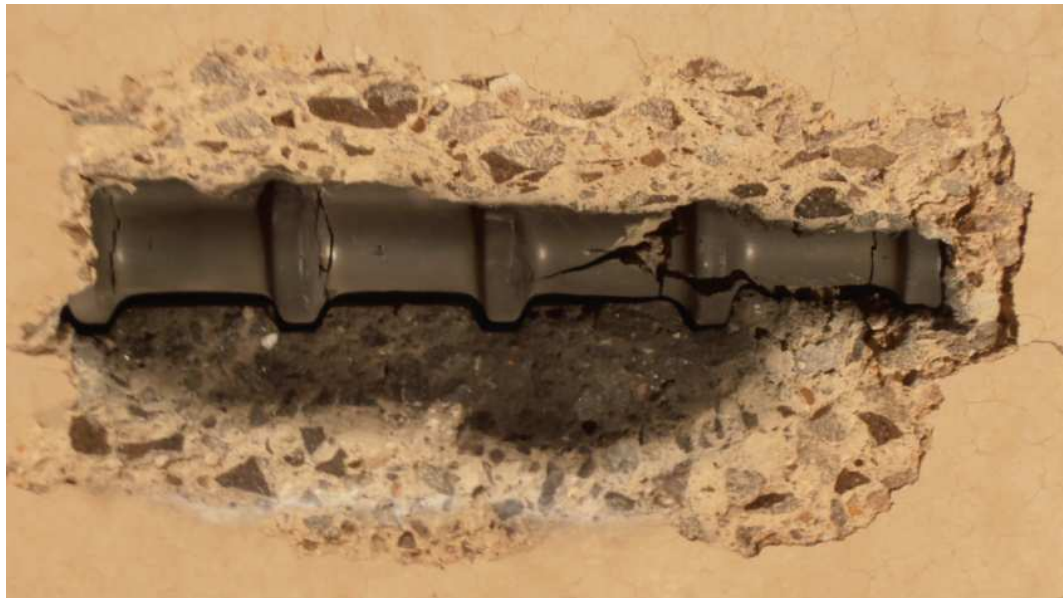
Figure 5.38: Exposed section of grouted duct after Test B.1 on exposed soffit.

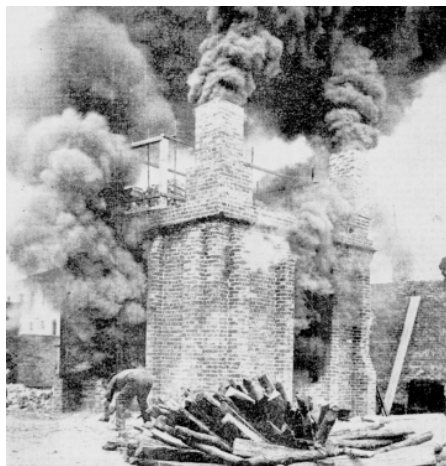
Fig. 1 Early ‘furnace’ test circa 1902 (Stewart and Woolson, 1902)
