Original Article

A Special Design to Facilitate Retrieval of Cement-Retained Zirconia-Based Implant-Supported Restorations

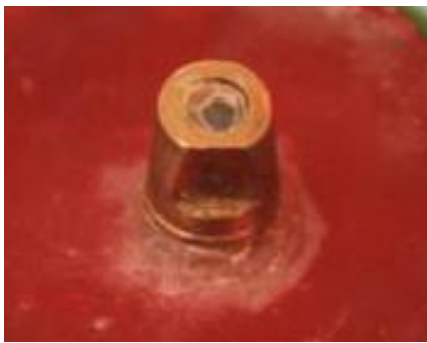
Figure 1: Brass die embedded in acrylic resin block

An implant analog (DioCorp, Busan, South Korea) with the diameter of 5mm and the height of 6.5mm was connected to a straight titanium abutment (DioCorp, Busan, South Korea) with the diameter of 5mm, the height of 7mm, and the collar height of 3mm. This complex was used as a pattern to mill 33 brass dies exactly similar to model by using a lathe (CNC 350; Arix Co; Tainan Hesin, Taiwan). A total of 9.5mm of each sample was embedded in an acrylic resin block vertically (Figure 1). Subsequently, the dies were sprayed with scan spray and scanned using a 3D-laser scanner (3Shape D810; 3Shape, Copenhagen K, Denmark). The data were transferred to CAD software (3Shape's CAD Design software; 3Shape, Copenhagen K, Denmark). By considering a 30- μ m space for the cement, a mandibular molar coping with a uniform thickness of 1mm around was designed. Twenty-two zirconia copings were milled from pre-sintered Y-TZP blanks (IPS Emax Zir CAD, Ivoclar Vivadent) in a milling machine (inLab MC, Sirona) and then sintered. Eleven samples were used for the control group and the other eleven samples were used for the second group (conventional). A 2mm diameter circle was drawn in the center of the occlusal table in the second group. Eleven zirconia frameworks were designed with the same sizes and shapes as those of the first and second groups except that a ledge was existed in the location of the screw access channel (Figure 2). The ledge was 1 mm in thickness and 1.5mm in height and it was located around a 2mm hole in the center of the occlusal surface. A silicone index was used to standardize porcelain application to all the samples. The crowns were then cemented by using zinc oxide-eugenol cement (TempBond; Kerr Mfg Co., Romulus, MI) to their corresponding dies. A 20-N load was applied during cementation for 15 minutes. A hole was prepared in the location of the abutment screw access

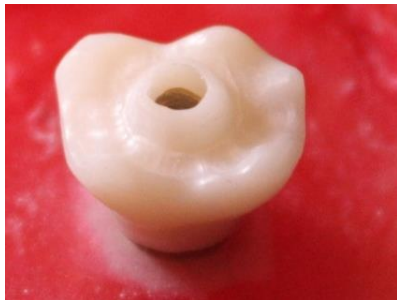
Figure 2: The ledge designed in the zirconia framework in the location of screw access channel of the third group

In our previous study [23], we designed a ledge in the framework of cement-retained implant-supported metal ceramic restorations in the location of screw access hole to support remaining porcelain after perforation of framework. This design has the advantages of cement-retained restoration as well as the convenience of retrieval [23]. Due to increasing demands for all ceramic restorations in the current study, zirconia based implant supported crowns were tested. The purpose was to compare the strength of crowns which containing ledge with those without a ledge. There were two null

In some clinical situations, to retrieve the restoration, making a hole on the occlusal surface of the cement-retained implant-supported restoration is inevitable due to screw loosening or porcelain fracture. In the current research, a ledge was designed in the framework of the implant-supported zirconia-based cement-retained restoration. The goal of this special design was to prepare a support for the remaining veneering porcelain after creating a hole in the restoration. Analyzing the values in the present study showed that the crowns with the special design had better fracture resistance than those with the conventional design perforated by creating an access hole on their occlusal surface. Therefore, this feature may be used in case of high risk for screw loosening in patients with high force factors.

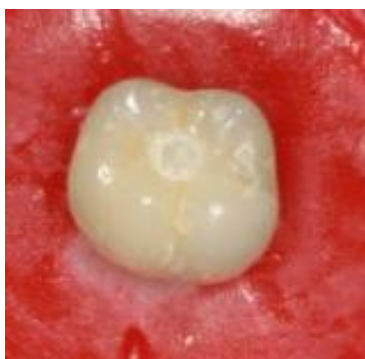
Figure 3: The holes in groups 2 and 3

channel in group 2 by using a 2 mm zirconia bur (Kom-et diamond bur, Lemgo, Germany) on a high-speed handpiece. Then the holes in groups 2 and 3 (designed in the framework) were filled with a photo-polymerized composite resin (3M ESPE Dental Products, Canada) (Figure 3). Afterward, all the crowns underwent thermal cycling for 500 cycles from 50°C to 65°C for 30 seconds with 12-second intervals to simulate oral conditions [24]. Finally, all the specimens were subjected to vertical static compressive load by using a universal testing machine (Zwick-Roell Z020; Zwick Gmb H & Co. KG, Ulm, Germany) until they were fractured. The force was applied perpendicular to the occlusal surface in the central part of the crown by using the rounded edges of the loading piston a rate of 2 mm/min.
