SECTION 21. GEOLOGY, MINING AND PETROLEUM ENGINEERING (ENGLISH, GERMAN)

THE STUDY OF LOCAL FAILURE TEST RESULTS FOR PIPELINES REPAIRED USING VARIOUS TECHNOLOGIES

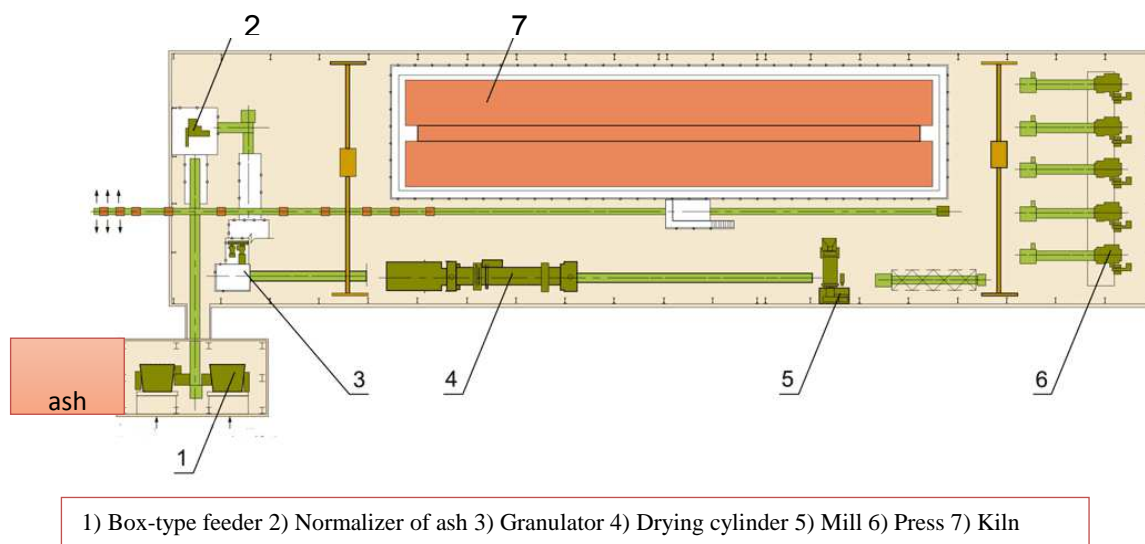
Fig. 2 Block diagram of an ash-ceramic bricks production plant

In the paper the stages of the investment as well as the tables and charts of the obtaining ash-ceramic bricks plant are given in Fig. 2.

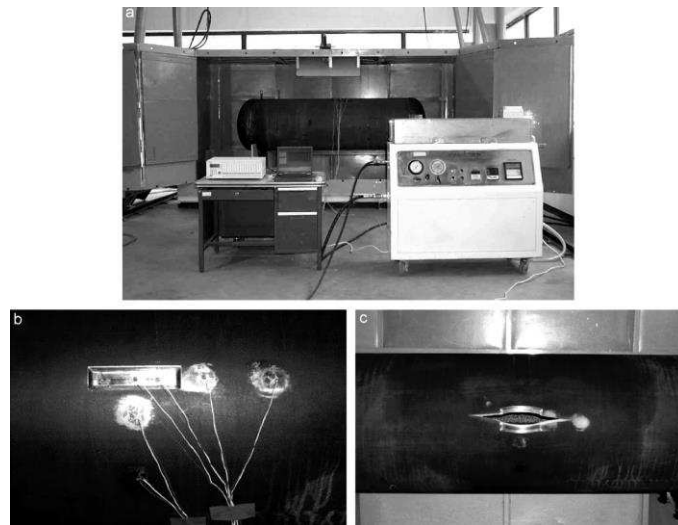
Fig. KOGAS tests: (a) Test set-up of full-scale burst test for pipes, (b) defect, and (c) failure

Testing was performed by increasing inner pressure up to 28.44 MPa. Length of the pipe being tested was 2.5 m, end caps were installed on the both ends of the pipe. Pressure boosted from 0.25 MPa per minute up to 19.6 MPa and from 0.15 MPa per minute to 28.44 MPa. Pressure increment was measured every second using computer software. In order to reveal deformations of a specimen monitors were attached both to the damaged and to the repaired pipes (Table4).
