1 **Floor vibration serviceability in a multistory factory building**

38 **Abstract**

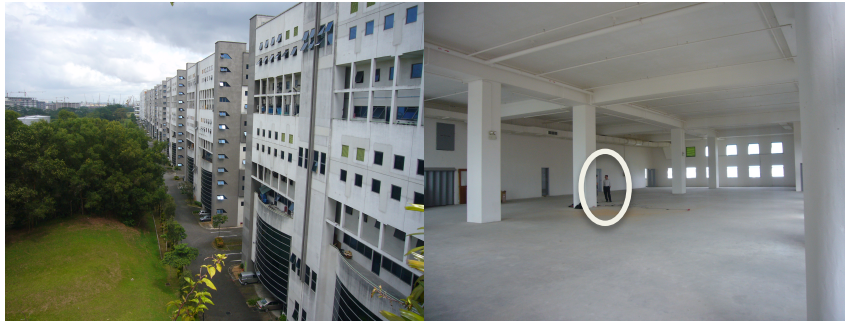
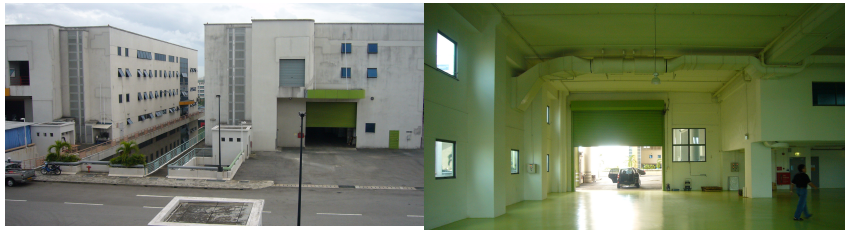
107 Figure 2 shows a vertical section through a T5000+T3000+T3000 six-level stack in the long  
108 (74m) axis of the units, with the driveways shown at the right.

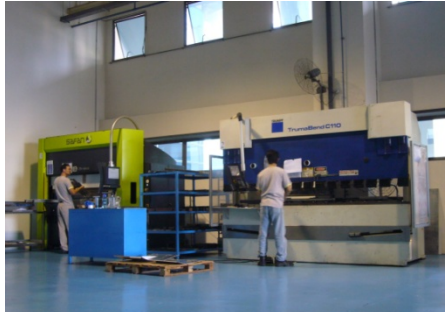
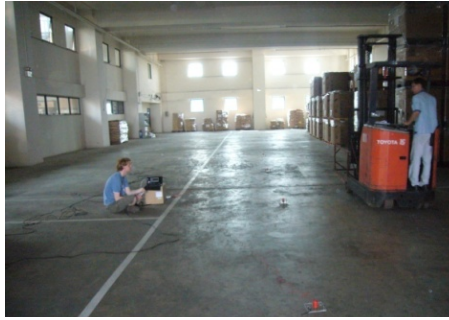
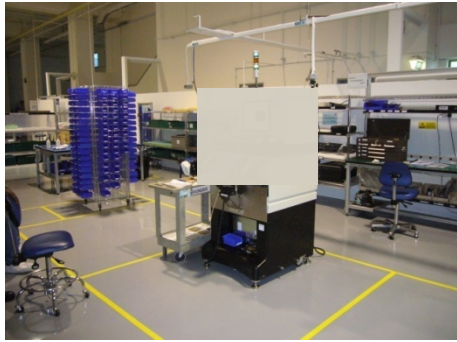
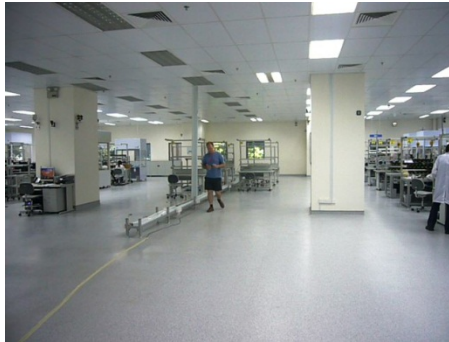
121 Table 1 summarises the ten floors and their usage while Figure 4 shows examples in  
122 operation and/or during testing. To identify the floors, the first number is the unit type, the  
123 second number is the roadway level (1, 3 or 5) and the letter L/U indicates lower or upper  
124 level. To provide a unique identification a tenant number is appended. Hence 2000-5U-6 is  
125 the upper floor of the T2000 unit having street address identified as level 5 and occupied by  
126 tenant 6.

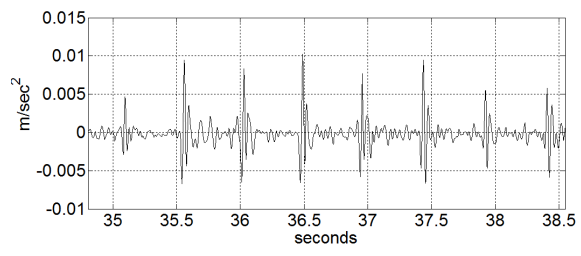
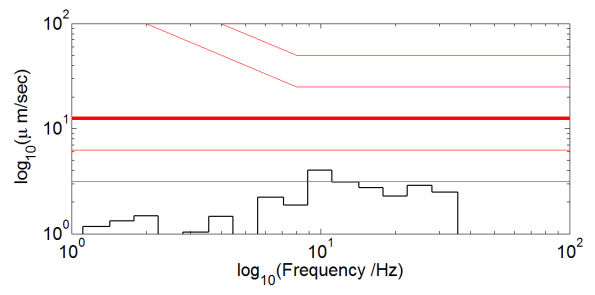
47 Figure 19: Walking test in 2000-1L-3 (VC-D: 10Hz)

405 Finally, Figure 19 shows response to footfall in the only large ground level floor studied,  
406 2000-1L-3. Being slab-on-grade, no modes were observed in the 10-40Hz and the one-third  
407 octave spectrum is uniform with mild enhancement at 10Hz, for VC-D rating. There are no  
408 machines in this unit, but on occasion (not during the walking) the ambient response reaches  
409 VC-B due to a strong signal at 10Hz from the structurally connected neighbouring unit that  
410 uses heavy manufacturing machinery.
