## Modal Testing of Tamar Suspension Bridge

JMW Brownjohn, A Pavic, P Carden, C Middleton  
Vibration Engineering Section, University of Sheffield  
Mappin Street, Sheffield S1 3JD, UK

The paper described modal testing of the Tamar suspension bridge by University of Sheffield in April 2006

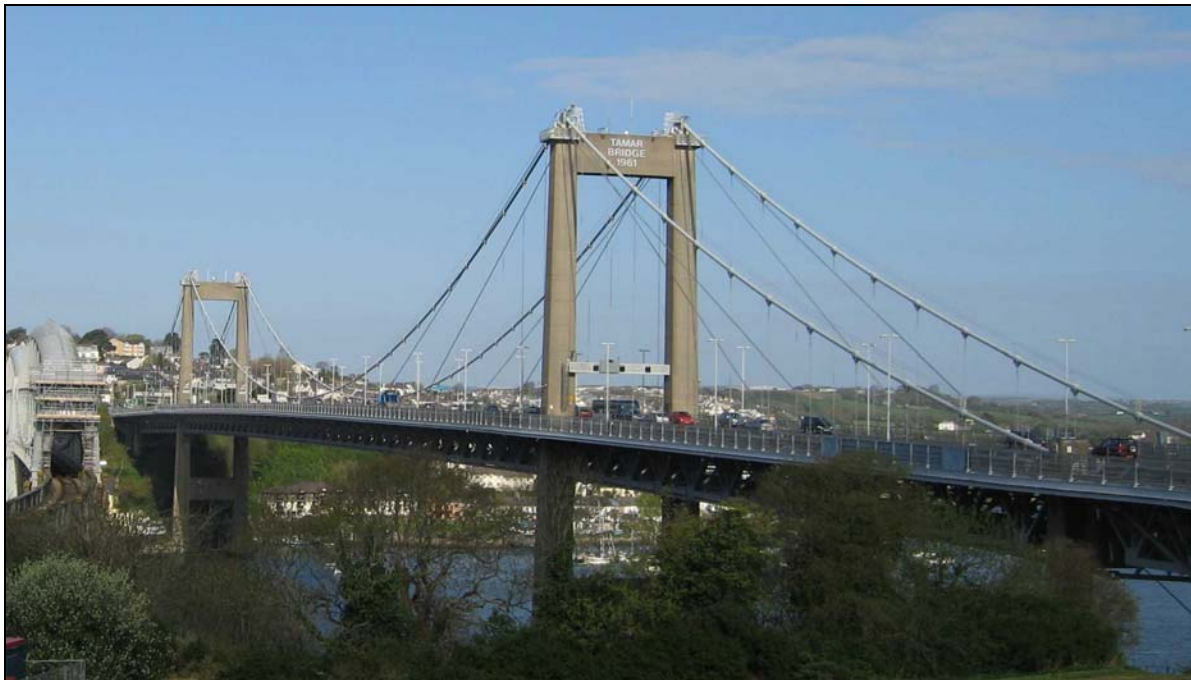
Figure 1 Tamar Bridge, Plymouth, UK

The Tamar Bridge (Fig. 1) is a vital transport link over the River Tamar carrying the A38 trunk road from Saltash in Cornwall to the city of Plymouth in Devon. The bridge is owned, operated and maintained by the two local authorities, and has relied solely on toll income to cover all capital and operating costs.

The original bridge opened in 1961, was designed by Mott Hay and Anderson as a conventional suspension bridge with symmetrical geometry, having a main span of 335m and side spans of 114m, and with anchorage and approach spans the overall length is 642m. Unusually for a suspension bridge of this era, the towers were constructed from reinforced concrete, and have a height of 73m with the deck suspended at half this height. The towers sit on caisson foundations founded on rock. Main suspension cables are 350mm in diameter and each consists of 31 locked coil wire ropes, and carries vertical locked coil hangers at 9.1m intervals. The stiffening truss is 5.5 metres deep and composed of welded hollow boxes.

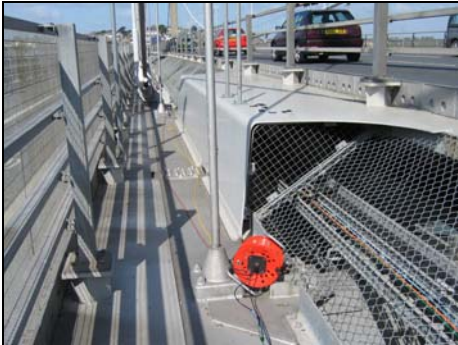
As the hangers are attached to main crossbeams of the truss, these provided ideal locations for the accelerometers. The hanger attachment points such as shown in Fig. 3 are in a walkway between the cantilever walkway (south side) or vehicle lane (north side) and the three-lane main deck. All except two measurement points were located on the south side of the deck; two biaxial accelerometer arrangements involving four channels such as shown in Fig. 4 were left at positions 1081 and 1085. Due to the limited cabling and the troublesome access between north and south sides of the deck no further measurements could be made on the north side of the deck. The measurement and acquisition station were planned to be located on a platform created by the widening of the cantilever around the Plymouth Tower where mains power was available.

Figure 3 Hanger connection, shear box and cabling

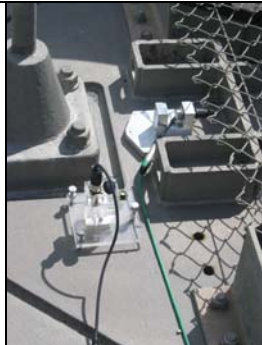
Figure 4 Hanger termination and biaxial accelerometers

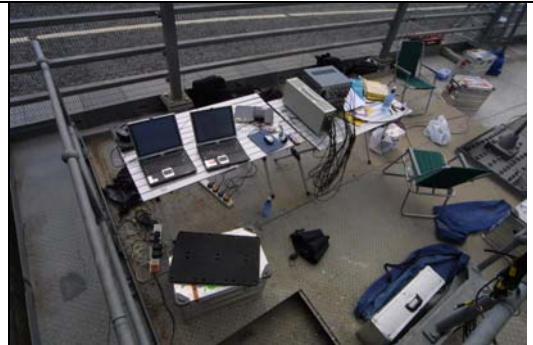
Figure 5 acquisition and control station adjacent to Plymouth tower

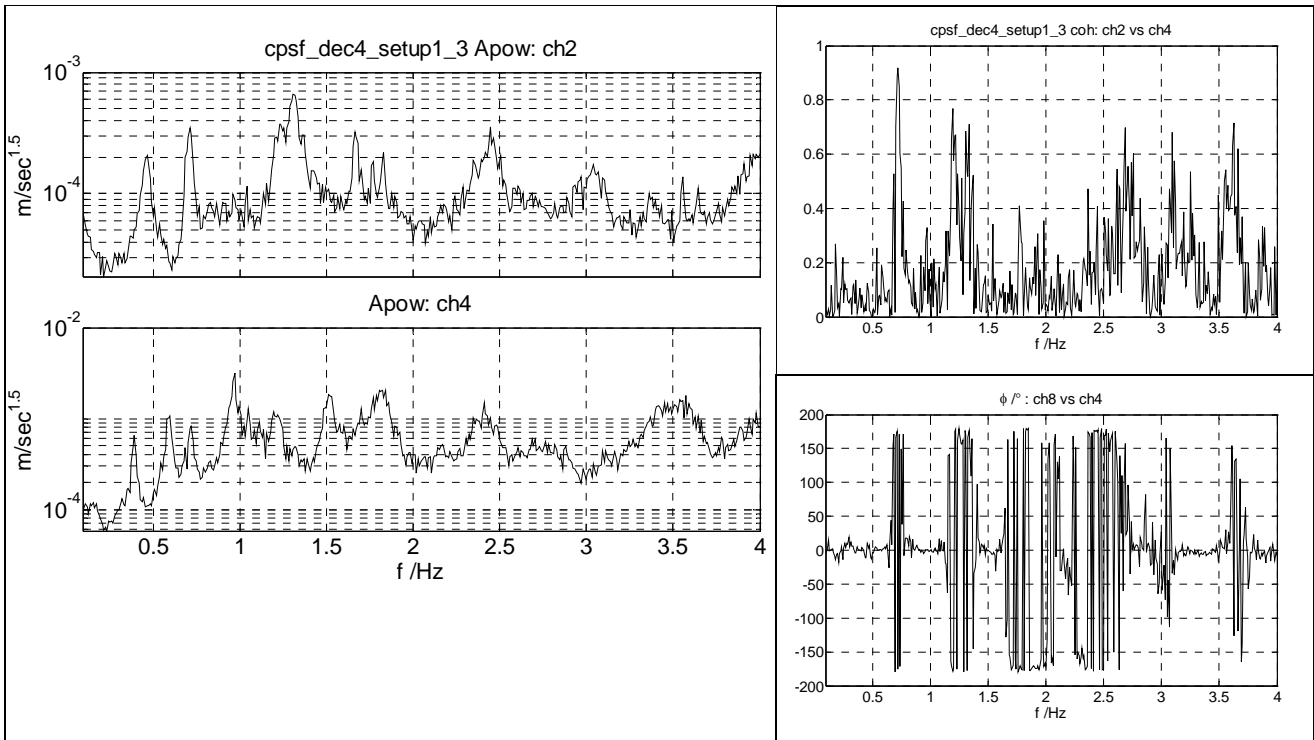
For this setup, Fig. 6 shows auto-spectra from channels 2 and 4 and their coherence, also relative phase between channels 4 and 8, both as indicators of torsional modes. Fig. 7 shows the resulting piece of mode shape for the first torsional mode obtained using NExT/ERA implemented in MODAL.

Figure 6 Auto power of lateral (ch2) and vertical (ch4) response at hanger 85, also torsional indication from (right, upper) lateral/vertical ch2/ch4 coherence and (right, lower) ch4/ch8 phase angle

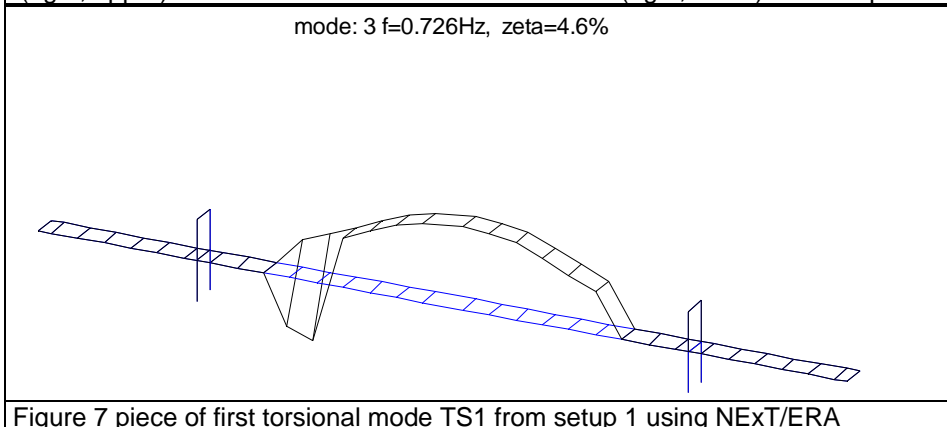
Figure 7 piece of first torsional mode TS1 from setup 1 using NExT/ERA

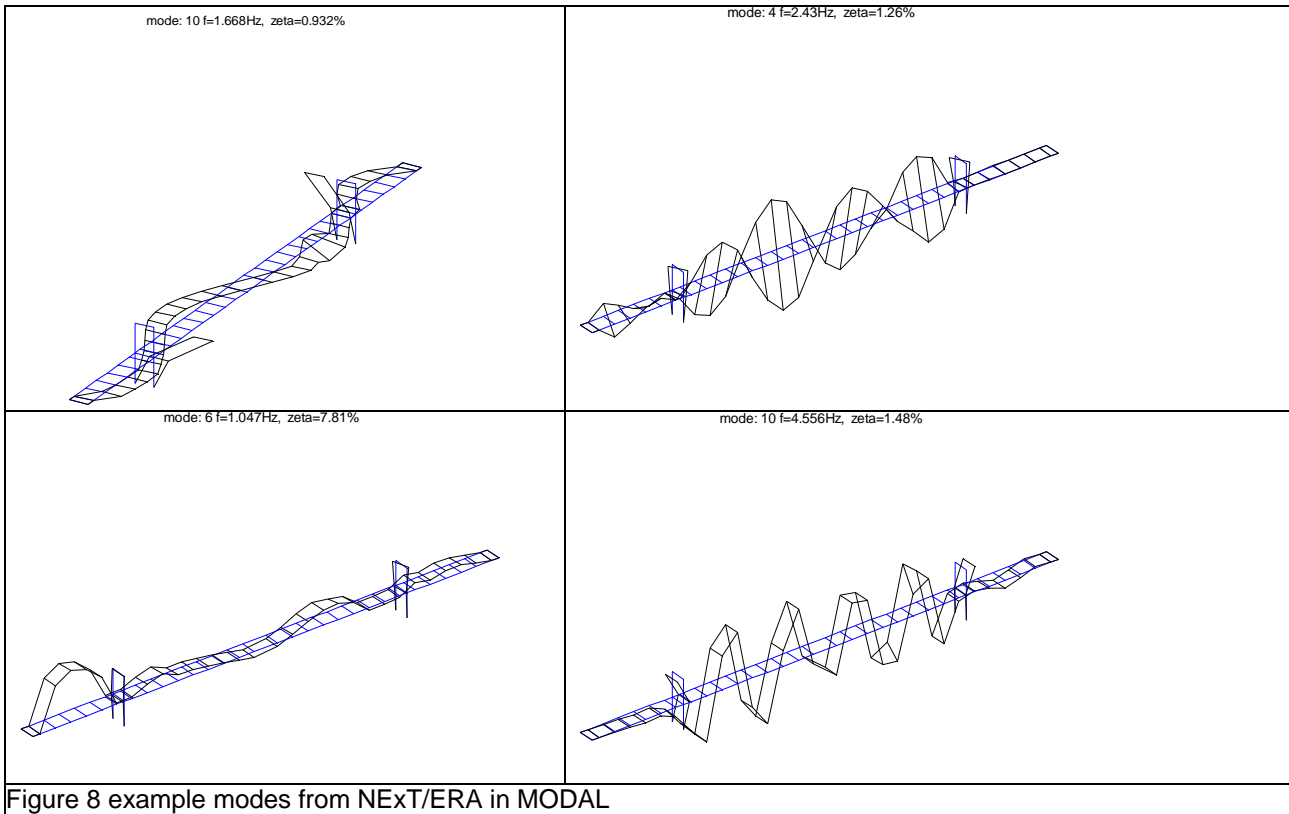
In each case, the mode shape ordinates for the unmeasured locations on the north span were 'guessed' as equal in magnitude to but either in phase or out of phase with the opposite locations on the south side. South side lateral mode ordinates were mapped directly to the north side. Due to technical problems (e.g. not having the keys to access doors and facing other physical barriers) it was not possible to map the mode ordinates at all tower locations; the tower base ordinates could not be measured as planned and so were assumed to be zero representing the towers as fully fixed at water level. Sample mode shapes are shown in Fig. 8.

From all the analyses the following set of modes was distilled. Modes up to higher frequencies were also identified (even to 5Hz as shown in Fig. 8). The best estimates of damping ratios were obtained from frequency domain SDOF curve fitting. This procedure works well enough for well separated modes but is subject to positive bias due to the limited frequency resolution and averaging available due to the limited duration of the records.

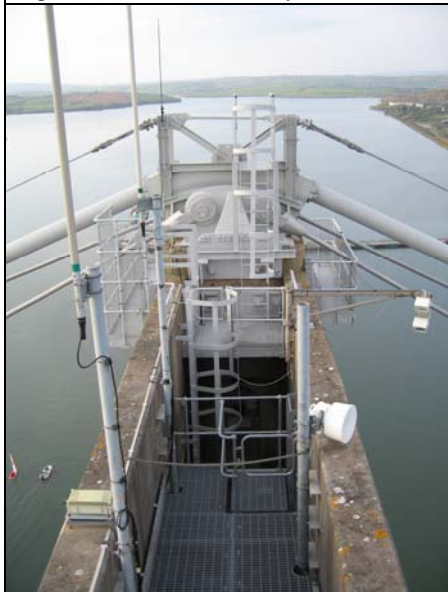
One significant concern with cable-stayed bridges is oscillations of stay-cables induced either by wind on its own or more usually by a combination of rain and wind [2]. Fig. 10 shows the additional stays for Tamar due to the upgrade; these are either 102mm or 112mm locked coil steel strands connecting tower tops (Fig. 11) to the deck (Fig. 12). According to Tamar Bridge staff

Figure 11 Saddle and stay anchorage points on Plymouth tower

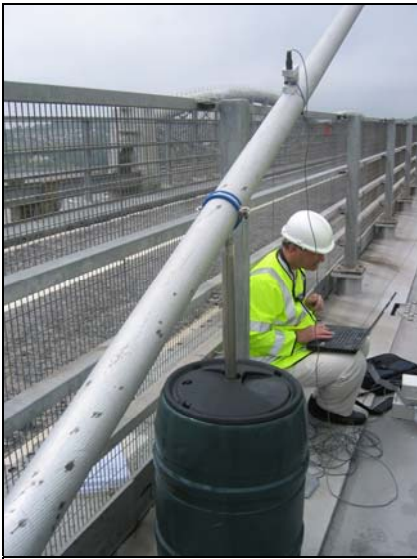
Fig. 13 shows the arrangement for one of the cables, P3S and (Fig. 14) results from forced vibration (manually). The lateral decay visible in the time/frequency (spectrogram) plot is much slower than the vertical decay; lateral damping is 0.3% for a fundamental frequency of 0.845Hz, for vertical oscillation damping is 2.8% for a frequency of 0.852Hz.

Figure 13 P3S under test
