**WIRELESS SENSOR NETWORK FOR MONITORING OF HISTORIC
STRUCTURES UNDER REHABILITATION**

A Thesis

Major Subject: Civil Engineering

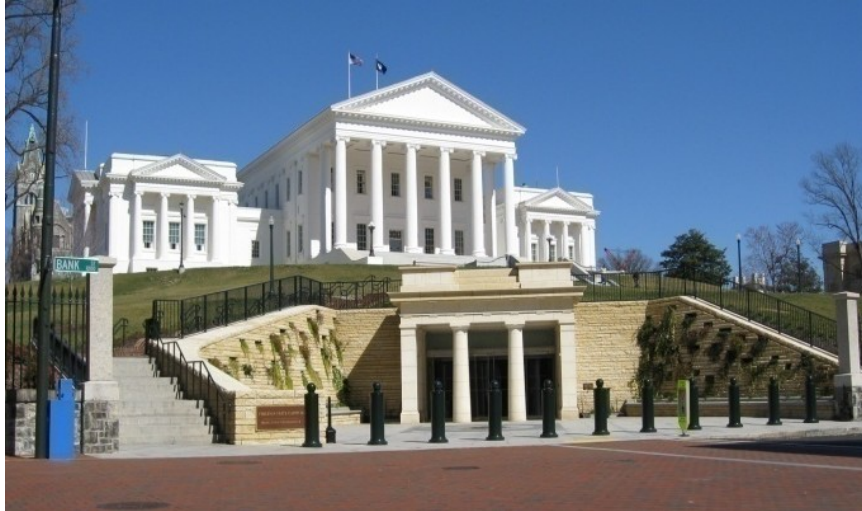
Figure 1-1. Virginia State Capitol after expansion (Staley 2008)

A prime example of an historic structure which could have benefitted from the use of monitoring is the Virginia State Capitol, which was renovated and added to in 2005. Figure 1-1 depicts the Virginia State Capitol after the expansion project was complete. This property is listed on the National Register of Historic Places, and therefore falls under the jurisdiction of the Secretary of the Interior's Standards for Historic Preservation. The original structure, built in 1785, was designed by Thomas Jefferson and is still the seat of government for the Commonwealth of Virginia. The scope of this project included replacing mechanical, electrical and heating, ventilation and air conditioning (HVAC) systems, preventing water penetration, restoring architectural details, renovating exterior surfaces, and the construction of a 27,000 square-foot underground expansion to bring the building up to Americans with Disabilities Act (ADA) standards (Fisher 2005). As can be seen in Figure 1-2, taken after the underground addition was completed, severe cracks appeared in the foundation under a column of the primary structure. In this case, glass tell-tales were affixed to the crack to detect any additional foundation shifts. This cracking may have been predicted if a wireless sensor network was in place to actively monitor the building during construction, allowing corrections to be made as the work proceeded. The use of

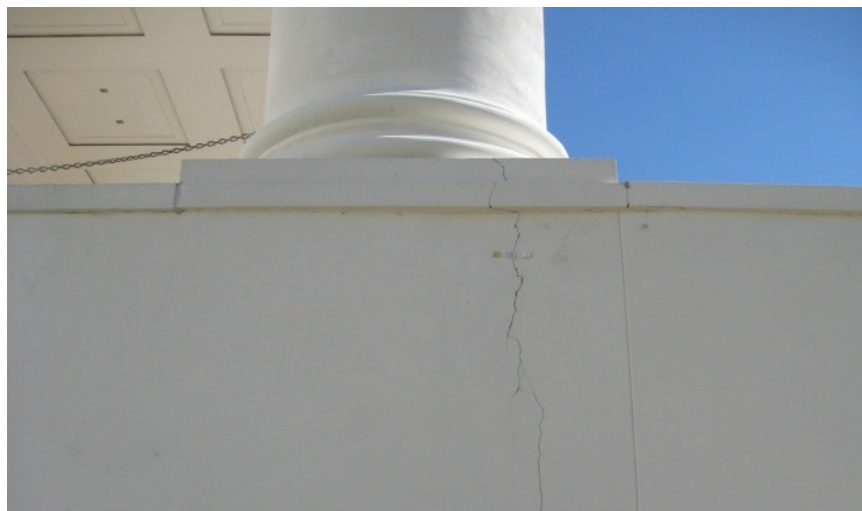
Figure 1-2. Cracking of foundation under column at Virginia State Capitol
(Staley 2008)

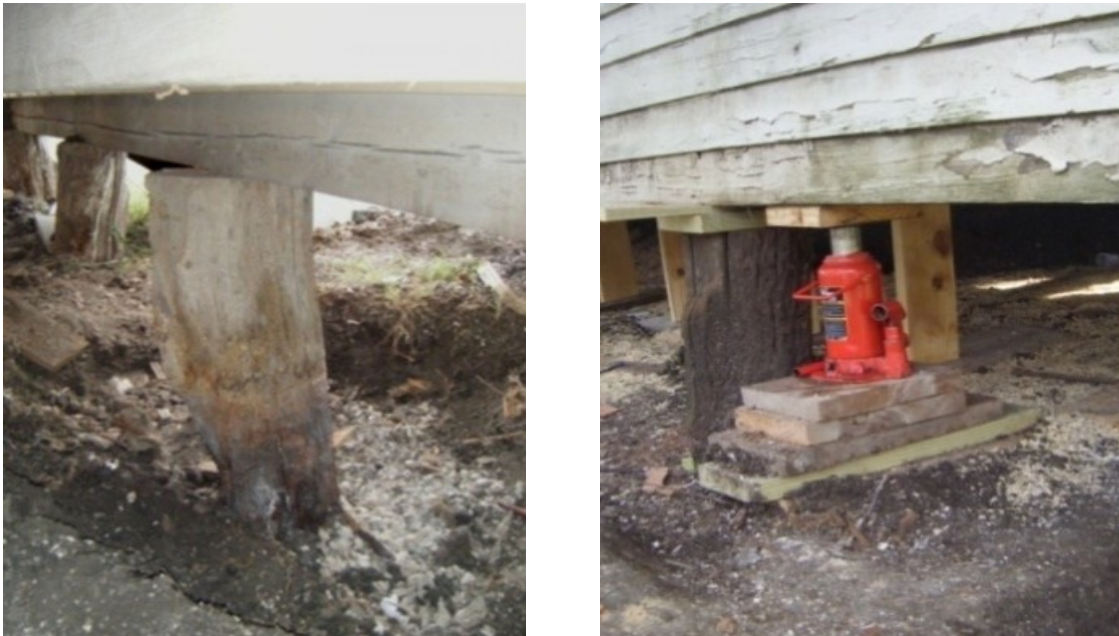
When it was built, the church was set on a foundation of bois d'arc tree stumps (Figure 3-3). Dallas is a region with very expansive clay soils so over the years the church developed differential settlements of up to 75 mm over approximately 15.25 m. To remedy the problems, the foundations are replaced by concrete masonry unit (CMU) blocks along the interior and steel pedestals on concrete pads under the exterior walls (Figure 3-4). To maintain the appearance of the stump foundations, bois d'arc stumps will be notched to fit around the steel supports. Over the course of the rehabilitation, the structure is leveled several times (Figure 3-3). For minor adjustments, steel pipe supports are connected to the concrete pads using leveling bolts.

Figure 3-3. Original foundations (left) and jacks used to level structure (right)

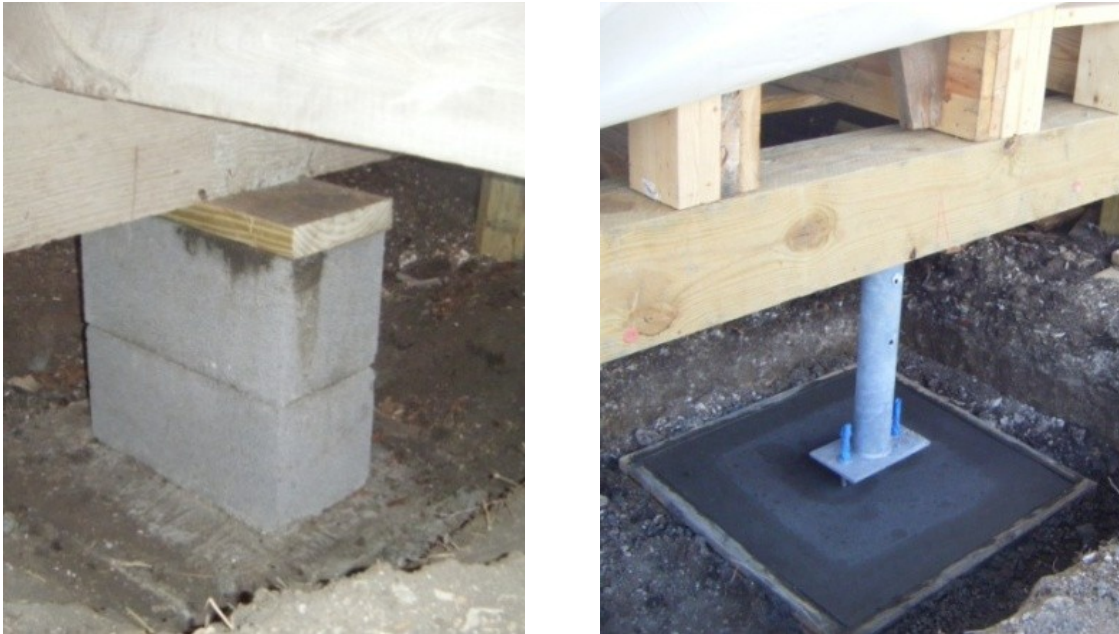
Figure 3-4. Interior span CMU foundation on concrete pad (left) and exterior span steel pedestal on concrete pad (right)

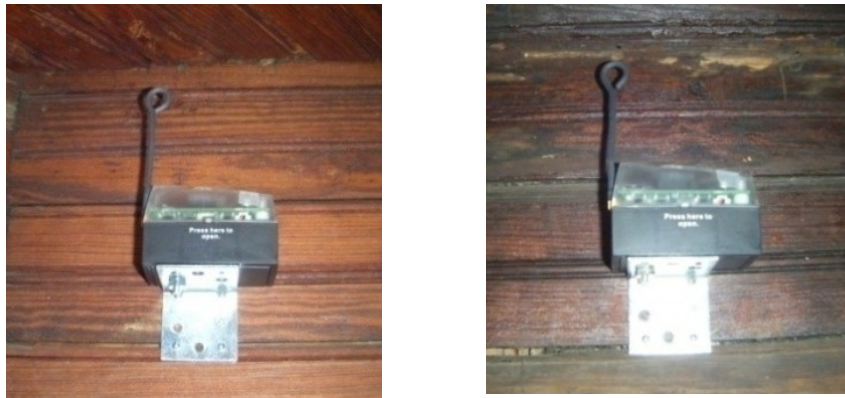
For this application, the sensors have a sensitivity of approximately one degree. They do display overall movements throughout construction as a result of leveling and re-leveling the structure. The worst settlement issues occur close to Motes 8 and 11. This is the reason that the results of the motes are chosen as examples (Figure 3-6).

Figure 3-6. Mote 8 (left) and Mote 11 (right)

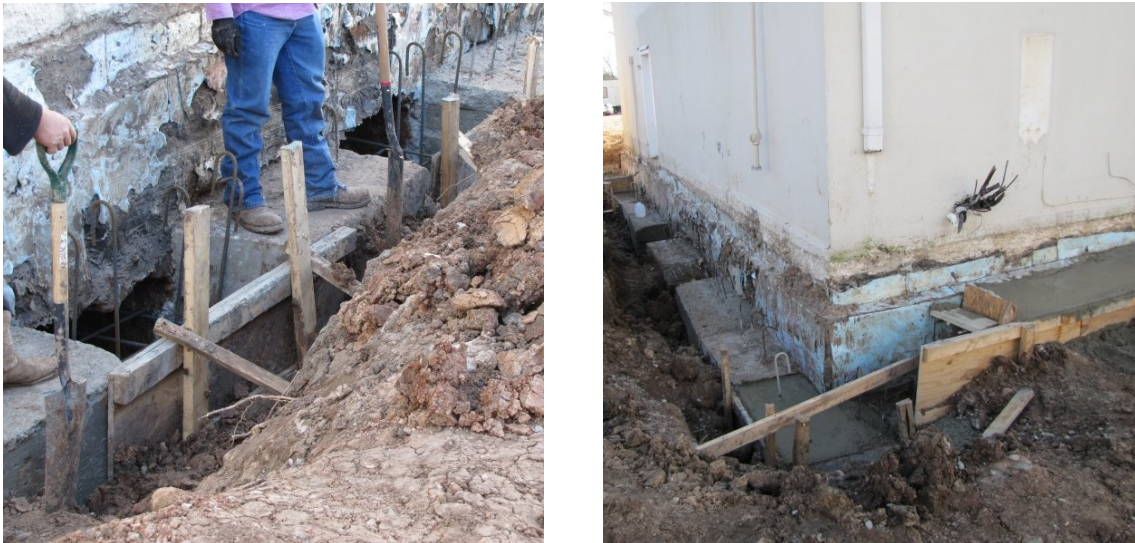
foundations (Figure 4-5). Water barrier mats are installed at the foundation level to redirect water away from the church to ensure water does not become entrapped under the foundations in the future. After the church is stabilized, the exterior and interior are replastered as needed in four stages, starting with a rough plaster and moving to a smooth finish for the interior and a brushed finish for the exterior, both of which are painted a shade of cream (Figure 4-6). Since the front wall has the worst problems, the entire front exterior wall has to be replastered (Figure 4-7).

Figure 4-5. Foundation excavations and new footing (left, St. Paul Lutheran 2010) and footing with beam stiffener (right, St. Paul Lutheran 2010)

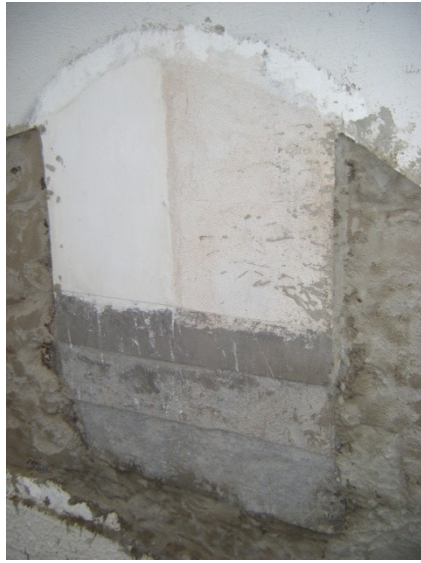
Figure 4-6. Four stages of plaster repair

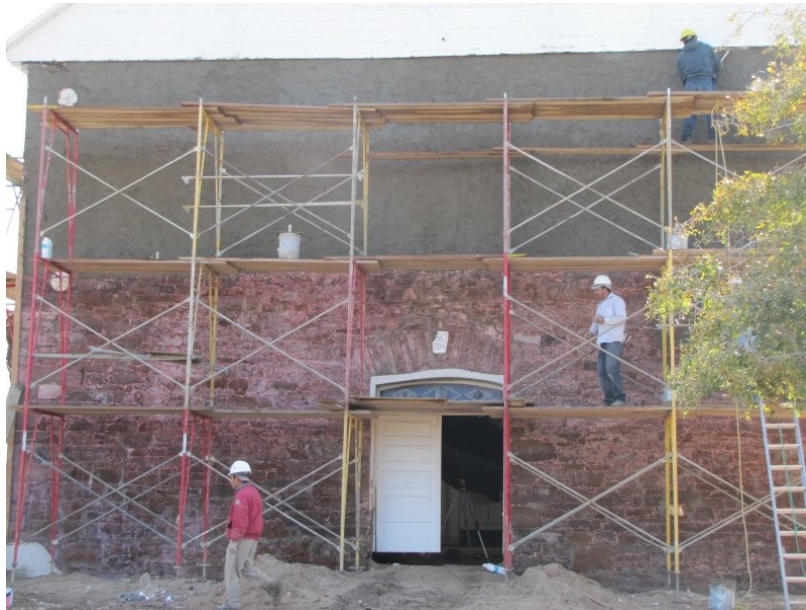
Figure 4-7. Front entrance partially replastered (St. Paul Lutheran 2010)

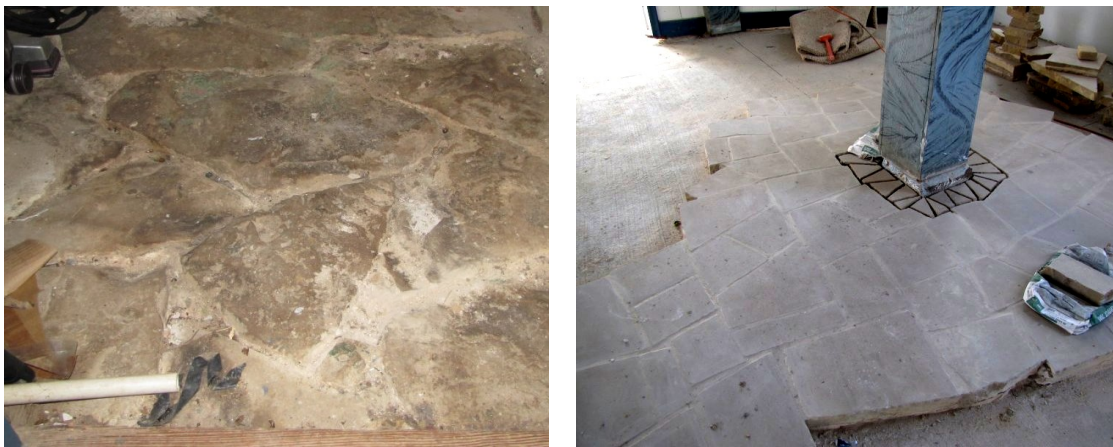
During construction, the original stone floor is found under the concrete slab (Figure 4-8). The majority of the stone is able to be salvaged and although it is too uneven according to the Americans with Disabilities Act (ADA) standards to be reset on the interior of the church, it is planned to be reused at the entrance. To create a similar feel as the original floor, stone tiles are set on the new concrete slab (Figure 4-8).

Figure 4-8. Original stone floor (left, St. Paul Lutheran 2010) and new stone floor (right, St. Paul Lutheran 2010)

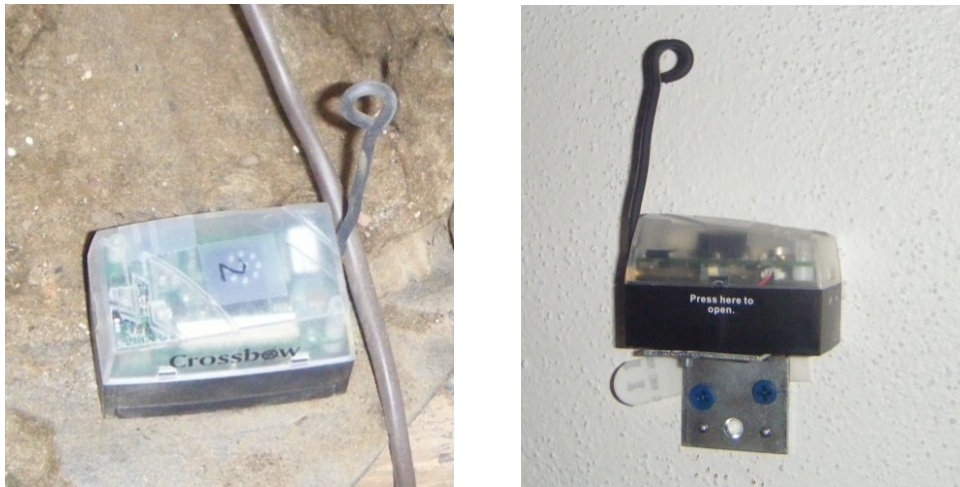
Motes 2 and 11 are chosen as examples (Figure 4-10). They display the results for a mote installed on an attic floor beam and a mote on the north wall near the stairs, respectively.

Figure 4-10. Mote 2 (left) and Mote 11 (right)

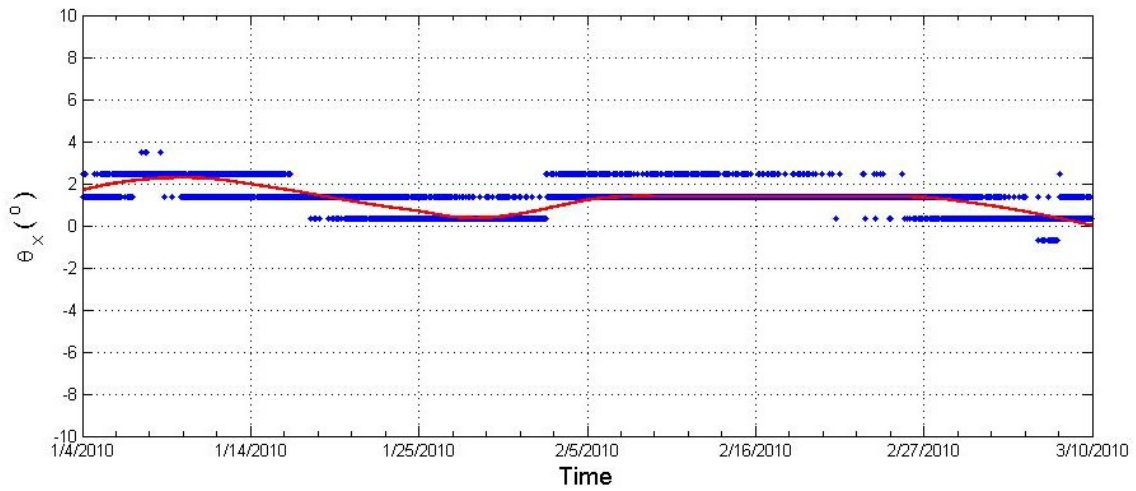
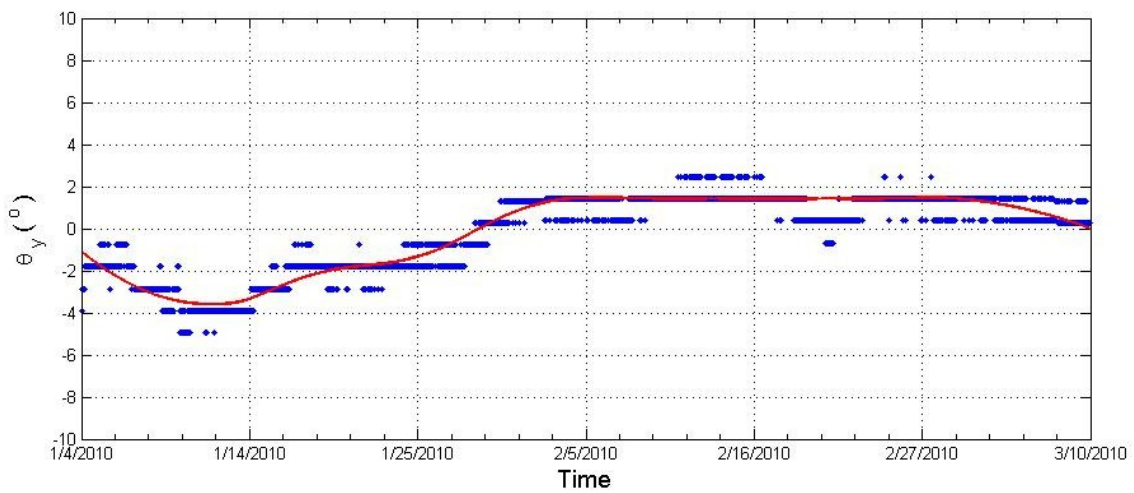
level while Mote 11 remains relatively unchanged. Since it only lasts one day, the structure does not have any significant movement during the unheard of snow delay (2/23/10). After the snow delay, the only remaining foundation work is to finish excavation and pouring concrete around the foundations (2/24/10 to 3/3/10). At this point, the majority of the structure is secured, as evidenced by the relatively small amount of movement (if any) recorded by the motes, excluding Mote 2 in the y -direction. The foundation work is completed on 3/4/10 and as can be seen, the motes remain fairly stable after this point, except for Mote 2 in the y -direction. It is unclear as to what caused this shift while everything else remained unchanged, but as previously stated, this mote is on a wooden beam and is therefore more susceptible to movement. The fact that the motes (excluding Mote 2 in the y -direction) show no significant movement from the end of the foundation work to the end of the measurement period (3/4/10 to 3/10/10) confirms the analysis of the structural engineer that the floor slab is detached from the structural system of the walls. This is proven because during this time, the existing concrete slab is demolished and the original stone floor underneath is removed. Figures 4-11 through 4-14 display the output plots, which are correlated to the construction activities detailed above.

Figure 4-11. Tilt of Mote 2 in x – direction

Figure 4-12. Tilt of Mote 2 in y – direction

Figure 4-13. Tilt of Mote 11 in x – direction

Figure 4-14. Tilt of Mote 11 in y – direction

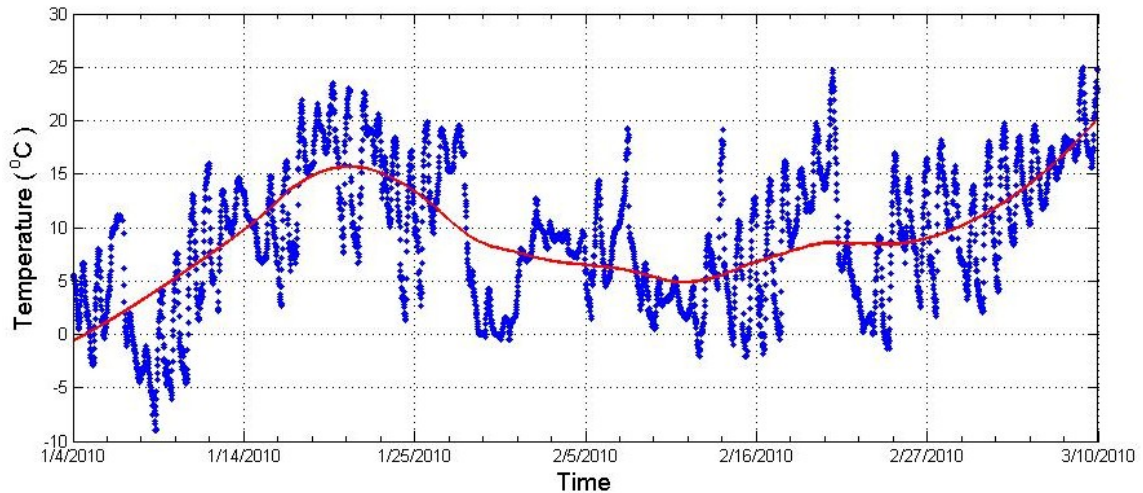
For an additional comparison, the temperature at the church is plotted each day at 20 minute increments (Figure 4-15). This displays the wide range of temperatures for which the sensors can be implemented (Weather Underground 2009).

Figure 4-15. Temperature at St. Paul Lutheran during monitoring

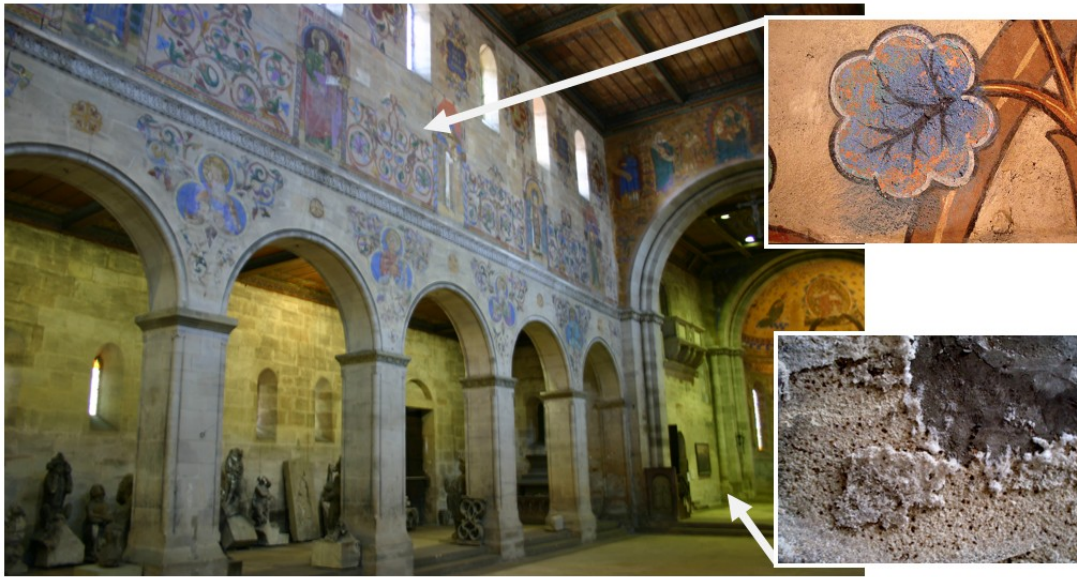
Heritage conservation of the Johanniskirche has been underway since 2009 to address the many problems facing this structure. The most critical issues involve the murals on the walls and effects of the interior and exterior climate conditions. Figure 5-3 provides a detailed view of the damage in both the upper and lower levels. Conservationists noticed delamination and deformation of the paint layer in the gilded areas. Paint and pigment loss due to degradation of the binder material as well as paint particles falling off or being washed away by condensation and dust deposition are major points of concern. In addition, the structure has no heating system and therefore the indoor climate can become very humid. This leads to condensation and traces of water running down the clerestory windows, which causes debonding of the mortar joints and material loss. The durability of the sandstone walls is also in question because damaging salts are found in the lower areas of the walls. Figure 5-3 documents the paint and salt damage observed in the structure.

Figure 5-3. Detailed view of damage: paint deterioration in upper level and salt damage in lower walls (Krüger et al. 2010)

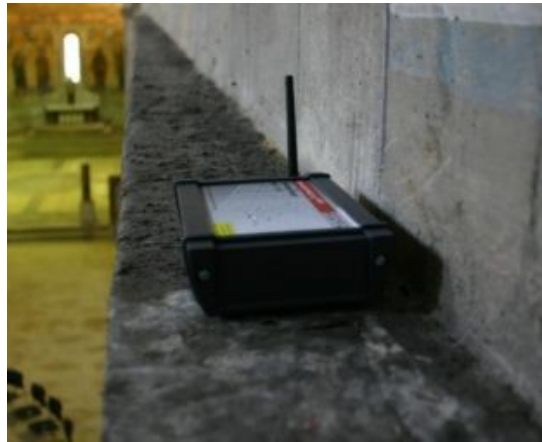
Figure 5-4. Wireless sensor installed in the Johanniskirche (SmartMote 2010)

For monitoring at the Johanniskirche, motes equipped with SHT15 sensor boards are placed at ten locations throughout the structure. At five of these locations, an

additional sensor is installed on the exterior and connected to the interior mote with a wire through a small hole near the window or between planks in the ceiling. Figure 5-4 displays a mote installed in the interior of the church. The locations of the motes are detailed in Figures 5-5 through 5-7.

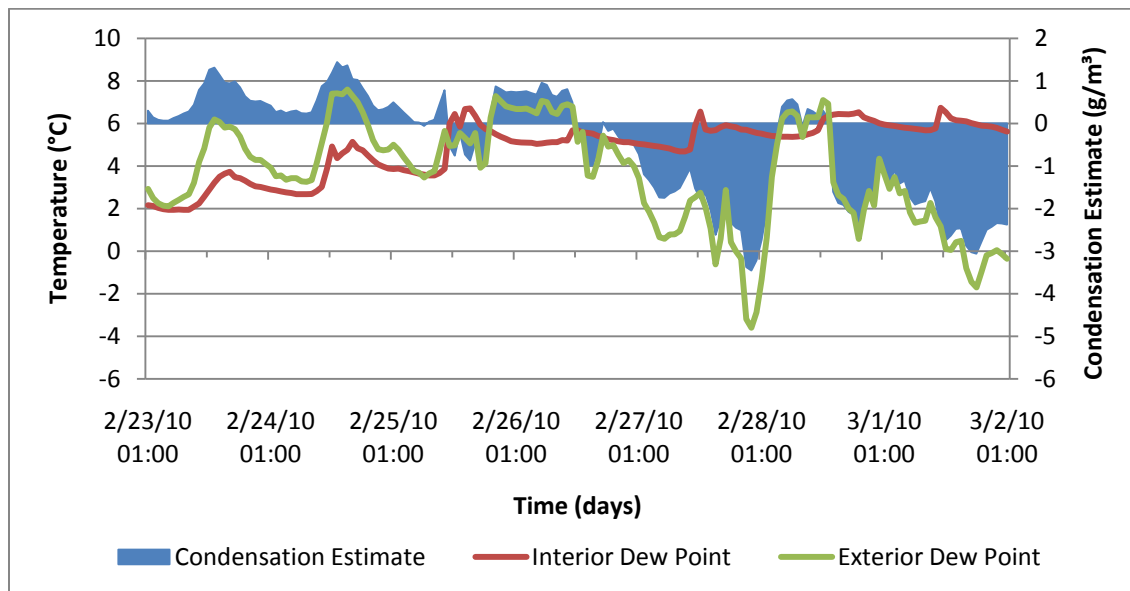
Figure 5-11 is an example of output from the risk analysis criteria using interior dew point (Mote 5), exterior dew point (Mote 38e) and the calculated condensation estimate. As seen in the Figure 5-11, condensation occurs when the exterior dew point is above the interior dew point, and likewise, evaporation occurs when the interior dew point is above the exterior dew point. Note, specifically, that the condensation estimate is a good indicator because condensation was observed at the Johanniskirche on 2/26/10 and the plot indicates condensation.

Figure 5-11. Week 10 interior dew point, exterior dew point and condensation estimate over time

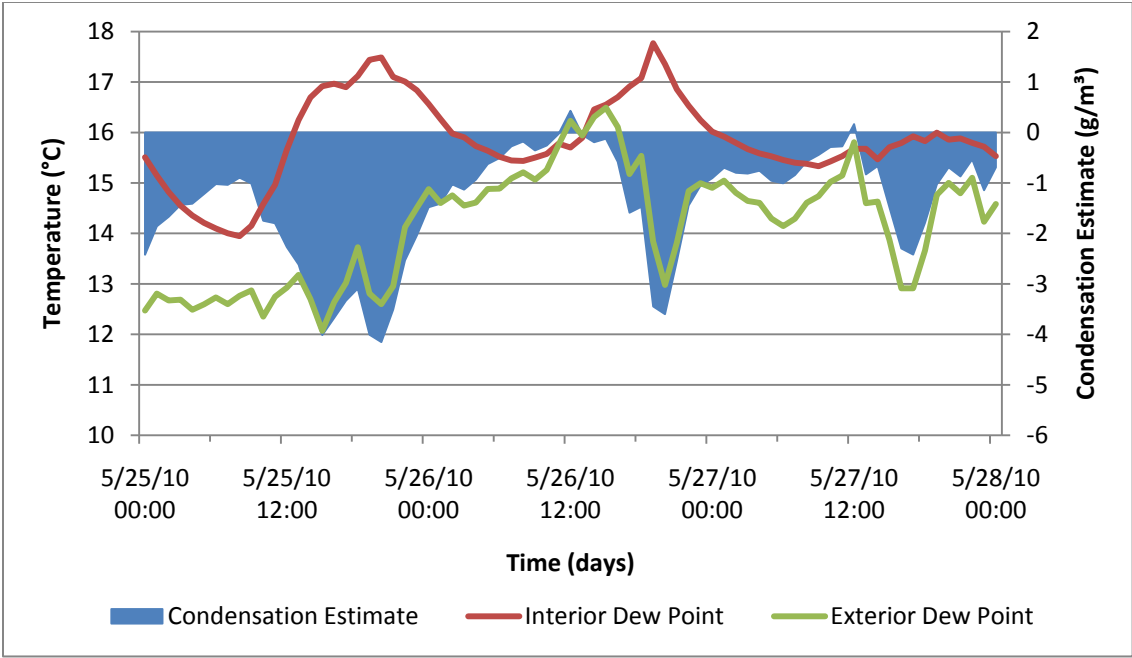
and Figures 5-13 through 5-17 display the plots for each of the five levels from 5/25/10 to 5/28/10. This time span is selected because condensation is documented on the floor of the church on 5/26/10. These plots provide valuable insight into locating areas of critical climate conditions. The ground level (Figure 5-13) has the highest condensation estimate during the condensation event of approximately 1.69 g/m^3 . At mid height (Figure 5-14), this value is almost cut in half at approximately 0.89 g/m^3 . In the clerestory (Figure 5-15), the condensation is again cut in half with a value of approximately 0.43 g/m^3 . Even higher, at the intermediate ceiling (Figure 5-16), the condensation estimate again decreases to approximately 0.32 g/m^3 . However, this trend ends at the attic level (Figure 5-17), which records the second highest condensation estimate of approximately 0.99 g/m^3 . This confirms the initial hypothesis that some of the moisture in the structure entered through the roof.

Figure 5-13. Measured and calculated data relationship at ground level (Mote 51)

Figure 5-14. Measured and calculated data relationship at mid height (Mote 5)

Figure 5-15. Measured and calculated data relationship at clerestory (Mote 38)

Figure 5-16. Measured and calculated data relationship at intermediate ceiling (Mote 7e)

Figure 5-17. Measured and calculated data relationship at attic level (Mote 7)
