Microbial water quality in clean water tanks following inspection and cleaning

Christensen, Sarah Christine Boesgaard; Esbjørn, Anne; Mollerup, Finn; Albrechtsen, Hans-Jørgen

Publication date:
2014

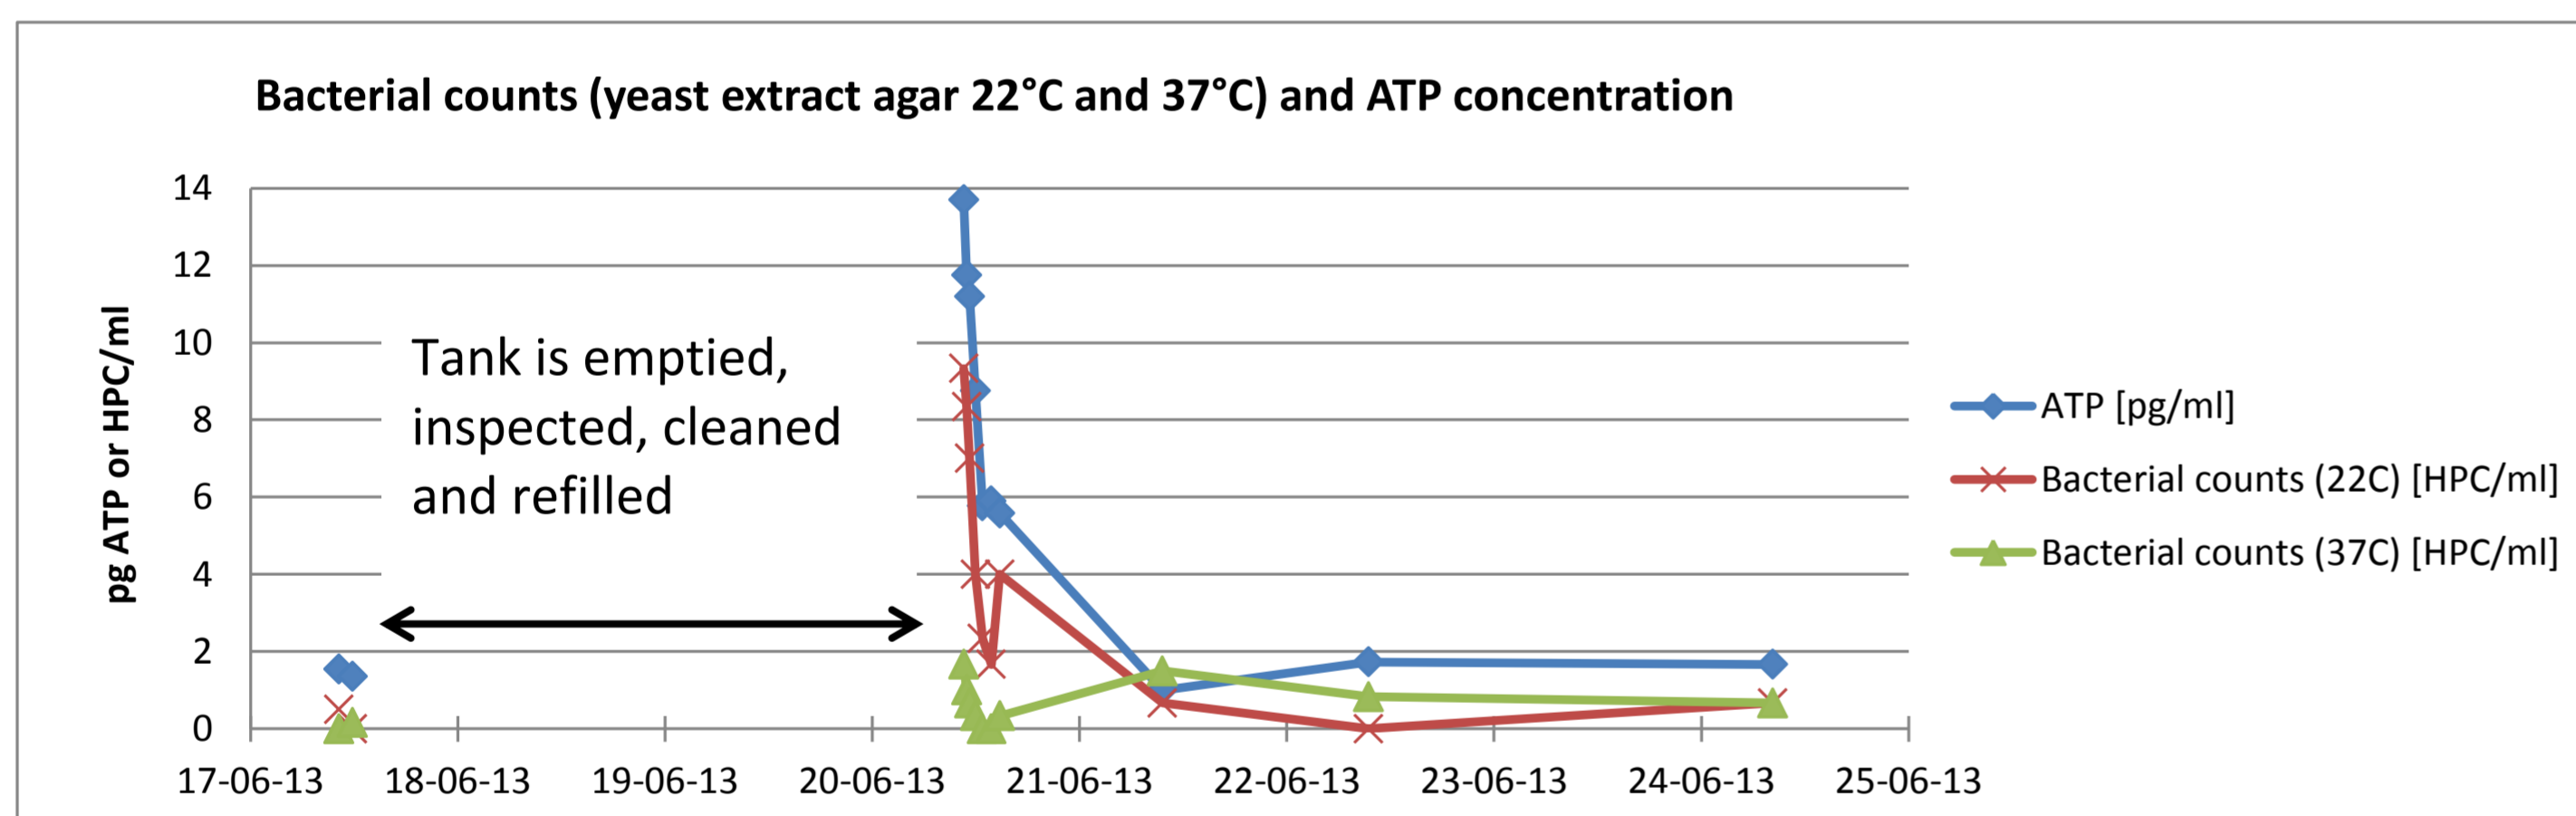
Concentration of ATP and bacterial counts [yeast extract agar, 22 and 37°C] in water leaving clean water tank from the main water works at VCS Denmark

Bacterial counts [yeast extract agar, 22°C] increased slightly after cleaning of the tanks, but did not exceed guideline values at any point during the investigations. Immediately after start-up, a maximum of 10 CFU/ml (Colony Forming Units) were measured in both tanks, and after less than

24 hours the concentrations were below 1 CFU/ml in both tanks. The low concentrations were maintained the following days. Bacterial counts [yeast extract agar, 37°C] were below 2 CFU/ml at all times.

To include bacteria not normally quantified by traditional methods, such as plating, we included ATP (Adenosin-Tri-Phosphate) measurements of the water. ATP is present in all living bacteria. ATP concentrations in the water immediately after start-up were high compared to the concentration of culturable bacteria which may indicate that bacteria from the sand filter e.g. nitrifying bacteria, which normally grow on substrates not present in the agar, were present in the water.
