IC3 and IC4 Trains Under Risk of Blocking their Wheels

A case study on challenges when working with data from multiple databases

Big Data, Data Warehousing, and Data Analytics

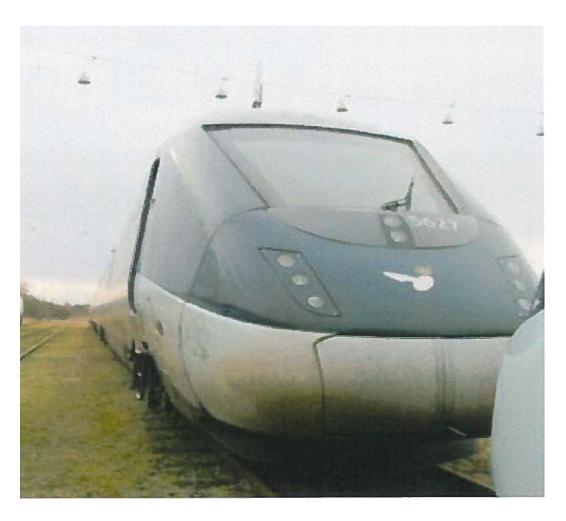
The Marslev Incident

On November 7th, 2011, an IC4 train passed an active stop sign at the Fuenen town Marslev.

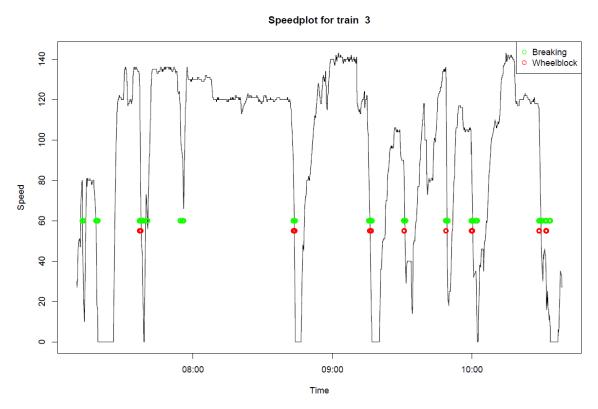
Data Base; Train logs:

- Data from train logs for the test rides contained:
- Speed; Time Stamp; Braking Power; Blocking Flag Status.

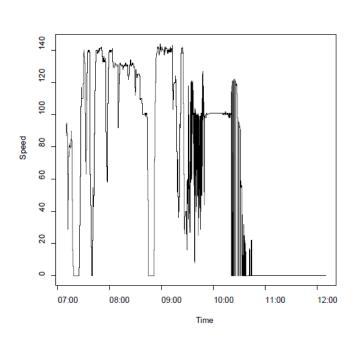
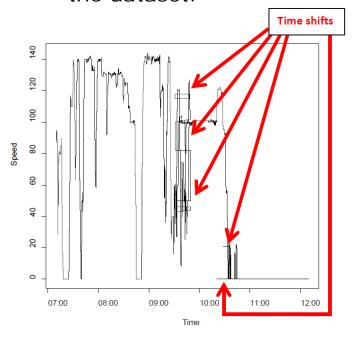
Data for train-log:

Here plotted sequentially from the dataset:

"Anders har ret. Tiden går baglæns. Jeg har ikke nogen forklaring på det" ("Anders is right. Time goes backwards. I have no explanation of it")

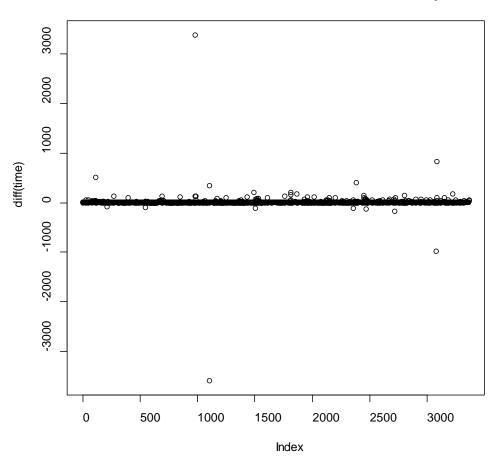
Differenced Time Stamps, Train 12

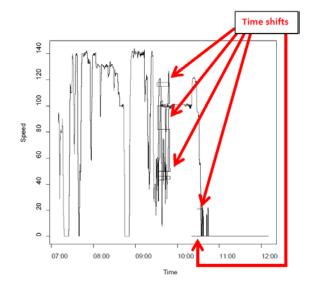
Cleansed Speed profile:

113 corrections for time shifts unaccounted for.

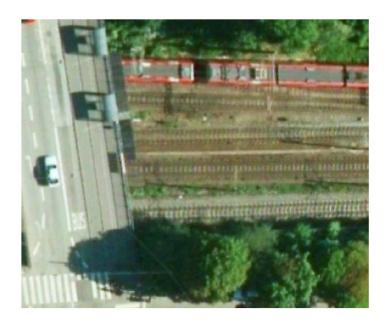
Figure 1: Track lanes around Toftegårds Alle near Valby Station. Source: Krak[®]/Eniro Danmark A/S.

After presenting this picture, a new dataset with 'most probable track' was constructed, for curvature measurements.

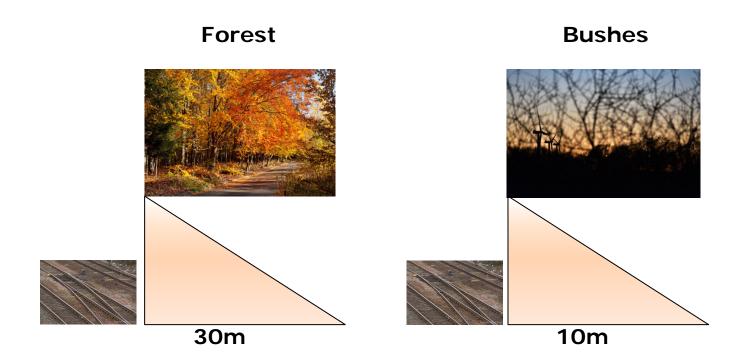
Construction of the local Leaf Fall Index: The Thickness Index T

30 meters thickness: T=1. 15 meters: T= 3/4. 10 meters: T= 4/9.

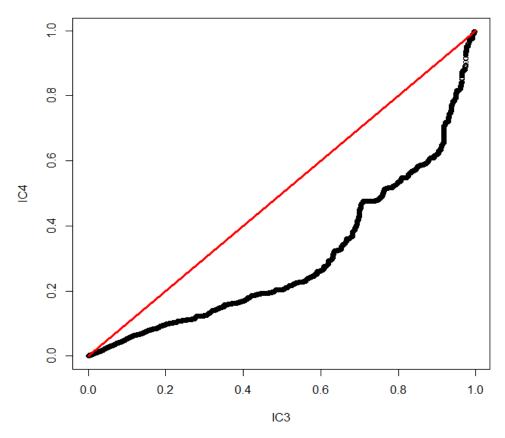
Predict probabilities for all test rides, assuming a constant speed of 140 km/h, and IC3/IC4 status. Inversed linear predictors:

P(Initiating Blocking Flag sequence)

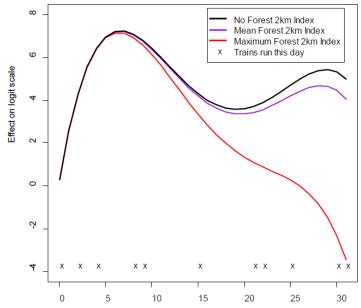
- Both Leaf Fall Index for forest and bushes are statistically significant; on site, 1km back and 2km back.
- Solitary trees are not signifikant.

The effect declines with calendar time; the amount of leaves becomes less.

Days since survey period start
