# **Lightning protection of flap system for wind turbine blades**

**PhD Thesis**

September 2014

The study of the lightning effects in the CRTEF system comprised the analysis of the discharge attachment, the current transmission, including the study of the induced electromagnetic fields, and the effects of degradation of the flap material due to the exposure to the lightning high electric fields. The main tools for this analysis were the simulation by the finite elements method and testing in the high voltage laboratory.

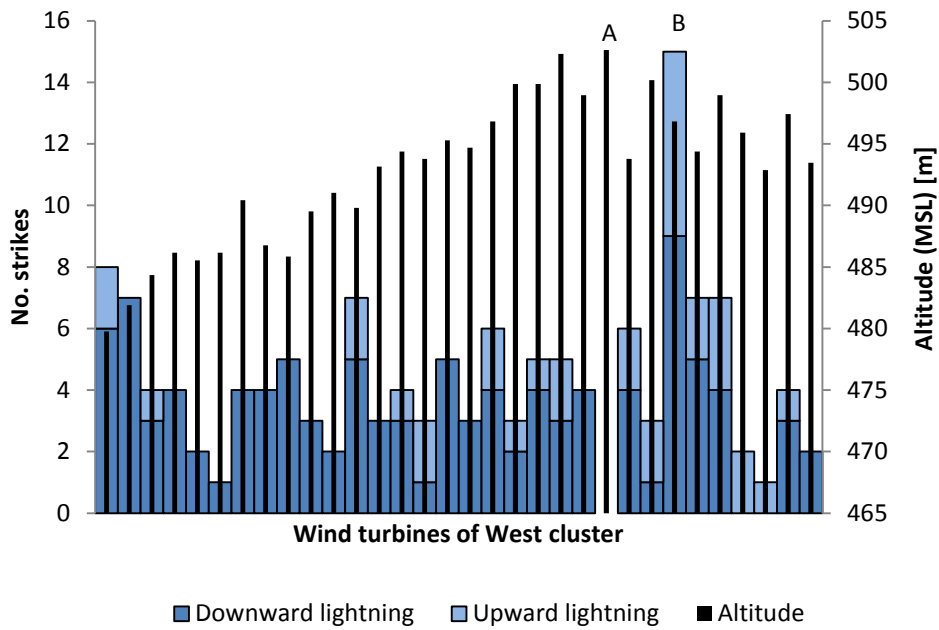
Figure 3-4. Above: Distribution of the downward and upward lightning strikes in the 32 wind turbines of the West Cluster, together with the altitude of the terrain where the turbine is installed. Below: Layout of the West Cluster. The red dots indicate the wind turbines with max. or min. number of strikes.

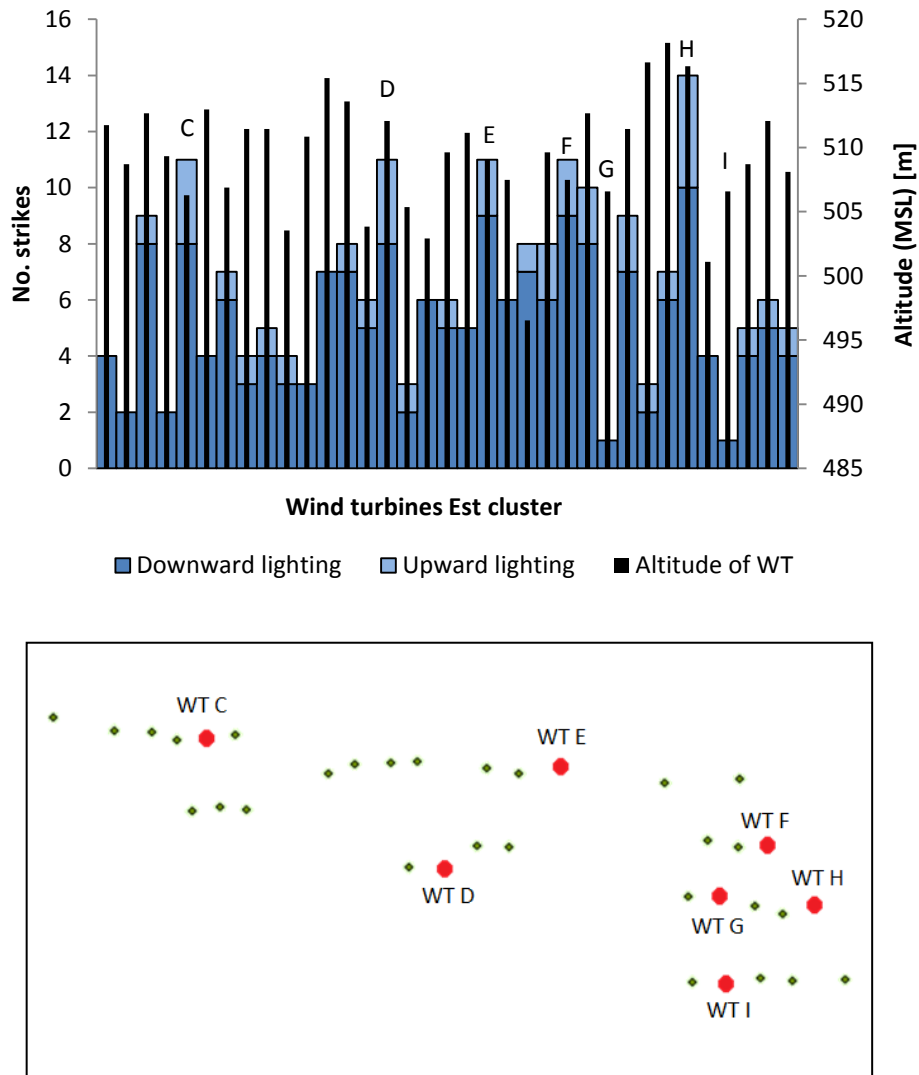
Figure 3-5. Above: Distribution of the downward and upward lightning strikes in the 32 wind turbines of the East Cluster, together with the altitude of the terrain where the turbine is installed. Below: Layout of the East Cluster. The red dots indicate the wind turbines with max. or min. number of strikes.

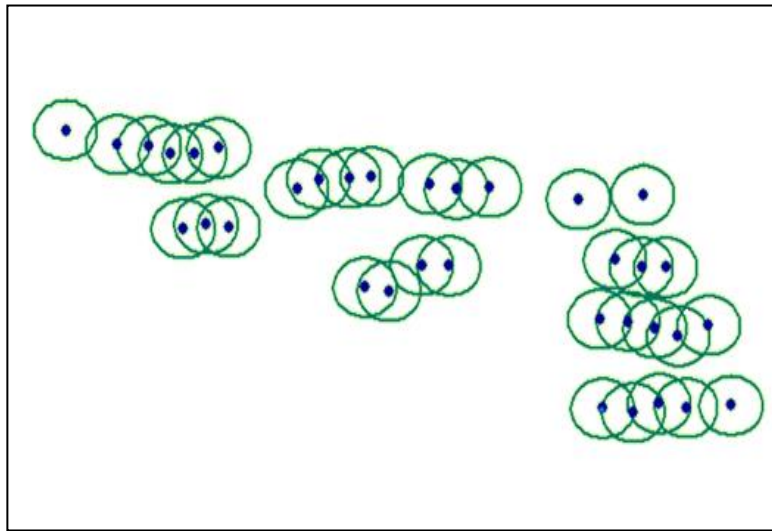
Figure 3-6. Overlap of collection area for the wind turbines in the east cluster (Blue dots: wind turbines, Green circles: collection area per turbine)

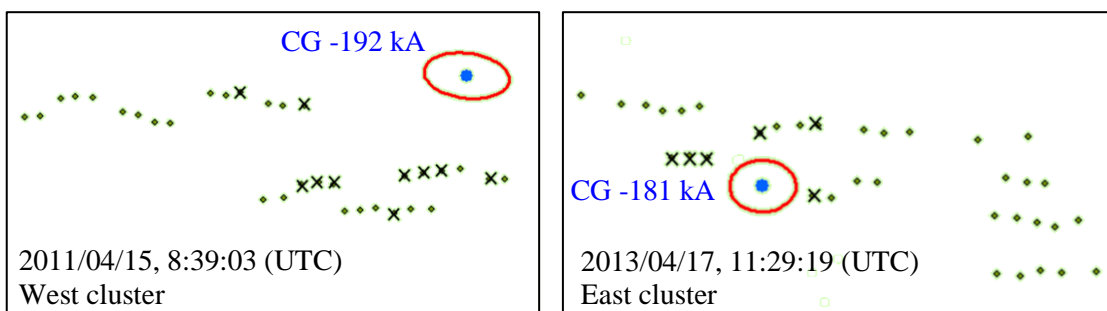
Figure 3-9. On the left event #1, on the right event #2. Location of the CG- discharges (blue dot) with 90% confidence (red ellipse). The wind turbines that triggered SCADA alarms are marked with a cross.

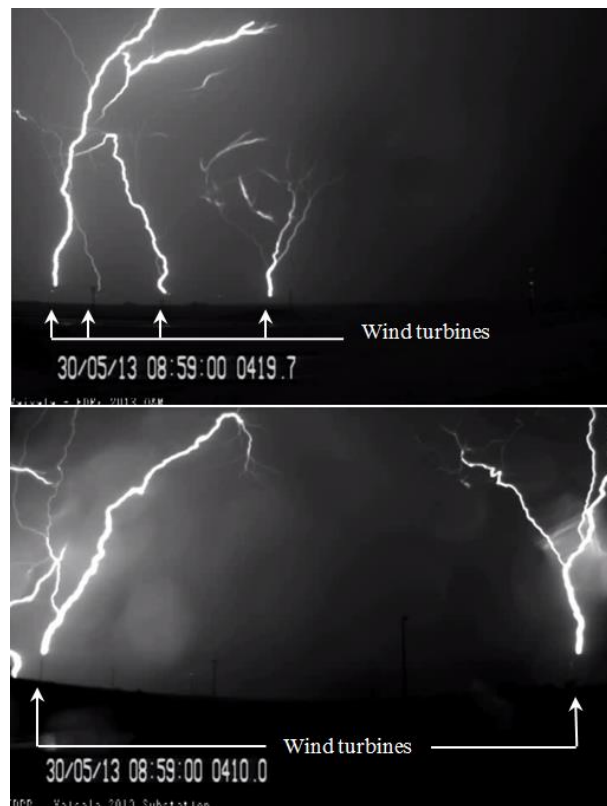
Figure 3-12. Upward discharges in wind turbines recorded by the video cameras. Above, frame from the camera installed further away from the west cluster, with a view of 25 wind turbines and the radio mast. Below, frame from the camera installed close to the west cluster, with a view of 8 wind turbines (included in the view of the first camera).

Event #5 occurred on 2013/05/30, and is included here in order to shed light on the likely nature of the simultaneous SCADA reports associated with CG+ flashes. Two video cameras installed in the west cluster of the wind farm captured simultaneous upward discharges in four wind turbines (Figure 3-12).

Regarding the mechanism that caused the discharges at the wind turbines in the events associated with nearby CG+, the video recording for Event #5 illustrates that the discharges at the wind turbines can be upward-moving. Other observations in the existing literature reported events where upward discharges from tall structures were initiated by CG+ and IC [35], [36], [37], [7], [44]. This suggests that the simultaneous discharges at the wind turbines are likely to be upward lightning or upward leaders triggered by the nearby CG+.

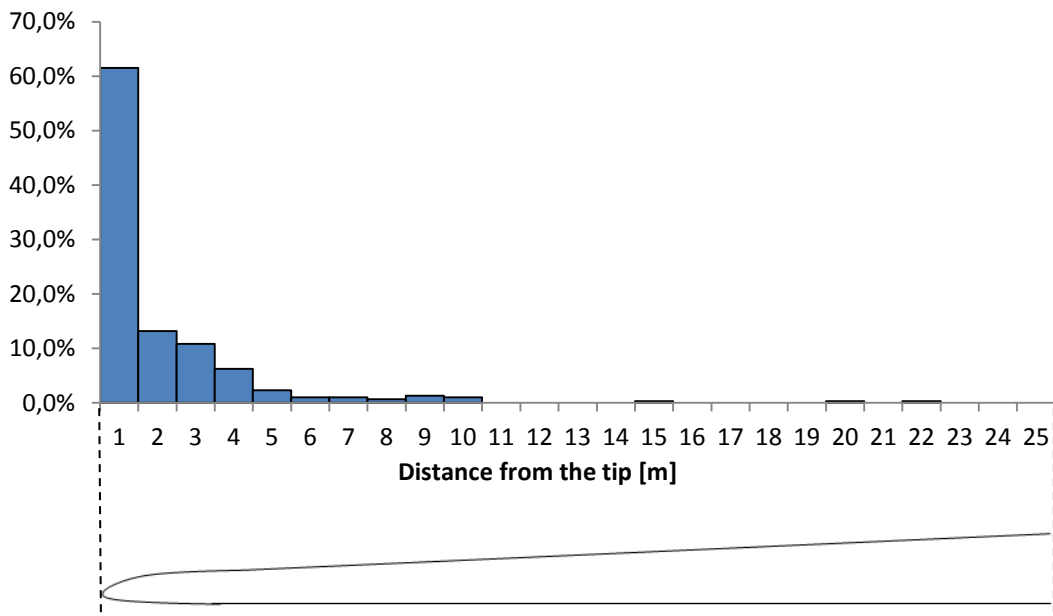
Figure 3-14. Location of the lightning damage (in percentage) for the total population of damaged blade.

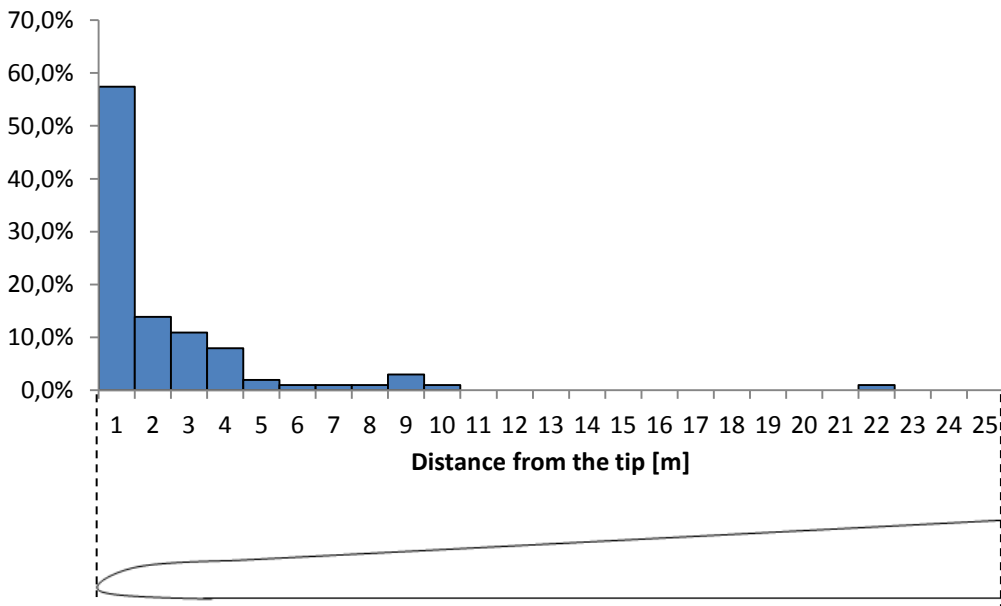
Figure 3-16. Location of the lightning damage (in percentage) in damaged blades with mixed fiberglass and carbon fiber structure.

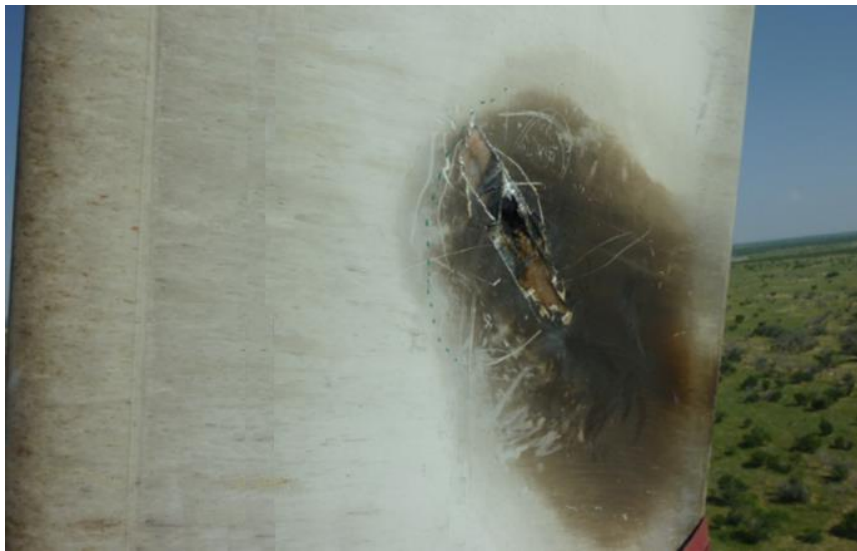
Figure 3-18. Burn and delamination on the shell at about 3m from the blade tip due to lightning direct strike.

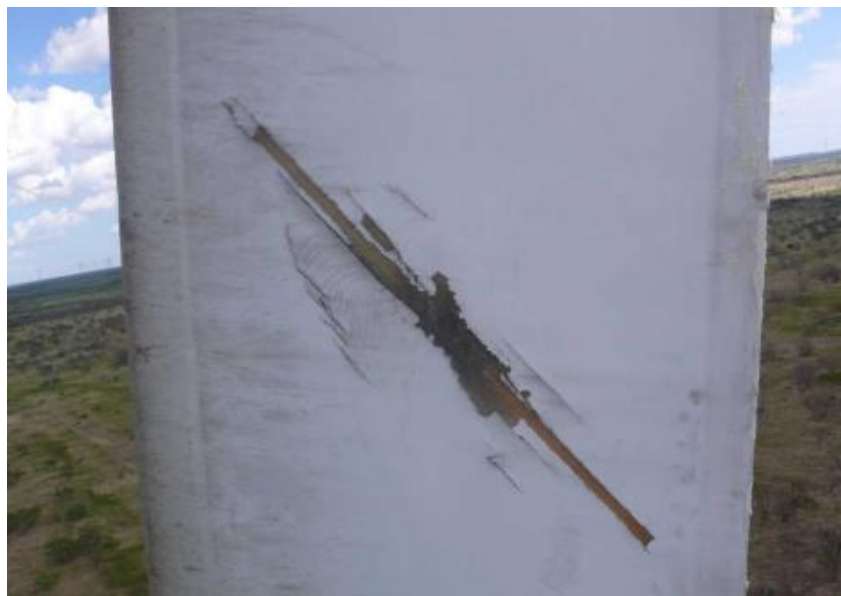
Figure 3-19. Delamination on the shell at about 2m from the blade tip due to lightning direct strike. It is observed how the fiberglass plies of the shell are detached around the strike point.

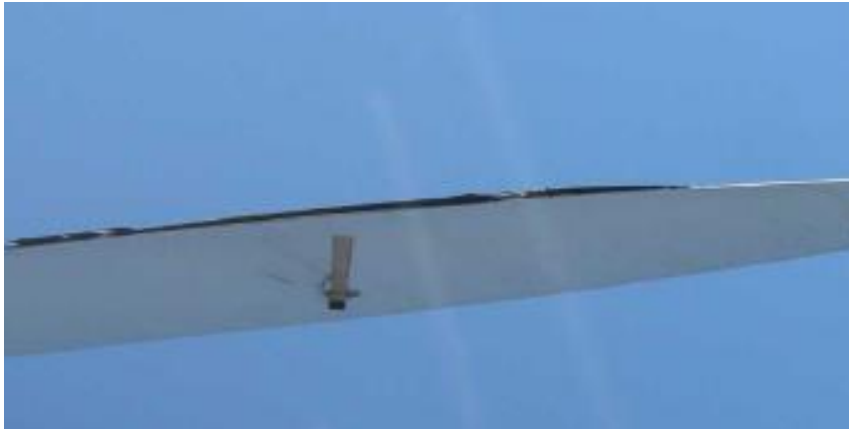
Figure 3-20. Delamination on the shell over the cap and debonding of the trailing edge likely caused by the expansion of the air caused by the lightning current.

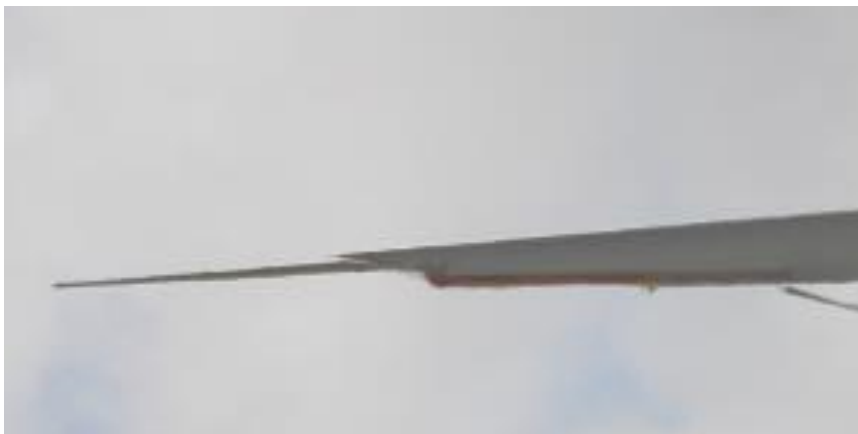
Figure 3-21. Detachment of the shells from the spar (load carrying structure) at the last meters of the blade.

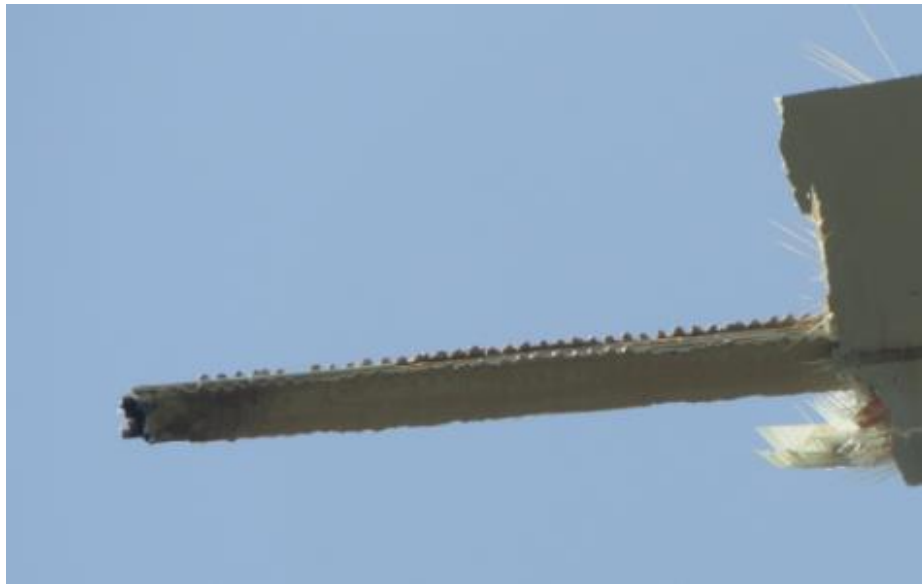
Figure 3-22. Tip detachment. The spar (load carrying structure) broke at several meters from the blade tip.

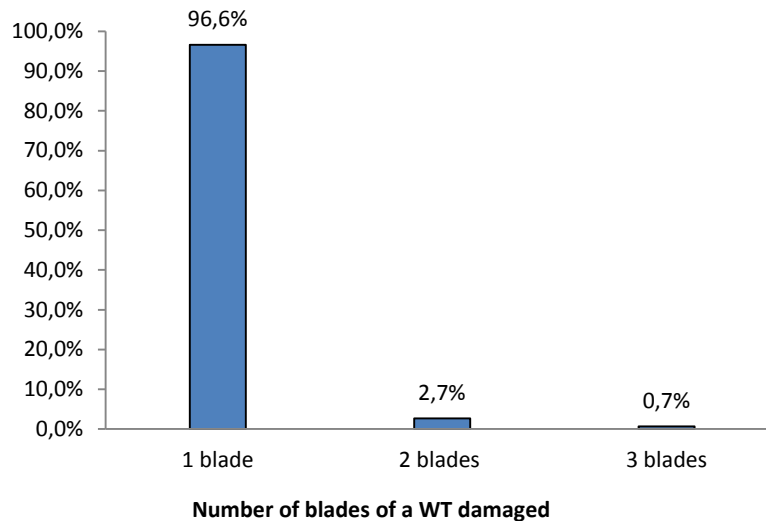
Figure 3-24. Number of damaged blades of a WT reported after a thunderstorm

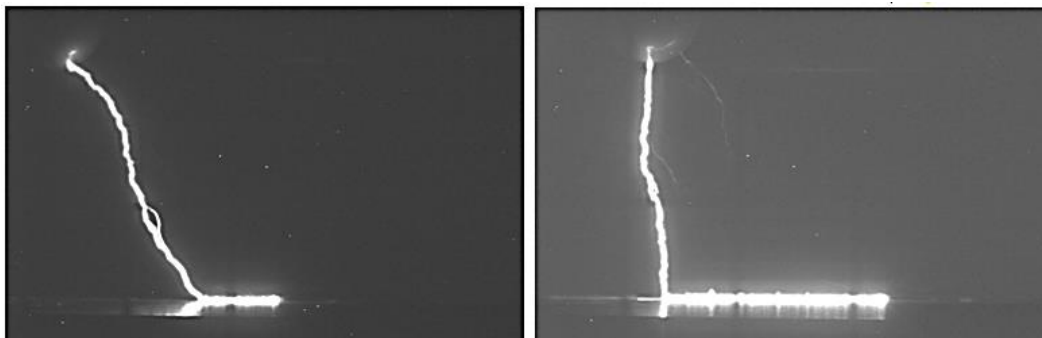
Figure 4-8. On the left, positive discharge in setup 1: the discharge path follows the panel surface approximately 100 mm. On the right, positive discharge in setup 3: The discharge path follows the panel 300 mm, the entire distance between the HV electrode and the receptor.

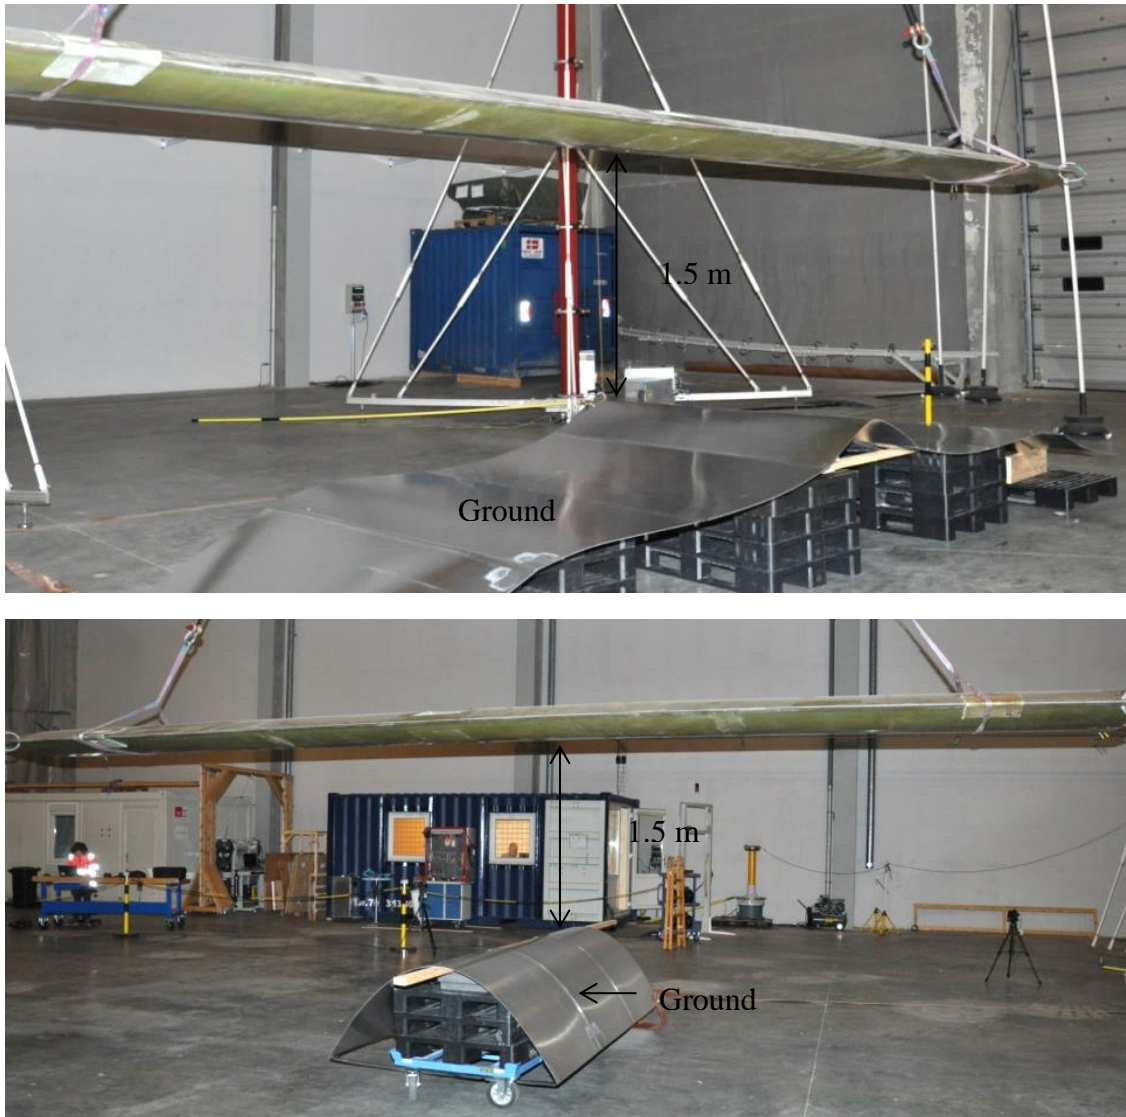
Figure 4-15. Blade section test setup, where the specimen is hanging at 1.5m from a ground plane. Above, setup for positive polarity. Below, setup for negative polarity.

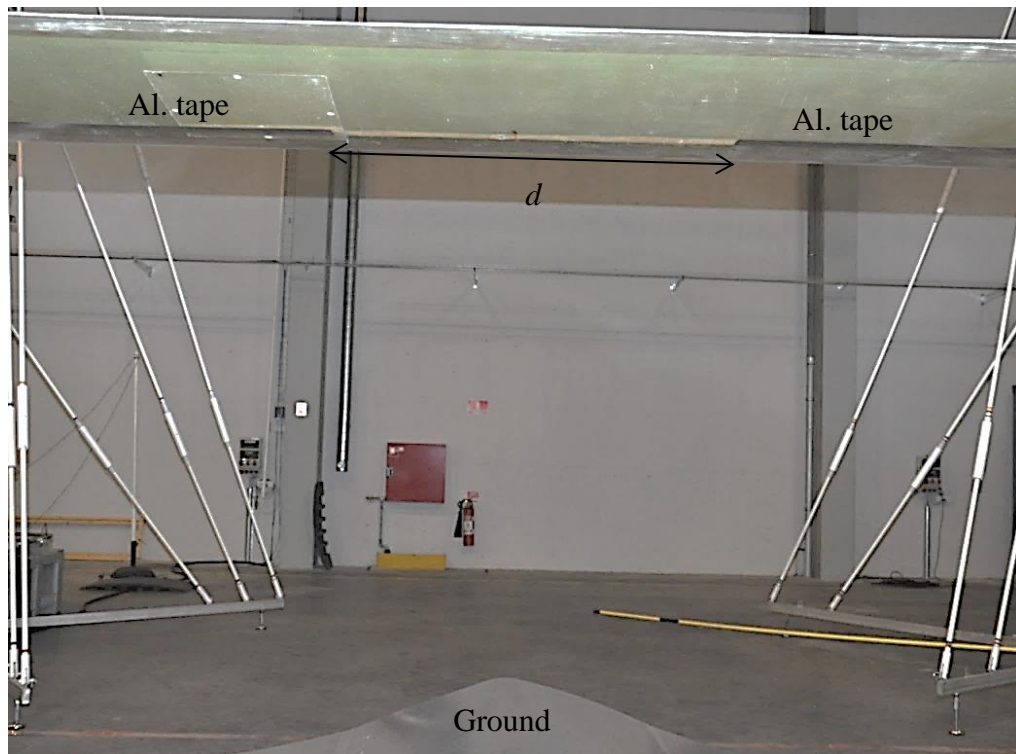
Figure 4-16. Aluminum tape stuck on the shell surface. Part of the tape is removed in a length  $d$ , over the protrusion on the grounding plane.

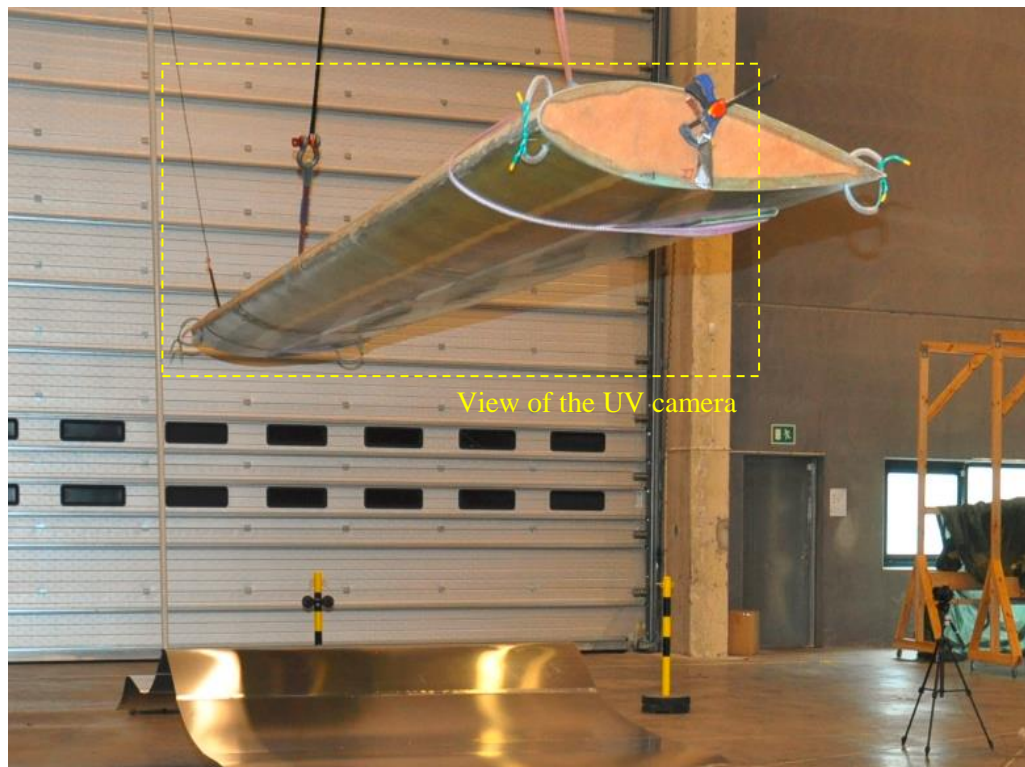
Figure 4-20. The dashed square indicates the view of the UV camera during the tests.

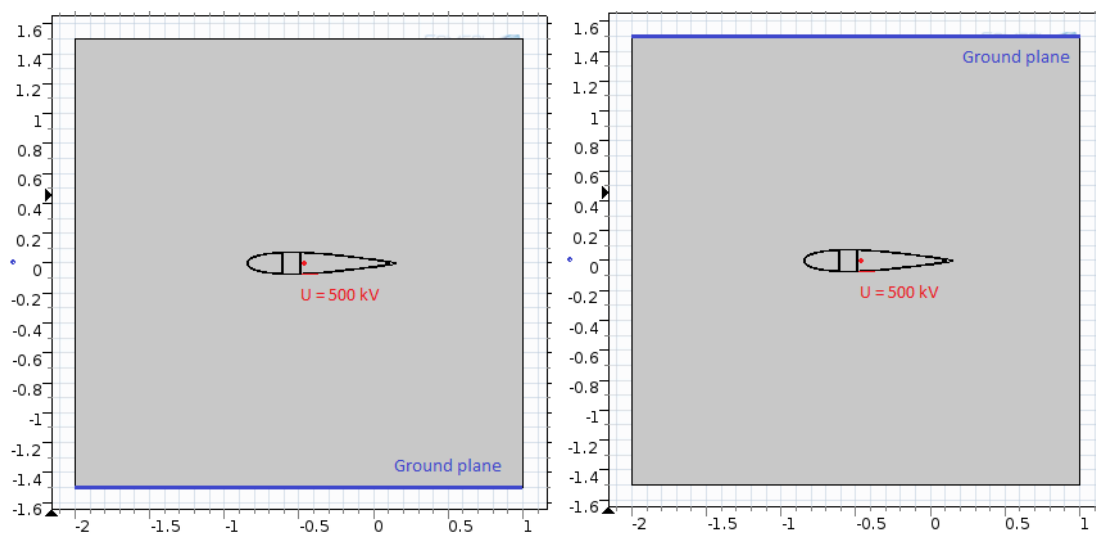
Figure 4-29. 2D model of the blade section. On the left, Case 1 where the lower shell equipped with the aluminum tape is facing the ground plane (blue line). On the right, Case 2 where the upper shell without aluminum tape is facing the ground plane (blue line).

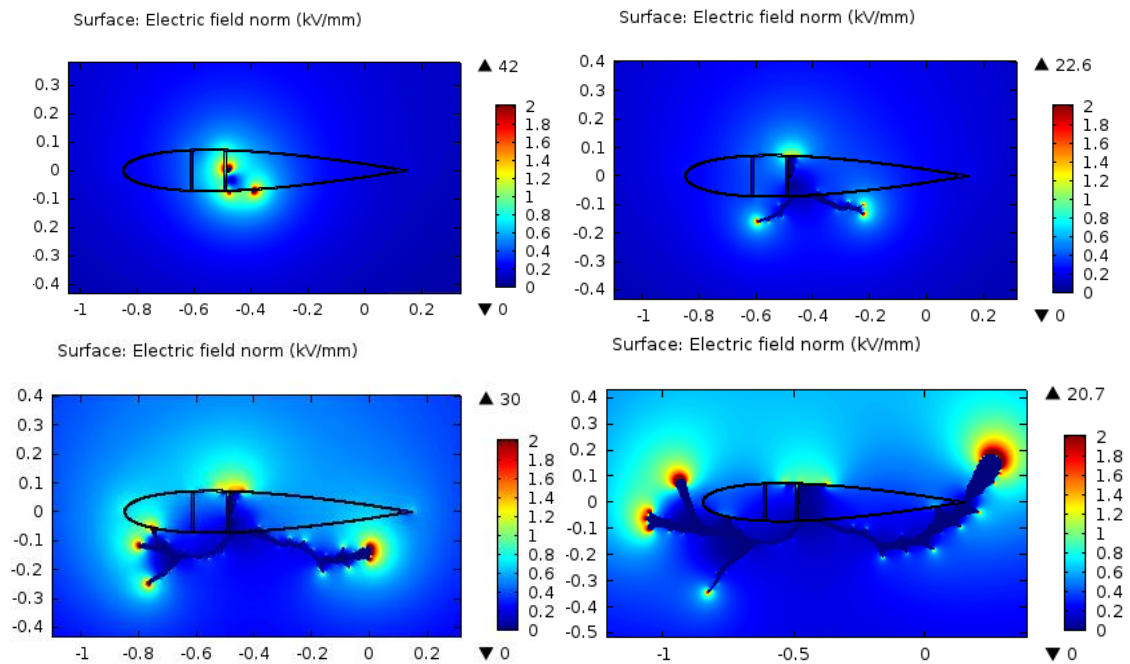
Figure 4-31. Propagation of streamers from the blade conductors in Case 2 with the ground plane facing the upper shell without aluminum tape (iteration sequence from left to right and down)

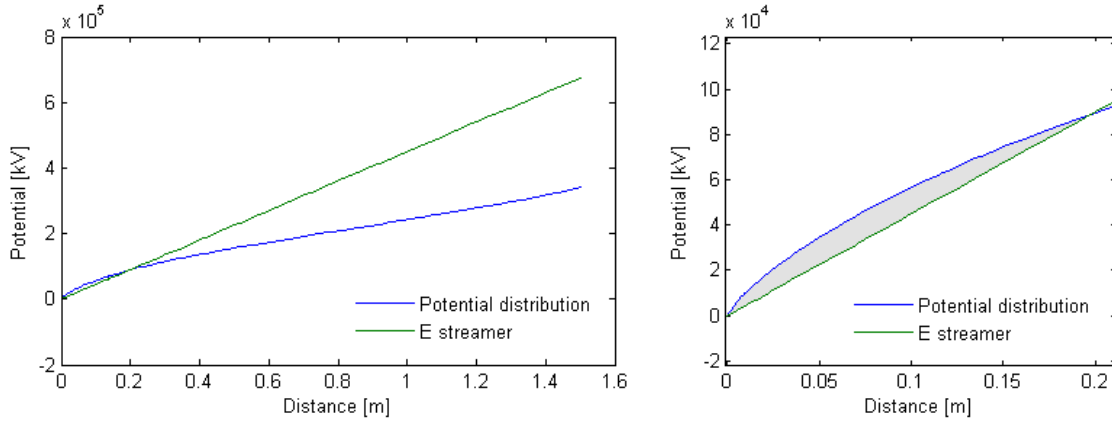
Figure 4-34. On the left, curve of potential distribution from the FEM simulation (in blue) and streamer gradient for positive polarity (in green). On the right, detail of the difference between the potential distribution and the streamer gradient (area in grey), which is proportional to the charge of the corona initiated at the aluminum tape.

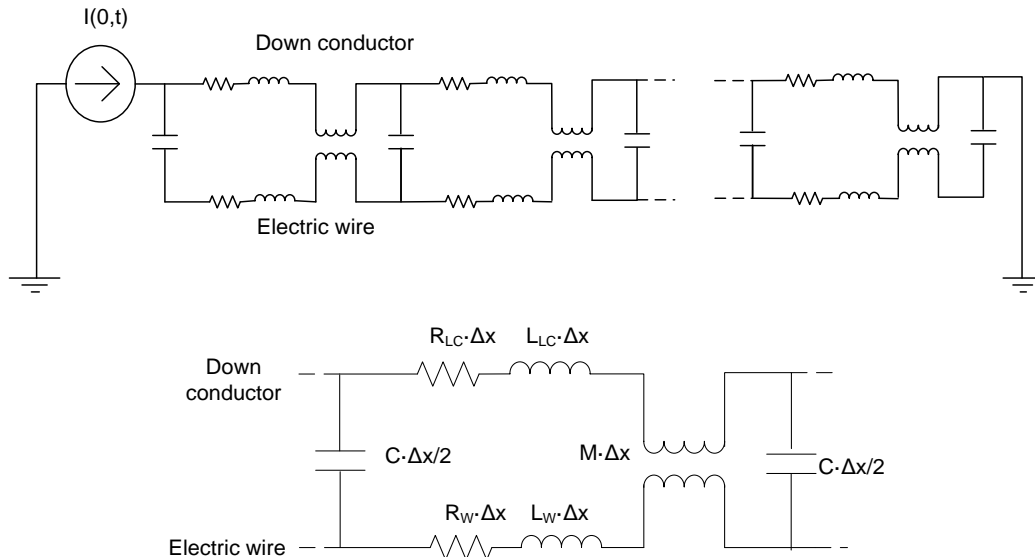
Figure 5-4. Above: Equivalent circuit of Model 2 consisting of 12  $\pi$ -sections, each representing a length  $\Delta x$  of 5 m of the blade. Below: Single 5-meter section of Model 2, consisting of the resistance and inductance of the lightning conductor and internal electrical wire, and their inductive and capacitive coupling.

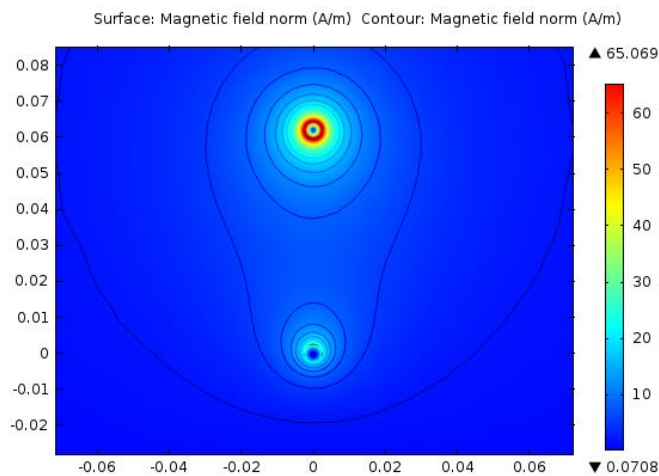
Figure 5-9. Flux generated at the upper conductor carrying 1A and linked by lower conductor carrying no current.

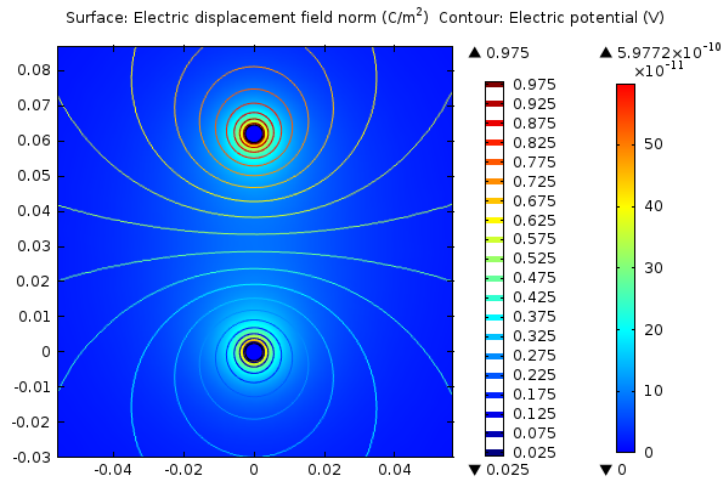
Figure 5-10. Equipotential lines between the upper conductor at 1V and the lower conductor at ground potential

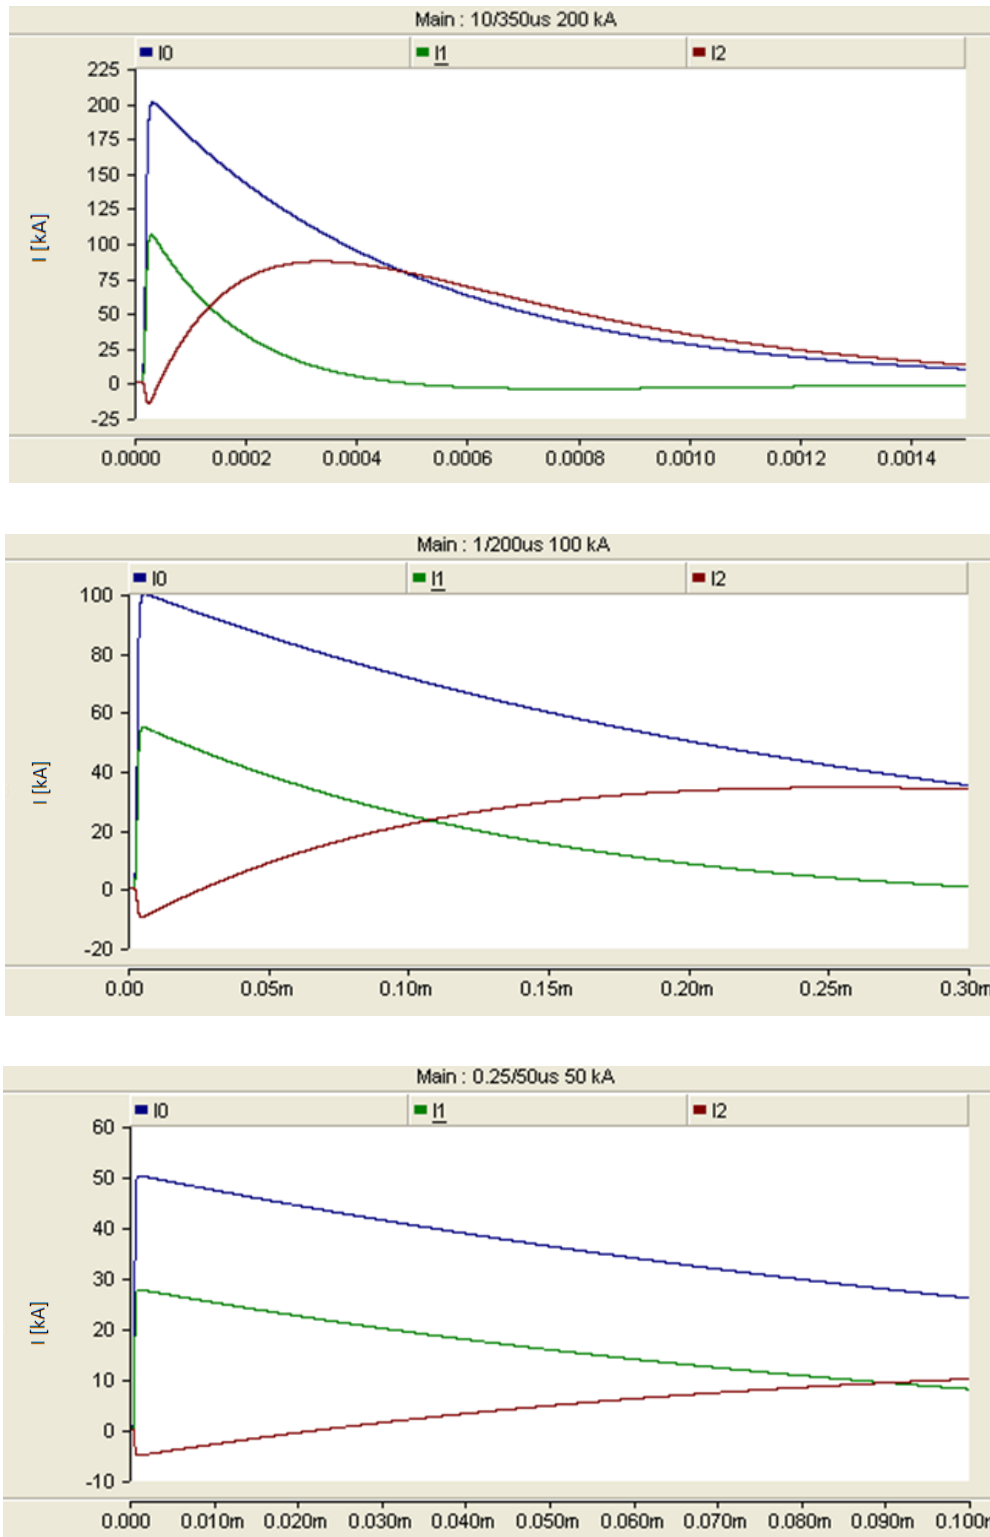
Figure 5-21. Case 2 (connections at R0 and R60), current waveforms measured at R60: Lightning impulse in blue, current waveform in the carbon laminate in green, current waveform in the down conductor in red. From top to bottom: 1<sup>st</sup> return stroke positive, 1<sup>st</sup> return stroke negative, subsequent stroke.

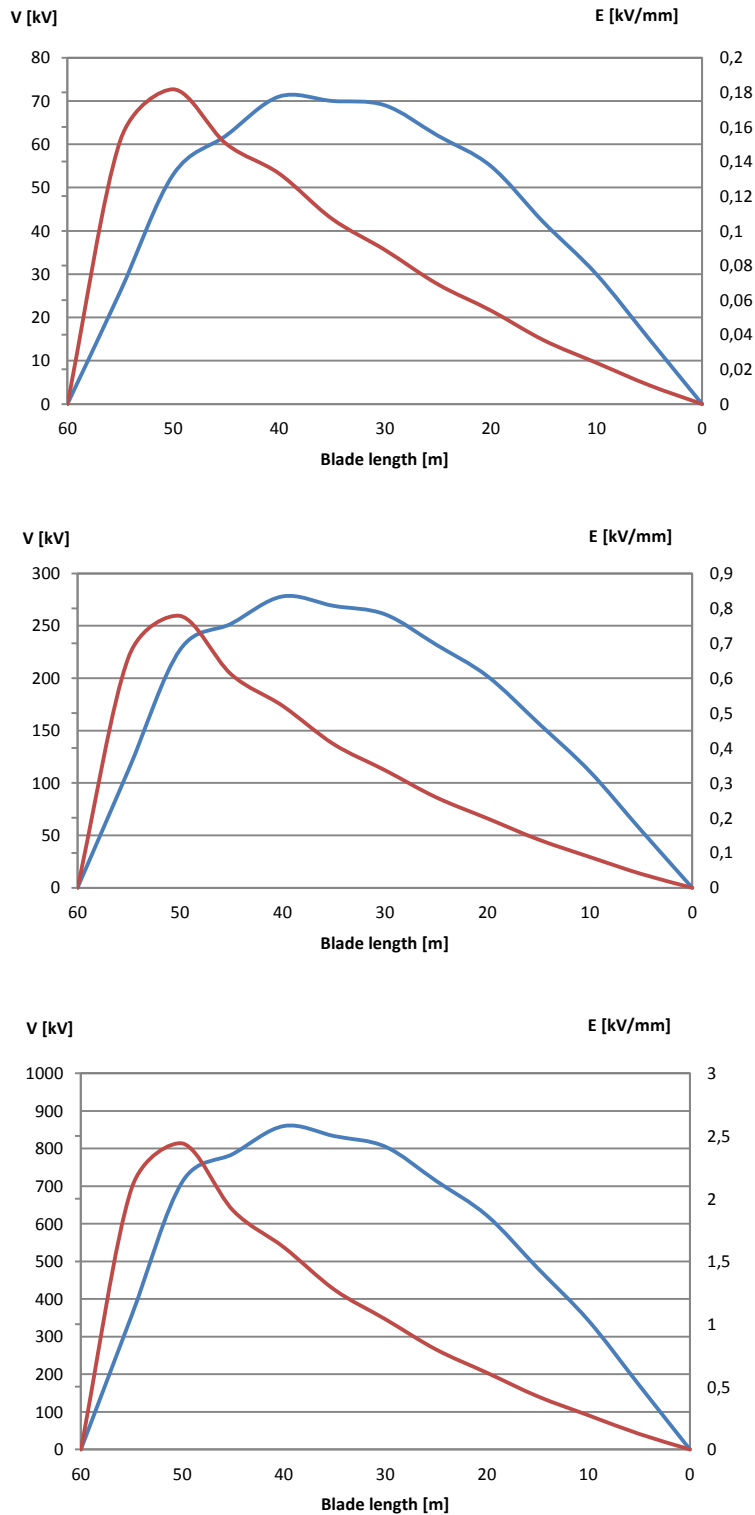
Figure 5-23. Case 2: Maximum voltage difference between the lightning down conductor and the wire (blue trace) and average electric field E [kV/mm] (red trace) for case 1. Top: 1<sup>st</sup> return stroke positive. Middle: 1<sup>st</sup> return stroke negative. Bottom: Subsequent stroke.

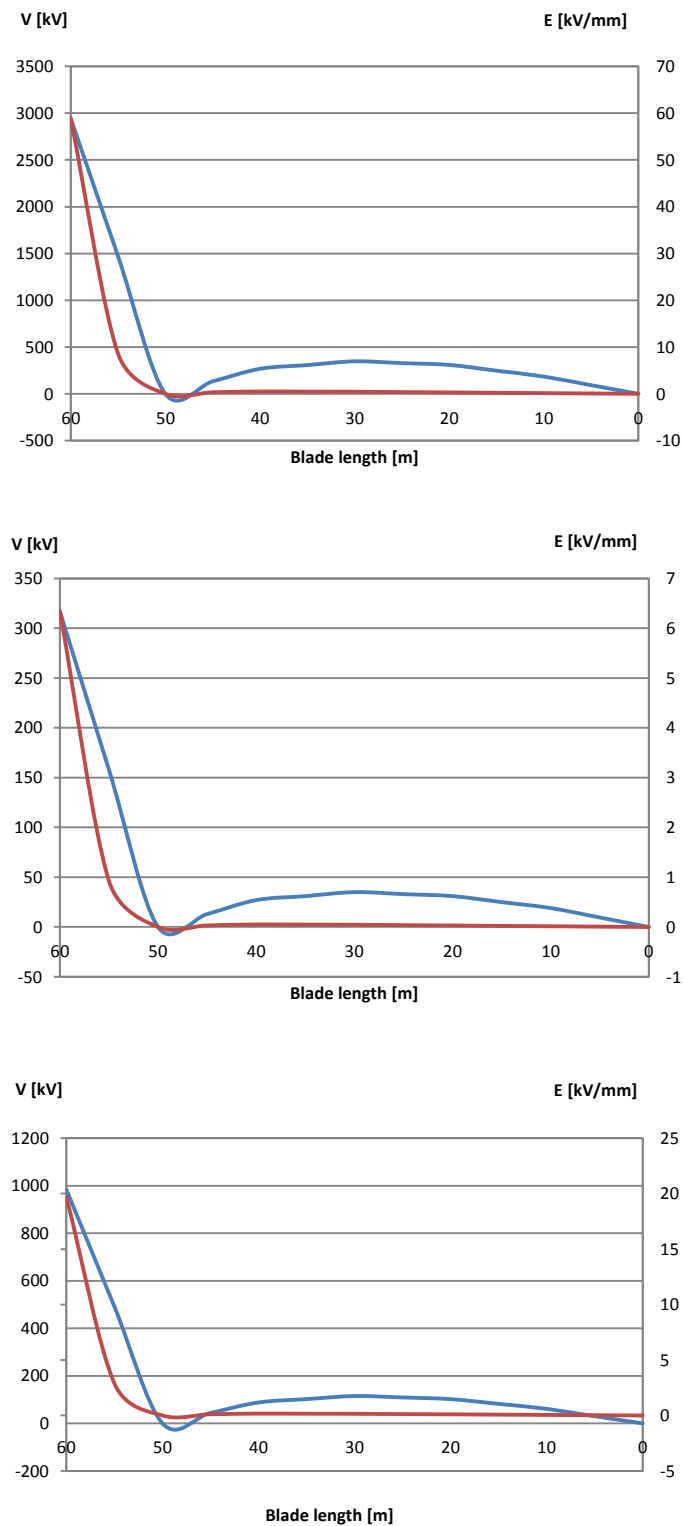
Figure 5-24. Case 3: Maximum voltage difference between the lightning down conductor and the wire (blue trace) and average electric field E [kV/mm] (red trace) for case 1. Top: 1<sup>st</sup> return stroke positive. Middle: 1<sup>st</sup> return stroke negative. Bottom: Subsequent stroke.

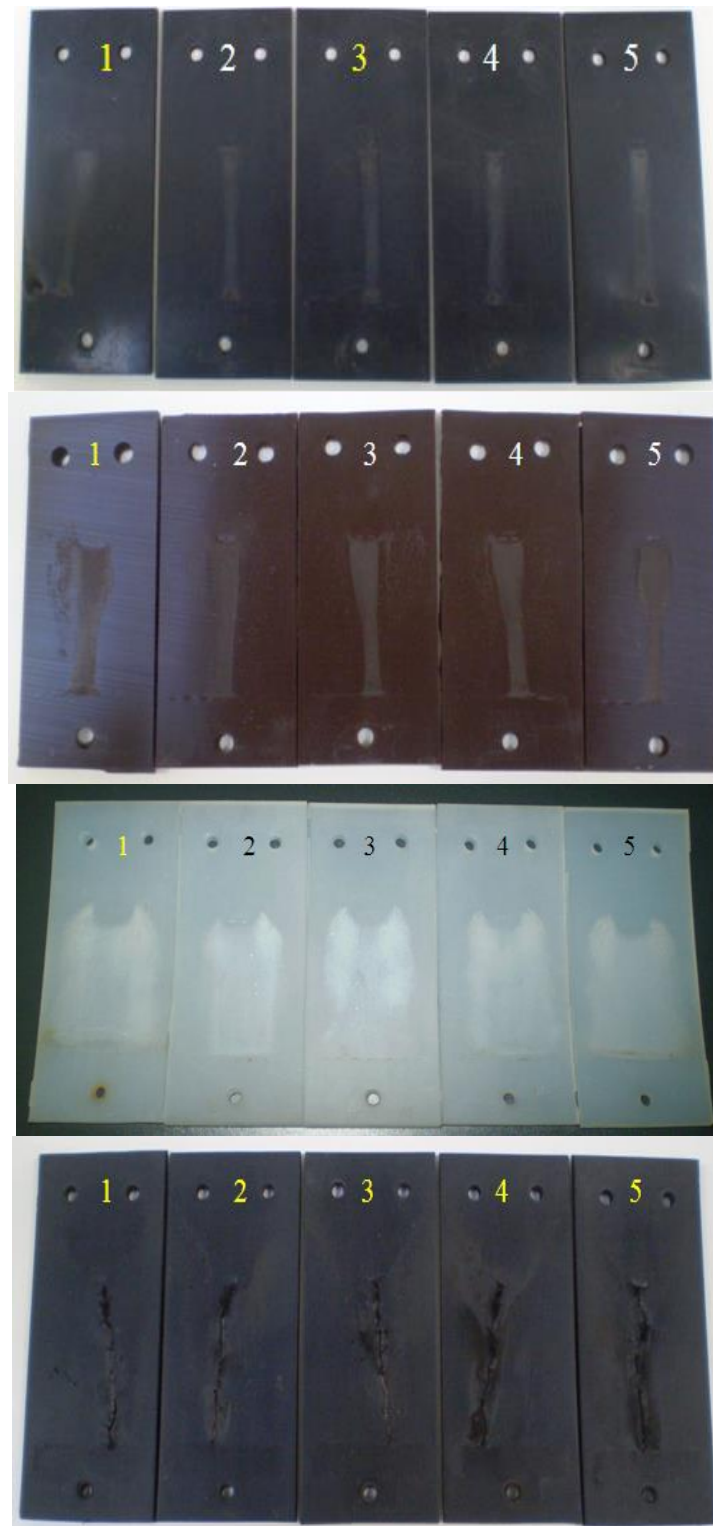
Figure 6-5. Surface erosion on the samples of the rubber materials after the tracking resistance tests. From top to bottom: Santoprene: Samples 1 and 3 failed, Silicone rubber: Sample 1 failed, PUR: Sample 1 failed, and EPDM: All the samples failed.

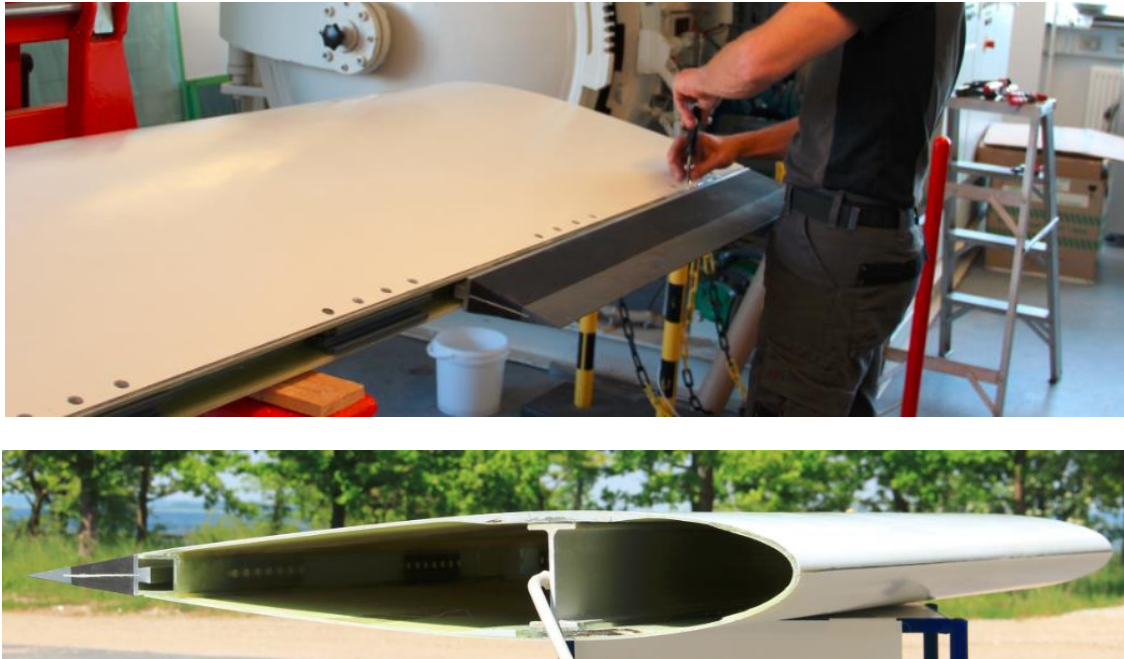
Figure 7-7. Prototype manufactured for testing. On the top, assembling of the rubber flap at the trailing edge using non-conductive bolts. On the bottom, finished prototype with the flap voids filled with propylene glycol.

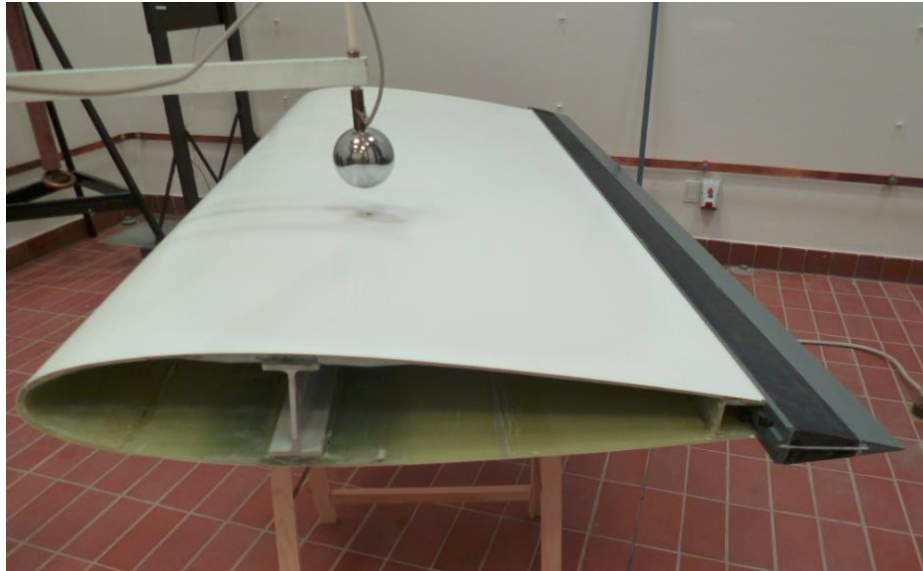
Figure 7-10. Setup of the high voltage swept channel tests performed to the prototype equipped with trailing edge flap and lightning protection system.
