## Description of the passive air supply system based on ventilation windows supported by chimneys

Rimante Andrasiunaite Cox  
Technical Report

Department of Civil Engineering  
Technical University of Denmark  
2015

Report: BYG R-342

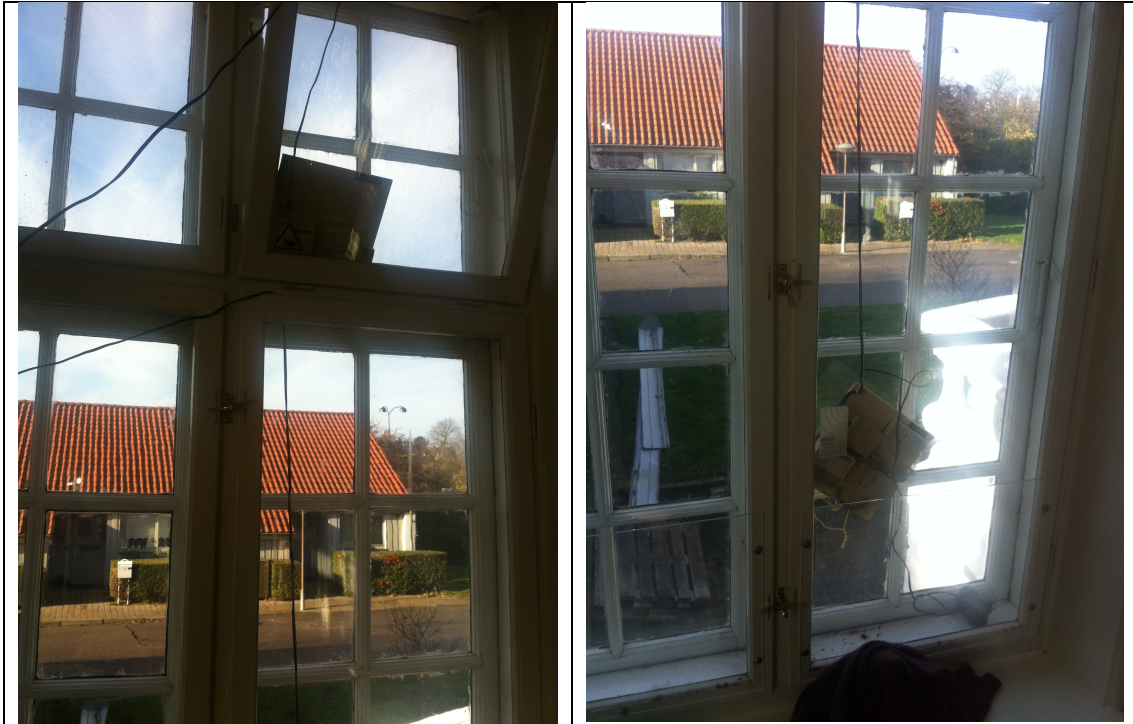
Figure 9 Location of the additional meters in the gap between external and internal frame: on the left is the meter located in the top of the window and on the right the meter is located in the bottom of the window.

On the 1<sup>st</sup> floor only one meter was installed in the top of the windows.

Automatic recordings of CO<sub>2</sub> levels and internal temperature were not sufficient to show whether the air was coming in through the windows and extracted by the chimneys. Therefore, additional CO<sub>2</sub>, temperature and relative humidity meters were installed in all 9 ventilation windows and chimneys. The locations of the additional meters are shown in Figure 8. On the ground floor two meters were used per window: (i) in the gap of the top of the window where both internal and external openings of the window were located, and (ii) in the gap at the bottom of the window, where there were no openings except from the additionally added holes in the window frame between upper and lower part of the window, as shown earlier in Figure 4 and in Figure 9.

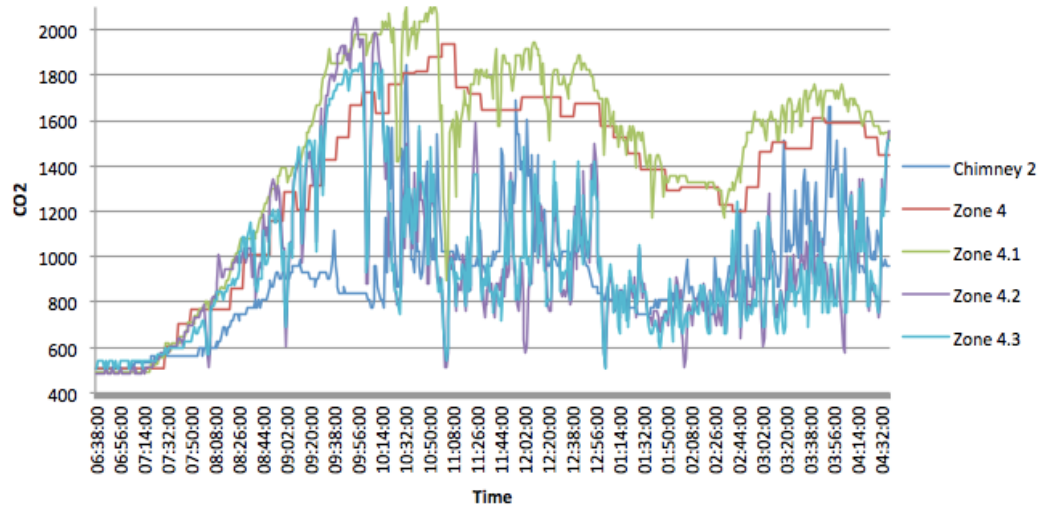
Figure 27 CO<sub>2</sub> concentration in the zone 4 (south façade) on the 1<sup>st</sup> floor during 7<sup>th</sup> of November 2013.

As chimney 2 was working as the air extractor for both floors, the high CO<sub>2</sub> concentration in chimney 2 could also be caused by the average higher CO<sub>2</sub> concentration on the 1<sup>st</sup> floor, as shown in Figure 27.
