## Coastal Erosion and Flooding Hazards on the North Sea Coast at Thyboron, Denmark

*Citation (APA):*  
Sørensen , P., Sørensen, C. S., Nielsen, P., Ciocan, R., & Knudsen, P. (2016). Coastal Erosion and Flooding Hazards on the North Sea Coast at Thyboron, Denmark. Poster session presented at International Coastal Symposium 2016, Sydney, Australia.

# COASTAL EROSION AND FLOODING HAZARDS ON THE NORTH SEA COAST AT THYBORON, DENMARK

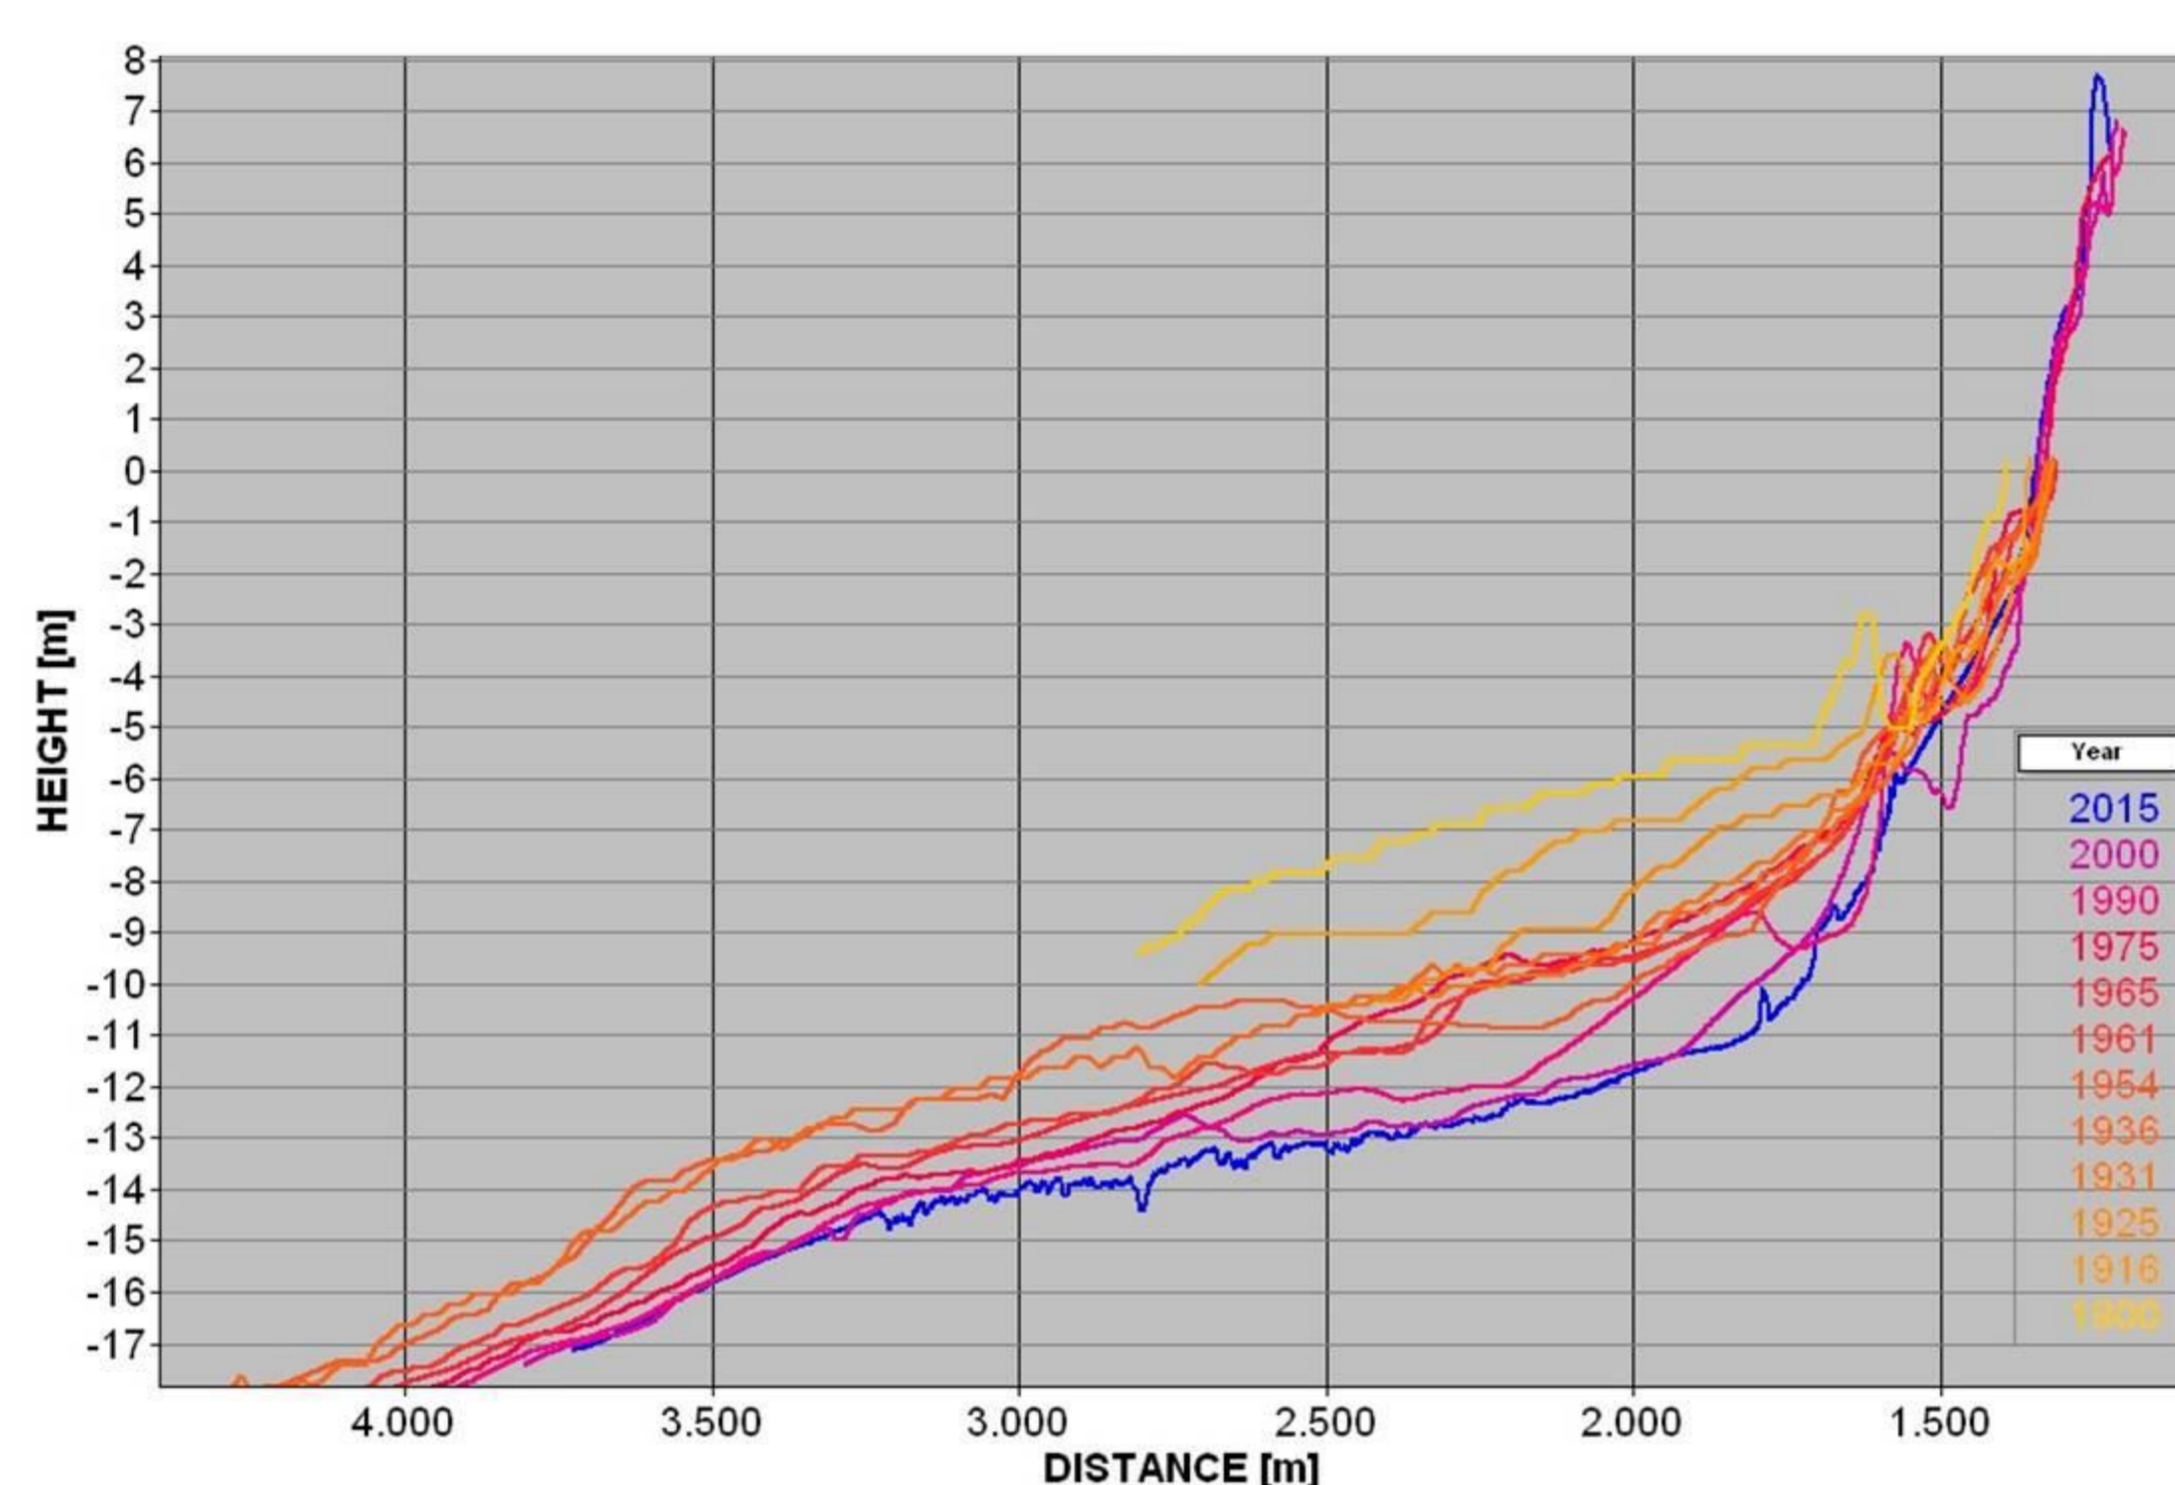
Figure 3. Coastal profile evolution, 1900-2015. The upper profile from -6 m DVR90 has been sand nourished since the late 1980's. Profile line shown in Figure 2.

The open coast still experiences net erosion in the lower parts of the profile, and Figure 2 shows the narrow sandy barrier which protects Thyboron from getting flooded. Each year the barriers on each side of the channel are nourished with 500,000 m<sup>3</sup> of sand on average. This volume is sufficient to stop the retreat of the upper profile to -6 m DVR90. However, this amount has to be increased by 20 % until 2050 as the coastal steepening continues, Figure 3, to counteract the increased sand depletion of the upper profile.

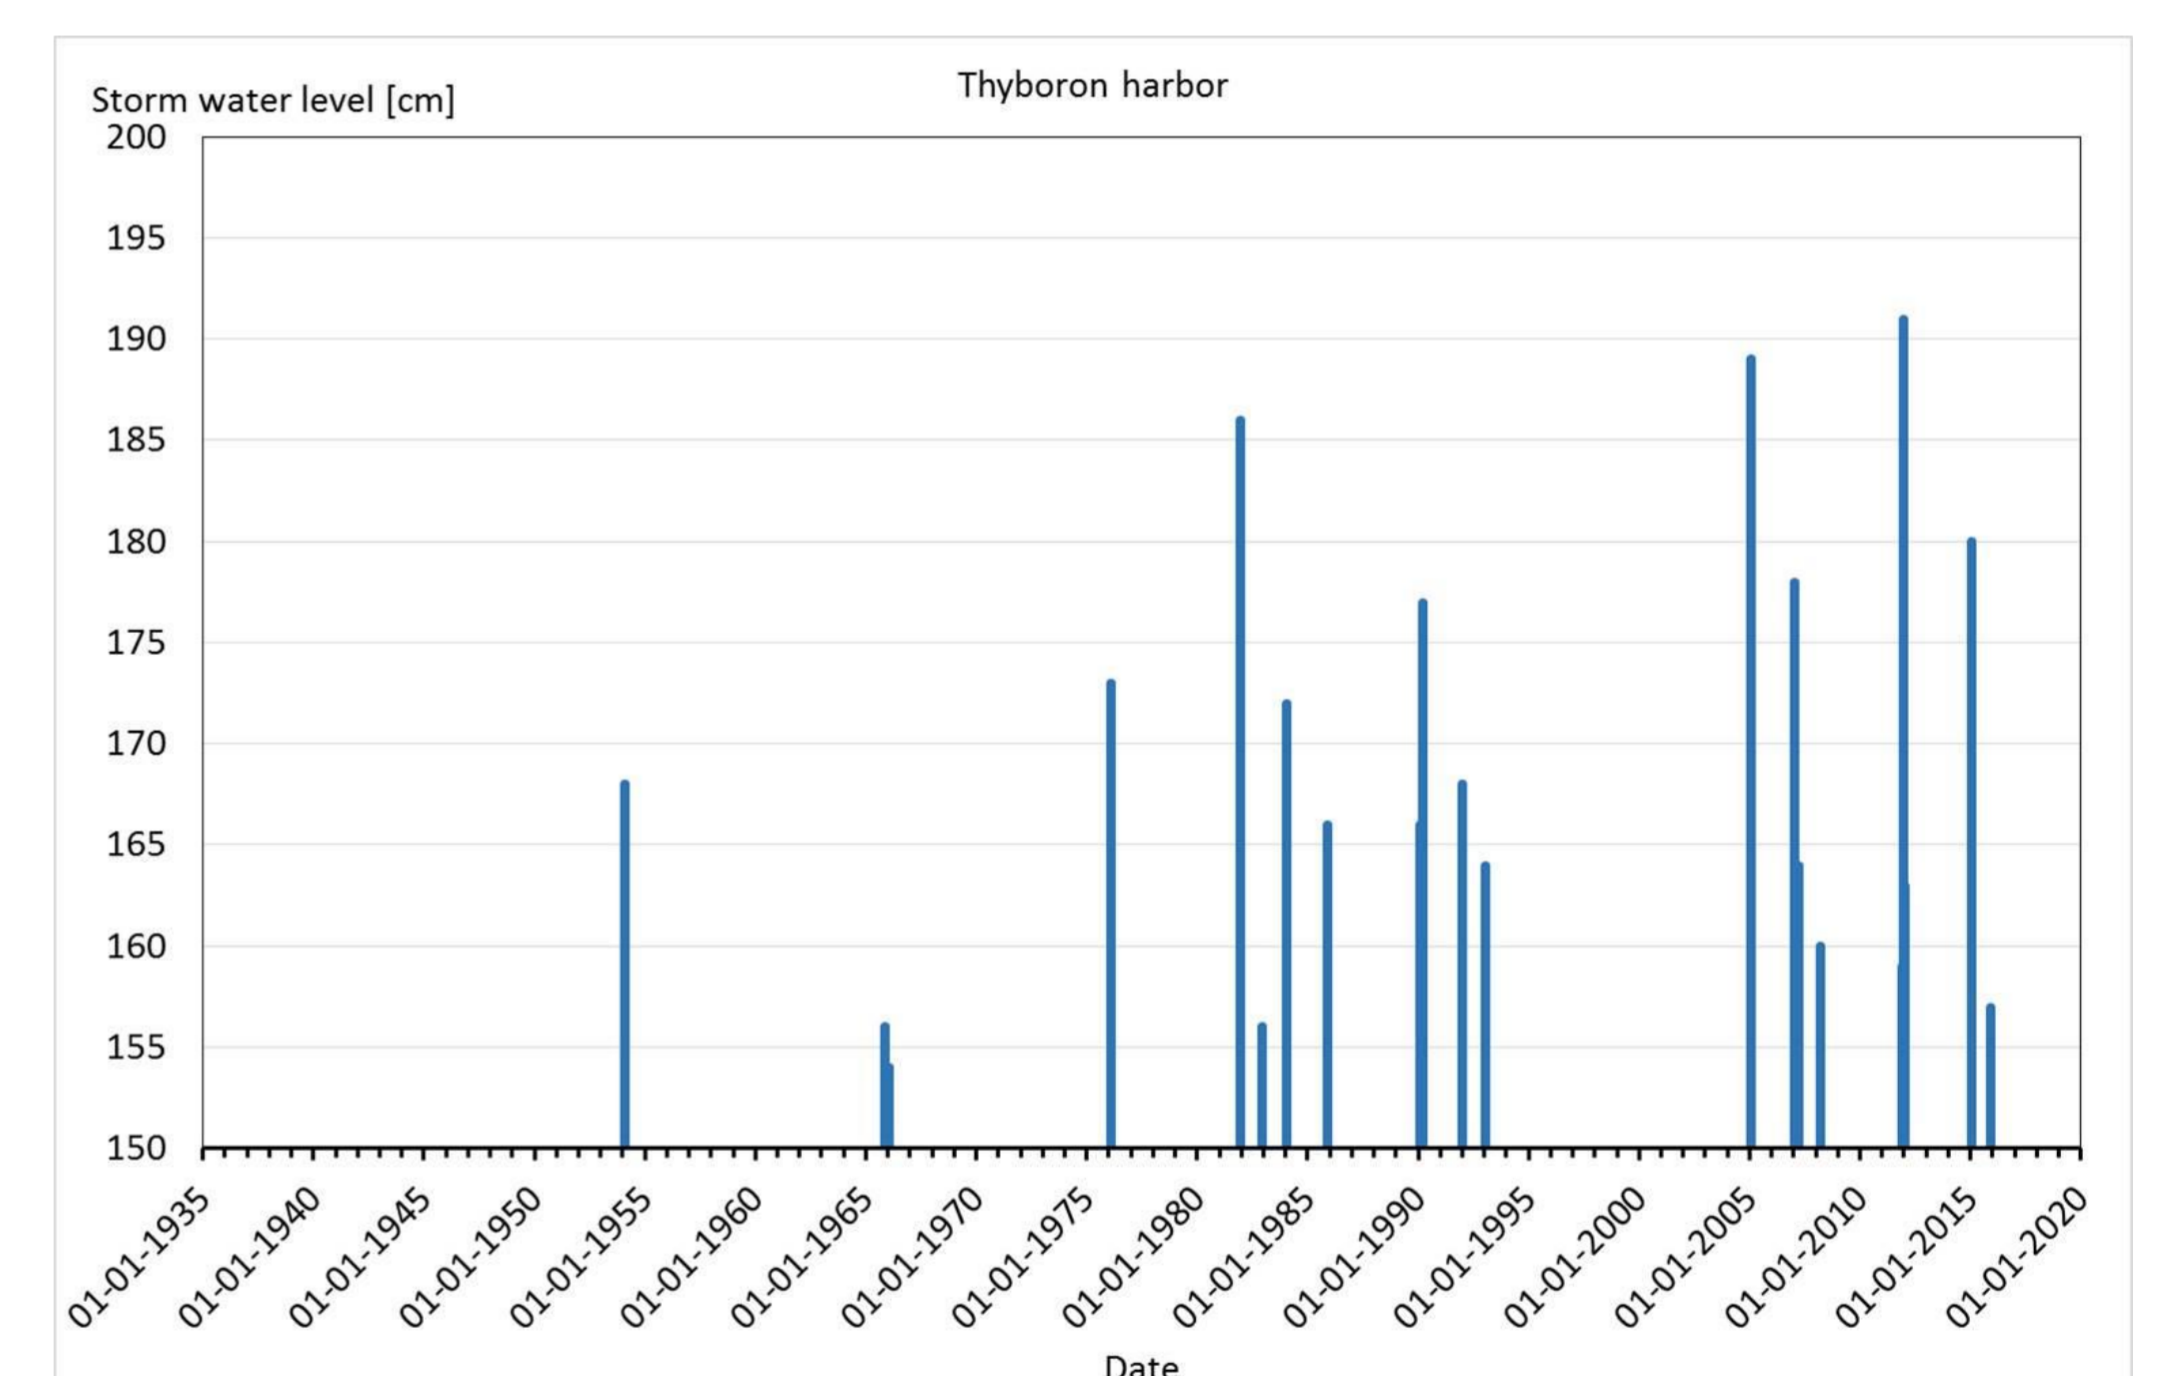
Figure 4. Heights of storm surge levels above 150 cm DVR90 at Thyboron Harbor tide gauge since 1935. Gauge position in Figure 1.

The cross-sectional area of the channel is out of equilibrium with the tidal prism and increases; leading to more extreme storm surge levels inside the fiord, Figure 4. Furthermore, the town of Thyboron experiences a differentiated net land subsidence of 2-8 mm/y. The increased cross-section, land subsidence and climate changes together will increase the future flood risk in Thyboron significantly, Figure 5.

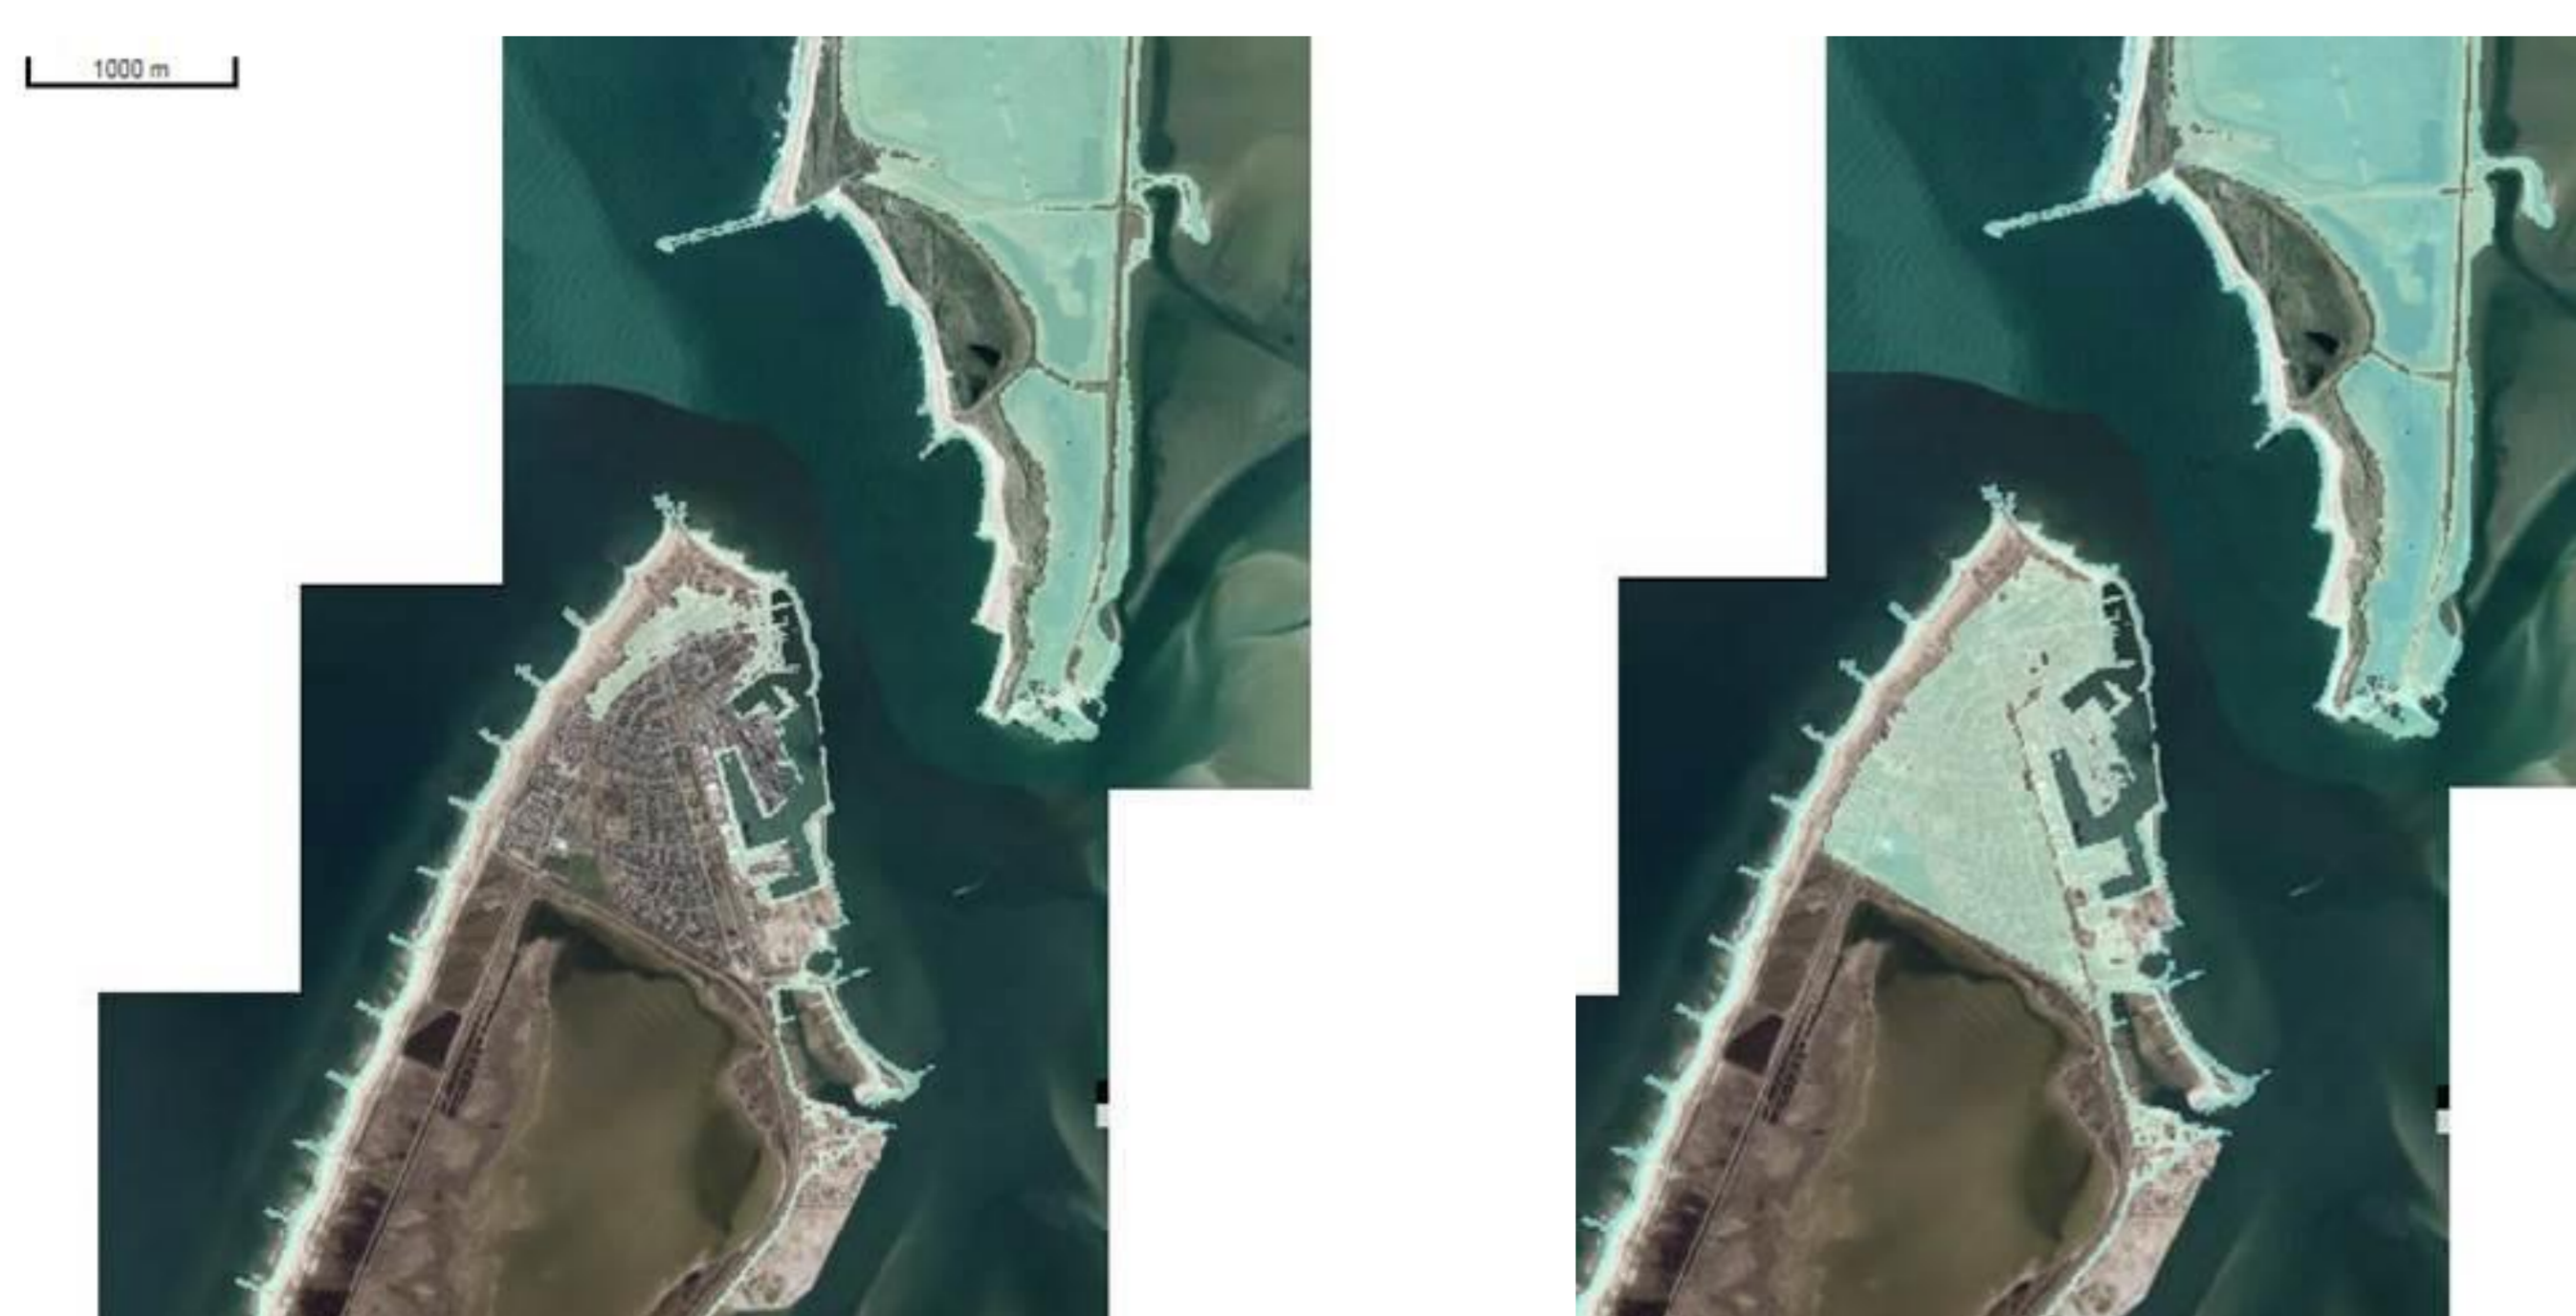
Figure 5. Potential flooding extent from a storm surge at Thyboron Harbor with a return period of 50 years in 2016 (left) and in 2060 including sea level rise and land subsidence.

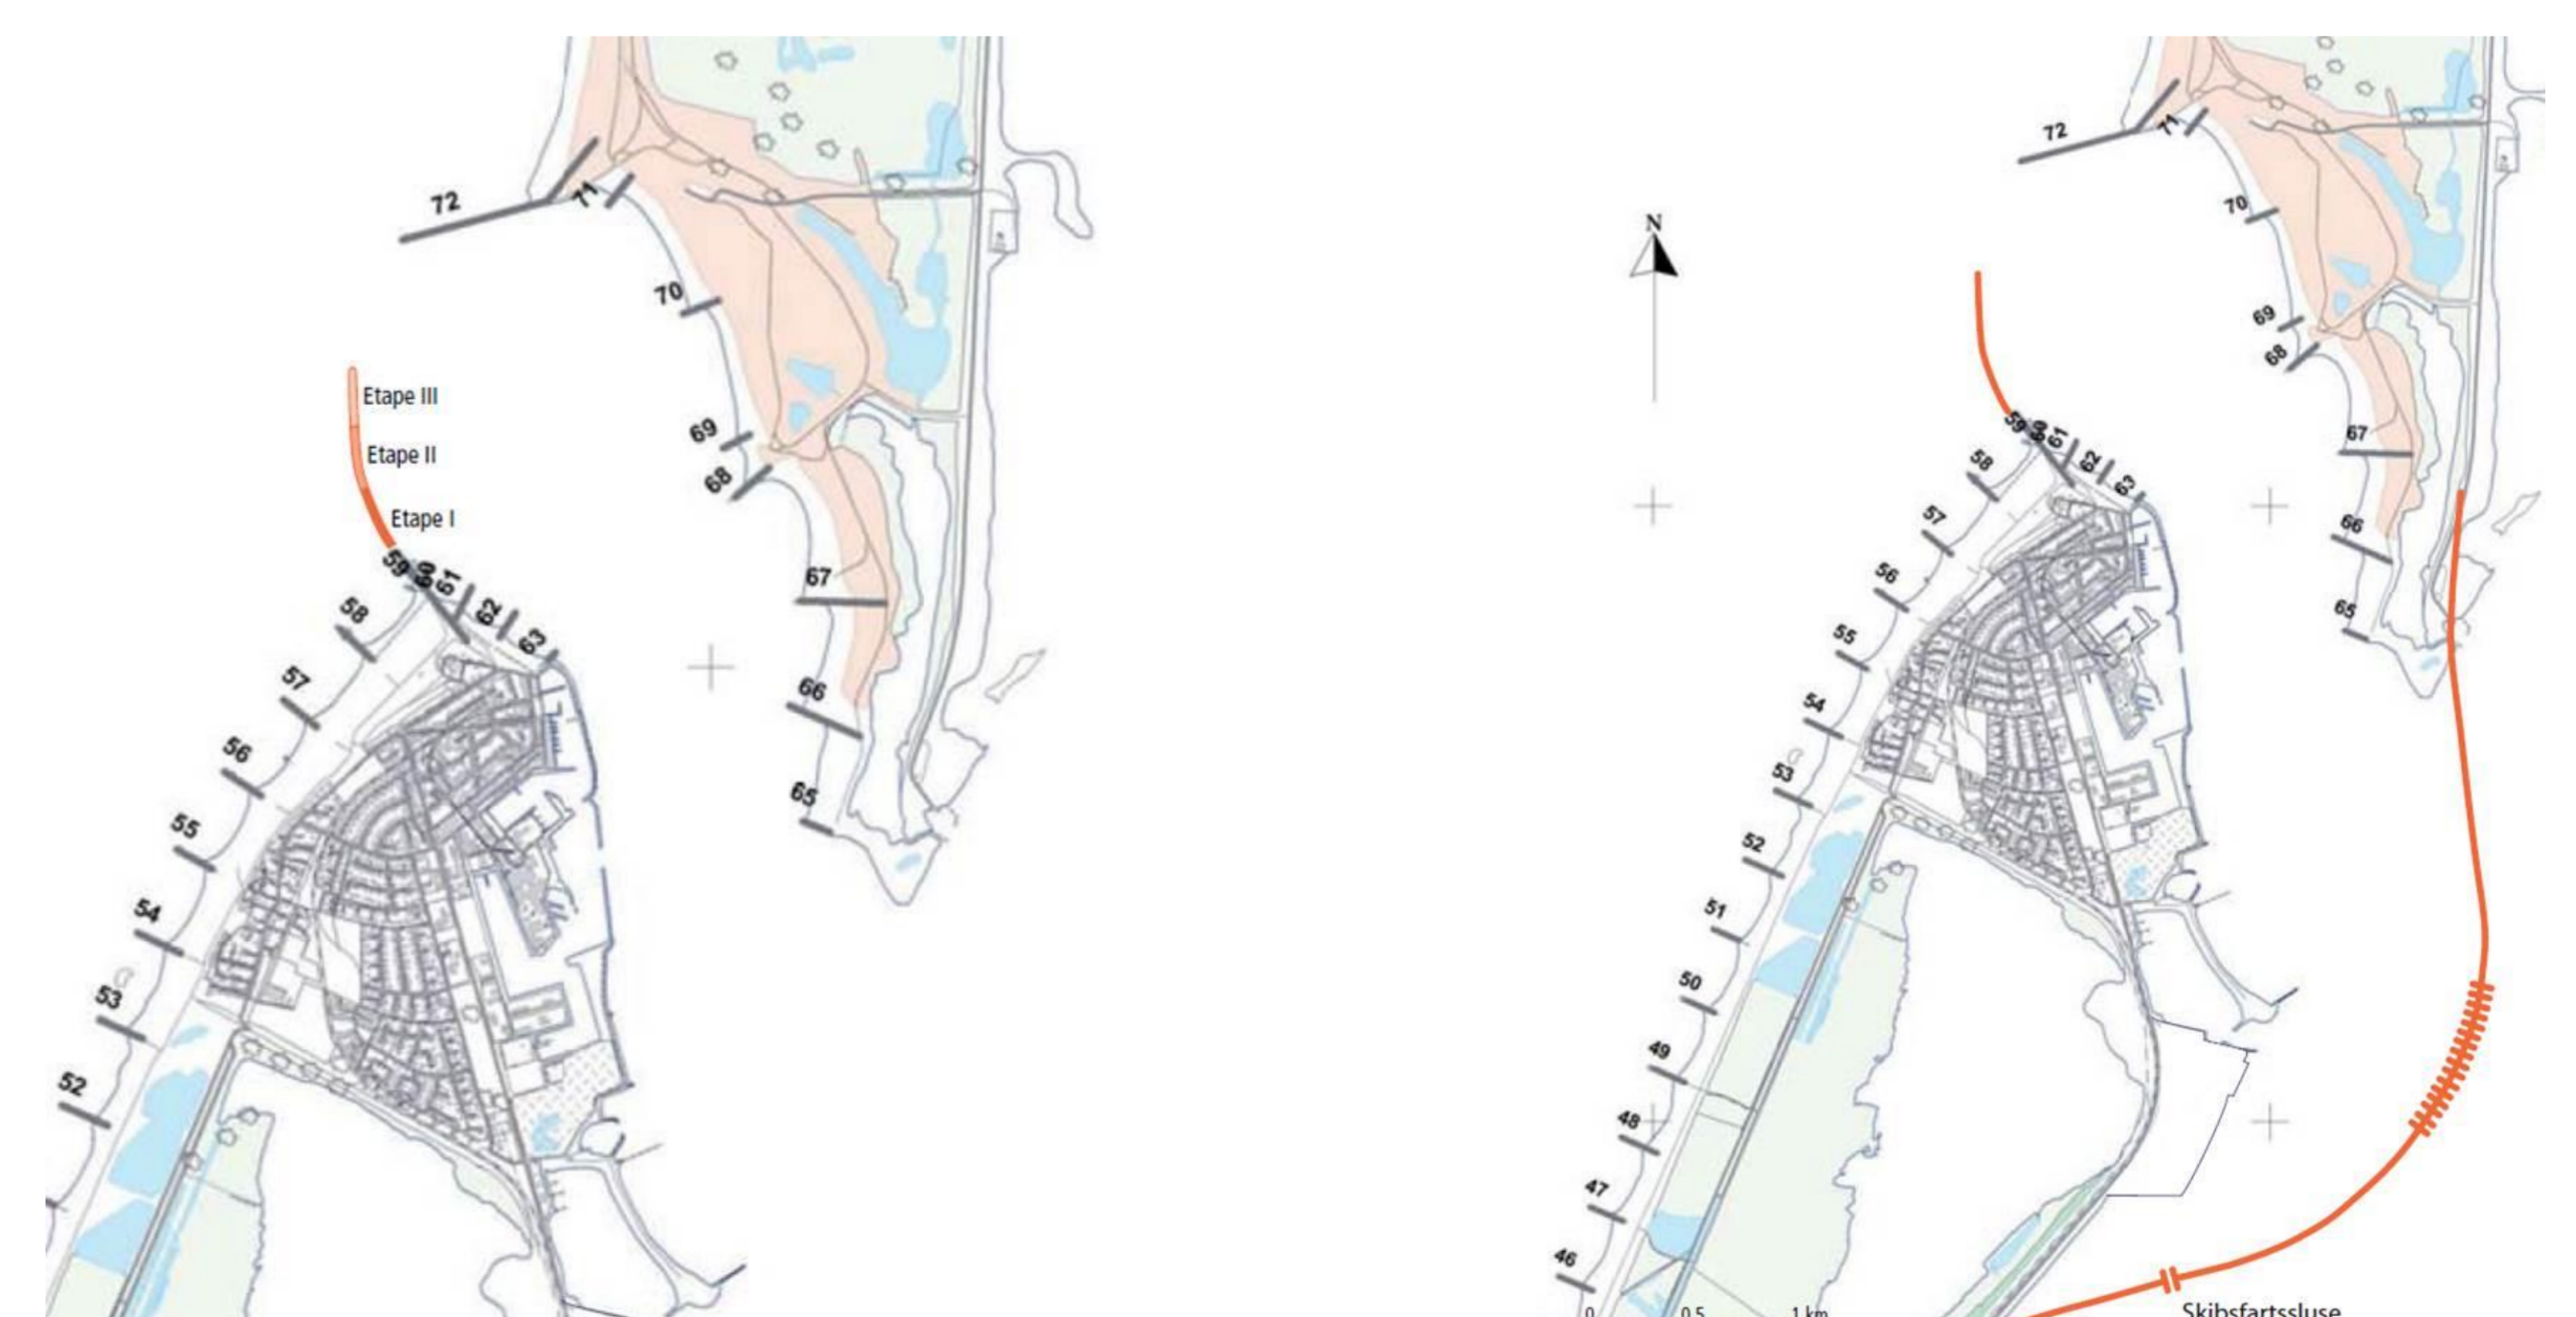
Figure 6. Technically preferred management option: extending a groin to a breakwater (left) and an alternative management option with a sluice.

Eight different options to manage the erosion and flooding hazards in the future have been analyzed. The technically preferred option is to extend one of the groins to reduce the cross-sectional area to reduce the net erosion rates on the barriers, to limit storm surge water levels, and to make it easier to enter the navigation channel. A sluice solution has also been analyzed due mainly to environmental issues, Figure 6. A more detailed analysis work is still necessary, however, in order to effectively deal with the combined erosion and flood hazard challenges and to decide upon the optimal solution for the future protection of Thyboron and the Lim Fiord barriers.
