Embankment Overtopping Protection Systems

Hubert CHANSON

CHANSON, H. (2015). "Embankment Overtopping Protection Systems." *Acta Geotechnica*, Vol. 10, No.3, pp. 305-318 & 2 video movies (DOI: 10.1007/s11440-014-0362-8) (ISSN 1861-1125).

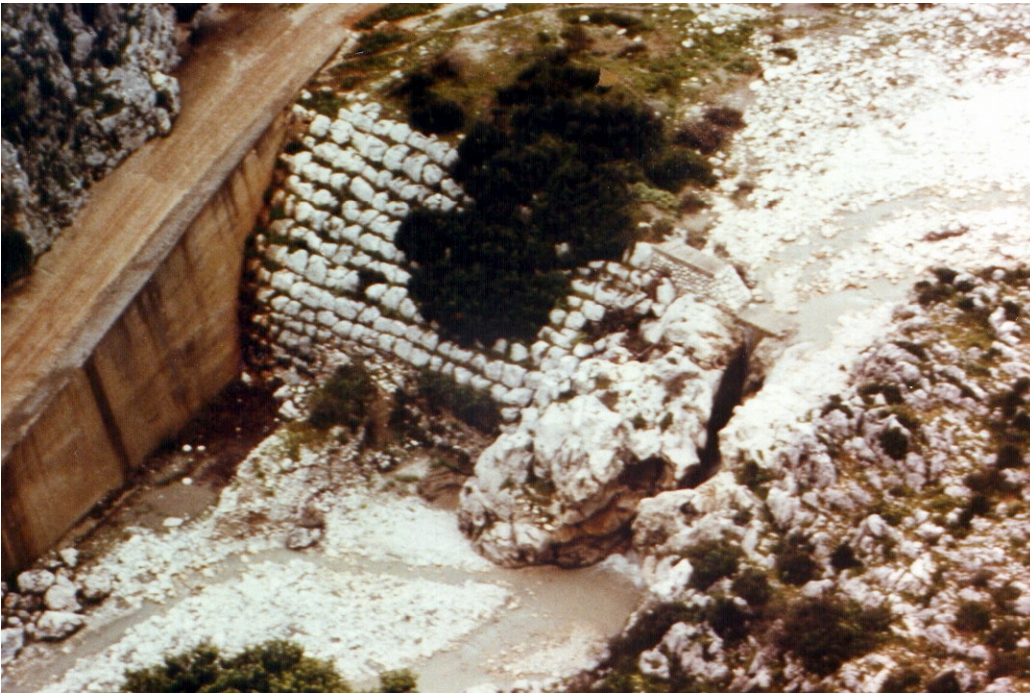
(A) Embankment dam with overtopping stepped spillway: stepped weir in Akarnania (Greece)

(Courtesy of Professor Knauss) - Completion: BC 1,300, H = 10.5 m, L = 25 m

considered as an earthfill structures designed to hold water. This definition encompasses river dykes, coastal barriers for storm surge and tsunami protections, as well as natural lakes and landslide dams (Fig. 1 and 2). Figure 1 presents some typical embankment dam structures, and Figure 2 shows some embankments for coastal protection.

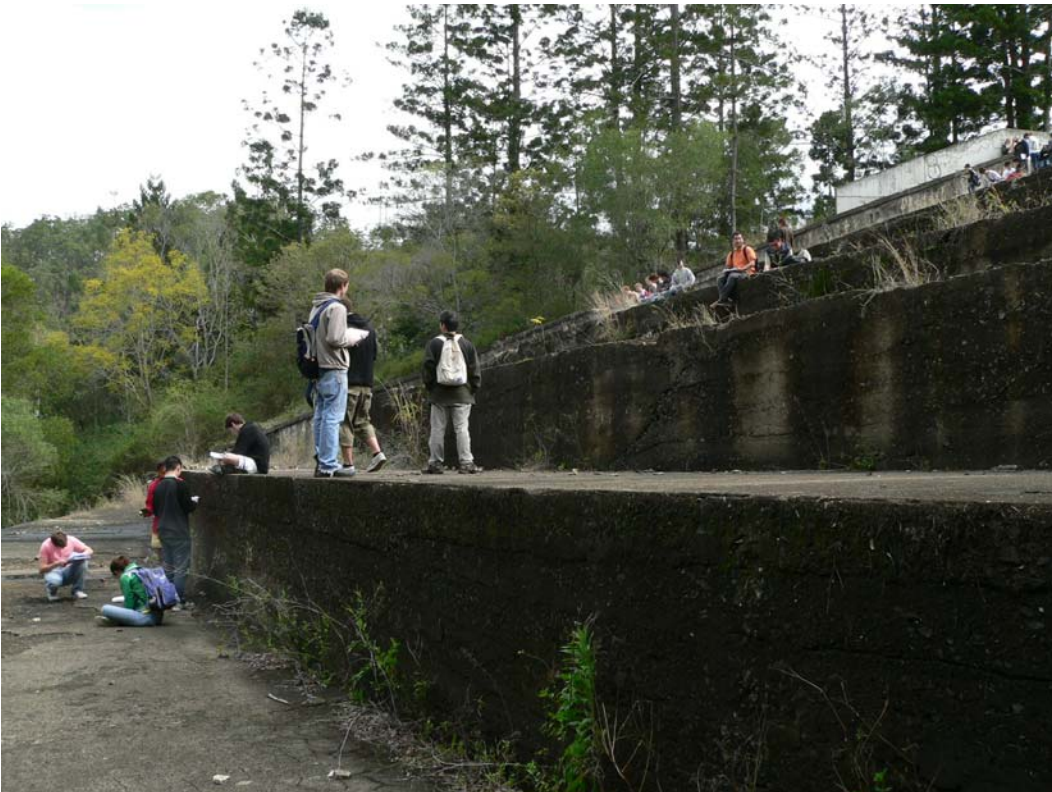
(B) Concrete stepped spillway of Gold Creek dam (Australia) with the embankment dam in the background - Completion: 1885, H = 26 m, L = 187 m - The concrete spillway was built over the right abutment

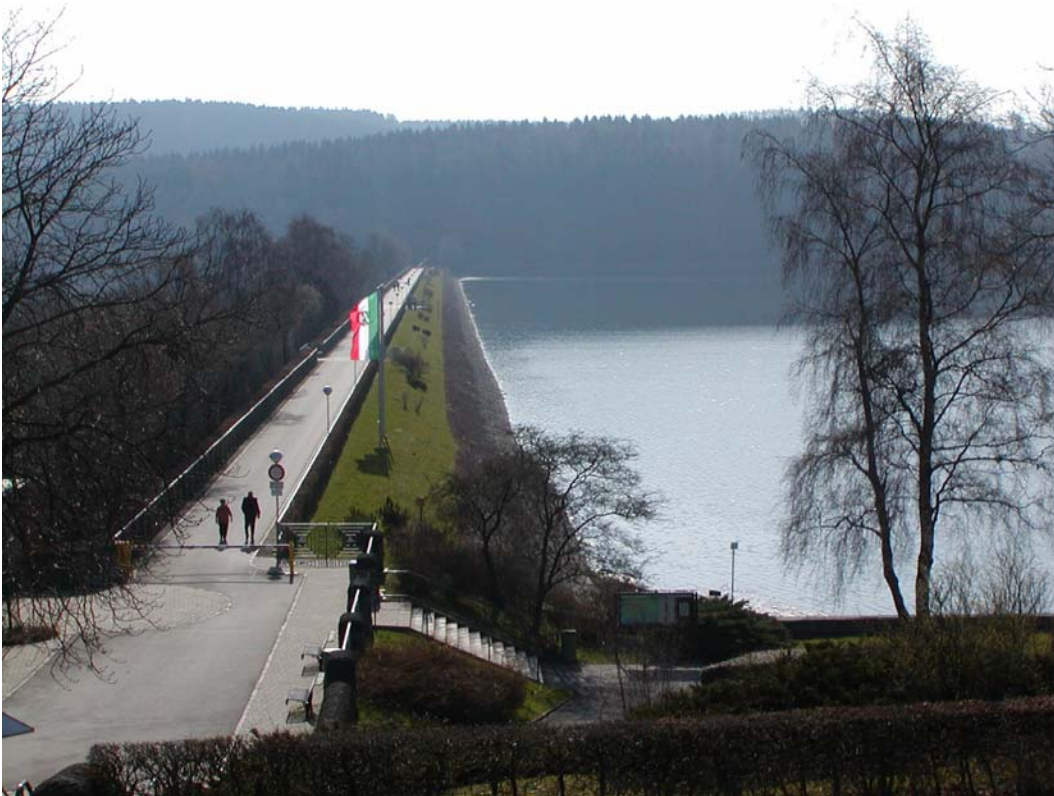
(C) Embankment dam: Sorpe dam (Germany) on 31 March 2004 viewed from left bank -
Completion: 1935, H = 69 m, L = 700 m

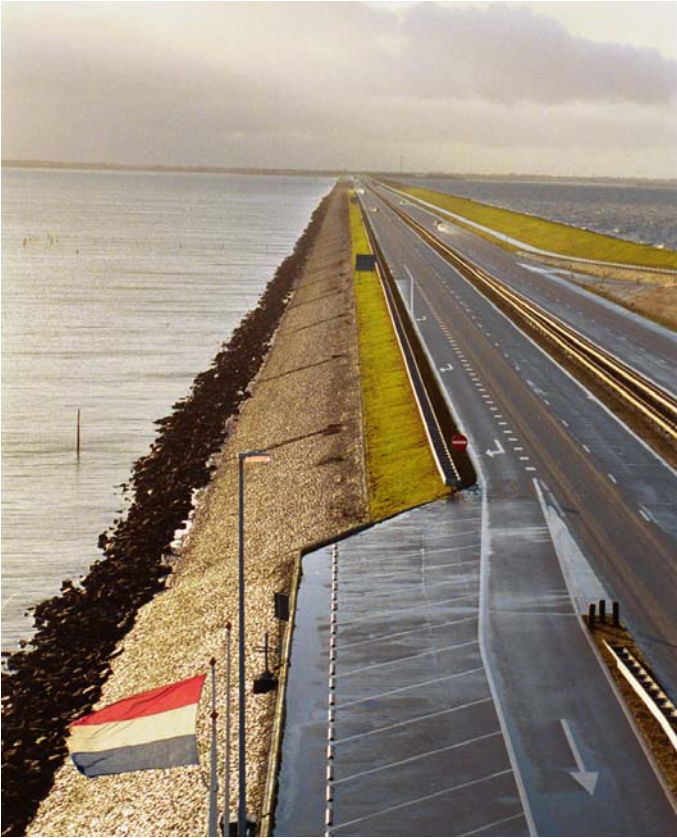
(A) Coastal barrier in Netherlands: Zeidersee enclosure dam (Courtesy of Ronald De Heer)

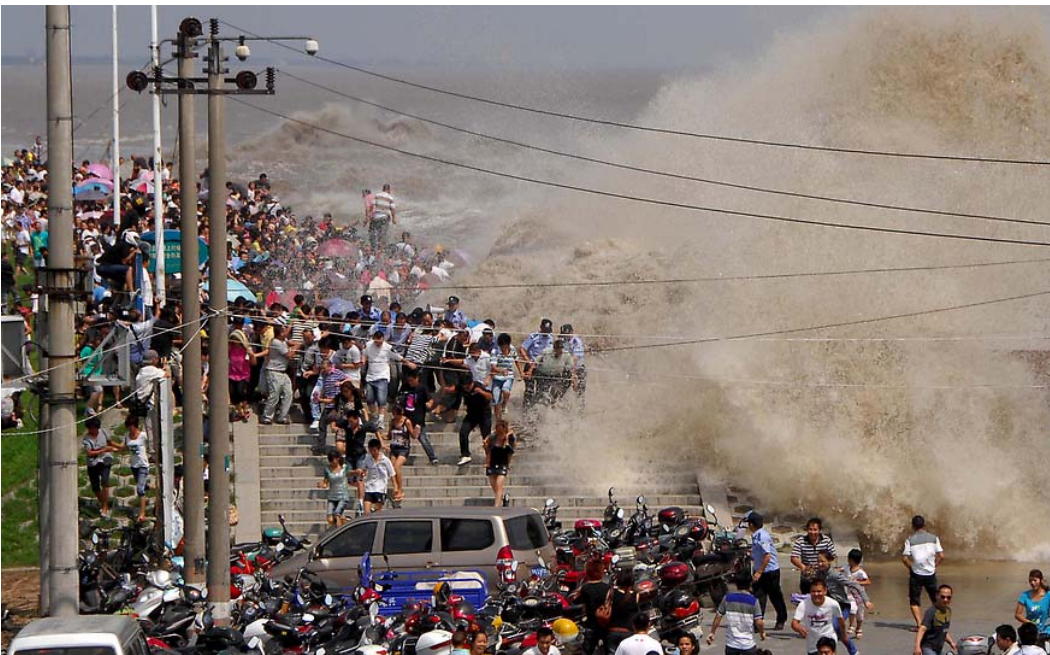
(B) Tidal bore of the Qiantang River (China) overtopping a river dyke on 31 August 2011

The overtopping of fluvial and coastal embankments was documented worldwide. During Hurricane Katrina in August 2005, several embankments protecting New Orleans and its surroundings were overtopped and breached, contributing to some extensive flooding (ASCE 2007). Figure 2B illustrates the overtopping of an earthfill dyke along the Qiantang River estuary in August 2011. The flood tide combined with a powerful storm surge during Typhoon Nanmado to cause an abnormally high tidal bore which overtopped the river dykes causing massive damages. Recent failures of coastal embankments were observed during the March 2011 Tohoku tsunami in Japan (Ogasawara et al. 2012, Suppasri et al. 2012). Figure 2C shows a physical study of coastal barrier conducted in 2012 to develop safer tsunami protection structures. The movie 1 highlights the rushing motion of water past and impact onto the rubble mound structure (Appendix A, Table 1). During the last five decades, a number of overtopping protection systems were developed for embankments. These include overtopping concrete protection systems, sheet-piles, gabions, reinforced earth, Minimum Energy Loss spillways, and embankment stepped spillway. In this contribution, several embankment overflow protection systems are presented and discussed, after a brief discussion of the embankment breaching process. The experience gained during the past decades is discussed.

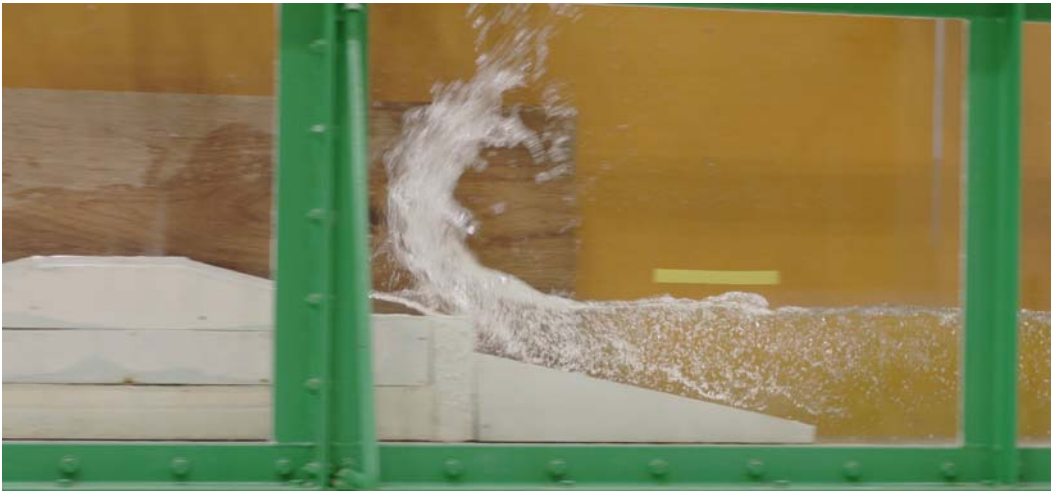
(C) Physical model of a coastal barrier during a tsunami - Physical test with tsunami wave model propagating from right to left and impacting the embankment

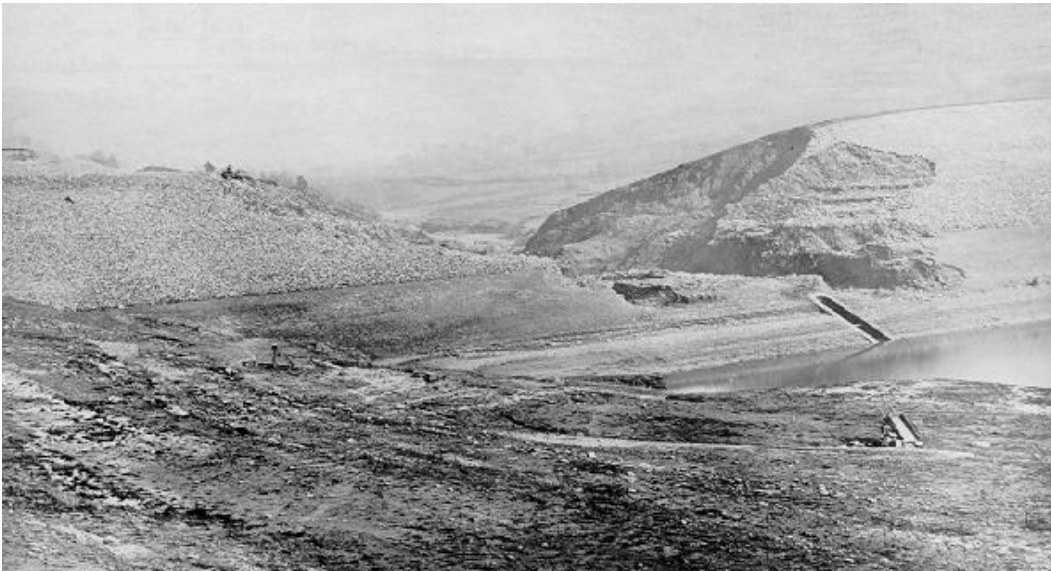
(A) The ruptured Dale Dyke dam embankment (UK) viewed from inside the reservoir, a few days after the disaster - Completion: 1863, Failure on 11 March 1864 because of piping and poor construction standards, 150 lives lost

All these structures are potentially erodible when overtopped, unless an overtopping protection system is designed. During the 19th to 21st centuries, numerous embankment structures failed worldwide (Fig. 3). With embankment dams, the two most common causes of failures were dam overtopping and cracking in the earthfill. The former issue is linked with inadequate spillway capacity, while the latter is the result of a combination of poor understanding of geotechnical concepts, inappropriate construction standards and internal failure (Fig. 3A). In recent years, a number of large floods caused dam overtopping because of the insufficient storage and spillway capacity of existing reservoirs. Figures 3B, 3C and 3D illustrate some examples of catastrophic failures. In each case, the spillway capacity became insufficient during a major hydrological event. A related form of embankment dams is the "natural dam" created by landslides and rockslides. For example, during the May 2008 earthquake in the Sichuan Basin (China), several lakes were formed, and some were artificially breached because they were natural hazards (Yin et al. 2009).

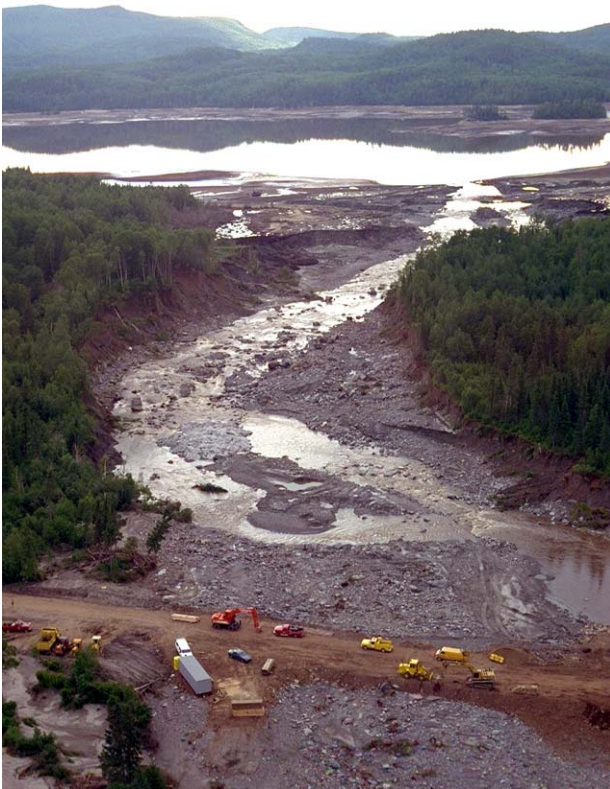
(B) Lake HaHa! failure (Canada) (Courtesy of Natural Resources Canada) - Failure in July 1996 because of inadequate spillway capacity

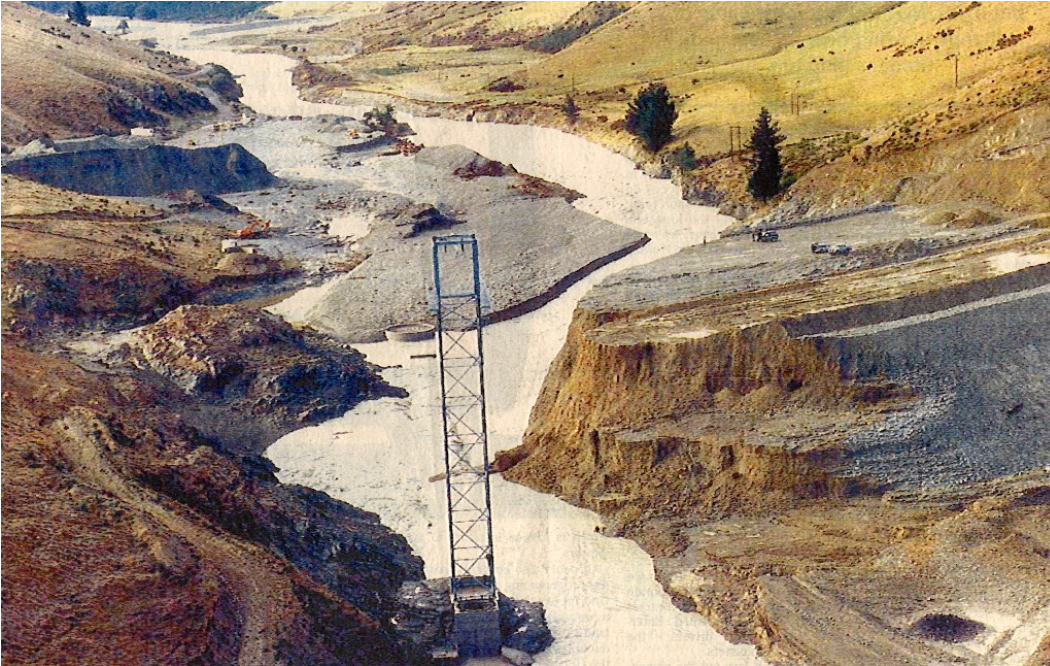
(C) Failed Opuha embankment dam (NZ) on 6 February 1997 (Courtesy of Tonkin and Taylor) - Completion: 1999, H = 50 m, L = 100 m, Failure by flood overtopping during construction

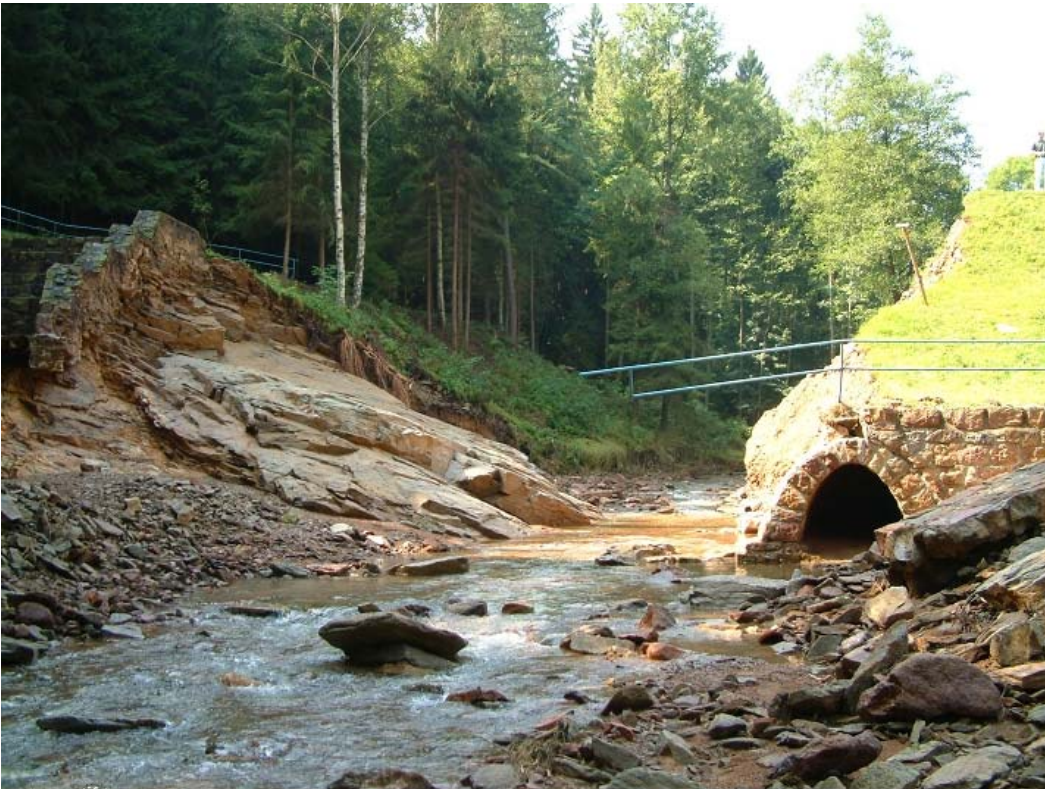
(D) Failed Glasshütte embankment dam (Germany) looking upstream (Courtesy of Dr Antje Bornschein) - Completion: 1953, H = 9 m, Failure on 12 August 2022 because of inadequate spillway capacity

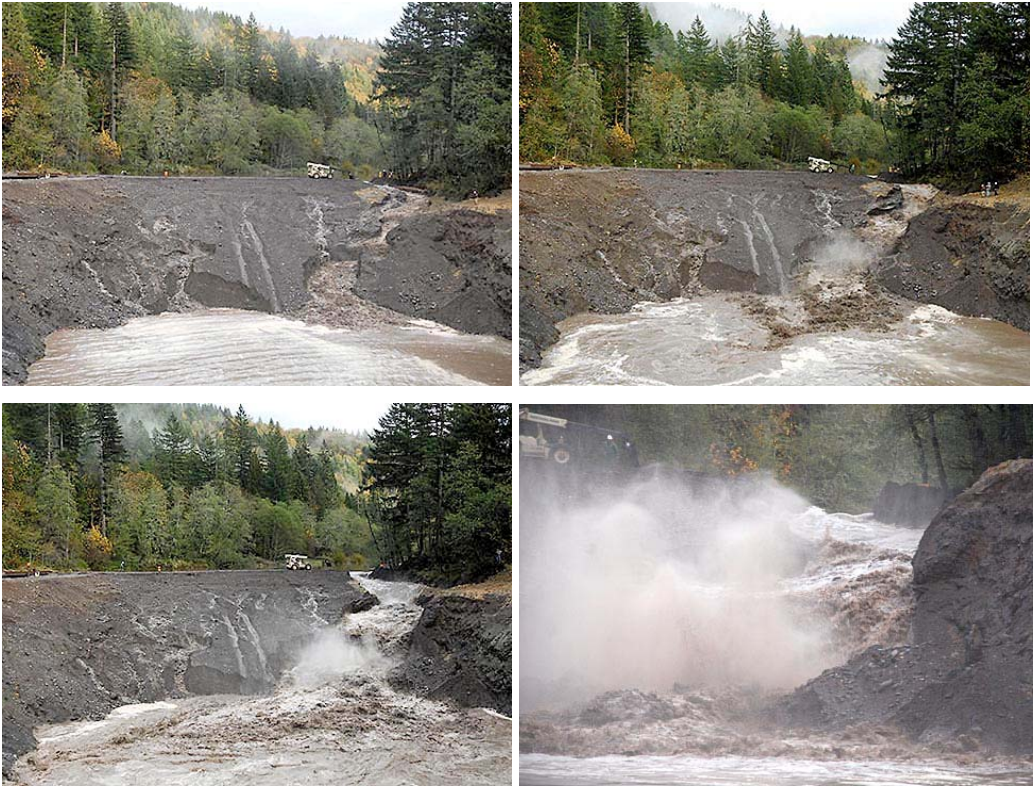
(A) Marmot Dam cofferdam breaching (USA) on 19 October 2007 (Courtesy of Portland General Electric) - The cofferdam was built as part of the Marmot (concrete) dam removal to restore fish migration along the Sandy River

The breaching of an overtopped embankment is a relatively slow process, for example in comparison to the failure of a concrete dam. While the latter may be a sudden, explosive failure, an earthfill structure may sustain some overtopping for some times before the breach develops and progressively opens leading to the complete failure (Fig. 3). For example, the Glashütte dam (Fig. 3C) was overtopped for near 140 minutes before the wall failed within 30 minutes (Bornschein and Pohl 2003). Figure 3 shows several examples of embankment dam failures, and Figure 4 presents some photographs of the embankment breaching process.

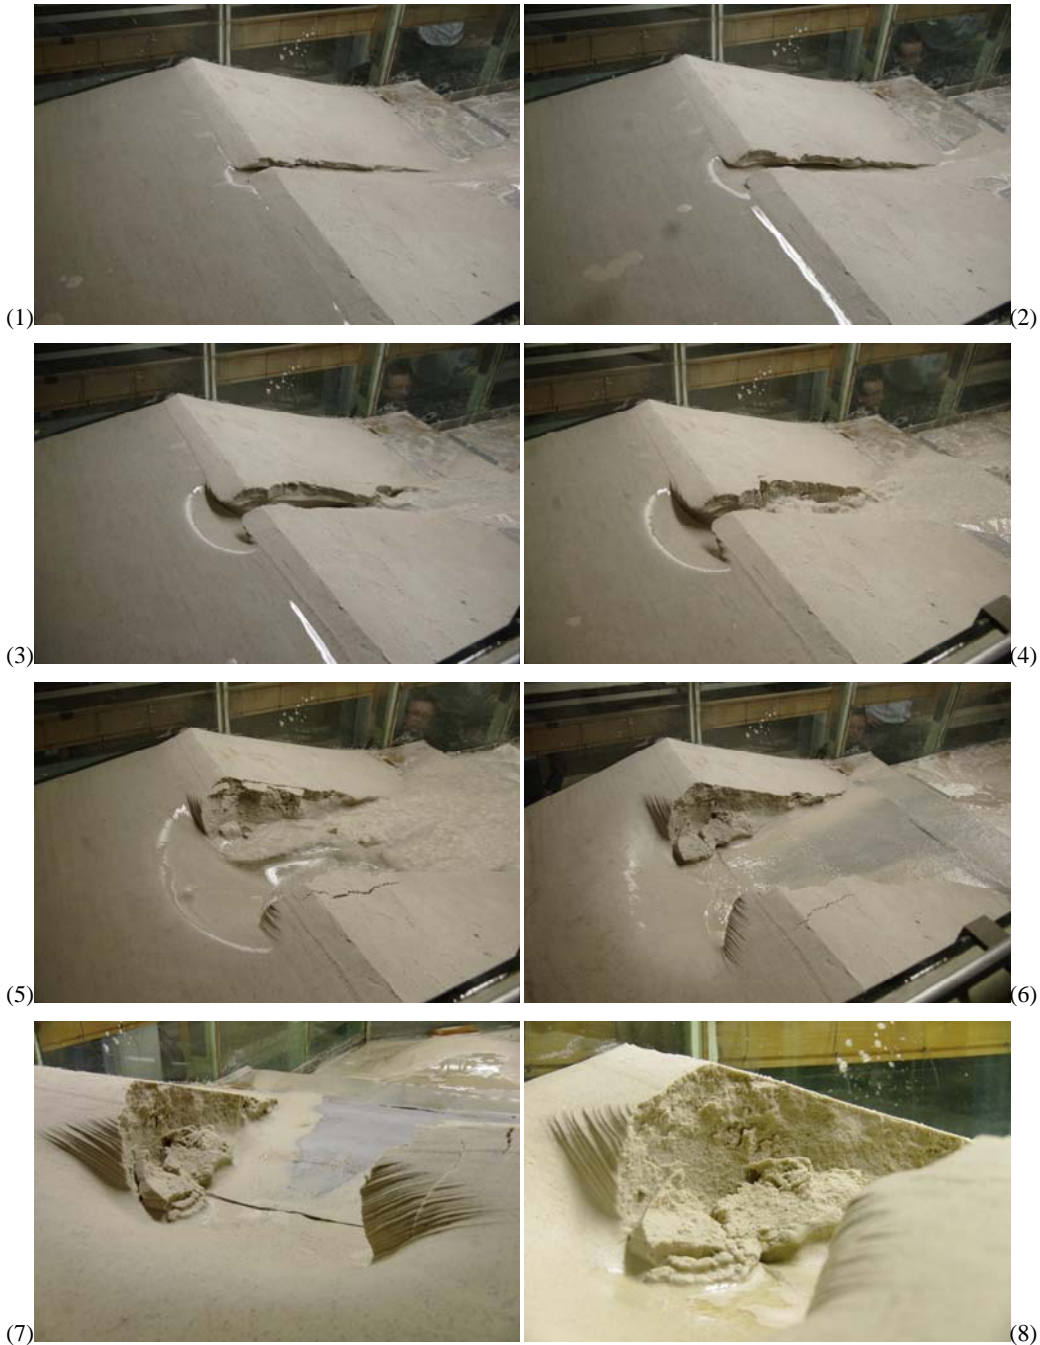
(B) Physical modelling of non-cohesive embankment dam failure at the University of Auckland in 2012 - $H = 0.3$ m, $L = 1.5$ m, $d_{50} = 0.3$ mm, constant upstream head experiment - Flow direction from left to right with the reservoir on the right - The first five shots (1-5) were taken during the breach development; the last two shots (7-8) show details of the breach after the reservoir draining

inlet lip to throat was somehow similar to the flow through a minimum energy loss (MEL) spillway inlet (see next paragraph). For example, let us compare Figure 4B with Figure 6A.

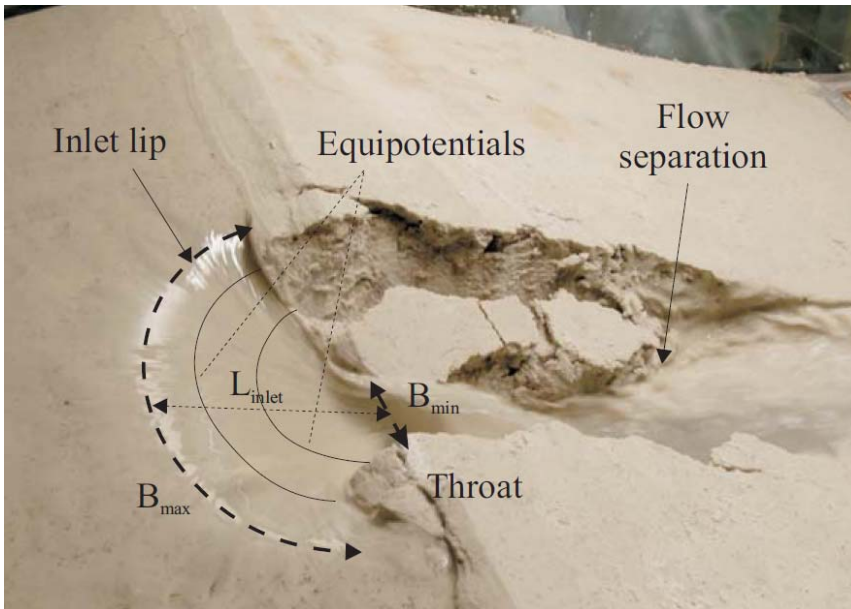
(A) Definition sketch

Fig. 5 - Physical measurements of non-cohesive embankment breaching - Data set: Coleman et al. (2002), data re-analysis by the author, embankment height; $H_1 = 0.30$ m, length: $L = 1.7$ m, upstream and downstream slopes: 1V:2.7H, 1.6 mm sand, constant upstream head experiment

Several studies on embankment breach were conducted during the last decade (Coleman et al. 2002, Rozov 2003, Vaskinn et al. 2004, Chanson 2005, Dai et al. 2005, Hanson et al. 2005, Hunt et al. 2005, Morris et al. 2007, ASCE/EWRI Task Committee on Dam/Levee Breaching 2011, Orendorff et al. 2011). Most physical studies under carefully-controlled laboratory flow conditions, together with prototype observations, showed that the embankment breach starts with an initiation phase, followed by a rapid development of the breach, and then an enlargement of breach width once the breach invert reaches the channel bed rock. Observations of embankment breach scour showed a challenging similarity with the flow in a minimum energy loss weir inlet during the breach development (McKay 1970, Visser et al. 1990, Chanson 2004). This was nicely illustrated by two seminal physical studies of the breaching of non-cohesive embankment structures (Coleman et al. 2002, Rozov 2003). It is also seen in Figures 4B and 5A, and movie 2 (Appendix A, Table 1). Figure 4B show the initial stages of the breach development (first 5 photographs), with some basic definitions in Figure 5A, while the movie 2 shows the progressive enlargement of the breach during the development. Figure 5 presents some quantitative data by Coleman et al. (2002).

where $H_1 - z_{\text{crest}}$ is the upstream head above spillway crest and B_{\max} is the crest width (see definition in Fig. 5A). A MEL spillway channel could be designed to achieve critical flow conditions at any position along the chute and, hence, to prevent the occurrence of a downstream hydraulic jump with high tailwater conditions. Assuming negligible energy loss along the inlet, the channel width B at any elevation $z - z_{\text{crest}}$ beneath the crest above the weir toe should satisfy:

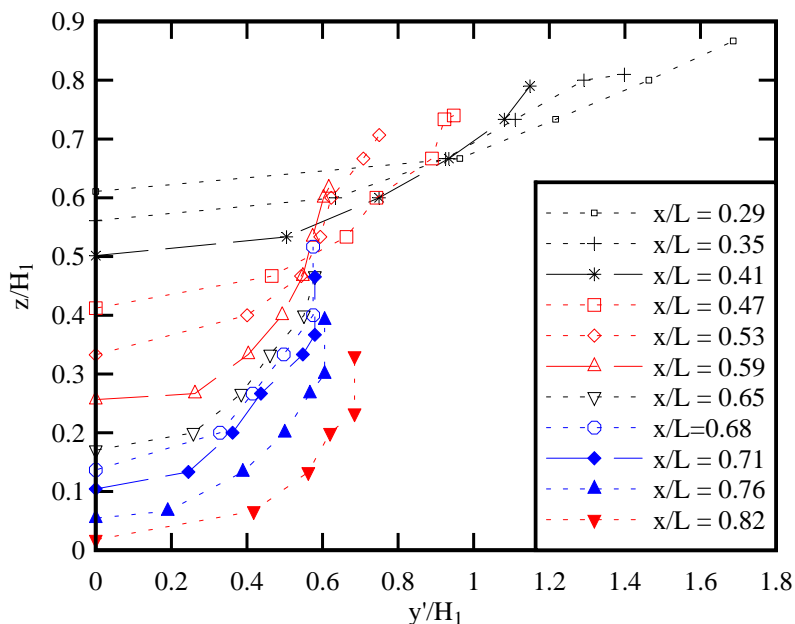
(B) Breach cross-sectional shape along equipotentials below the water line, $t = 87$ s, $Q_{\text{breach}} = 0.024$ m³/s

A flow net analysis of the physical data of Coleman et al. (2002) was conducted and the three-dimensional flow cross-section areas were measured along equipotential planes at different times (Chanson 2004). A typical example is shown in Figure 5B in the form of the breach cross-sectional shapes below the water line. The results indicated that the flow through the embankment breach was transcritical: that is, the flow was about critical between the inlet lip and the throat when the total head remained constant (Fig. 5C and 5D). Head losses occurred downstream of the throat when the flow streamlines diverged and flow separation occurred at the lateral boundaries. Typical results are shown in Figure 5C and 5D where the dimensionless total head H/H_1 is plotted as a function of the dimensionless centreline location, where H_1 is the upstream total head above downstream channel elevation and L is the embankment base length. Visually the flow through the breach between the

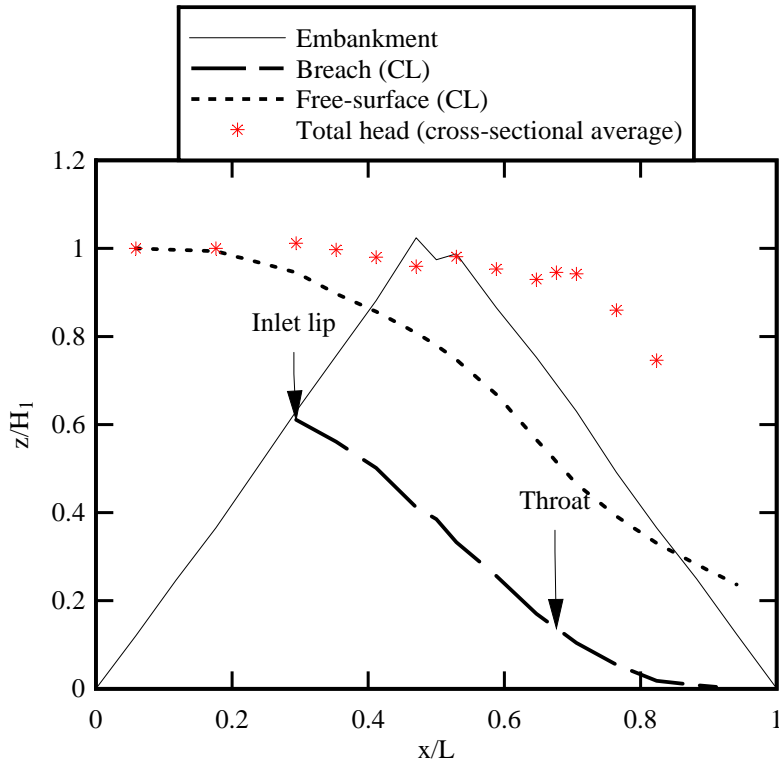
(C) Longitudinal bed elevation and total head along breach centreline, $t = 87$ s, $Q_{\text{breach}} = 0.024$ m³/s

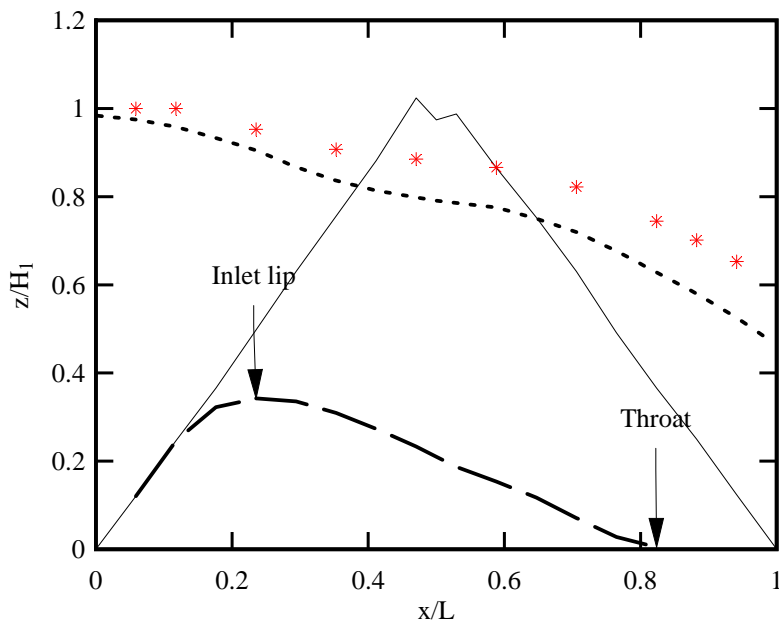
(D) Longitudinal bed elevation and total head along breach centreline, $t = 147$ s, $Q_{\text{breach}} = 0.071$ m^3/s

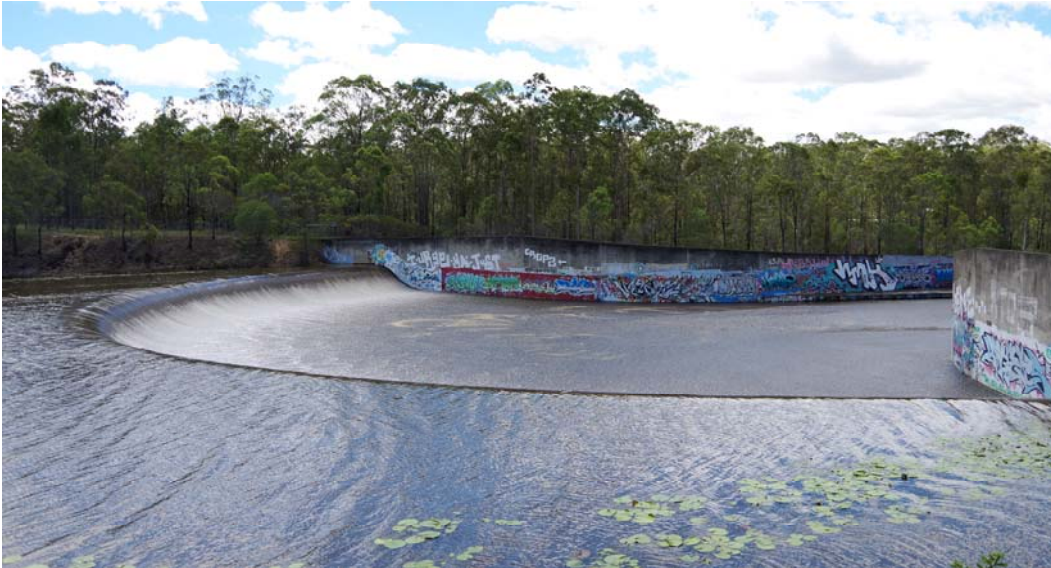
(A) Minimum energy loss spillway inlet of Lake Kurwongbah (Brisbane, Australia) in operation on 29 January 2013

where H_{des} is the design upstream head. Equation (6) is only valid at design flow conditions. In practice, the variations of the tailwater elevations with discharge are important and a weak jump takes place at the inlet toe as seen in Figure 6B. The downstream conjugate depth is fixed by the tailwater conditions downstream of the hydraulic jump.

The MEL overflow spillways are typically earthfill structures protected by concrete slabs (Fig. 6) and the construction costs must be minimum. The operations of a number of MEL spillways and weirs were documented, with a complement of field inspections and discussions with designers (Table 2) (Chanson 2003,2009). A number of MEL structures were observed to operate at design flow conditions and for floods larger than design. Inspections during and after flood events showed the sound operation together with little maintenance. The successful operation of several structures for over 40 years has highlighted further considerations. Some improper approach flow conditions could affect adversely the spillway operation. MEL weirs are typically earthfill structures and the spillway section is protected by concrete slabs. An efficient drainage system must be installed underneath the chute slabs. A known issue is the overtopping risk during construction as for the Sandy Creek weir and Chinchilla weir (twice).

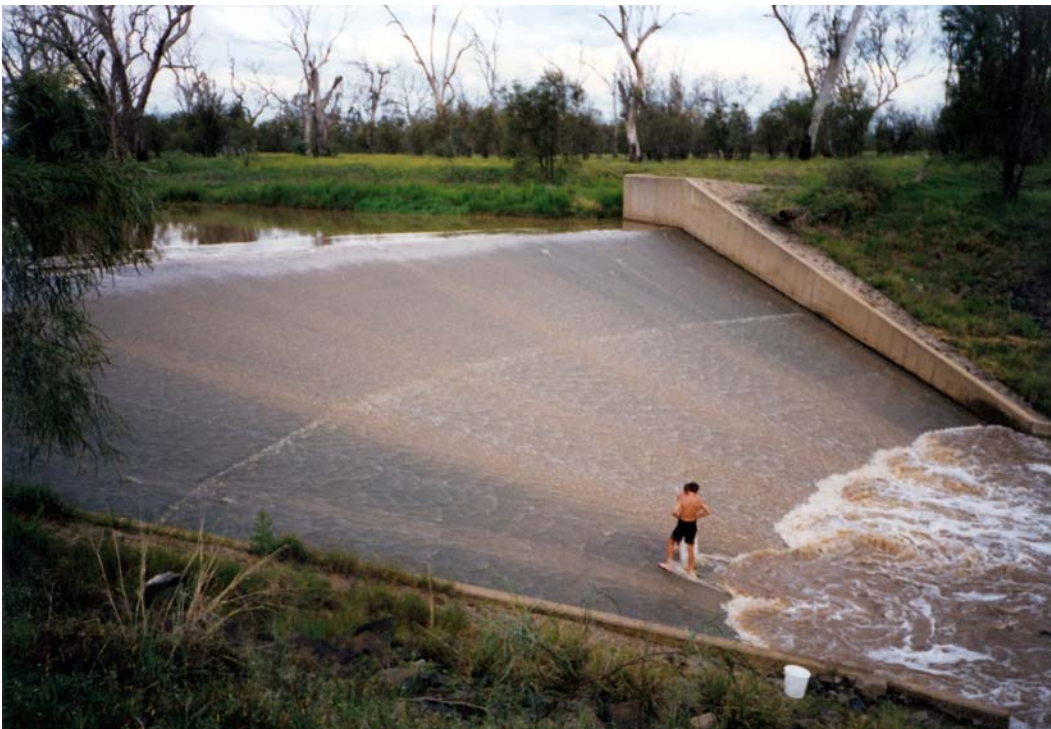
(B) Lemontree minimum energy weir (Australia) on 8 November 1997 for a small discharge ($Q \ll Q_{des}$)

An unusual embankment overflow protection system is the minimum energy loss (MEL) inlet design introduced in Australia during the 1970s (McKay 1971,1978). The first MEL inlet structure was the Redcliffe storm waterway system (1960); the inlet system is still in use and passed floods greater than its design flow ($Q_{des} = 25.8 \text{ m}^3/\text{s}$) without damage (McKay 1970, Chanson 2007). The minimum energy loss (MEL) inlet was developed to pass large floods with minimum energy loss and afflux, where the afflux is the rise in upstream water level caused by the presence of the embankment structure. Commonly used in culvert design, the afflux is a quantitative measure of the upstream flooding caused by the hydraulic structure. In the approach flow region, the water discharge is smoothly converged towards a streamlined chute, the MEL inlet system, and the design yields a nearly-constant total head along the waterway (Fig. 6). Figure 6 presents two prototype applications during a low flow operation. The approach flow region and MEL waterway are streamlined to avoid significant form losses. At design conditions, the flow may be critical from the inlet lip to the chute toe. The MEL inlet system was developed for embankment dam applications where the river catchment is characterised by large rainfalls and a very small bed slope. Figure 6A shows the MEL inlet at Lake Kurwongbah dam spillway: the efficient inlet design allowed and extra 0.457 m of water storage for the same maximum discharge capacity (McKay 1971). Figure 6B presents an overflow MEL embankment weir.

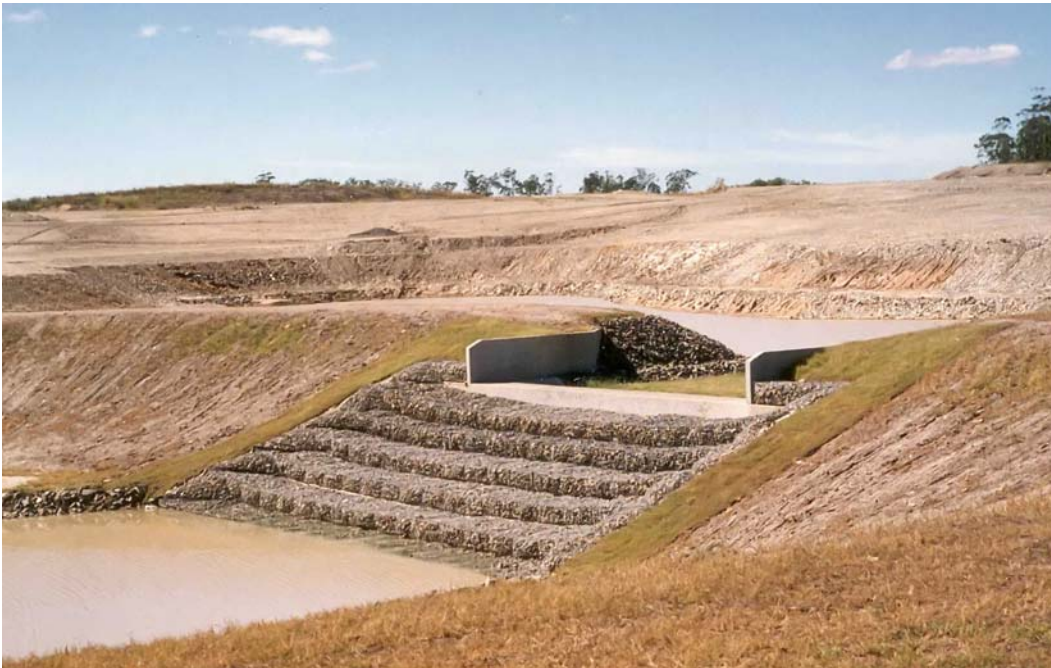
Fig. 7 - Gabion weir: Robina stepped weir No. 1 (Gold Coast, Australia) on 2 April 1997, shortly after completion: $h \sim 0.5$ m, $h/l \sim 0.5$

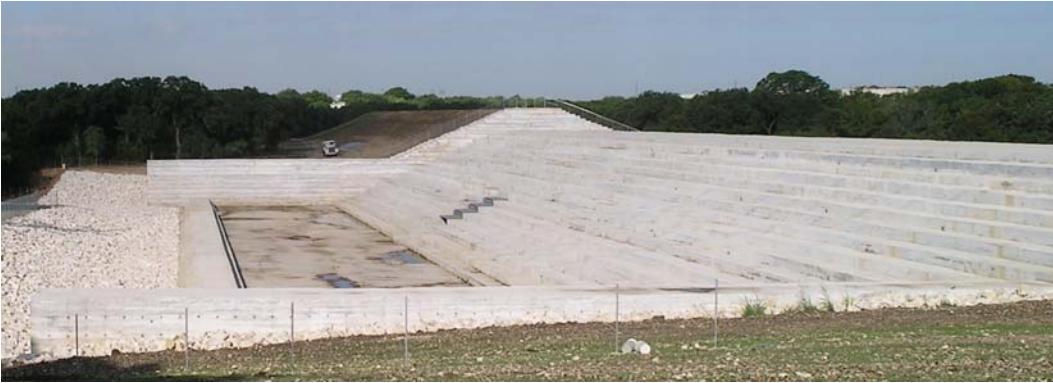
(A) Salado Creek Dam Site 15R in February 2005 (Courtesy of Craig Savelle, USDA)

During the last decades, a number of embankment dams were equipped with an overflow concrete stepped spillway (Chanson 2001) (Fig. 8). Applications included both primary and secondary spillway structures: Figure 8A illustrates a recent embankment dam equipped with a primary embankment overflow stepped spillway. Most modern stepped spillways consist of flat horizontal steps, although different step configurations may be considered (Andre et al. 2004, Gonzalez et al. 2008, Guenther et al. 2013, Felder and Chanson 2014). The preferred construction method is the placement of roller compacted concrete (RCC) overlays on the downstream embankment slope (Ditchey and Campbell 2000). Roller compacted concrete (RCC) is defined as a no-slump consistency concrete that is placed in horizontal lifts and compacted by vibratory rollers. During the construction, the RCC is placed typically in a succession of 0.2 to 0.4 m thick overlays with a width greater than 2.5 m for proper hauling, spreading and compacting. The advantages of RCC construction are the cost effectiveness and the short duration of construction. For an embankment overtopping protection, exposed RCC is frequently used for secondary spillways with infrequent overflows. In harsh climatic conditions, or for a primary spillway, a conventional concrete protection layer may be installed to protect the RCC. In all the cases, a drainage layer beneath the concrete overlays is essential to prevent uplift pressures. Its purpose is to relieve pore pressure at

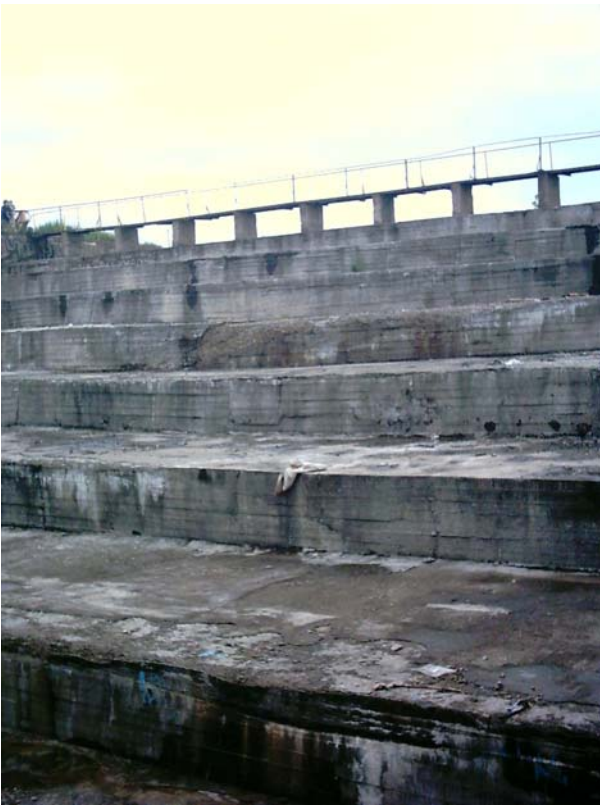
(B) Old 17th century rockfill embankment with timber crib overflow near Moscow (Russia)

(Courtesy of Dr Marat Mirzoev) - A concrete stepped chute was installed in the last twenty years

The performances of gabion stepped weirs are often restricted by the gabion resistance to damage and their stability. Sediments and debris carried by the stream flow may affect and fracture the gabion mesh. With large-size debris, it is common practice to protect the step surfaces with timber, steel sheets, concrete facing or even reinforced concrete slab (Agostini et al. 1987, Peyras et al. 1992). Figure 8B show a more extreme example of concrete facing.

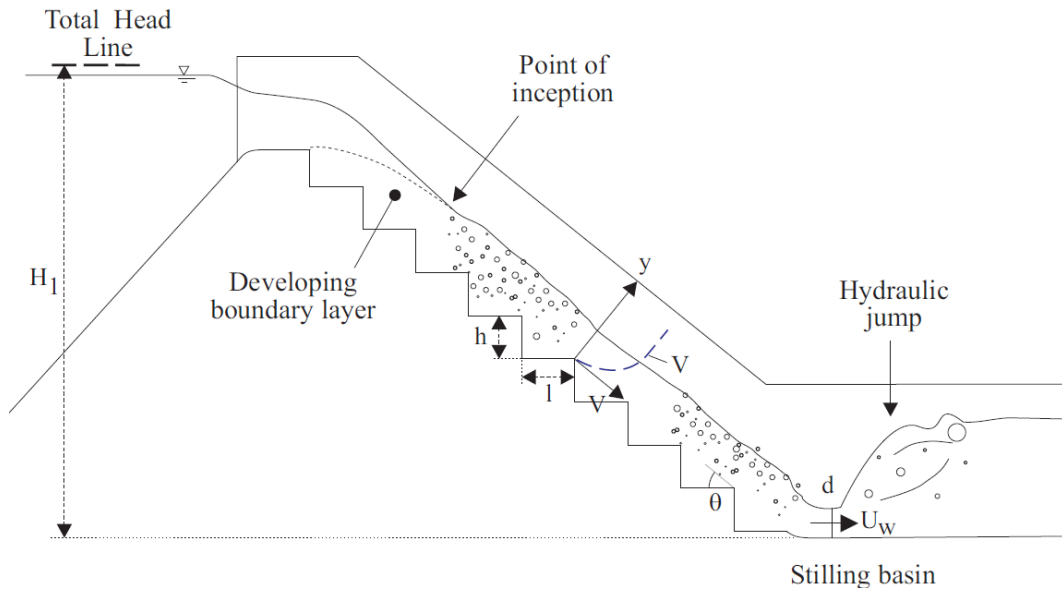
Fig. 9 - Sketch of an embankment overtopping stepped spillway

In a skimming flow above the stepped spillway, the upstream flow is characterised by a developing boundary layer (Amador et al. 2006, Meireles and Matos 2009) (Fig. 9). When the outer edge of the boundary layer interacts with the free-surface, the turbulent shear stress becomes greater than the surface tension force per unit area resisting the interfacial breakup and free-surface aeration takes place (Ervine and Falvey 1987, Chanson 2009b). The location and flow depth at the inception point of free-surface aeration may be estimated as:

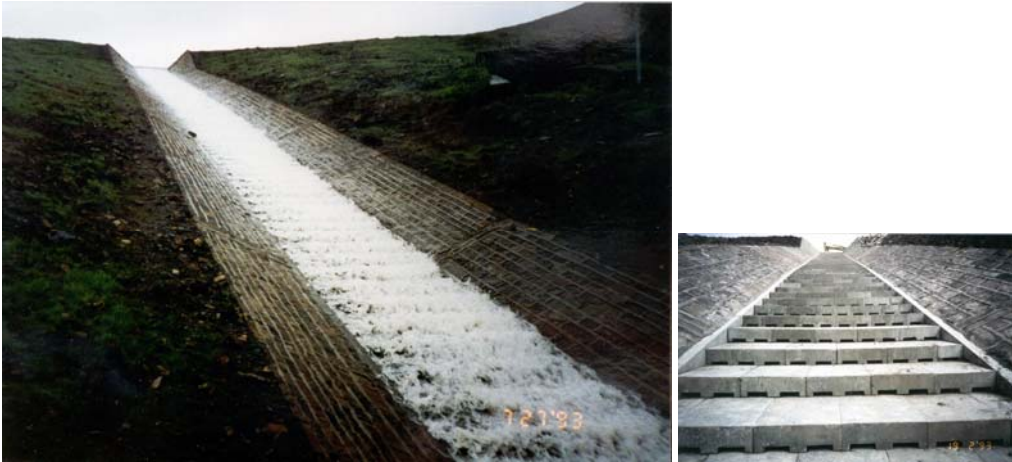
(B) Brushes Clough dam (UK) in 1993 (Courtesy of Mr Gardiner, NWW) - Left: small overflow; Right: details of the concrete block placement

blocks, possibly made of reinforced concrete. A step height-to-length ratio in the range 1:4 to 1:6 may ensure maximum stability of the blocks during the overtopping. Drains must be placed in areas of sub-atmospheric pressure to relieve uplift pressures (Fig. 10B). Figure 10B illustrates some drains on the vertical step face.
