## CASE REPORT

# Dental root elevator embedded into a subgingival caries: a case report

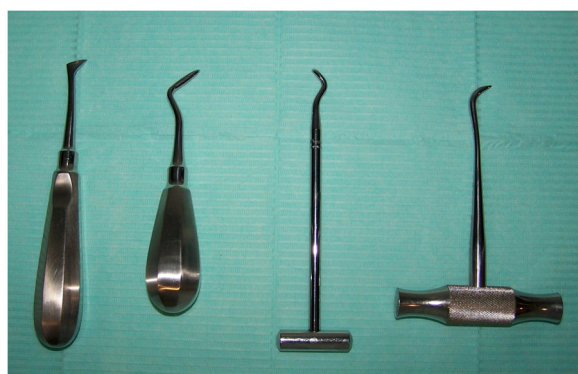
A tooth elevator is an instrument used in minor oral surgical procedures to luxate the tooth or fractured root from its socket. There is a vast range of elevator designs, including right and left sides for several types (Figure 1). Alveolar bone fracture and fracture/luxation of the adjacent tooth are two common problems associated with their use.

**Figure 1** Luxating dental elevators with curved bladed tips to facilitate root extraction.

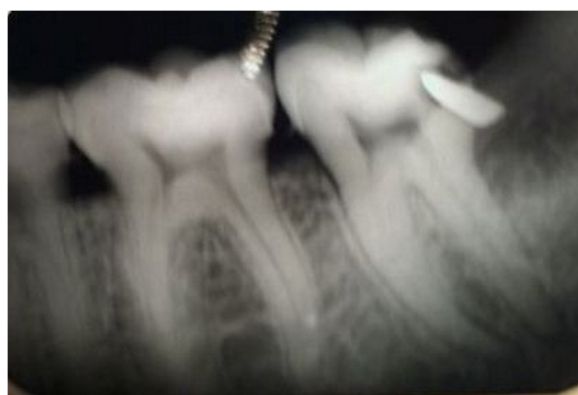
findings. The patient explained that his mandibular left third molar had been extracted six months previously and that the surgery had been quite laborious and lengthy. Although the healing process had been satisfactory, considerable pain had recently begun in this area. The dental X-ray showed an image consistent with a piece of metal embedded in a subgingival distal caries at the mandibular left second molar (37), which was probably related to a previous tooth impaction process of the mandibular left third molar (38). Two periapical lesions detected at the mandibular left second molar roots might have justified his acute tooth ache due to acute exacerbation (Figure 2).

Initially, the differential diagnosis of this radiographic finding was that of a possibly loosened or released piece of amalgam. Nevertheless, the patient had never previously undergone any dental fillings. After repeating the X-ray twice in order to rule out a possible image artefact, it was concluded that during the third molar extraction a curved

**Figure 2** Periapical radiographic image: Notice the curved blade elevator tip broken and embedded in a subgingival caries cavity of the mandibular left second molar (37). Observe two radiolucent apical lesions in the affected molar (37) and a slight radiopacity located on the distal part of the first molar crown (36), which was a consequence of the Kocher clamp used during a manual developing process.

blade elevator tip had fractured and impacted into the subgingival caries cavity. As the patient had only been referred for a dental X-ray he was given a written note explaining the finding. His dentist was informed about the need to perform an occlusal access cavity in order to initiate a root canal treatment and remove the foreign body from the second molar (37).
