Vanessa RODRIGUEZ, Jacob SUKUMARAN, Yeczain PEREZ DELGADO, Mariana STAIA, Alain IOST, Patrick DE BAETS - Scratch evaluation on a high performance polymer - Mechanical Engineering Letters - Vol. 9, p.76-84 - 2013

Scratch evaluation on a high performance polymer

Vanessa RODRIGUEZ¹, Jacob SUKUMARAN¹, Yeczain PEREZ DELGADO¹, Mariana STAIA¹, Alain IOST², Patrick DE BAETS¹

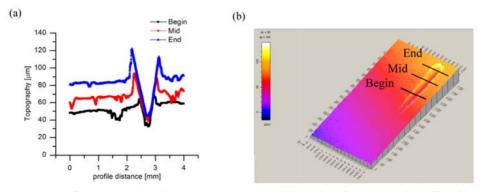
Figure 3. Profilometer results of a typical scratch on a PEEK-E02 surface: (a) depth profile with clear evidence of the scratch with different positions of the scratch; beginning, middle and end (b) 3D view of the scratch test

An evaluation of the scratch produced using profilometry leads to the profiles shown in figure 3 (a) the penetration depth with less material deformation at the beginning and a progressively increasing residual scratch towards the end of the scratch. At this position the scratch depth is also slightly deeper from the normal scratch course, due to the back-movement of the scratch head. In the figure 3(b) a corresponding a 3D view of the scratch following the original scratch direction, so that the deeper valley and the pushed-up hills at the rim of the scratch are more visible.

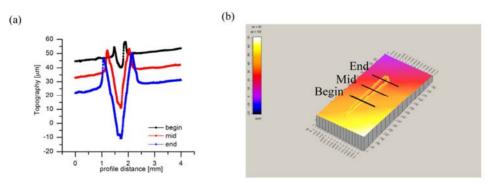
The depth profilometry allows obtaining more precise information on the remaining penetration depth during scratching test. In the figure 6 (a) we can see the variation of the penetration in the bulk of polymer for the PEEK-S01 filled with carbon fibers and graphite it can be seen how is slightly deeper and smoothly in the beginning until the end of the scratch test. And it can be notice in the figure 6 (b) the 3D images and the penetration depth and the grooves formation during the scratching test in the material tested.

Figure 6. Profilometer results of a typical scratch on a PEEK-S01 surface: (a) depth profile with clear evidence of the scratch with different positions of the scratch; beginning, middle and end (b) 3D view of the scratch test.
