Henderson County Hazardous Materials Commodity Flow Study

Final Report

September 18, 2013

This project was completed by Western Kentucky University

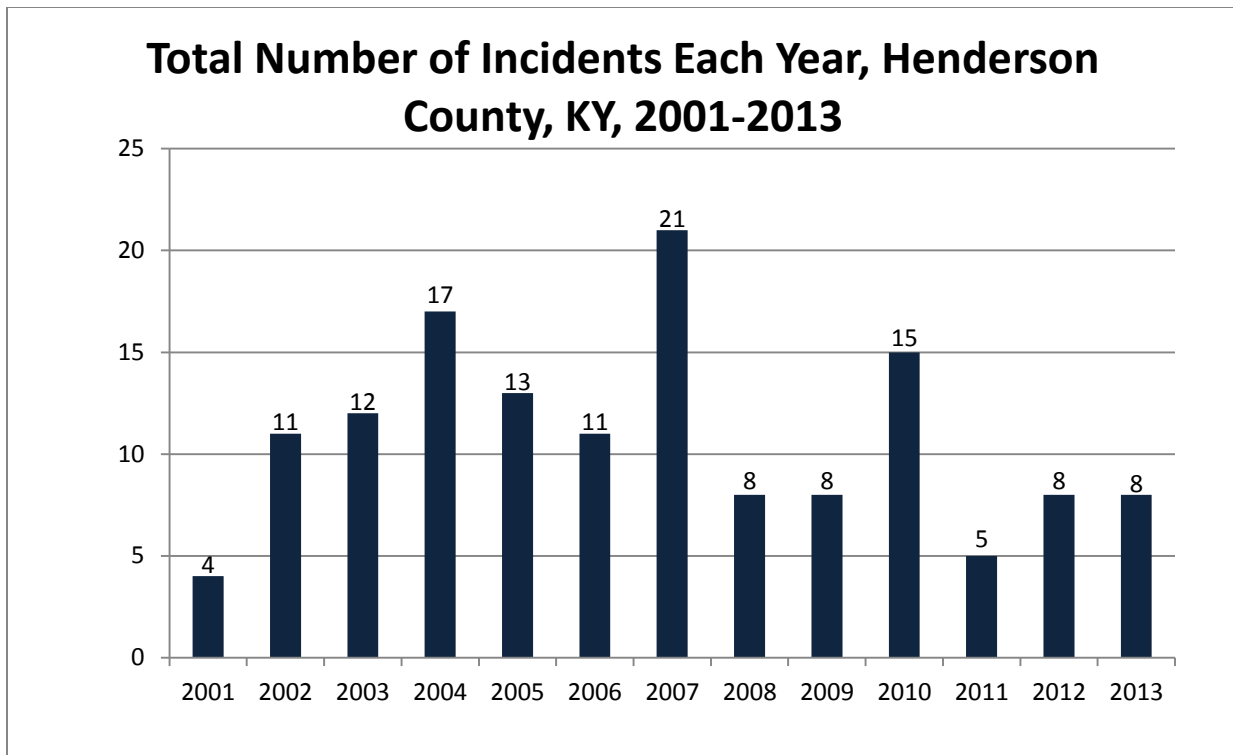
Figure 2.2. Total number of incidents each year in Henderson County from 2001-2013

The numbers of incidents that have occurred each year over the period of record for this study are shown in Figure 2.2. A maximum of 21 incidents occurred in 2007, followed by 17 in 2004, and 15 in 2010. The complete years of record for the dataset analyzed were from 2002 to 2012. During these years, the minimum number of incidents in a year was five, this occurred in 2011. From the time period of 2002 through 2007 the average number of incidents per year was about 14 (14.2). In the period from 2008 through 2012 the average number of incidents per year was about 9 (8.8). The standard deviation in the number of incidents per year, for the period 2002 through 2012, was 4.6 or about 5 incidents. This indicates that the database is quite variable in the number of incidents from year to year. Based on the data, it is reasonable to expect about 8 incidents or more each year.

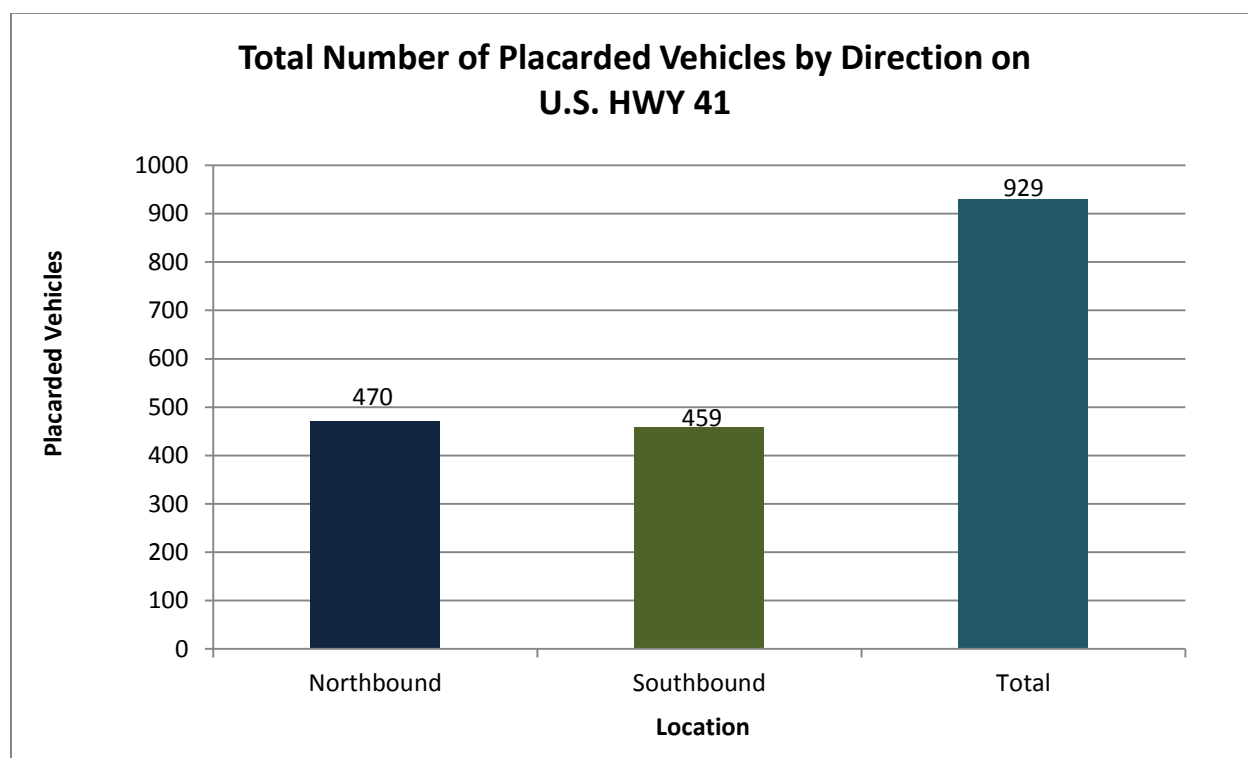
Figure 3.1. Placarded commercial vehicles observed on U.S. Hwy 41.

During the 5 days of monitoring, a total of 929 placarded vehicles were observed on both southbound and northbound lanes (Figure 3.1). The number of vehicles transporting hazardous materials was similar on the northbound lane (470) compared to the southbound lane (459) of Hwy 41. The average number of vehicles transporting hazardous materials per hour was nearly equivalent between the northbound (11.8 vehicles per hour) and southbound lanes (11.5 vehicles per hour) (Figure 3.2).
