# Daviess County Hazardous Materials Commodity Flow Study

*Final Report  
September 27, 2013*

This project was completed by Western Kentucky University in partnership with

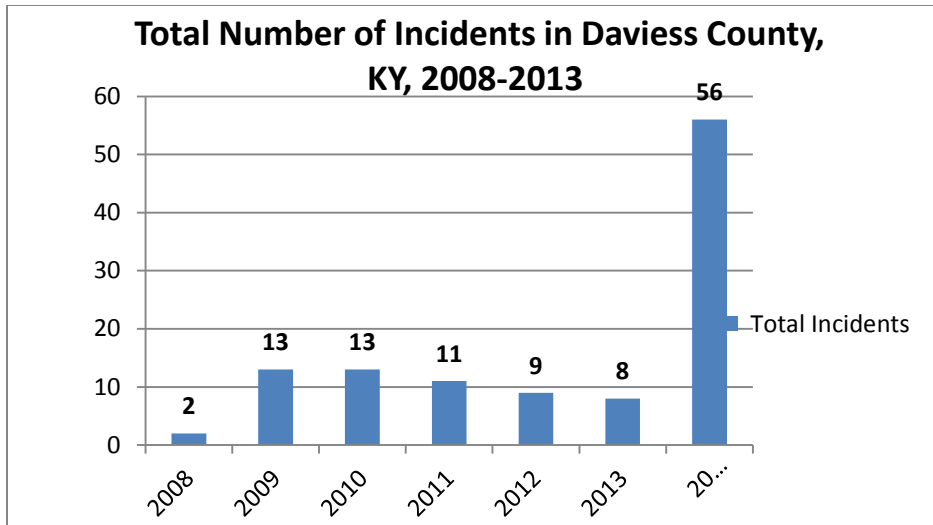
Figure 2.2. Total number of hazmat incidents in Daviess County by year and for all years.

Note: Data for 2008 and 2013 were not for an annual period. Data were collected in 2008 beginning in December, two events occurred in one month, and through June for 2013. These data are presented for information only.

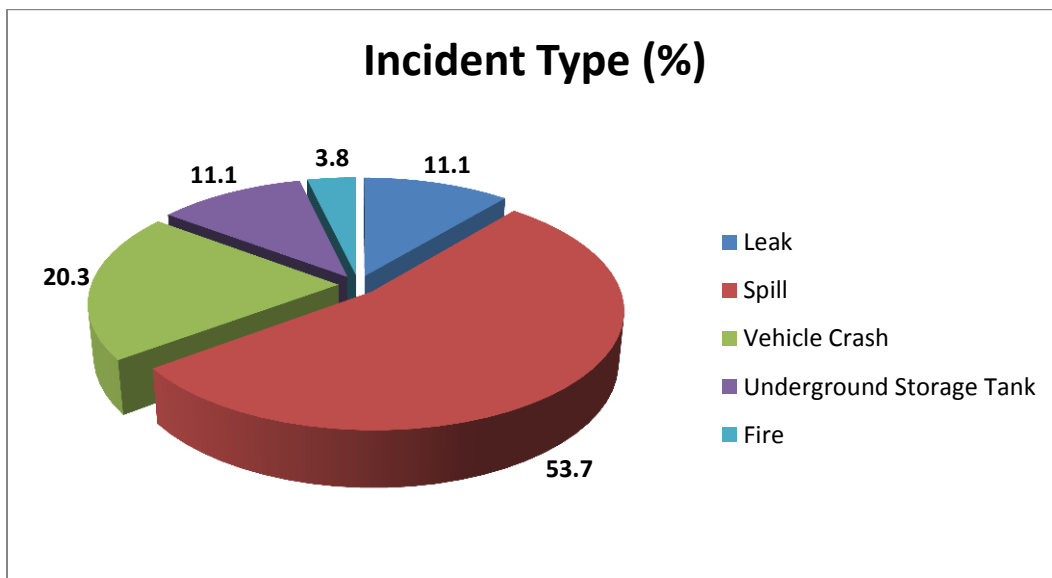
Figure 2.3. Types of incidents occurring from December 2008 through June 2013.

The type of emergency and hazardous material involved ultimately determines the appropriate emergency response. Five types of incidents were reported between 2008 and 2013 (Figure 2.3). Spills accounted for 53.7% of all incidents reported, followed by vehicle crashes (20.3%), while leaks and underground storage tank failure accounted for 11.1% each, and fires accounted for the remaining 3.7%. Numerous types of materials were identified in the incident reports. As shown in Figure 2.4, the most common material classes identified were fuel products 40.4 % .Oil represented 36.8% of reported incidents, while unspecified material accounted for 7.0%. A combination of other materials accounted for 15.8%.

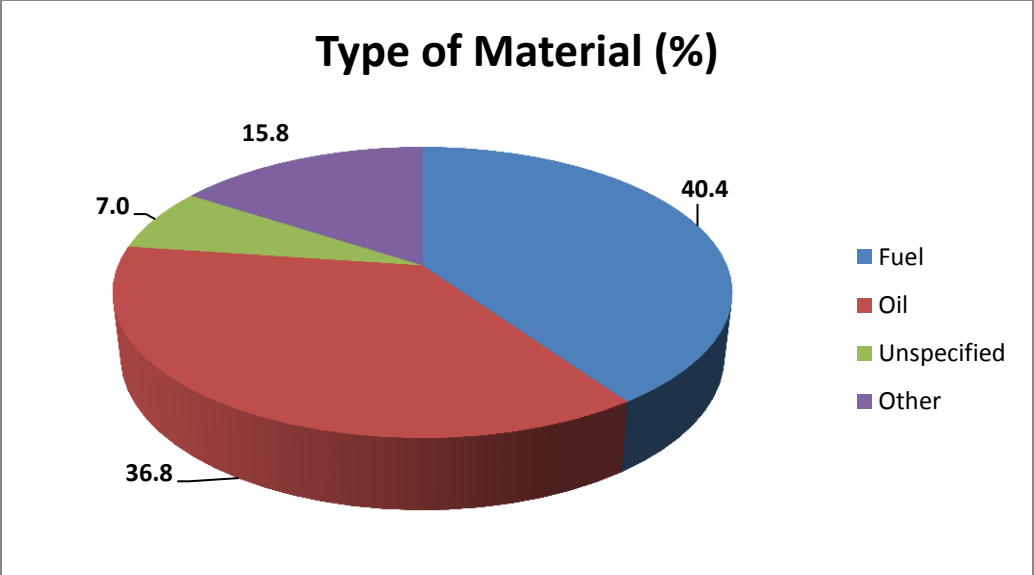
Figure 2.4: Types of hazmats identified in the incidents from December 2008 through June 2013.

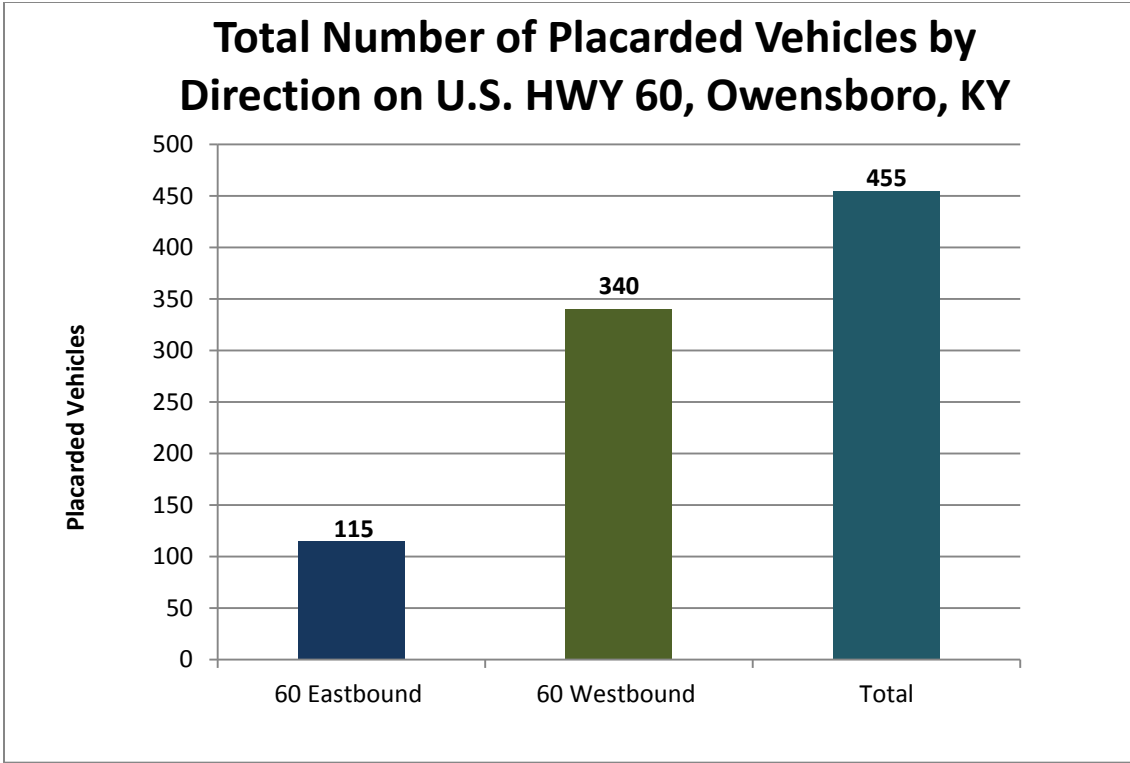
Figure 3.1. Placarded vehicles observed on Hwy 60.

During the Hwy 60 monitoring period, June 24-28, 2013, the total number of placarded vehicles observed, on both eastbound and westbound lanes, was 455 (Figure 3.1). There were more vehicles transporting hazardous materials on the westbound lane of Hwy 60 (340) compared to the eastbound lane (115), representing a 75% difference between westbound and eastbound lanes. Similarly, the average number of vehicles transporting hazardous materials per hour was greater in the westbound lane (8.0 vehicles/hour) compared to the eastbound lane (3.6 vehicles/hour) (Figure 3.2).

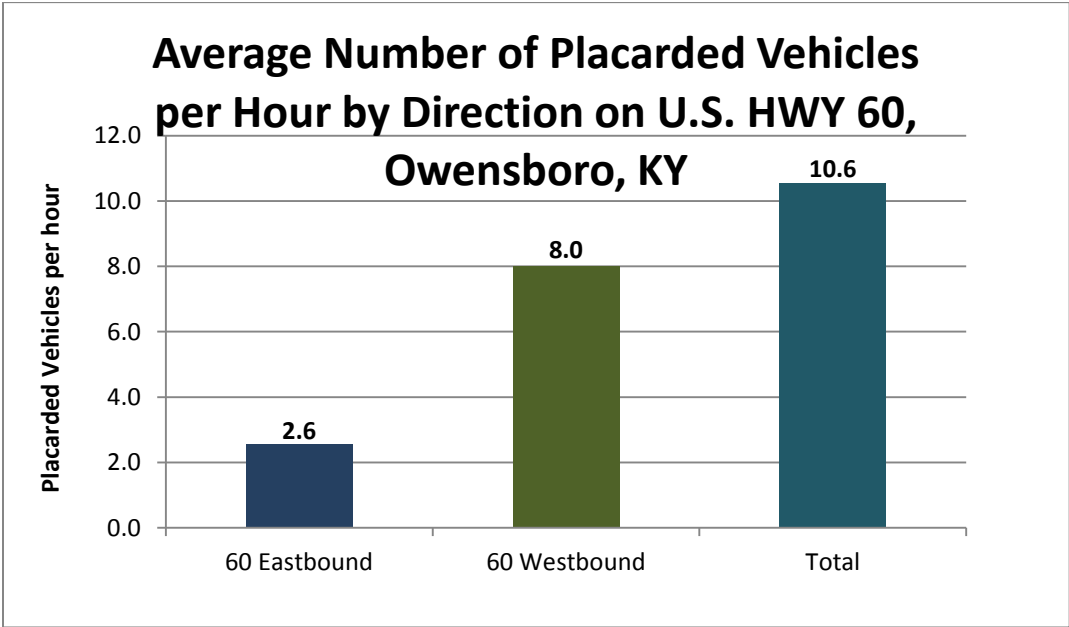
Figure 3.2. Frequency of placarded vehicles per hour on Hwy 60.

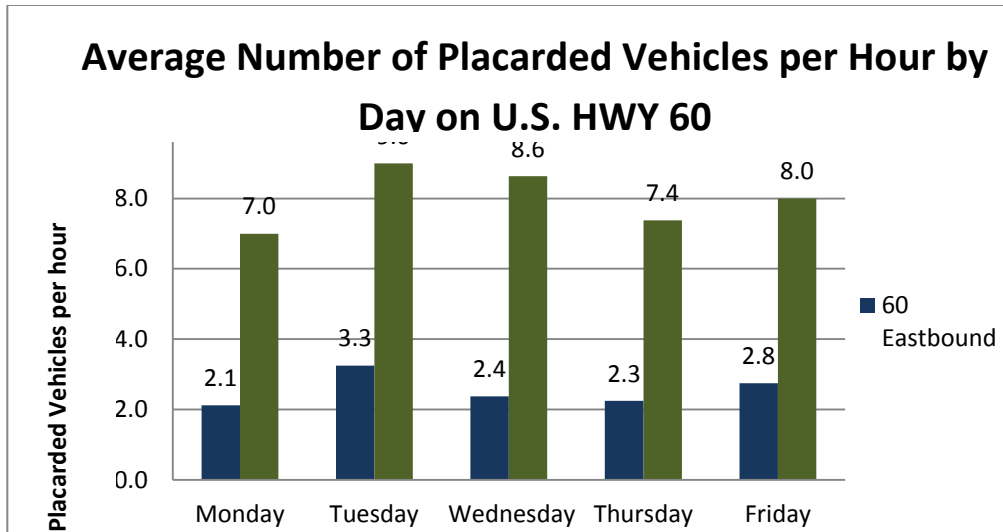
Figure 3.3 Commodity flow rates of placarded vehicles by day of the week on Hwy 60.

Hazardous material transportation frequency displayed differences throughout the week (Figure 3.3). Total hazardous material transport across Hwy 60 peaked on Tuesday, with an average of 9.0 vehicles per hour westbound and 3.2 vehicles per hour eastbound. This peak is seen in both eastbound and

The average number of placarded vehicles observed, on both eastbound and westbound Hwy 60, was determined to be 10.6 per hour (422 placarded vehicles/40 monitoring hours), as shown in Figure 3.3. An average of 8.0 westbound and 2.6 eastbound were observed for the monitoring period.

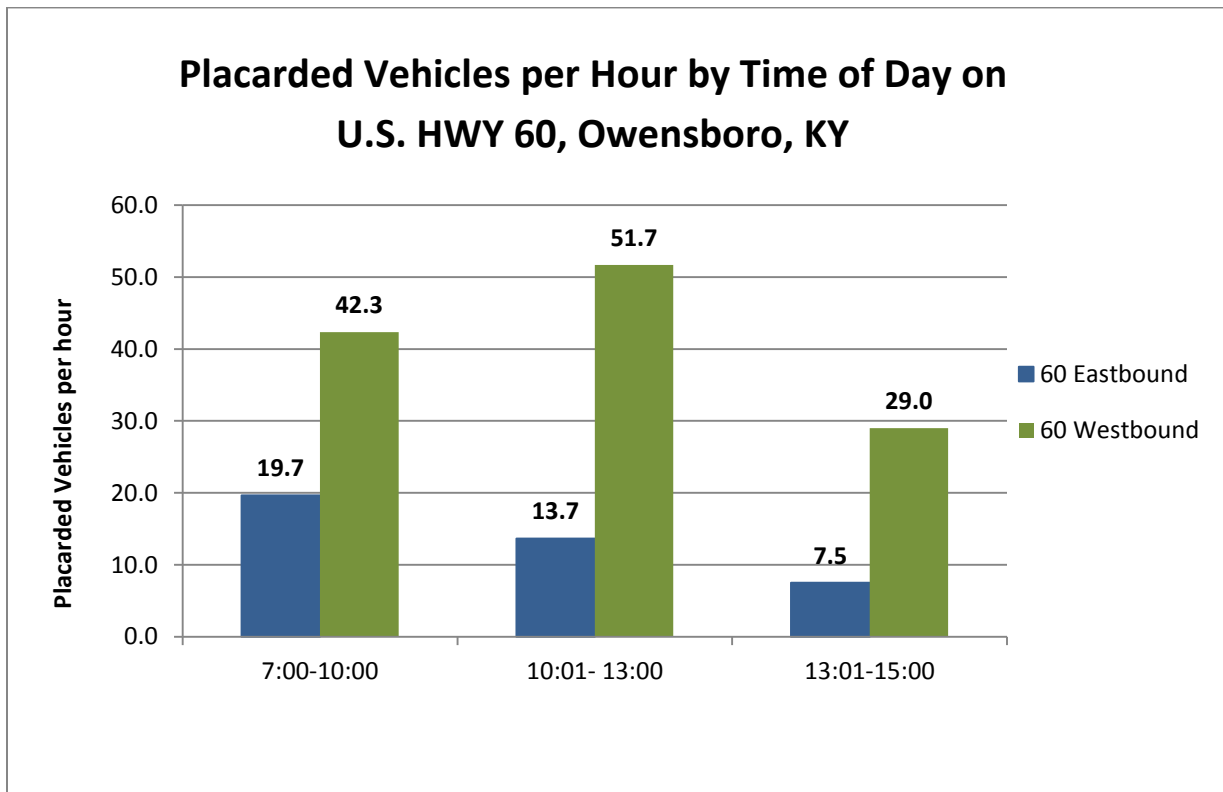
Figure 3.4: Commodity flow rates of placarded vehicles by time of the day on Hwy 60.

As shown in Figure 3.4, the maximum frequency of hazardous materials observed was during the midday period for the westbound lane, about 52 placarded vehicles per hour, and in the morning for the eastbound lane, about 20 placarded vehicles per hour for the study period. For both eastbound and westbound lanes, the lowest frequency of placarded truck traffic was seen in the afternoon period, with 7.5 and 29 vehicles per hour, respectively.

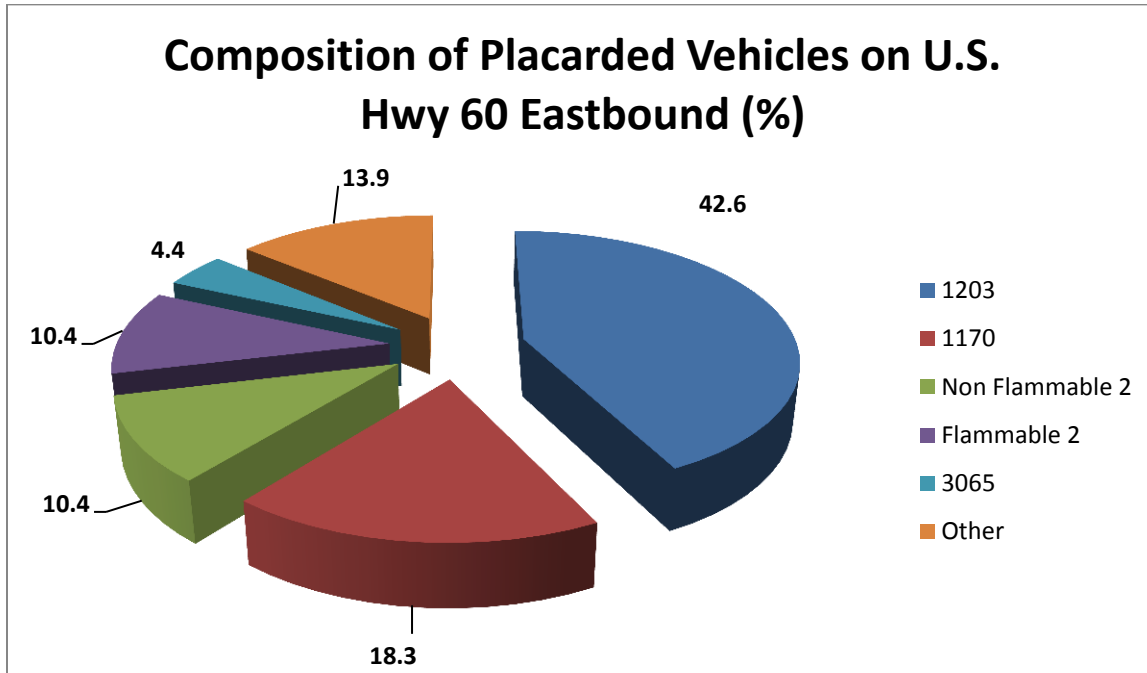
Figure 3.5: Composition of hazardous materials transported on eastbound Hwy 60.

The composition (%) of hazardous material transported by vehicles on eastbound Hwy 60 is displayed in Figure 3.5. Gasoline (Placard ID 1203) was the most frequently transported material on eastbound Hwy 60, accounting for 42.6% of the total hazardous material observed. Other commonly observed materials Ethanol (Placard ID 1170 ) (18.3%), Nonflammable gas (10.4%), Flammable gas

(10.4%) Alcoholic beverages (Placard ID 3065) (4.4%). Appendix 3 shows frequencies of other hazardous materials transported; the “Other” category indicates all other observed materials, which individually account for than 2% of the observations.

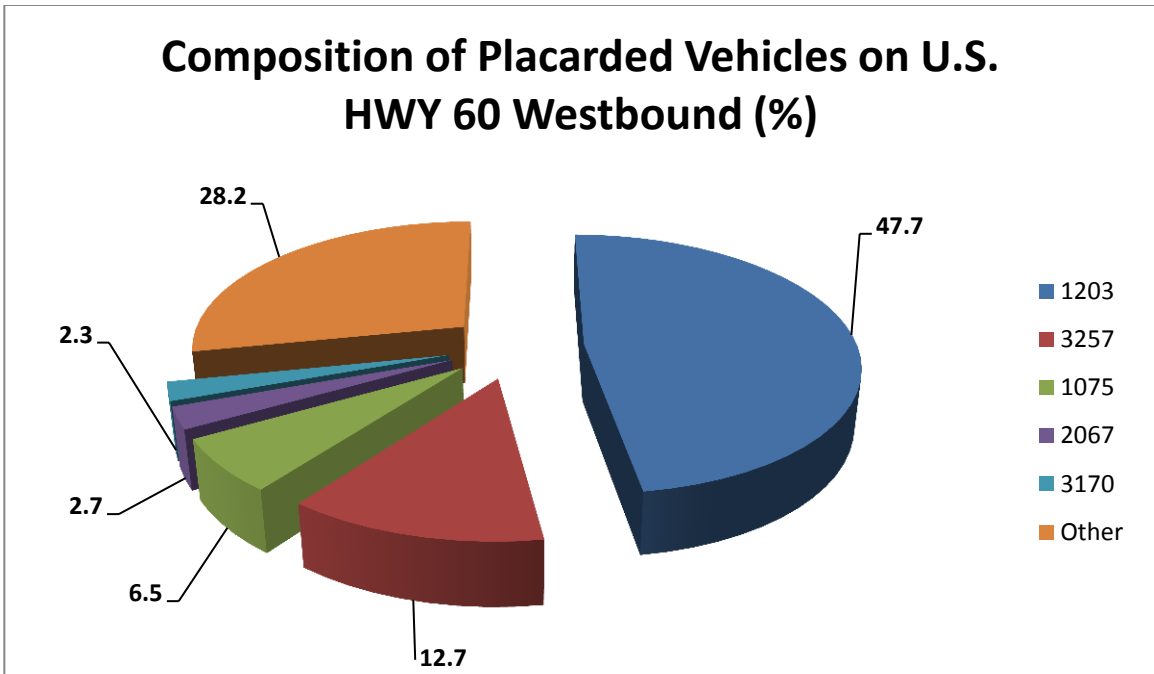
Figure 3.6. Composition of hazardous materials transported on westbound Hwy 60.

As shown in Figure 3.6, gasoline (Placard ID: 1203) was the most frequently transported hazardous material on westbound Hwy 60, (47.7) of the total hazardous material observed. Other commonly observed materials include Elevated Temperature Liquid (Placard ID 3257) (12.7%), Propane (6.5%), Ammonia Nitrate (Placard ID 2067) ( 2.7%) and Aluminum by-products (Placard ID 3170 ) (2.3%). A table presented in Appendix 4 shows frequencies of other materials transported; the “Other” category indicates all other observed materials that individually account for less than 2% of the observations. A complete list of these materials can be found in Appendix 4.

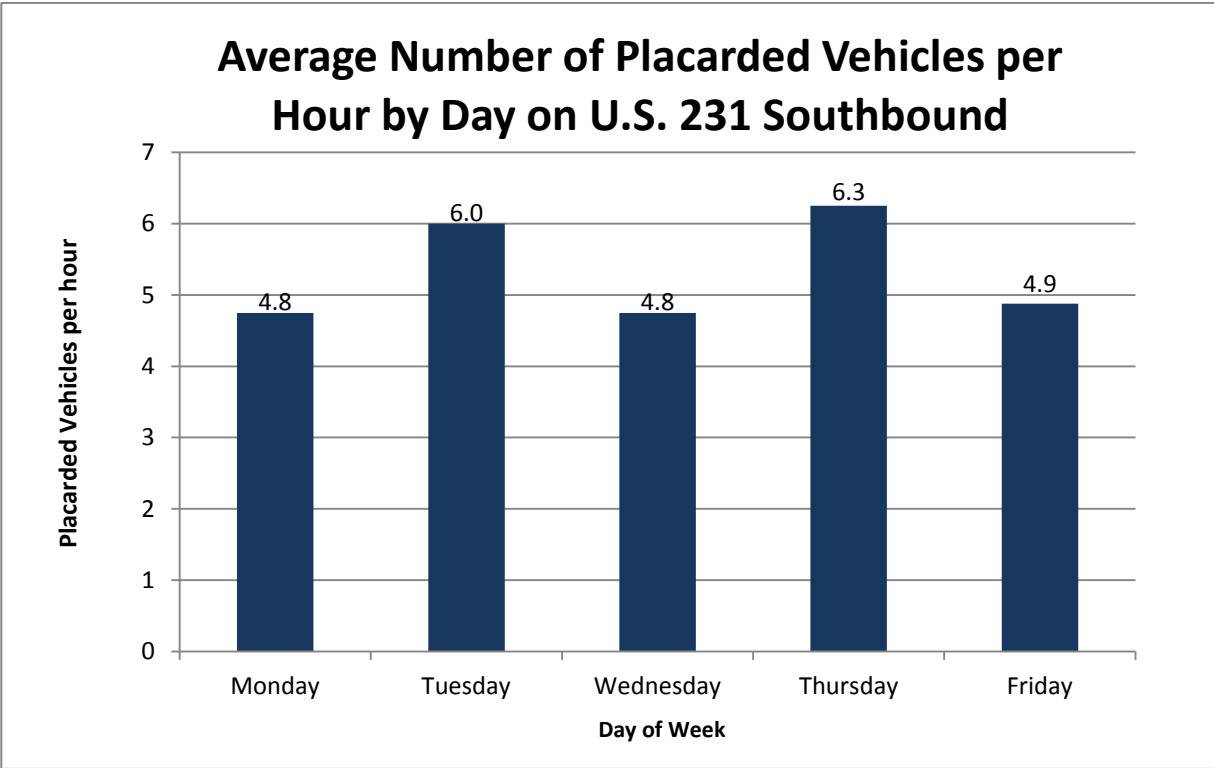
Figure. 4.1. Commodity flow rates of placarded vehicles by day of the week on southbound U.S. 231.

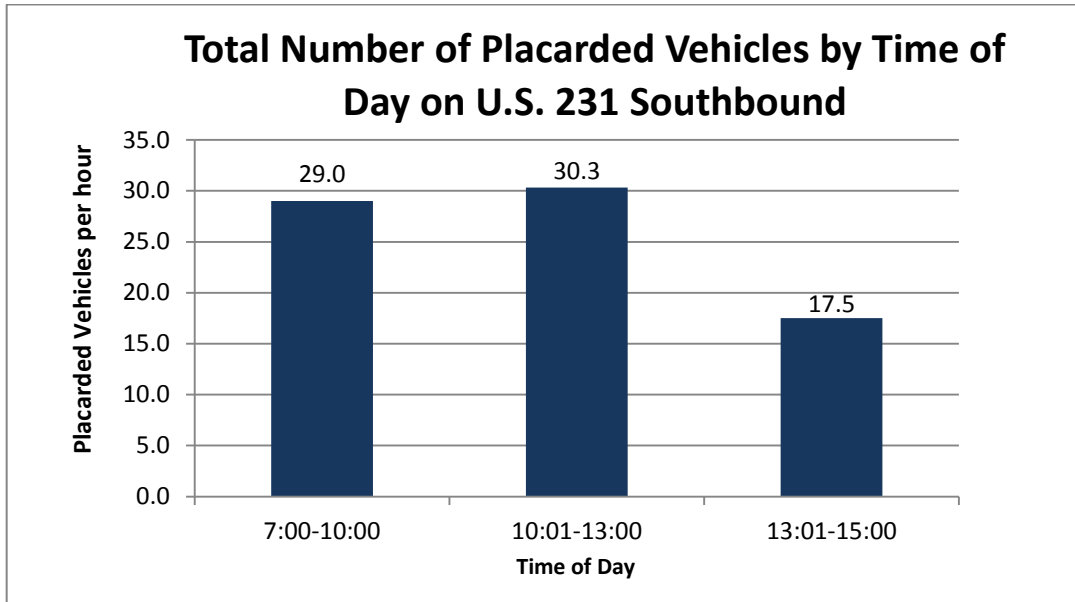
Figure 4.2. Commodity flow rates of placarded vehicles by time of the day on southbound U.S. 231.

As shown in Figure 4.2, the maximum frequency of placarded vehicles per hour, 30.3, was observed during the midday period for the southbound lane. A similar load was witnessed during the morning, 29 placarded vehicles per hour. The lowest frequency of placarded vehicles was seen in the afternoon period, with 17.5 vehicles per hour.

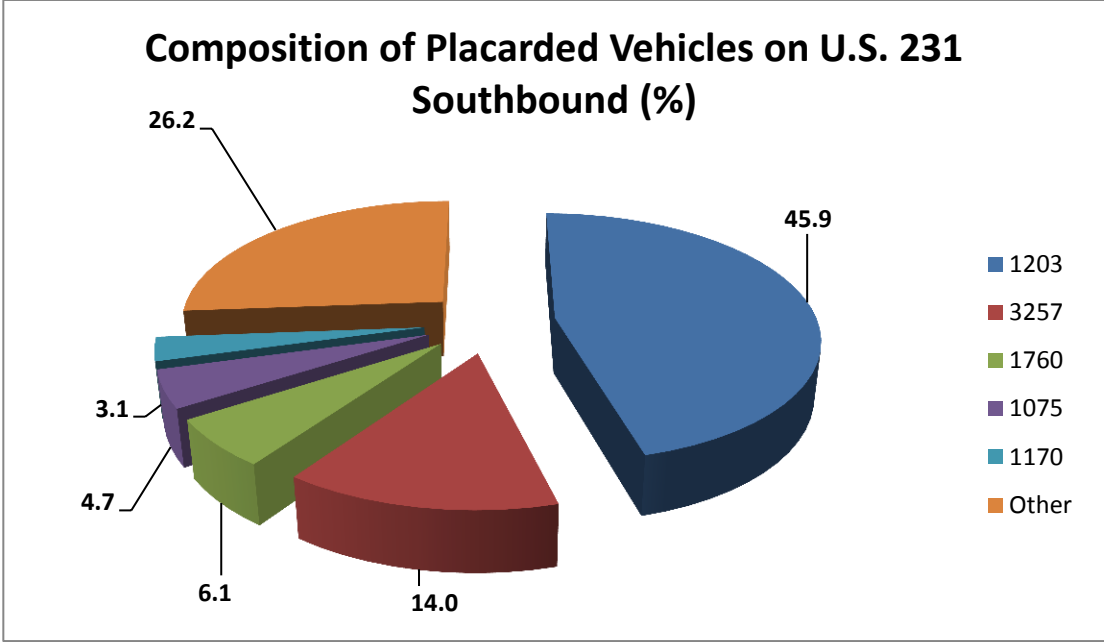
Figure 4.3. Composition of hazardous materials observed on southbound U.S. 231.

Analysis of the placard data was used to assess the materials being transported southbound. As shown in Figure 4.3, Gasoline, Placard ID 1203, was the most frequently transported material on U.S. 231, accounting for 45.9% of the total hazardous materials observed during the observation period. Other commonly observed materials Elevated Temperature Liquid, Placard ID 3257 (14.0%), Corrosive Liquid, Placard ID 1760 (6.1%), Propane, Placard ID 1075 (4.7%), Ethanol, Placard ID 1170 (3.1%). Frequencies of other materials transported; the “Other” category indicates all other observed materials that individually account for less than 2% of the observations and cumulatively accounted for 26.2%. A list of these materials can be found in Appendix 5.

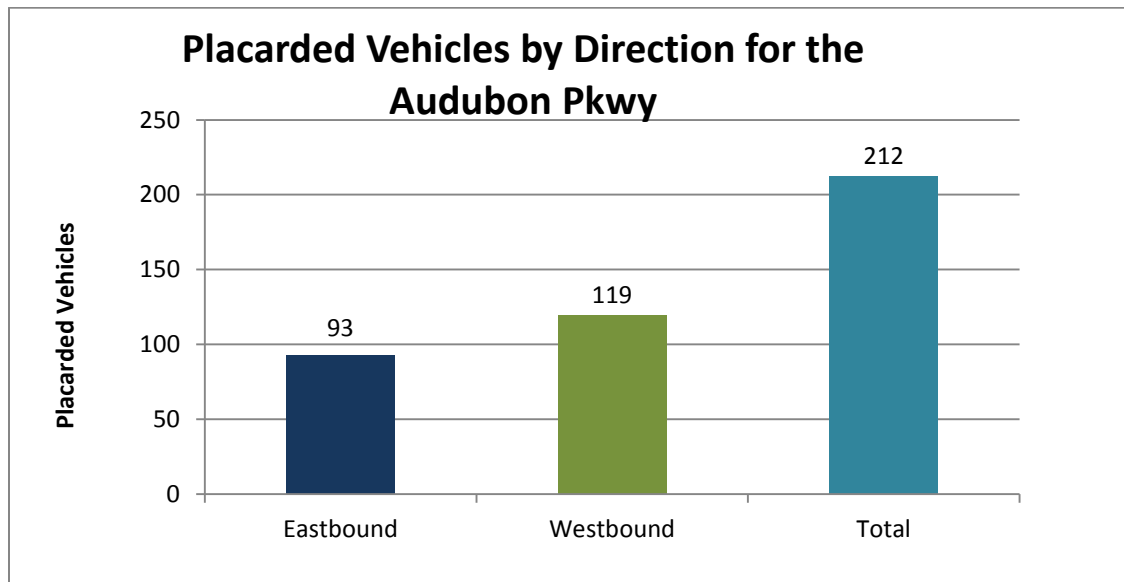
Figure 5.1. Placarded vehicles observed on the Audubon Parkway.

A total of 212 placarded vehicles were observed during the Audubon Parkway monitoring period (Figure 5.1). The average commodity flow rate observed on both east and westbound per hour was 5.3 placarded vehicles per hour (Figure 5.2). Higher number of placarded vehicles was observed transporting hazardous materials on westbound Audubon Parkway, 119, than eastbound, 93, representing a 21.9% difference between the lanes. Similarly, the rate of placarded vehicle transport was greater westbound, 3.0 placarded vehicles per hour, compared to eastbound, 2.3 placarded vehicles per hour.

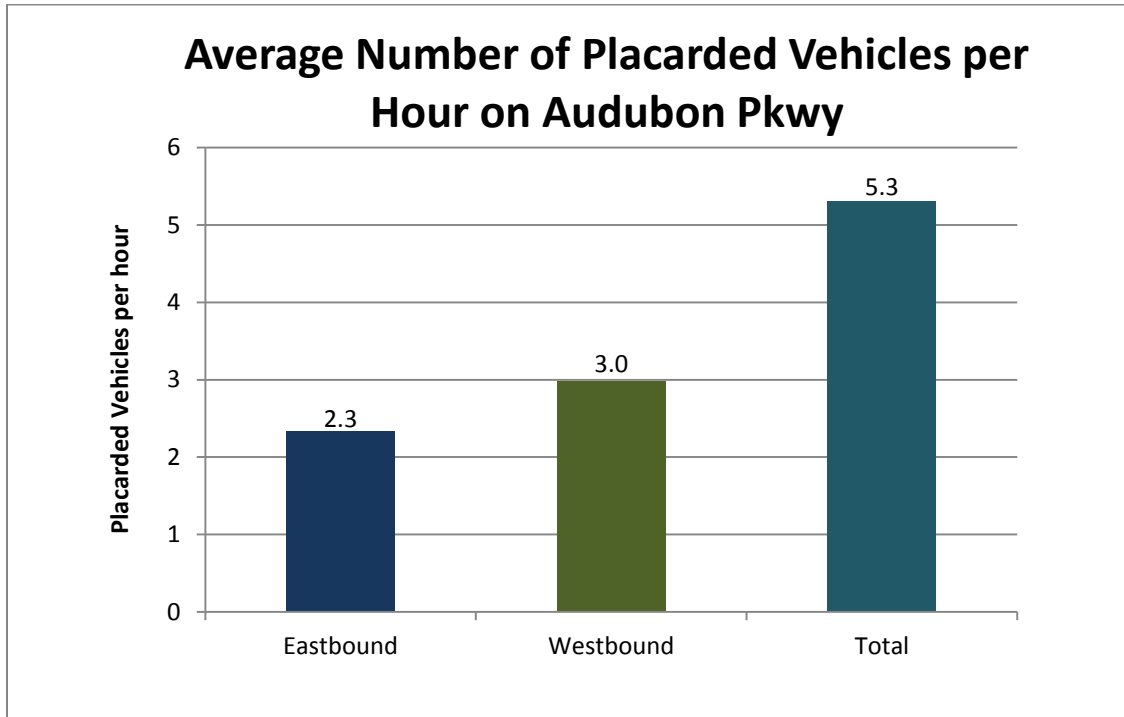
Figure 5.2. Frequency of placarded vehicles per hour on Audubon Parkway

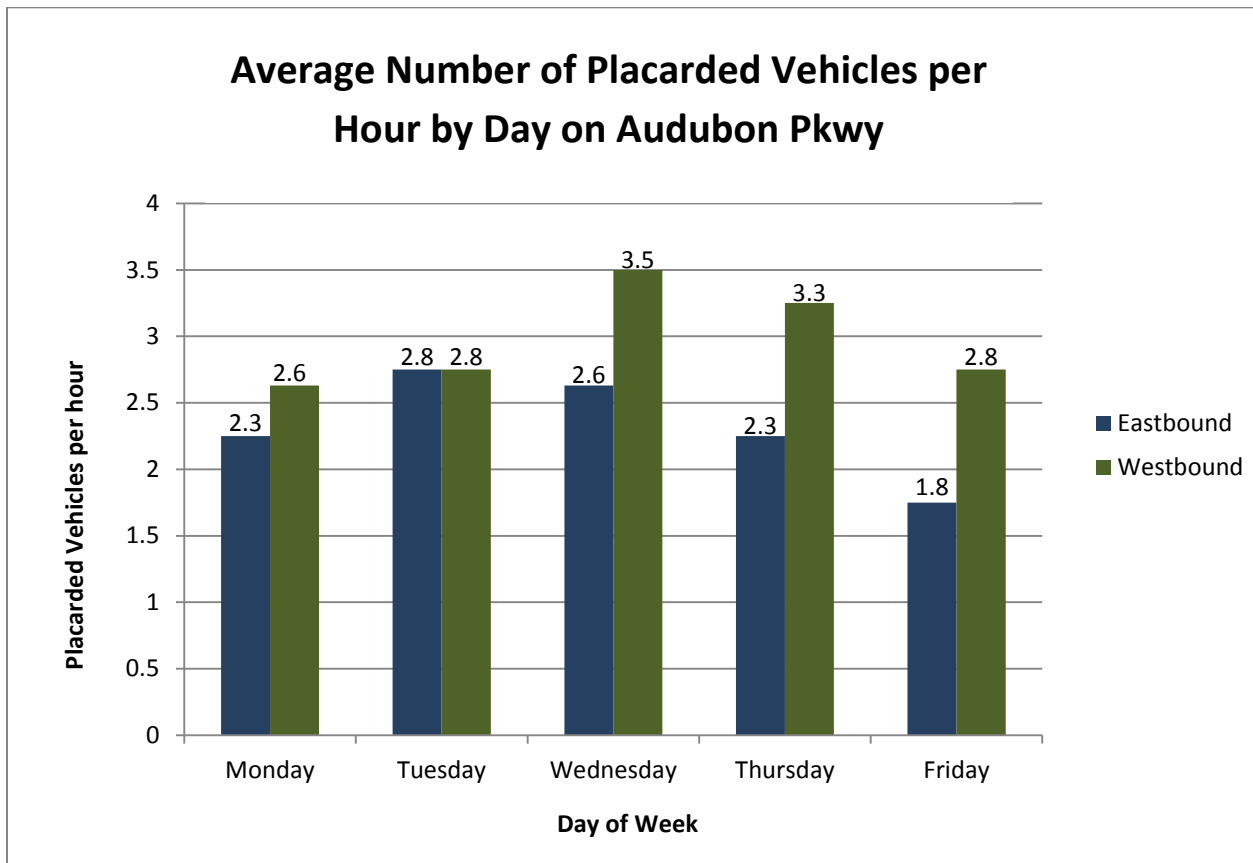
Figure 5.3. Commodity flow rates of placarded vehicles by day of the week on Audubon Parkway.

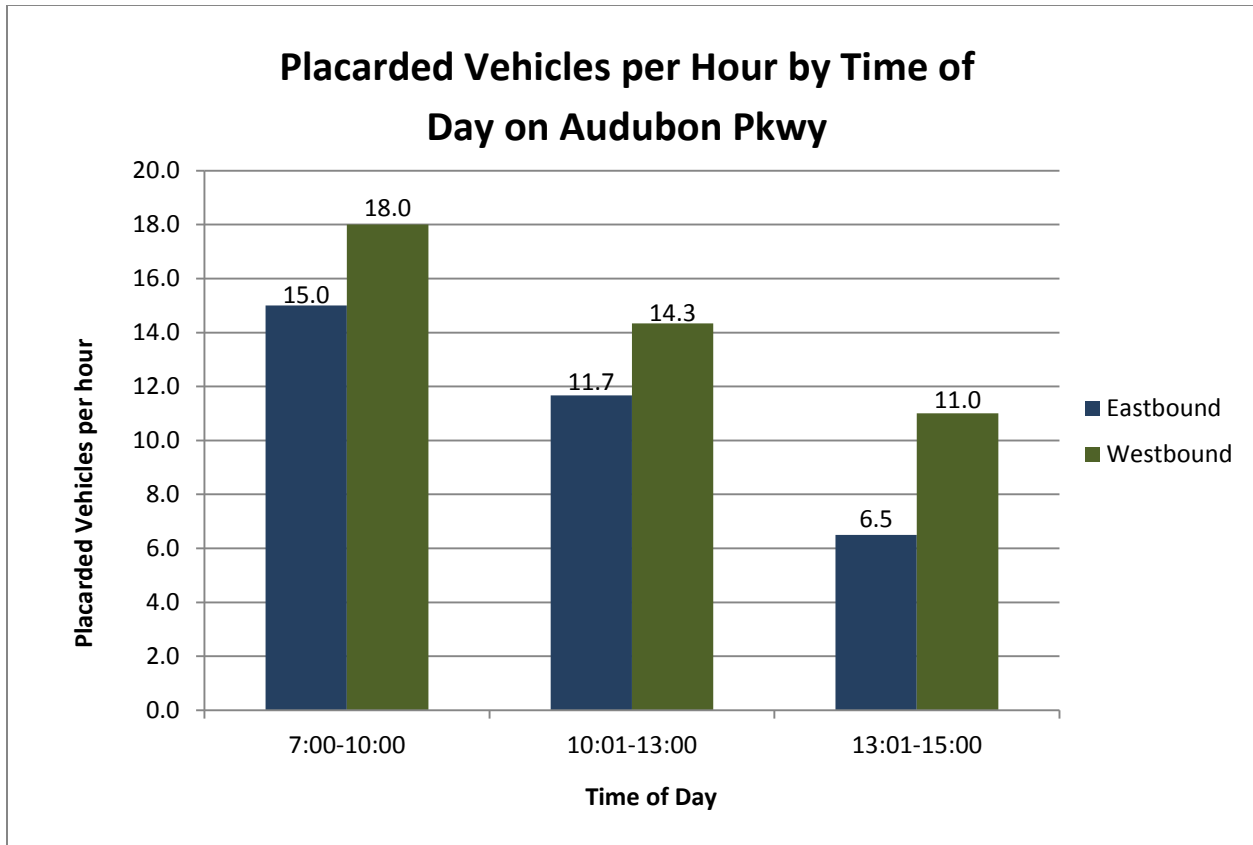
Figure 5.4. Commodity flow rates of placarded vehicles by time of the day on Audubon Parkway.

As shown in Figure 5.4, the maximum rate of hazardous materials was observed during the morning period for eastbound and westbound lanes, 15.0 and 18.0 vehicles per hour, respectively. Minimum hazardous materials loads were identified in the afternoon period for east and westbound, with 6.5 and 11.0 placarded vehicles per hour, respectively. Rates of 11.7 and 14.3 placarded vehicles per hour were observed midday. The variation in loads from morning to midday to afternoon shows a negative trend or decreasing trend over time.

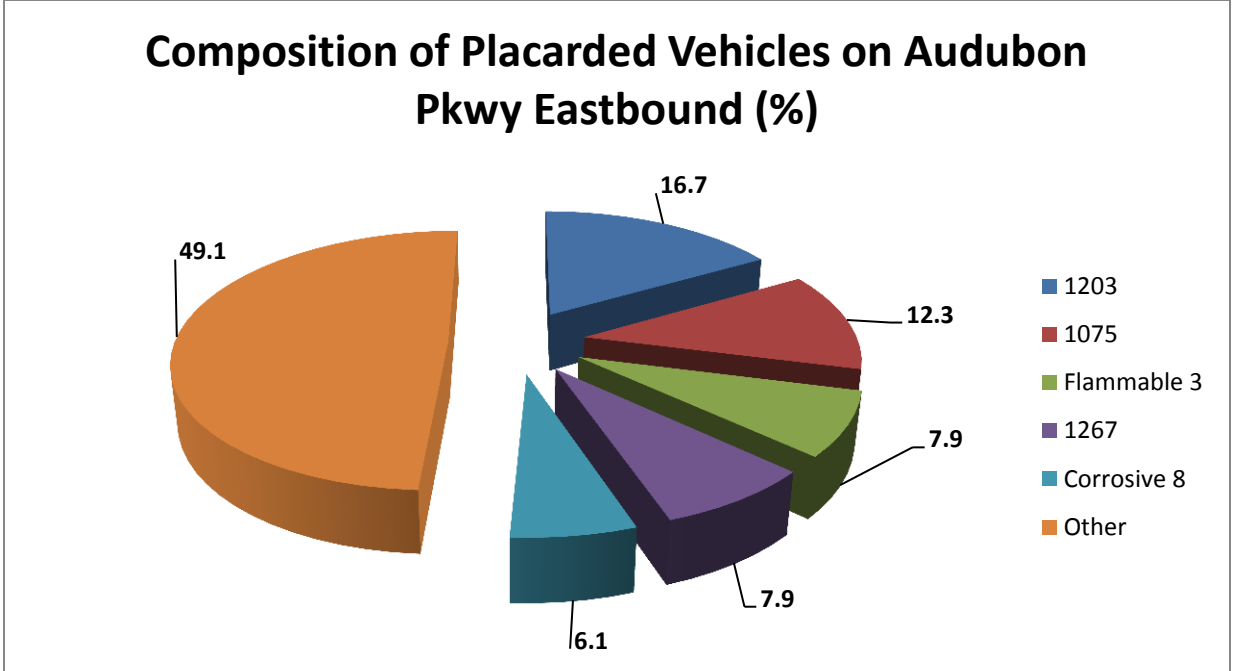
Figure 5.5. Composition of hazardous material observed on eastbound Audubon Parkway.

Analysis of placard data was used to assess the materials being transported both eastbound and westbound on the Audubon Parkway. As shown in Figure 5.5, Gasoline, Placard ID 1203, was the most frequently transported material on eastbound Audubon Parkway, with 16.7% of the total hazardous materials observed. Other frequently observed materials included Propane, Placard ID 1075, 12.3%, Flammable Liquids, 7.9%, Petroleum Crude Oil, Placard ID 1267, 7.9%, and Corrosive Liquids, 6.1%. The “Other” category indicates all other observed materials, which individually account for less than 5.3% of the observations. A list of these materials can be seen in Appendix 6.

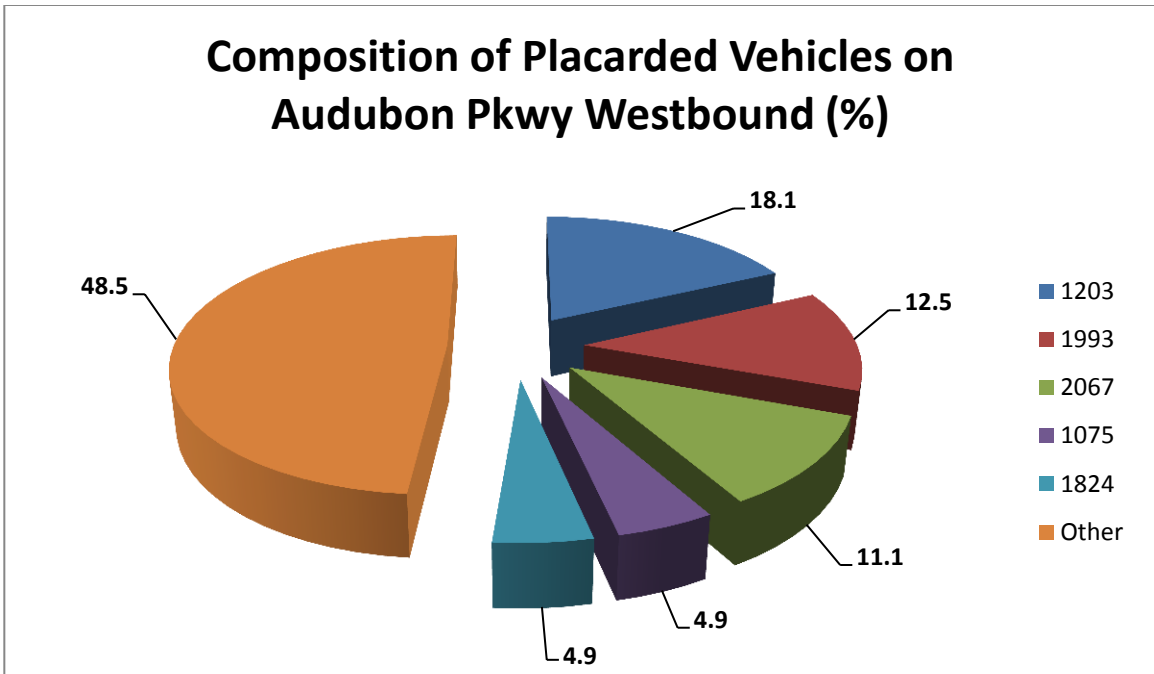
Figure 5.6. Composition of hazardous material observed on westbound Audubon Parkway.

Composition of the hazardous materials observed for westbound Audubon Parkway is shown in Figure 5.6. Gasoline, Placard ID 1203, was the most frequently detected material during the placard survey on westbound Audubon Parkway, accounting for 18.1% of the total hazardous materials observed. Other commonly observed materials include Combustible liquid, Placard ID 1993, 12.5%, Ammonium Nitrate, Placard ID 2067, 11.1%, Propane, Placard ID 1075, 4.9%, Sodium Hydroxide, Placard ID 1824 4.9%. The “Other” indicates all other observed materials, which individually accounted for less than 4.2% of the total observations. A table with the hazardous materials observed and frequency of occurrence is presented in Appendix 7.

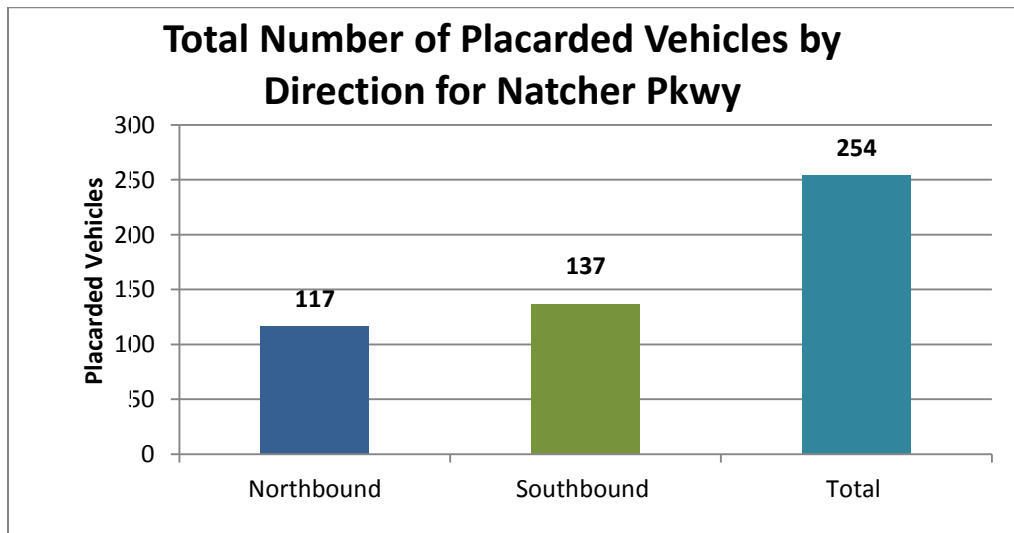
Figure 6.1. Placarded vehicles observed on the William H. Natcher Parkway.

A total of 254 placarded vehicles were observed for the Natcher Parkway (Figure 6.1). The average number of placarded vehicles observed for both directions of flow was determined to be 6.4 vehicles per hour (Figure 6.2). There were a greater number of vehicles transporting hazardous materials on southbound Natcher Parkway, 137 vehicles, than northbound, 117 vehicles, representing a 14.6% difference. The average number of placarded vehicles transporting hazardous materials per hour was greater southbound, 3.4 vehicles/hour, compared to northbound, 2.9 vehicles/hour.

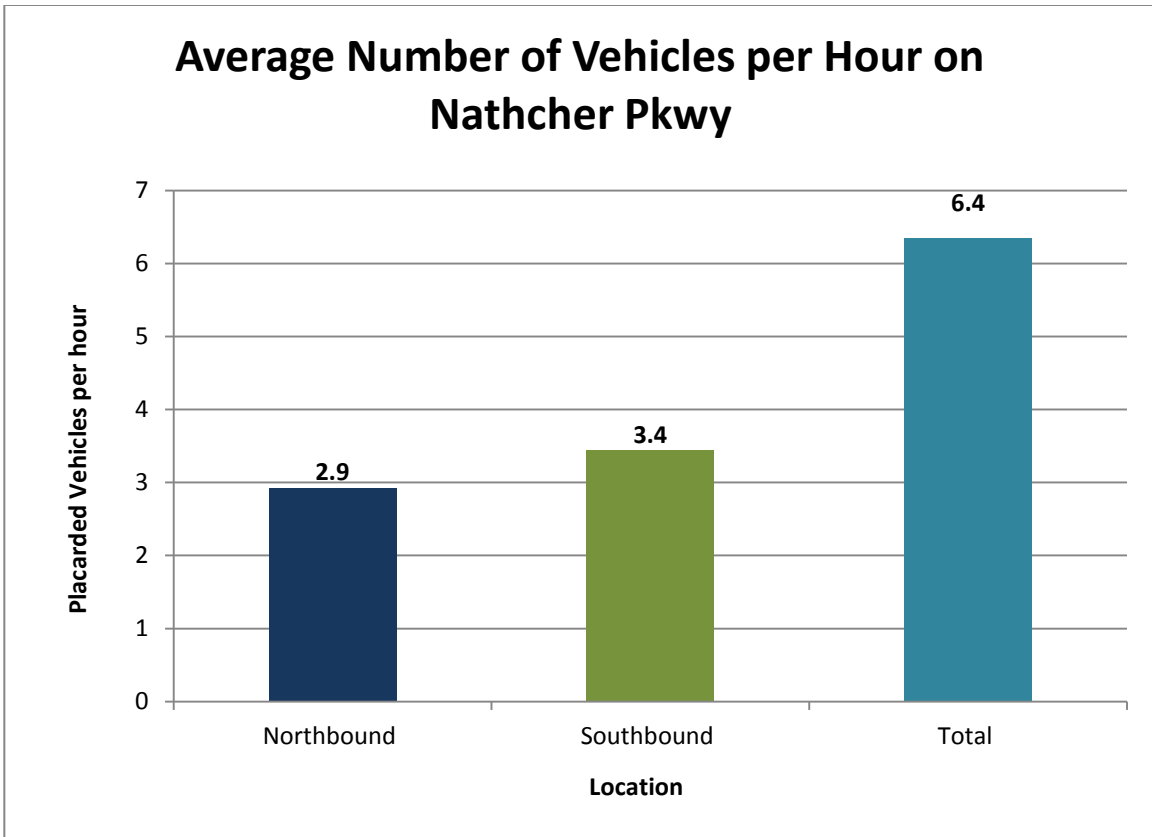
Figure 6.2. Frequency of placarded vehicles per hour on William H. Natcher Parkway.

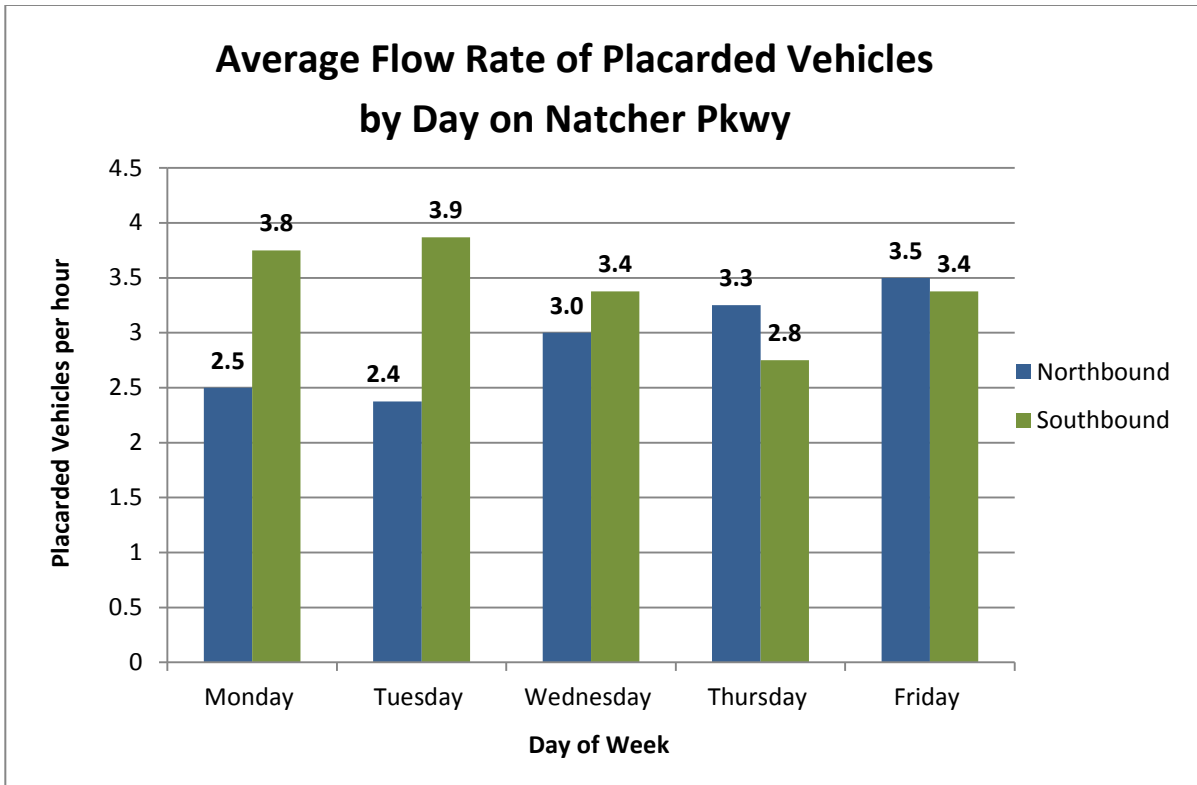
Figure 6.3. Commodity flow rates of placarded vehicles by day of the week on William H. Natcher Parkway.

The observation hours for the Natcher Parkway monitoring site were scheduled to study differences in the average flow rates of hazardous materials during the week. Hazardous materials transported along Natcher Parkway peaked on Tuesday southbound with an average of 3.9 vehicles per hour and peaked on Friday northbound, with an average of 3.5 vehicles per hour (Figure 6.3). The lowest average rates occurred on Tuesday northbound, 2.4 vehicles per hour, and Thursday southbound, at 2.8 vehicles per hour. Opposite patterns of flow rate occurred for each direction on the Natcher Parkway. Commodity flow increased through the week northbound and decreased southbound through Thursday, with an increase of placarded vehicles on Friday.

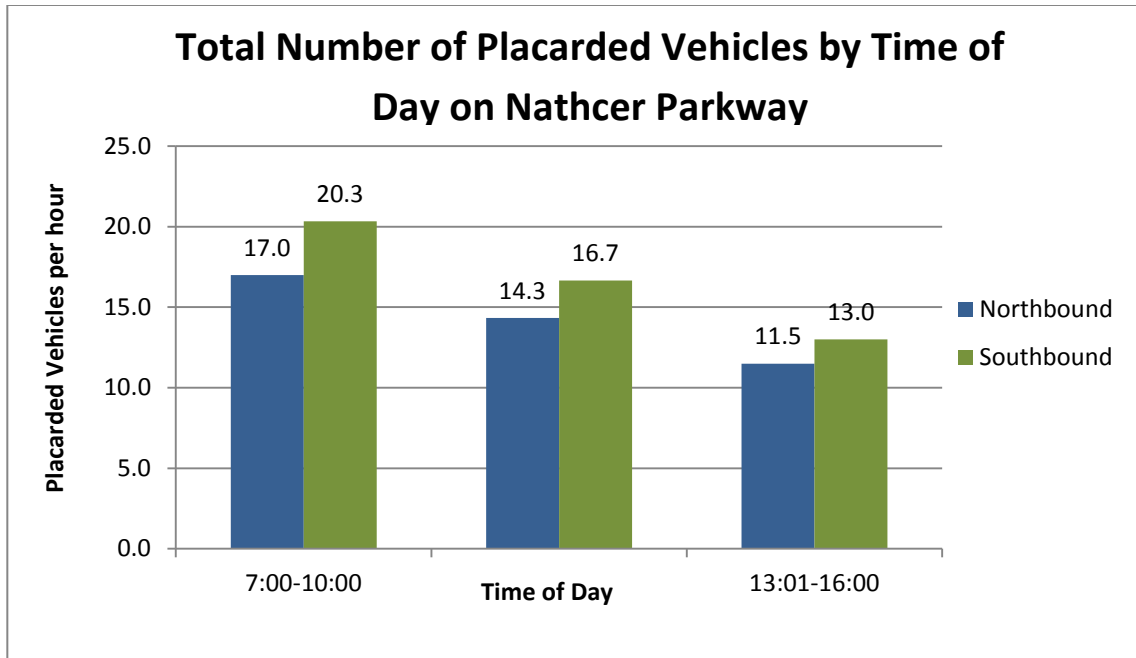
Figure 6.4. Commodity flow rates of placarded vehicles by time of the day on the William H. Natcher Parkway.

As displayed in Figure 6.4, the maximum rates of hazardous materials were observed during the morning period for the southbound and northbound lanes, 17.0 and 20.3 vehicles per hour, respectively. The least rates of hazardous materials commodity flow was found to occur in the afternoon period, with 11.5 and 13.0 vehicles per hour, for north and southbound lanes, respectively. These data indicate that hazmat commodity flow decreases throughout the day.

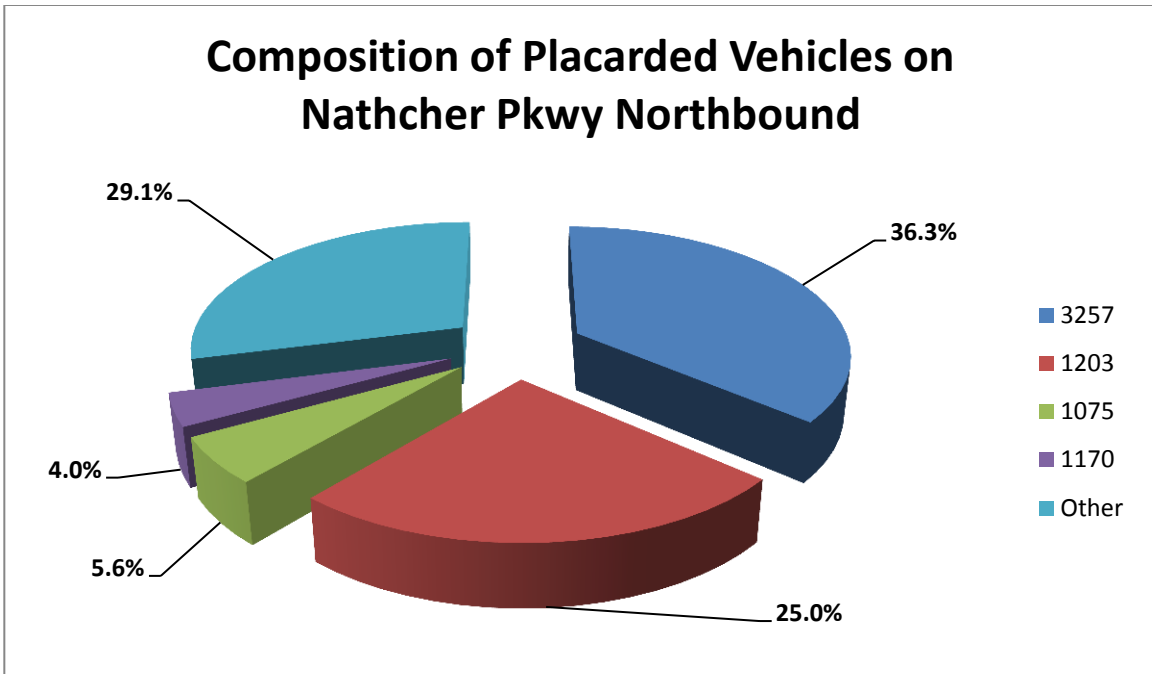
Figure 6.5. Composition of hazardous materials observed on northbound Natcher Parkway.

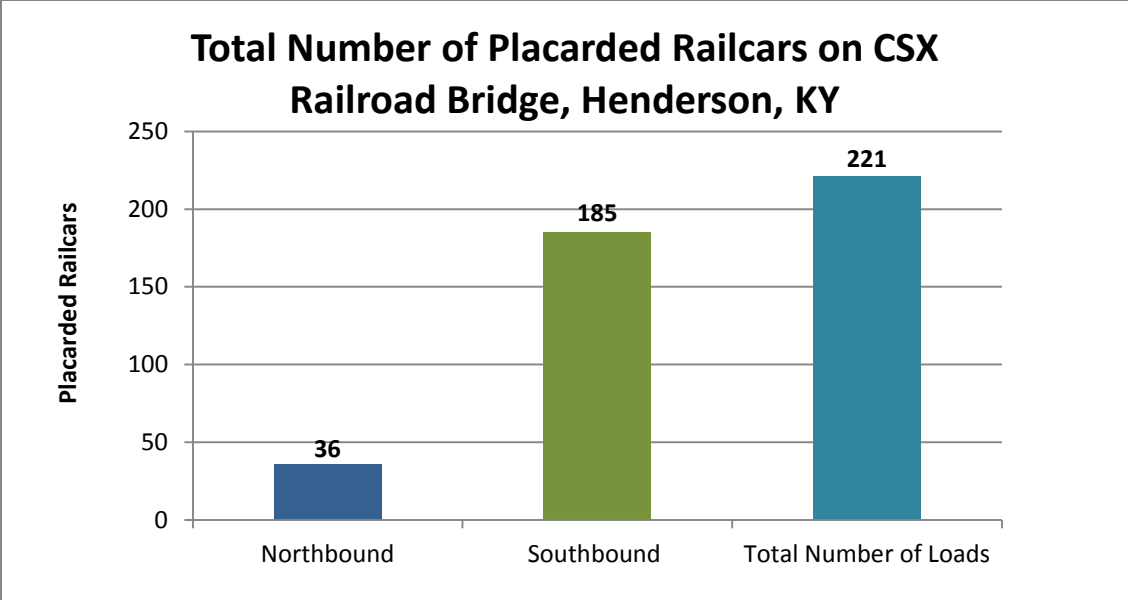
Figure 7.1. Placarded railcars observed on CSX Railroad Bridge

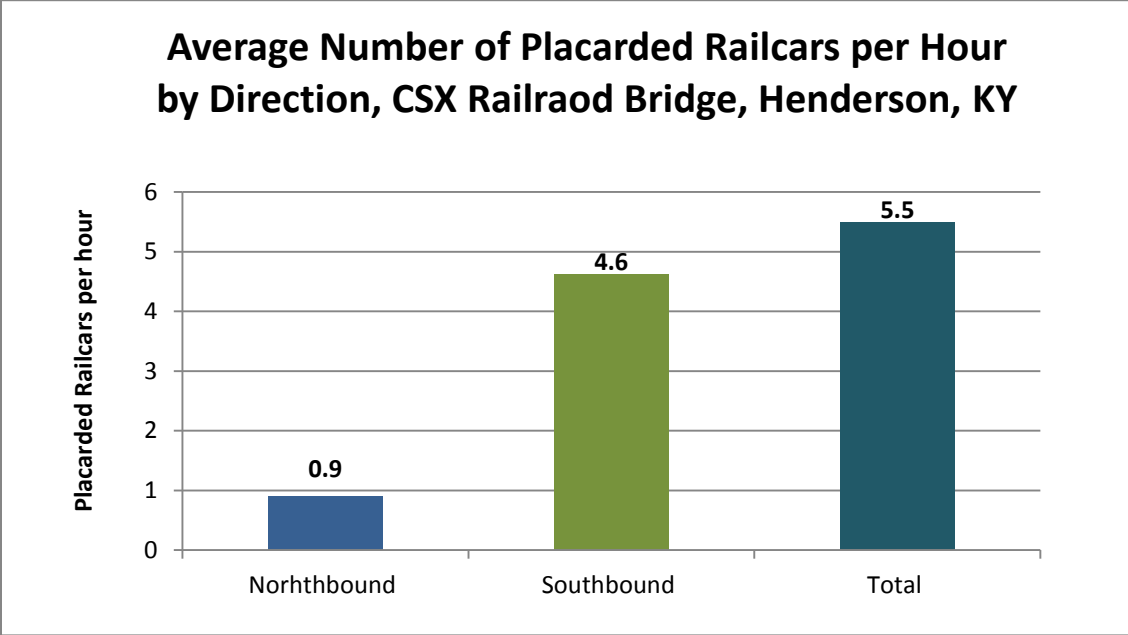
Figure 7.2. Frequency of placarded railcars per hour on CSX Railroad Bridge.
