# Daviess County Hazardous Materials Commodity Flow Study

*Final Report  
September 27, 2013*

This project was completed by Western Kentucky University in partnership with

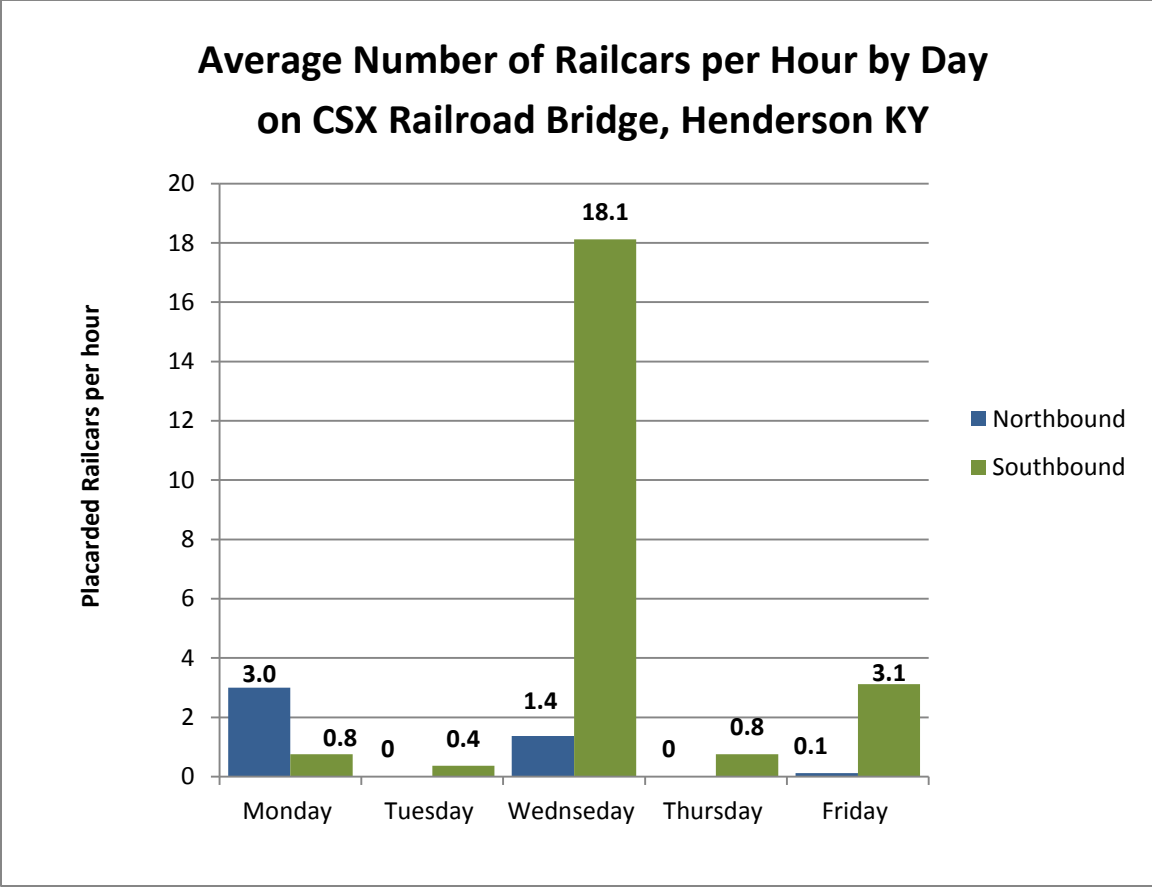
Figure 7.3. Commodity flow rates of placarded railcars by day of the week on CSX Railroad Bridge.

Hazardous materials transported showed differences throughout the week (Figure 7.3). A maximum flow rate of 18.1 railcars per hour occurred on Wednesday for the southbound direction. Hazmat flow rate was highly variable; with no placarded railcars observed Tuesday and Thursday northbound, and only minimal flow southbound on Monday, Tuesday, and Thursday (Figure 7.3). Data for the CSX railway indicate that heavy loads occur on specific days, thus these days have a disproportionate risk of exposure. It should be noted that railroad transport of hazardous materials was

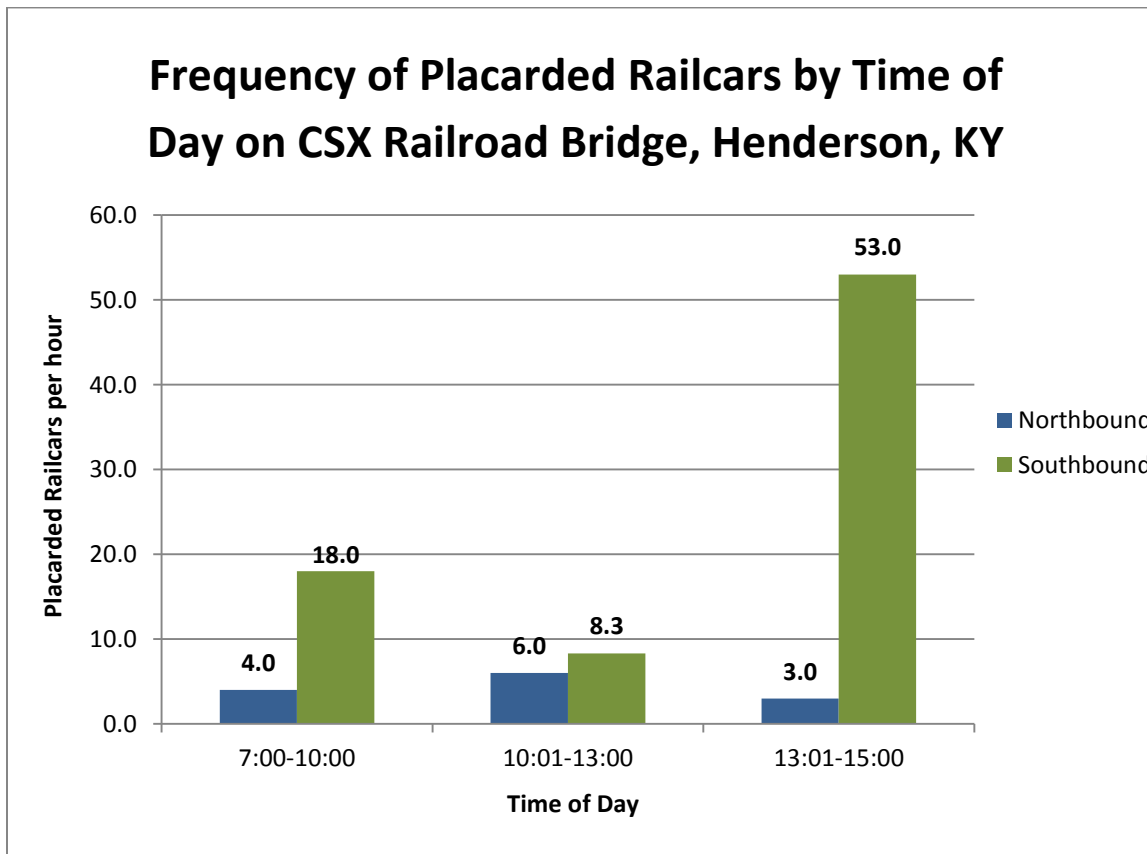
Figure 7.4. Commodity flow rates of placarded railcars by time of the day on CSX Railroad Bridge.

As shown in Figure 7.4, the maximum rate of placarded railcars per hour was observed during the afternoon period southbound with 53 railcars/hour. For both north and southbound lines, the least rates of placarded railcars were seen in the afternoon and midday, with 3.0 and 8.3 railcars per hour, respectively. Morning and afternoon periods showed the heaviest loads of hazmats being transported into Kentucky. However, with the sporadic nature observed for these data, additional placard surveys of the CSX railroad should be conducted over an extended period of time.

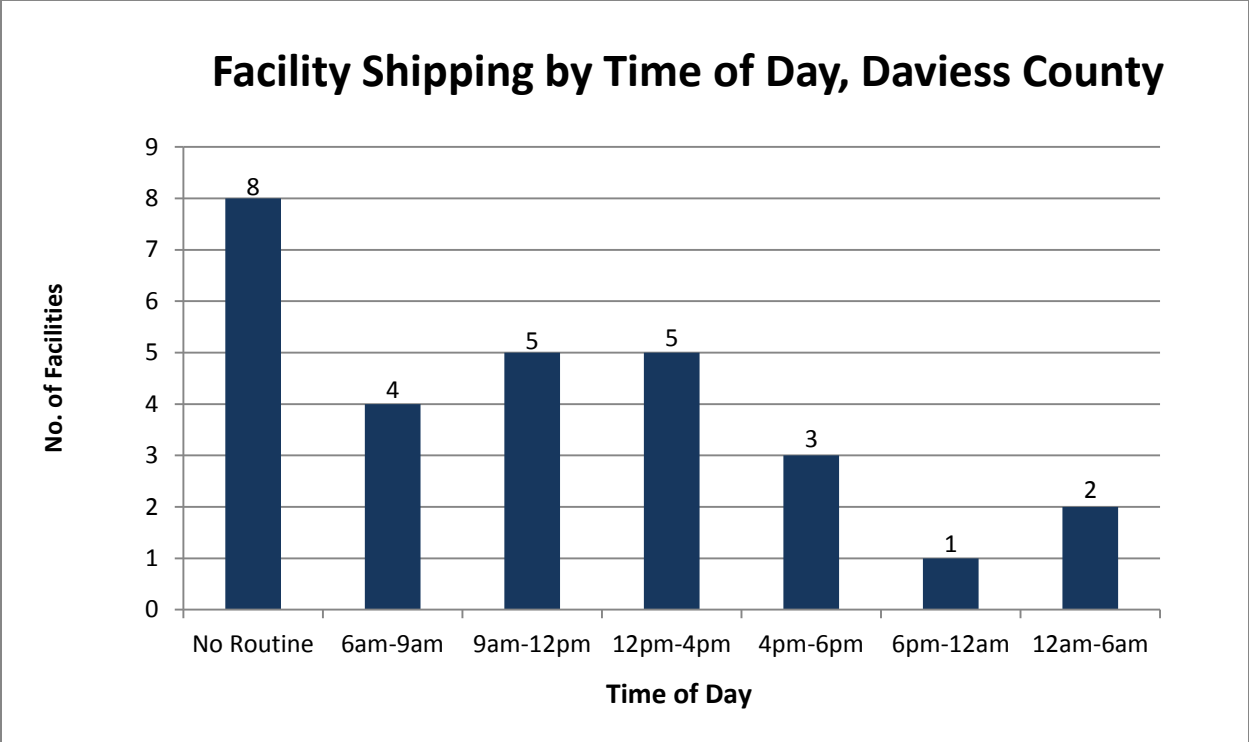
Figure 8.6. Fixed facilities shipping hazardous materials by time of the day.
