# Quantitative Dye Studies to Evaluate the Spill Response System for Mammoth Cave National Park

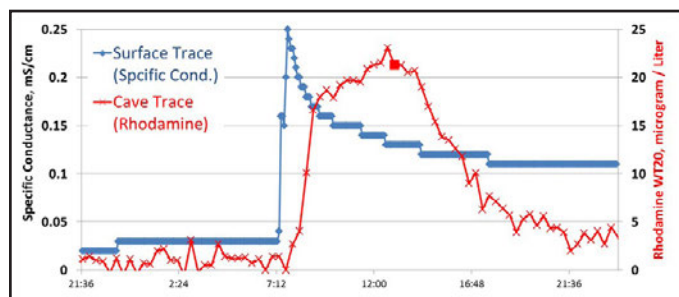
**Figure 2:** Breakthrough Curve for Test 1 conducted August 31, 2014

For the first test on August 31, 2014 (Figure 2), the rainfall depth was a 2.4 inch rain event. Two check dams were still in place along the surface flow routes. There was a tracer breakthrough in the cave 10 hours after the dye was released. Sixteen hours after the time of the release, approximately half of the recovered dye (center of mass) had moved past the monitoring station at Cataracts. The total amount of dye accounted for was approximately 4 mL out of the 180 mL released, which is less than 3% of the tracer used in this study. These results indicate that the dams did a great job retaining most of the dye on the surface despite the heavy rain.

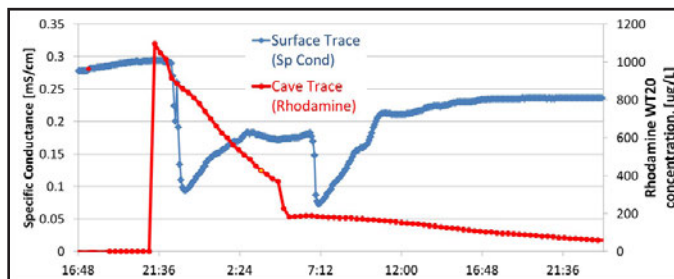
**Figure 3:** Breakthrough Curve for Test 2 conducted October 13, 2014

The second test (Figure 3) was initiated on the evening of October 13, 2014 during a 2.1 inch rain event. Both check dams had been removed for this study to estimate the amount of time it would take for the dye to reach the cave with no obstacles. The breakthrough and center-of-mass were calculated from the results. Breakthrough in the cave occurred 4 hours after the dye was released. The center of mass occurred 10 hours after the release time. The total amount of dye accounted for via concentration and discharge was 262 mL out of the 600 mL released (43%).

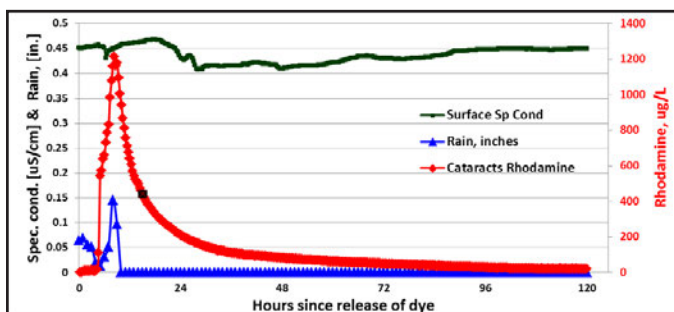
**Figure 4:** Breakthrough Curve for Test 3 conducted January 3, 2015

During the final tracer test on January 3, 2015 (Figure 4), the rain depth was 0.7 inches. Due to timing, the release of tracer was on the tail end of the storm instead of the rising limb like the other two tracer tests. Breakthrough in the cave occurred only 50 minutes after the time of release. The center

of mass was determined to be 15 hours after the time of release. The maximum tracer amount recovered was 288 mL of dye which was 48% of the total amount of dye released.
