Exploiting carbon nanotube networks for damage assessment of fibre reinforced composites

Baltopoulos, A, Polydorides, N, Pambaguian, L, Vavouliotis, A & Kostopoulos, V 2015, 'Exploiting carbon nanotube networks for damage assessment of fibre reinforced composites' *Composites part b-Engineering*, vol. 76, pp. 149–158. DOI: 10.1016/j.compositesb.2015.02.022

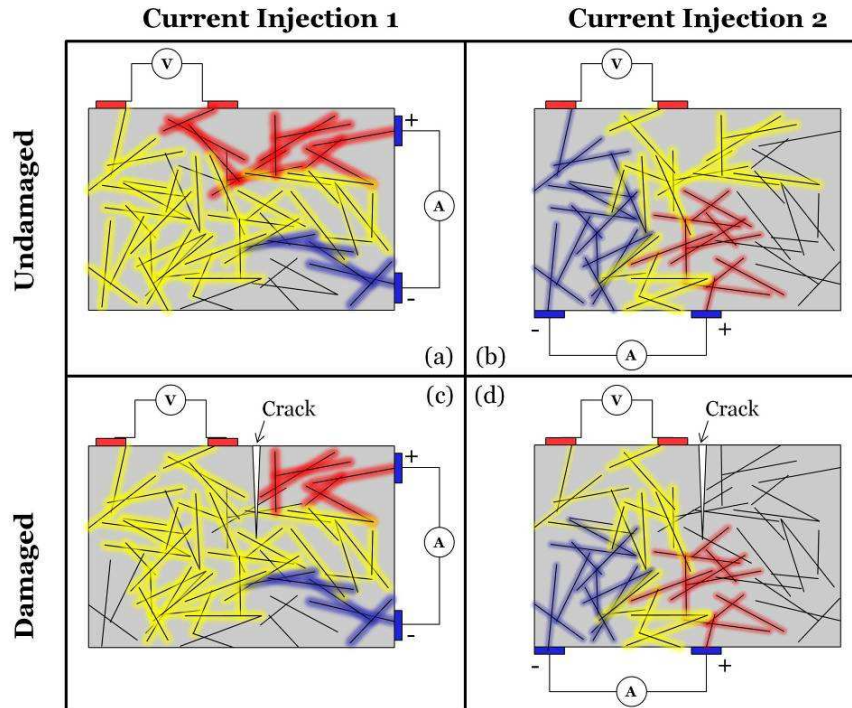
16
17
18
19
20
21
22
23
24
25
26
27
28
29
30
31
32
33
34
35
36
37
38
39
40 **Figure 1.** CNT network exploitation and Principle of ERT technique; (a), (b) undamaged material, (c), (d)
41 damaged material. (Red: High voltage, Yellow: Medium voltage, Blue: Low voltage).
42
43
44
45
46
47
48
49
50
51
52
53
54
55
56
57
58
59
60
61
62
63
64
65

1
2
3
4 principle idea of this work is illustrated in a simplified way in the schematic of Figure 1. For clarity, glass
5 fibers are excluded from the schematic.
6

19 When damage is considered, any defect in the CNT network (e.g. due to cracking or
20 delamination) will create a local disruption in the electrical network (Figure 1-c, d). Parts of the network
21 may be separated and isolated and this will have an effect on the total apparent resistance (seen by the
22 current source) and the local current flow (seen at the voltage measurement ends). This means that when
23 injecting a current at the same location to the network, a different electrical potential field will be
24 established between the undamaged and the damaged state. Taking a step further, by injecting current at
25 different points of the network, the effect of the disturbance on the boundary voltage measurements may
26 be magnified or suppressed.
27
28
29
30
31
32
33

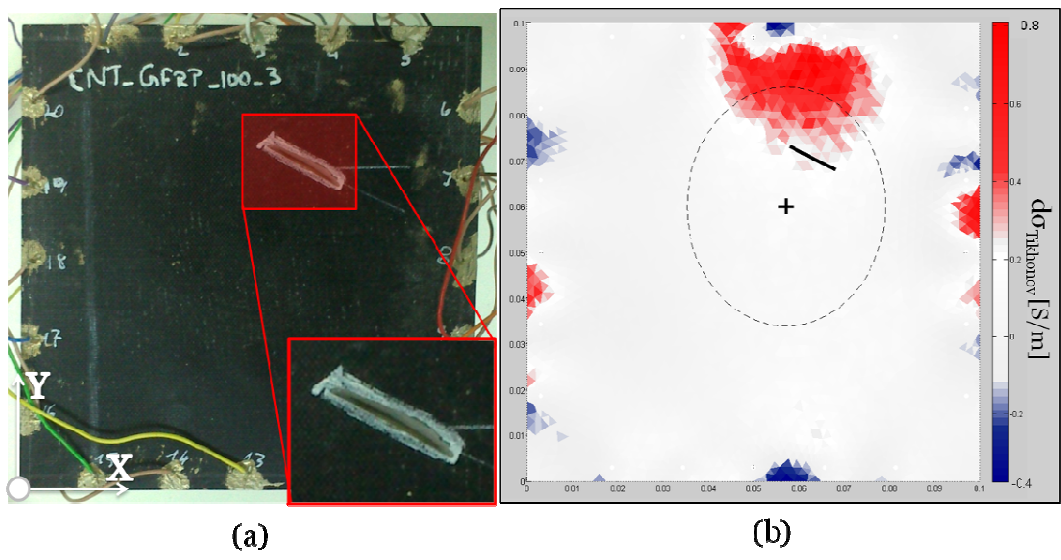
Figure 7. Oblong notch: (a) Damaged specimen, (b) Reconstructed conductivity change map, where red indicates decrease in conductivity; Line indicates the real damage location, Cross (+) indicates the Centre of Interest, Dashed Ellipse indicates the Region of Interest.

The second damage mode that was assessed was an oblong notch. The notch was created having
a -30° angle to the horizontal. The centre of the notch was at $(X_{notch}, Y_{notch}) = (63.0, 70.5)mm$. The
thickness of the notch was 2mm while the length of the notch was 16mm. The damaged specimen is seen
in Figure 7-a. The inserted photograph shows the zoomed region of the notch. The conductivity change
map calculated for this damage mode is shown in Figure 7-b. The map is smooth throughout the central
region of the inspected area, indicating no changes. An extended region of conductivity change is
predicted at the central top region of the part close to electrodes 3 and 4. The CoI for the case of the notch
