Deflection response of reinforced concrete slabs tested in punching shear in fire

DEFLECTION RESPONSE OF REINFORCED CONCRETE SLABS TESTED IN PUNCHING SHEAR IN FIRE

Holly K. M. Smith^{ab}, Tim J. Stratford^b, Luke A. Bisby^b

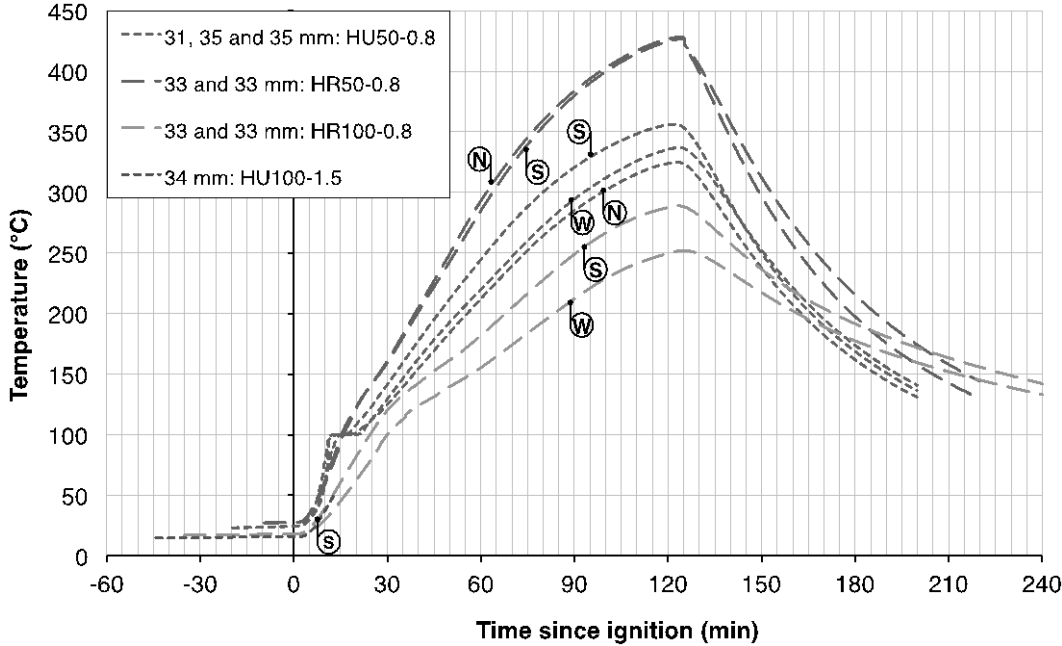
The thermocouple data was compared between different tests to investigate if the radiant panels produced an even heating across the upper surface of the specimens. The positioning was measured post-failure to correct for potential casting errors. In each test, the temperature readings were similar at comparable slab depths, even at different thermocouple tree locations. The radiant array therefore produced an approximate even distribution of heating insult on the upper surface of each slab. Assuming the same boundary conditions at the upper and lower slab surface, allows the thermocouple data for different slab thicknesses to be compared. Figure 2 shows a large test variation in temperature curves at approx. the same slab depth. This proves that the fire scenario between different tests was not consistent, due to environmental impacts and gas supply differences/limitations (Smith *et al.*, 2014). Both the 100 mm thick, reinforced, unrestrained slabs failed soon after ignition with ambient flexural reinforcement temperatures. The HR100-1.5 specimen failed 40 minutes into the cooling phase, with a maximum flexural steel temperature of approx. 148°C. According to Eurocode 2, the steel had no strength reduction at this temperature.

Fig. 2 Comparison of temperature curves for similar thermocouple depths in various tests

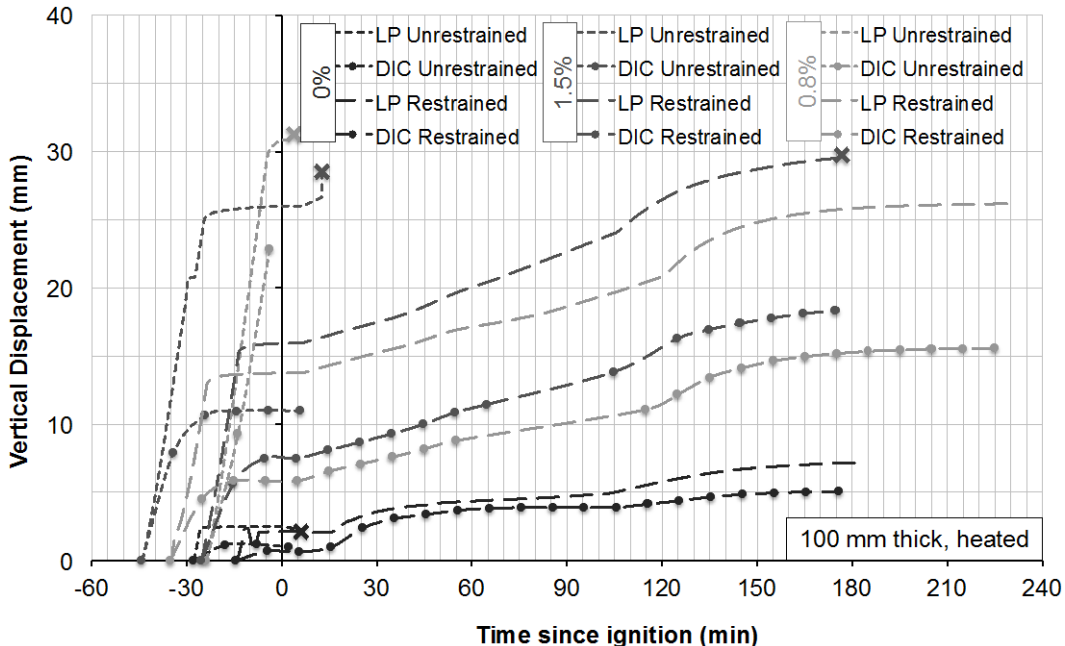
angles to the lower (unheated) surface of the slab. A sensitivity analysis showed all three cameras measured similar deflections and axis symmetrical failures, which were confirmed by post-failure plan and cross-sectional photos. Figure 4 presents a comparison of the DIC central vertical displacement from one of the 650D cameras, to the displacement transducer readings for the heated, 100 mm thick specimens. The DIC readings show the same displacement behaviour as the transducers, however the DIC displacements are consistently less. There is a clear correlation in the percentage difference in displacement readings, however it is not consistent throughout the test. The displacement transducer readings must have been impacted by structural reaction frame movements, causing them to overestimate the central displacement.

Fig. 4 Comparison of DIC and displacement transducer central vertical displacement history for the 100 mm thick, heated specimens

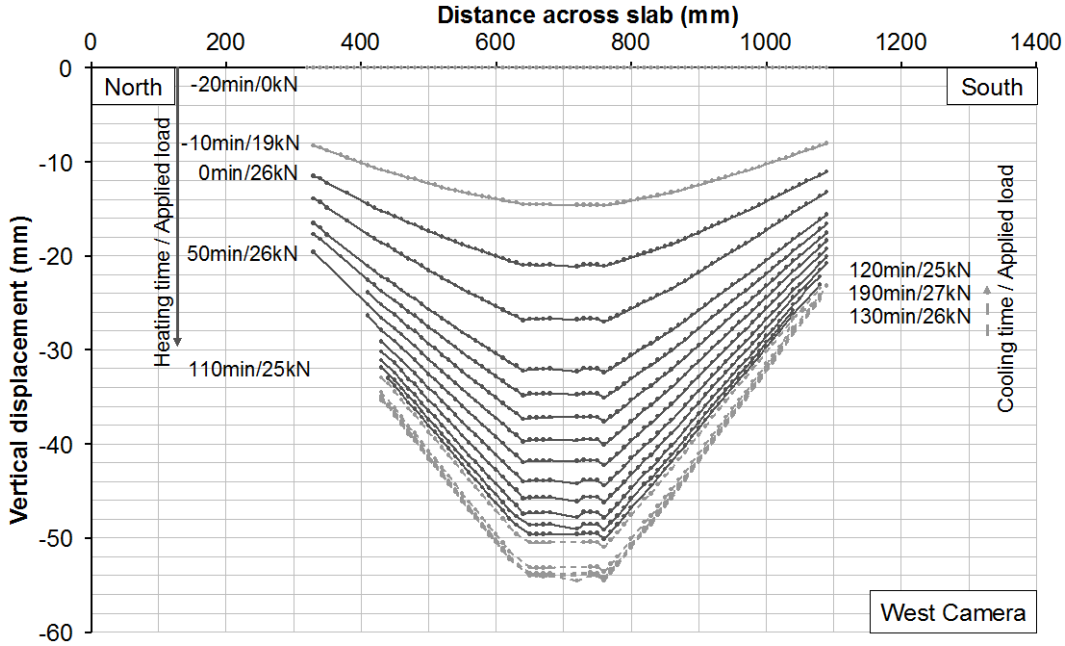
Fig. 5 DIC vertical displacement profile at 10 minute intervals for specimen HU50-0.8

Figure 5 shows the vertical DIC displacement profile across the 50 mm thick, 0.8% reinforced unrestrained slab at 10 minute intervals relative to ignition. Negative deflection is downwards, in the direction of loading and away from the heat source (see Fig. 1). DIC confirms that the central

cross-sectional surface, for all the slabs, continually deflects away from the heat source, with a small approximate recovery of 1 mm towards the end of the HU50-0.8 cooling phase. A direct comparison of the central DIC displacement between the ambient and elevated temperature unrestrained tests (prior to residual testing) gives no clear trend in the thermally induced deflection (Table 2). The restrained support condition adds complexity, which cannot be explained with the experimental data recorded. A heat transfer analysis is required to evaluate what impact the support condition, heating and loading each have on the punching shear behaviour.
