Smith, HKM, Stratford, T & Bisby, L 2015, The Punching Shear Mechanism in Reinforced-Concrete Slabs under Fire Conditions. in PROTECT 2015 - Fifth International Workshop on Performance, Protection & Strengthening of Structures under Extreme Loading. pp. 704-711.

The Punching Shear Mechanism in Reinforced-Concrete Slabs under Fire Conditions

HOLLY K. M. SMITH, TIM STRATFORD and LUKE BISBY

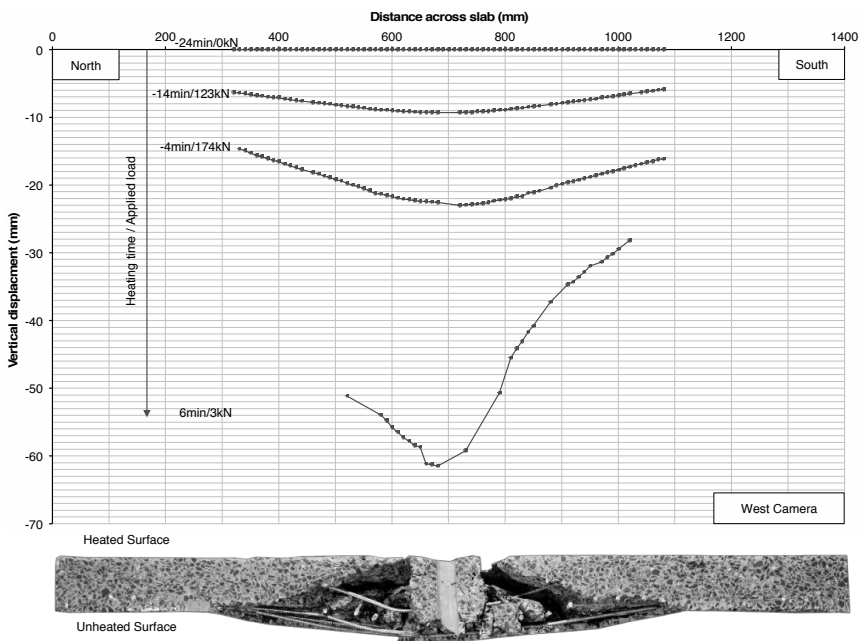
Figures 4 and 5 show the vertical displacement profile across the slab (from DIC) at 10 minute intervals for the 0.8%, 100mm thick slabs. Figure 4 is the restrained slab; Figure 5 is unrestrained. The restrained slab is stiffer and has a maximum vertical displacement of approximately 15mm, whereas the unrestrained slab failed 4 minutes into heating with a maximum vertical displacement of approximately 61mm. The rate of change in vertical displacement across the surface of the slab shows rotation of the slab, and the formation of cracks. As expected, the angle of rotation of the unrestrained slab is much greater than for the restrained slab. The deflection profile in Figure 4 also shows the formation of the punching shear cone during loading.

Figure 5. HU100-0.8 vertical displacement.
