# EMBRITTLEMENT MECHANISMS OF

# NICKEL-BASE ALLOYS IN WATER

Submitted to the Department of Nuclear Engineering in Partial Fulfillment of the Requirements of the Degree of Doctor of Philosophy in Nuclear Engineering

Massachusetts Institute of Technology

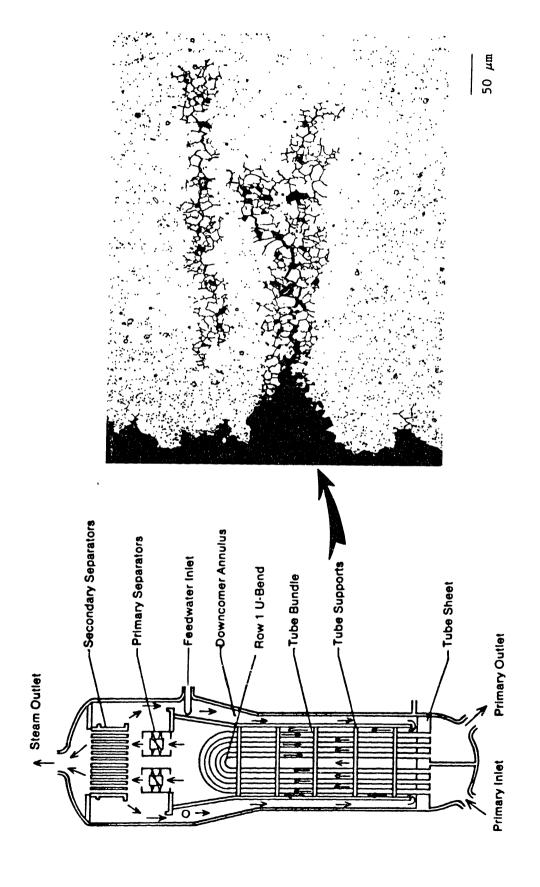
Schematic of a Steam Generator Design and Typical Intergranular Stress Corrosion Cracking of Alloy 600 Steam Generator Tubing (cracks initiated from the secondary side). Figure 1.1

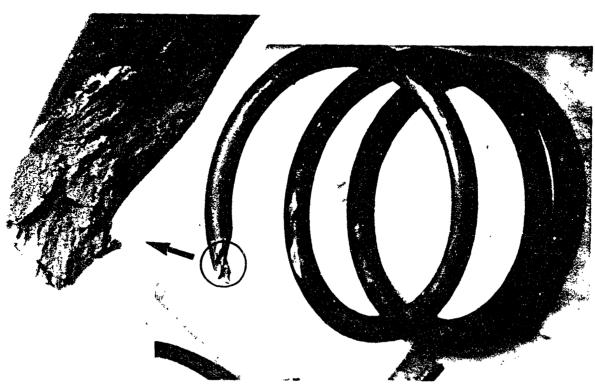
Figure 1.3

Failure Example of PWR Fuel Assembly Holddown Spring (Curtesy: G.O. Hayner, Babcock and Wilcox Co.).

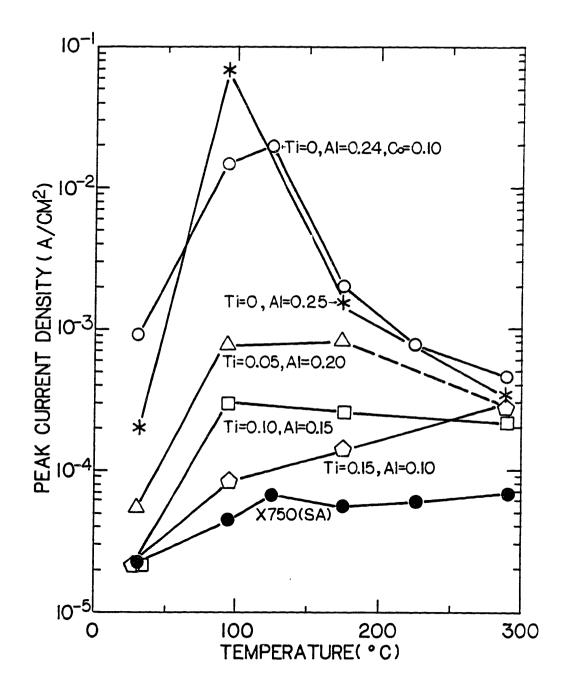
Figure 2.1 Peak Anodic Current Densities of various  $\gamma'$  Chemistries determined by Potentiodynamic Polarization as a Function of Temperature in 0.05M Na $_2$ SO $_4$ (pH 3) Solution [57].

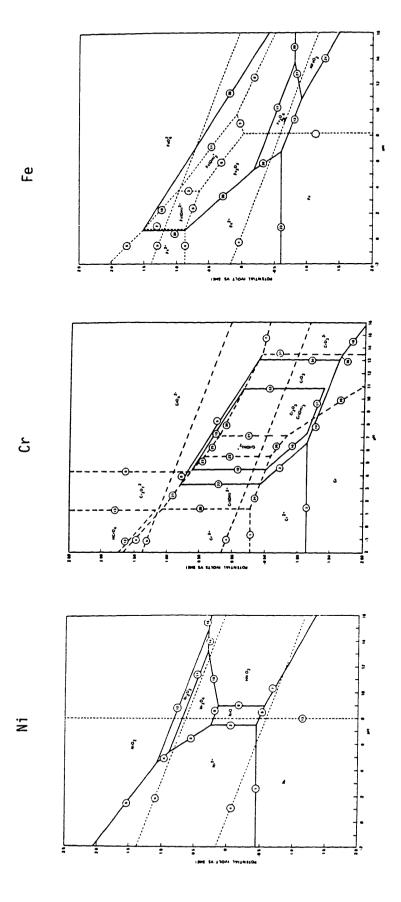
Pourbaix Diagrams of Nickel, Chromiium and Iron in Water at 100 C [71]. Figure 2.3

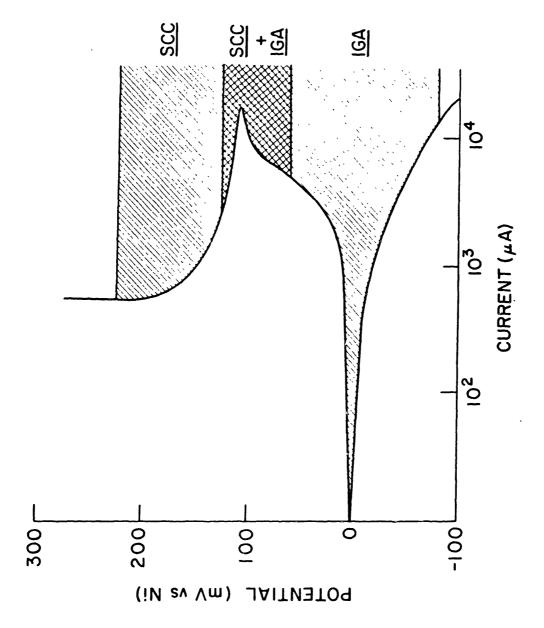
Observed Potential Range for Intergranular Stress Corrosion Cracking of Alloy 600 in a High Temperature Caustic Environment [46].

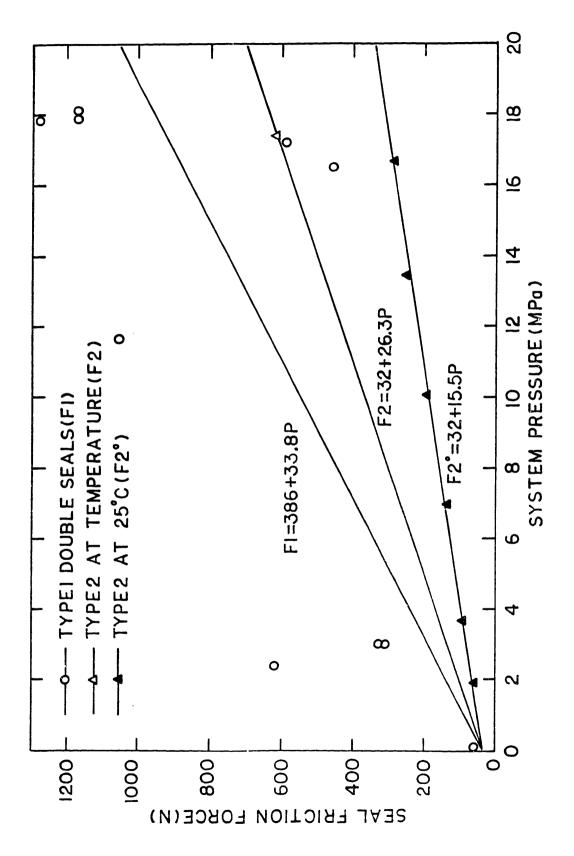
Estimated Seal Forces as a Function of the System Pressure for the SSRT of Alloy 600~(F1) and Alloys X-750 and 718 (F2) in comparison with the Measured Friction at  $25~\mathrm{C}$ . Figure 4.3

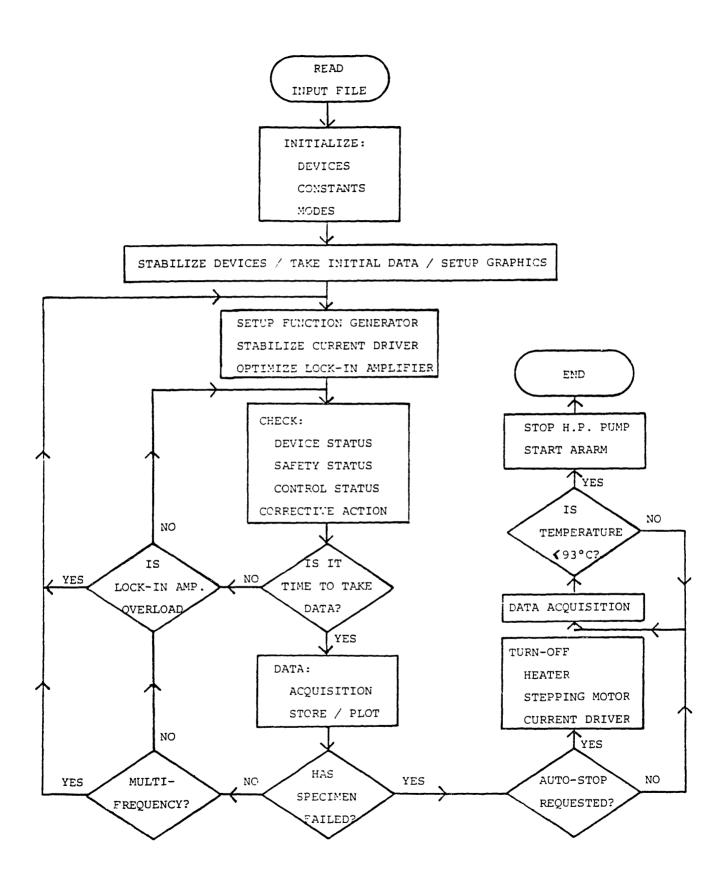
Figure 4.5 Logic Flow Diagram for the SSRT System Software.

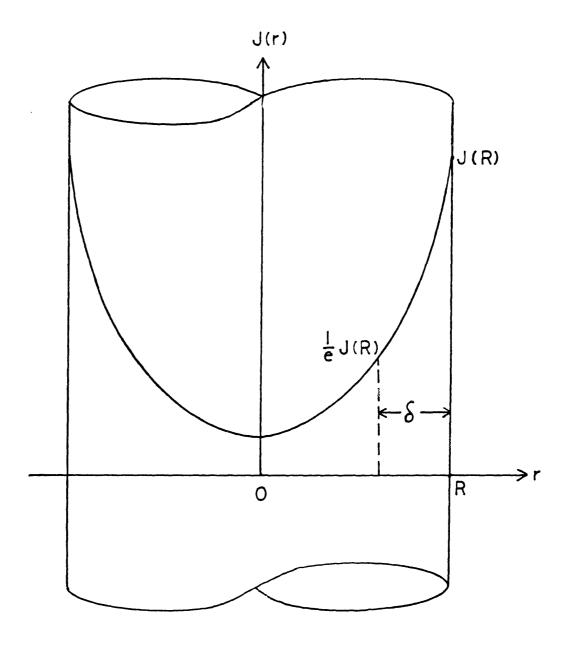
Figure 4.7 Definition of Variables Used in the Skin-effect Analysis of a Round Bar Geometry.

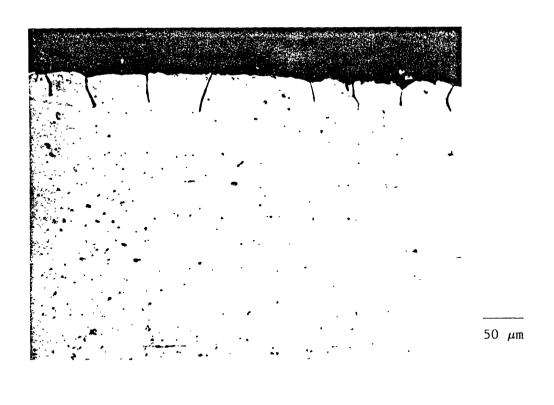
Figure 4.12 Cross Sectional and Surface View of Multiple Cracks initiated during a Constant Load Test on the SAS Condition of NX2650 in a Sodium Tetrathionate Solution

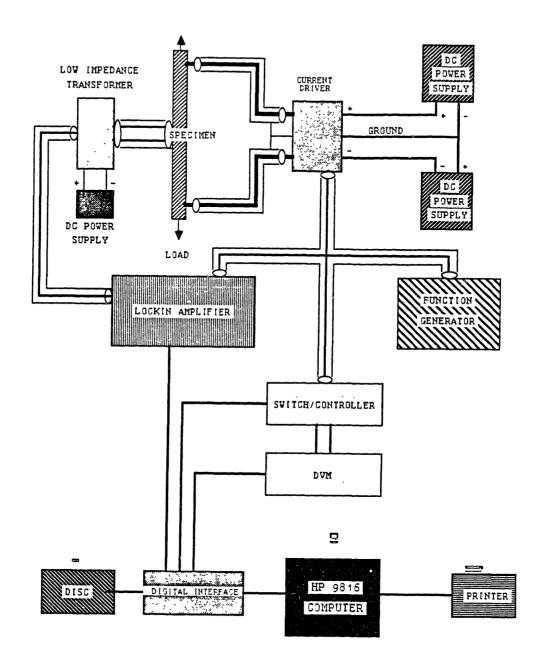
Figure 4.15 Schematic of Developed ACPD Crack Detection System.

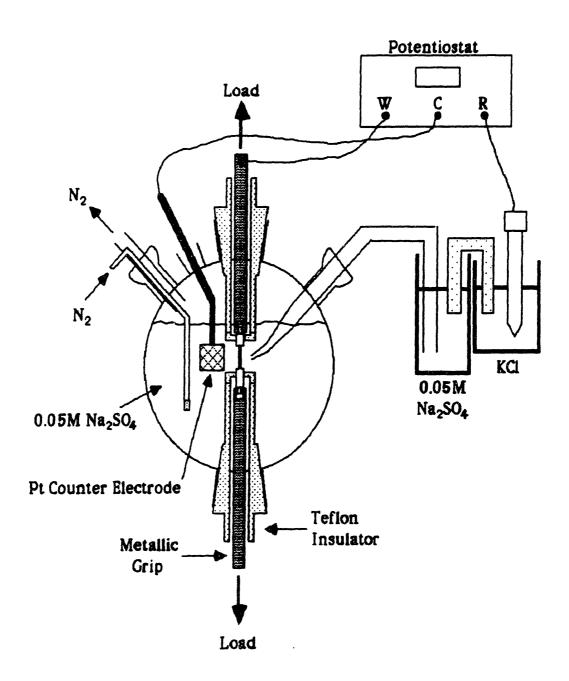
Figure 5.11 Schematic of the Straining Electrode Tensile Test Apparatus.

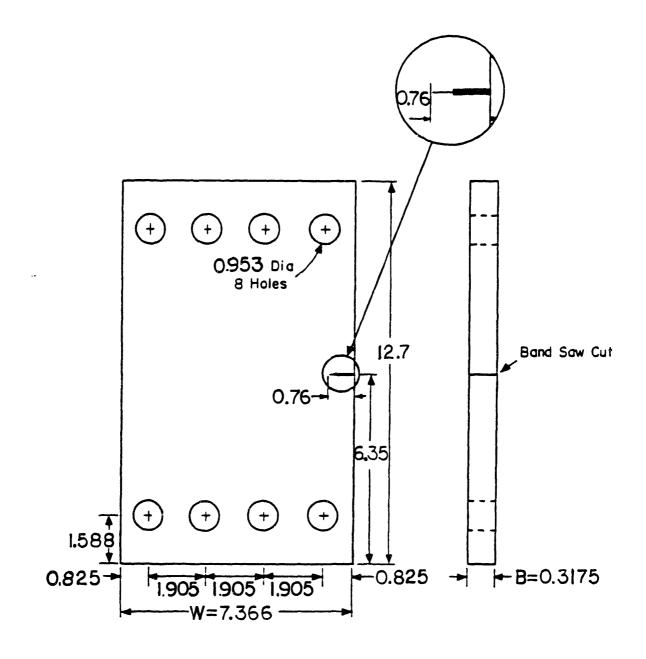
Figure 5.12 Single Edge Notch Specimen Design for Corrosion Fatigue Tests.

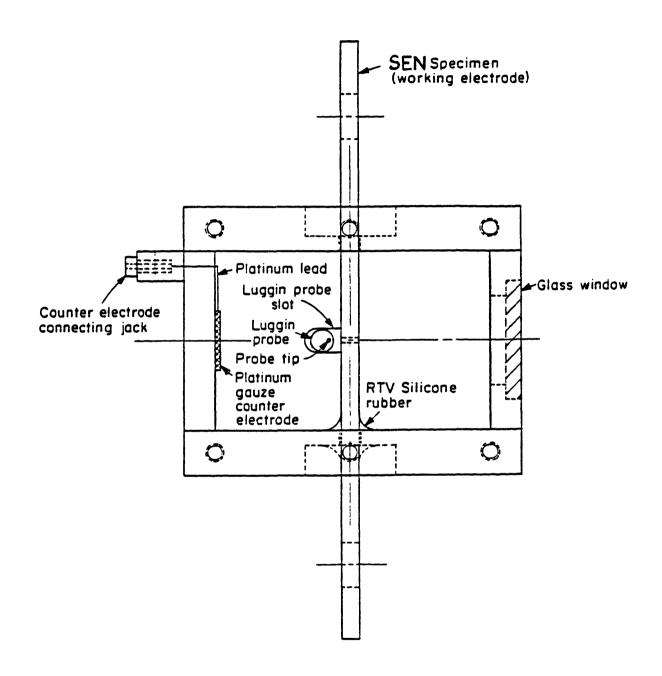
Figure 5.13 Cut-away View of Plexiglass cell for the Corrosion Fatigue Tests.

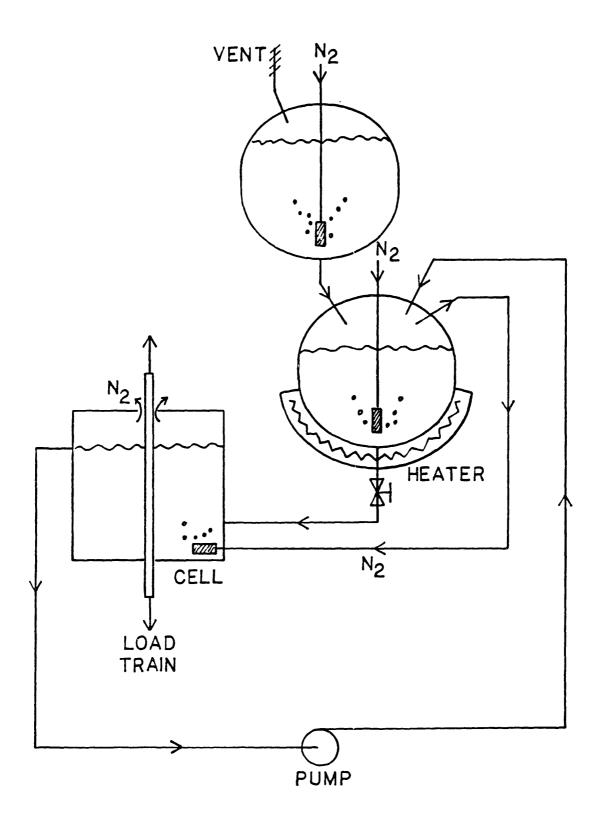
Figure 5.14 Schematic Diagram of the Solution Flow for the Corrosion Fatigue Tests at Temperatures up to 60 C.

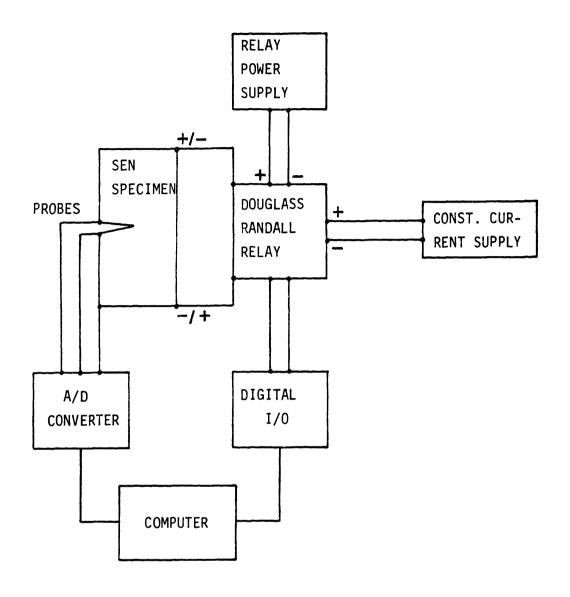
Figure 5.15 Schematic Diagram of the Switched DC Potential Drop Technique Used in Corrosion Fatigue Tests.

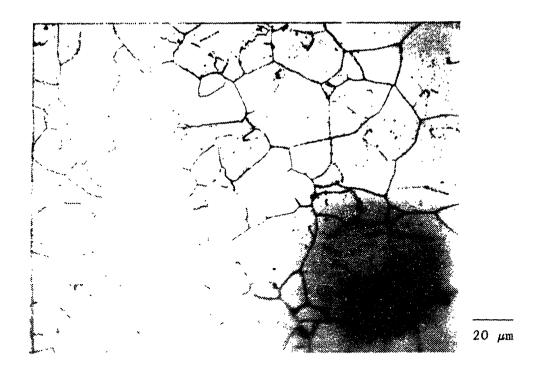
Figure 6.5 Two-step Etch Micrographs of Longitudinal Section of Alloy 600 Tubing Heat NX1638 at 700 C for 15 hours (upper orthophosphoric and lower nital etch).

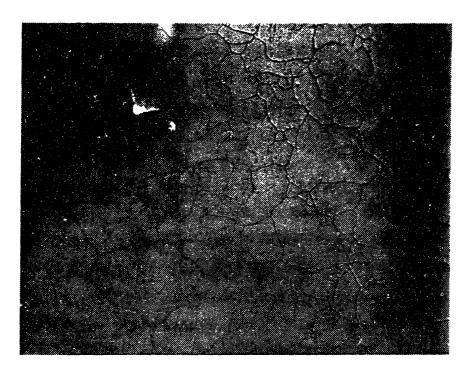
Figure 6.9 Two-step Etch Micrographs of Longitudinal Section of the HTMA Condition of Heat NX2650 (upper orthophosphoric and lower nital etch).

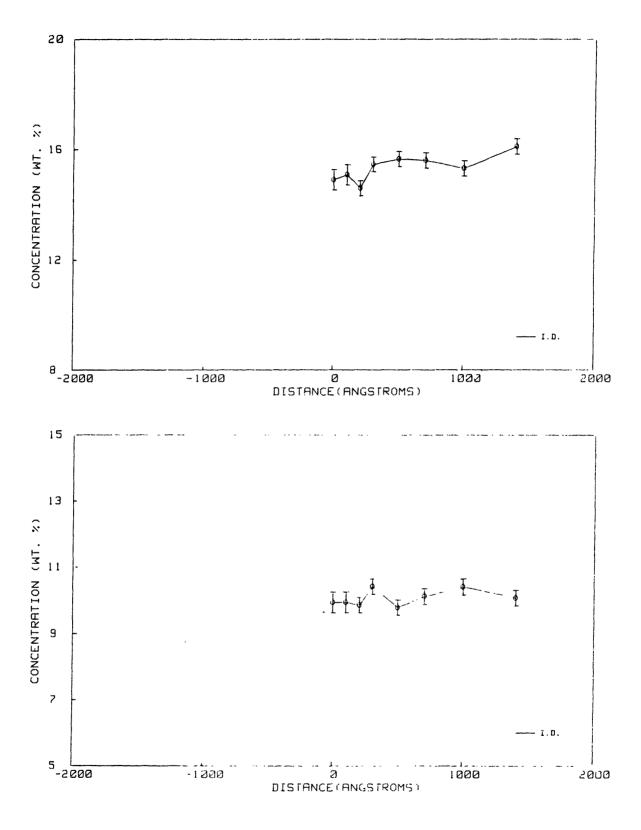
Figure 6.11 Chromium and Iron Distributions as a Function of Distance from a Grain Boundary in the HTMA Condition of Heat NX2650.

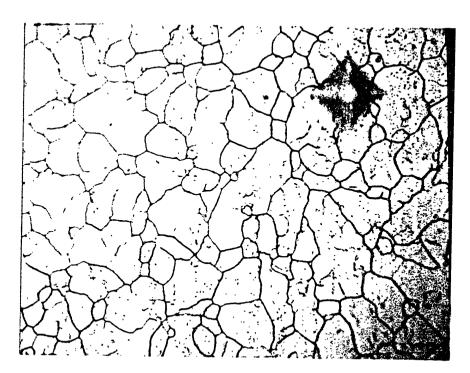
Figure 6.12 Two-step Etch Micrographs of Longitudinal Section of Alloy 600 the Thermally Treated Condition of Heat NX2650 (upper orthophosphoric and lower nital etch).

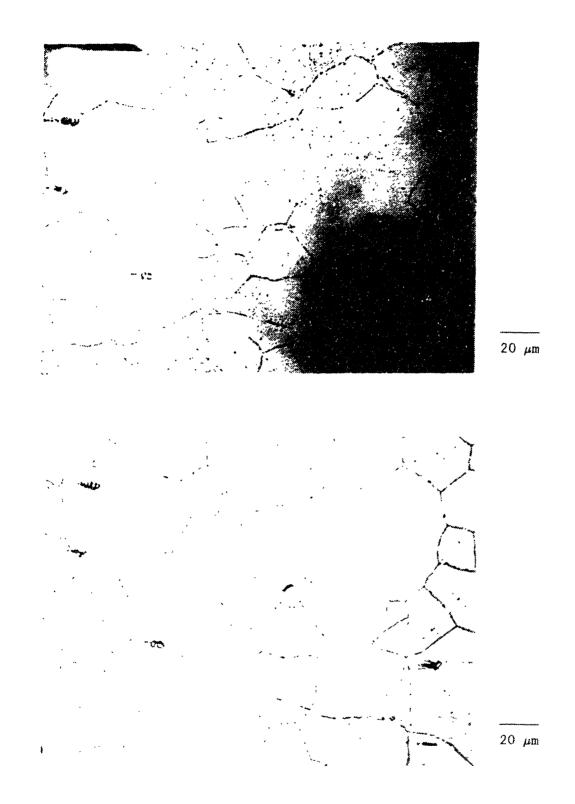
Figure 6.14 Two-step Etch Micrographs of Longitudinal Section of Alloy 600 a HTMA Condition of Heat 96834 with 2.2cm Nominal Diameter (upper orthophosphoric and lower nital etch)[21].

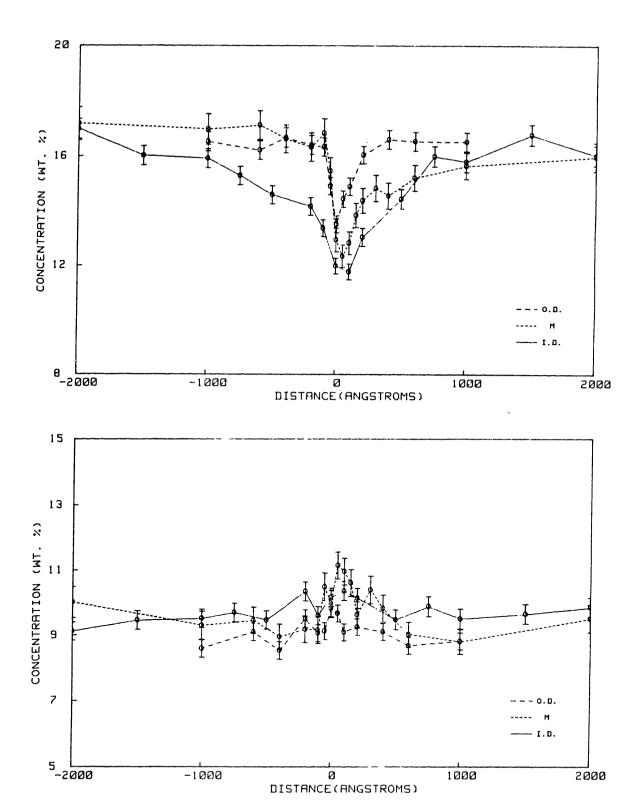
Figure 6.17 Chromium and Iron Distributions as a Function of Distance from a Grain Boundary in a 2.2cm Diameter Tubing of a HTMA Condition of Heat 96834.

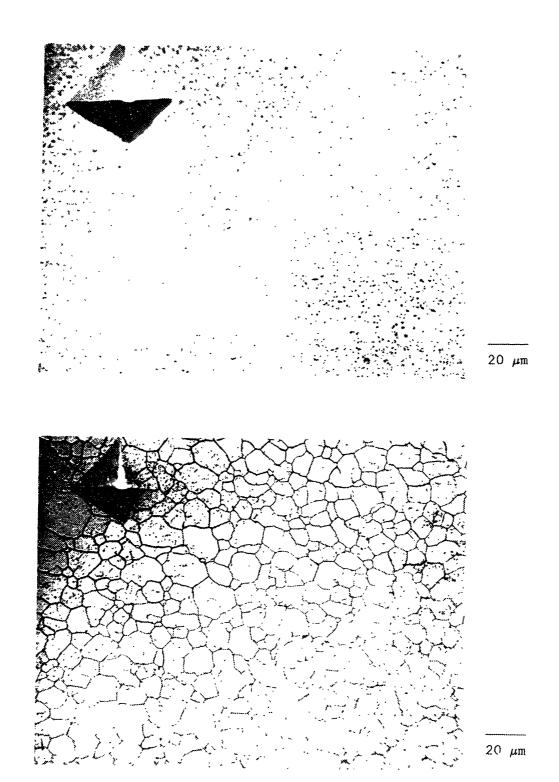
Figure 6.20 Two-step Etch Micrographs of Longitudinal Section of a 2.2cm Diameter Tubing of the LTMA Condition of Heat 96834 (upper orthophosphoric and lower nital etch).

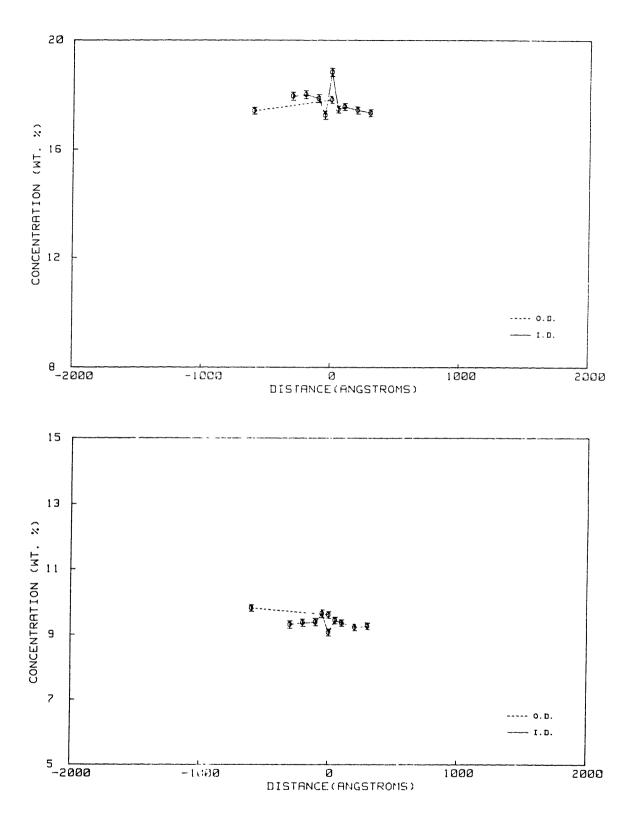
Figure 6.30 The Chromium and Iron Distribtutions as a Function of Distance from a Grain Boundary in a HTMA Condition of Heat 763675.

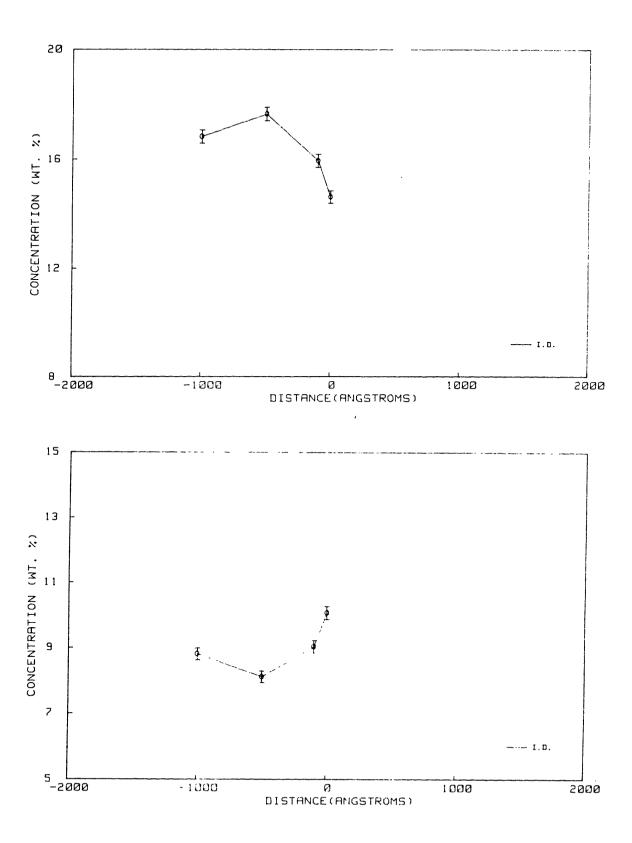
Figure 6.31 The Chromium and Iron Distributions as a Function of Distance from a Grain Boundary in a LTMA Condition of Heat 763675.

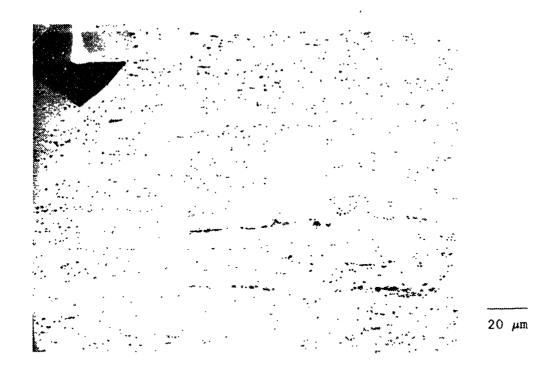
Figure 6.33 Two-step Etch Micrographs of a Longitudinal Section of a LTMA Condition (upper orthophosphoric and lower nital etch).

The LTMA condition of heat NX3857, shown in Figure 6.33, shows a microstructure with heavy intragranular precipitation and almost no grain boundary carbides. The average grainsize was measured to be  $15\mu m$ . This LTMA microstructure is similar with the LTMA conditions of both heats 96834 and 763675. Intragranular carbides are mostly lined up in the direction of cold work. The STEM observation shows grain boundaries which is essentially free of carbides, as shown in Figure 6.35. Microchemical analysis revealed no disturbance in chromium or iron concentration near the grain boundary, as shown in Figure 6.37.

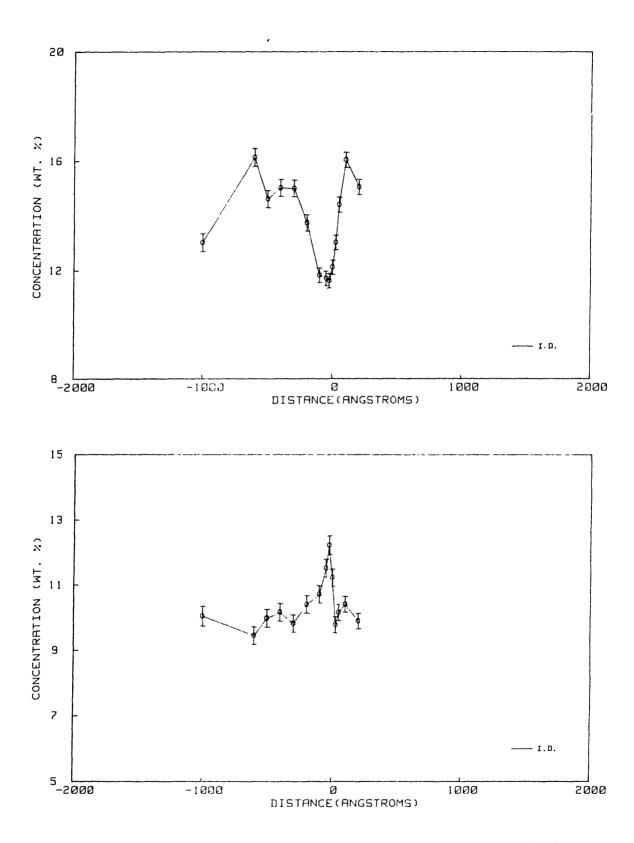
Figure 6.36 Chromium and Iron Distributions as a Function of Distance From a Grain Boundary in a HTMA Condition of Heat NX3857.

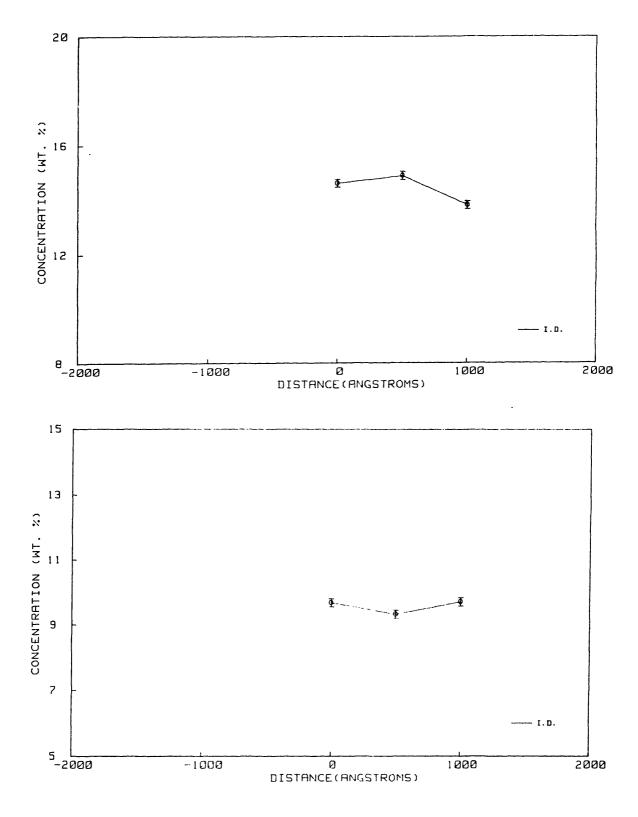
Figure 6.37 Chromium and Iron Distributions as a Function of Distance From a Grain Boundary in a LTMA Condition of Heat NX3857.

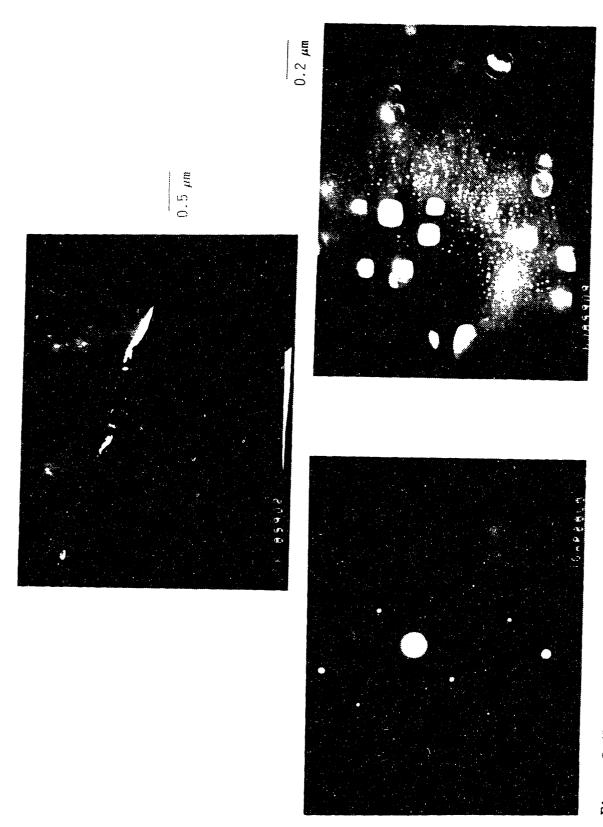
The TEM Micrographs of the AH Conditions of a0.28cm thick Plate of Alloy X-750. Figure 6.43

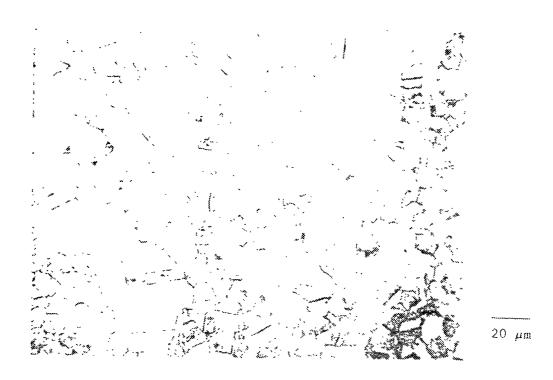
Figure 6.44 Optical Micrographs of the BH Condition of the Alloy X-750.

Microstructure of BH condition of heat 96457E6 is characterized by a bi-modal grain size, as shown in Figure 6.44. The coarse grains about 100 µm in diameter are usually surrounded by the original fine grained structure. The average grain size of the condition is determined to be 30 µm. The coarse grains are usually clustered in an isolated area where the grain coarsening took place after the 1 hr anneal at 982 C. The large variation in the microstructure obtained by the treatment can be attributed to the transition nature of microstructure in the BH

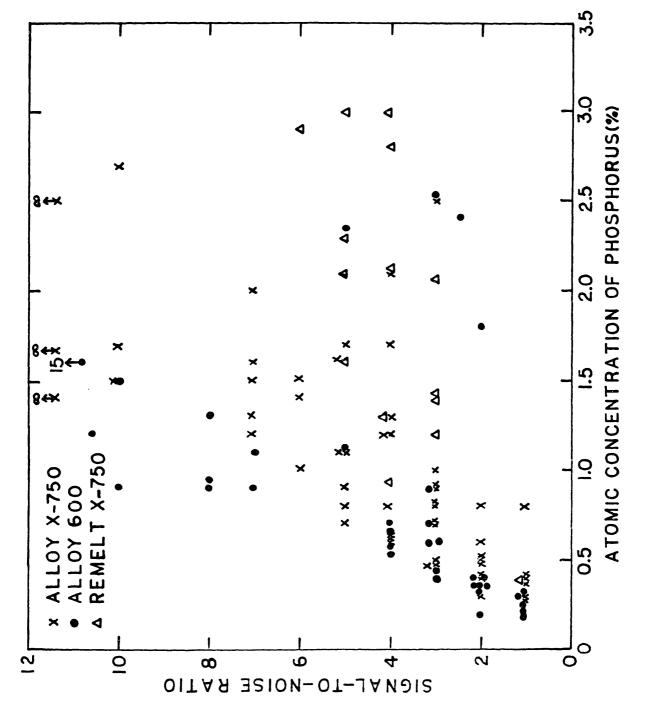
The Relation between Signal-to-Noise Ratio and Atomic Concentration of Phosphorus Measured by AES with in-situ Fracture. Figure 6.50

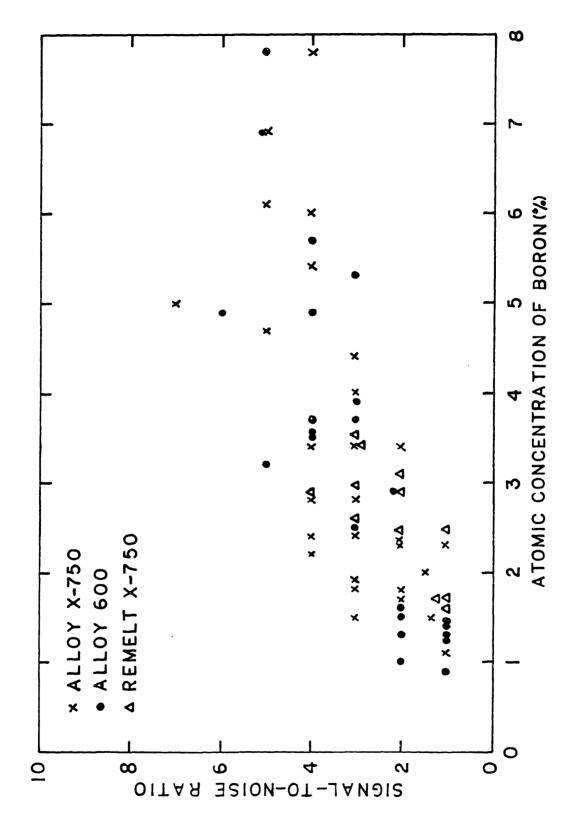
The Relation between Signal to Noise Ratio and Atomic Concentration of Boron Measured by AES with in-situ Fracture. Figure 6.51

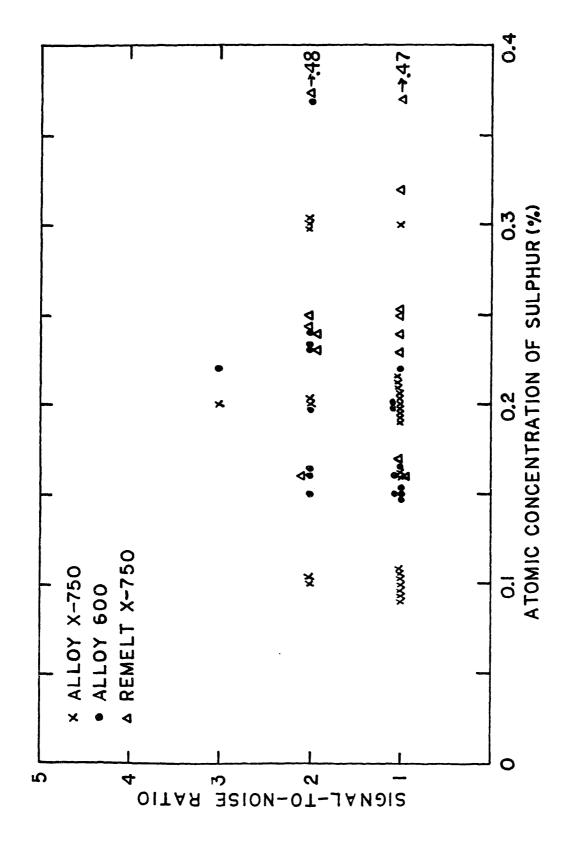
The Relation between Signal to Noise Ratio and Atomic Concentration of Sulphur Measured by AES with in-situ Fracture. Figure 6.52

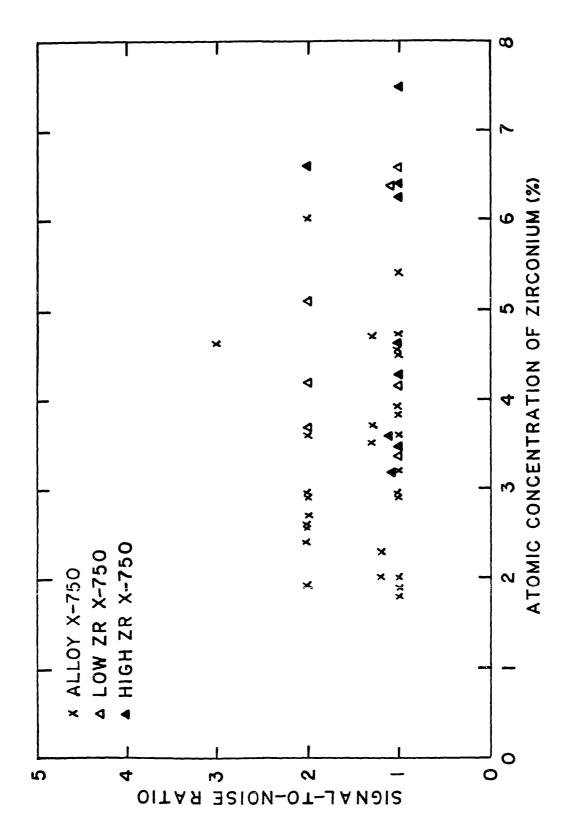
The Relation between Signal to Noise Ratio and Atomic Concentration of Zirconium Measured by AES with in-situ Fracture. Figure 6.53

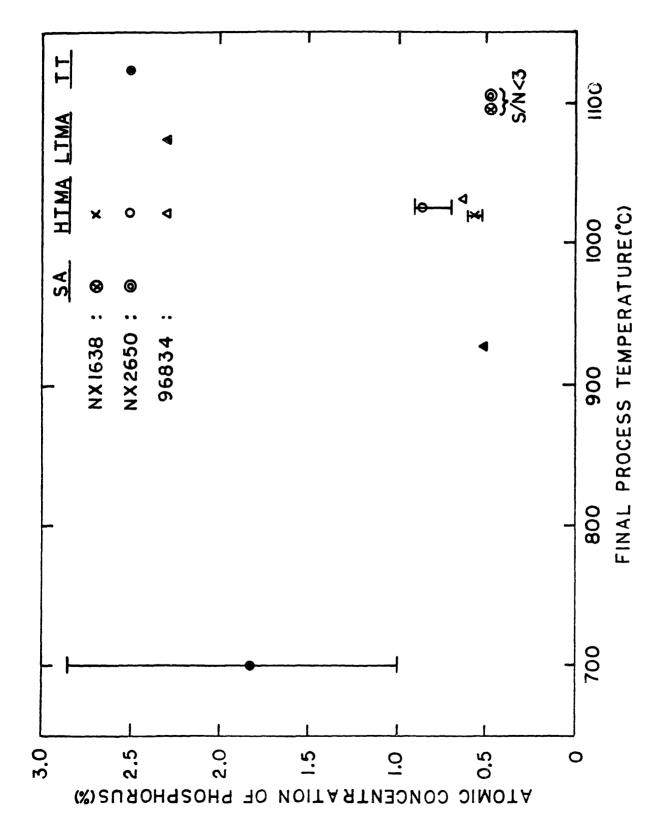
The Measured Concentration of Phosphorus on a Intergranular Surface in Alloy 600 as a Function of the Final Process Temperature. Figure 6.54

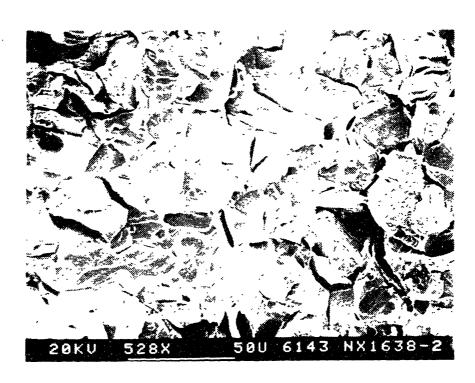
Figure 6.56 Fracture Surface of the AES Specimen for the HTMA Condition of Alloy 600 Heat NX1638.

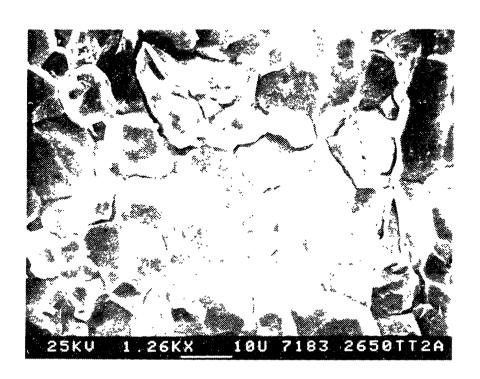
Figure 6.58 Fracture Surface of the AES Specimen for the Thermally Treated Condition of Heat NX2650.

nearly the same as those in the bulk matrix although the fracture surface showed the presence of carbide precipitates at a high number density. This suggests that the fracture after hydrogen charging does not occur through the carbides.

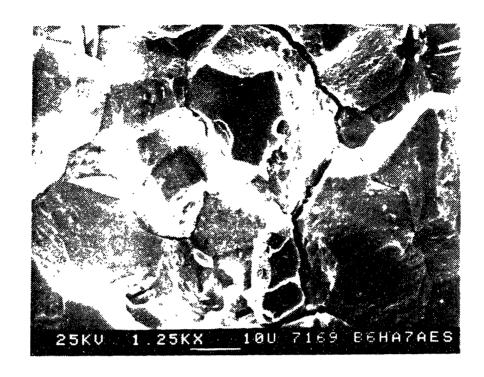
Figure 6.59 Fracture Surface of the AES Specimen for the HTMA Condition of Alloy 600 Heat 96834.

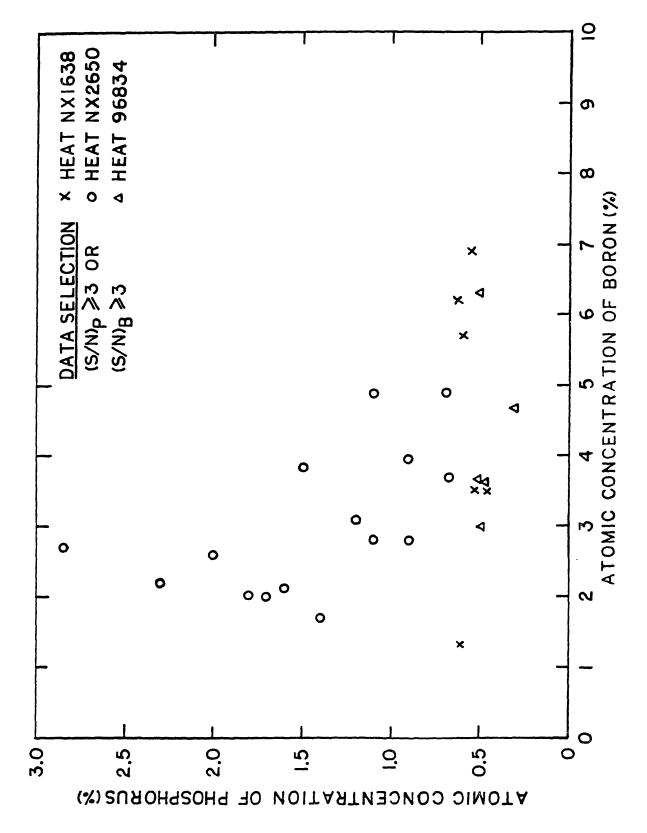
The Relation Between the Measured Concentrations of Phosphorus and Boron in Alloy 600. Figure 6.63

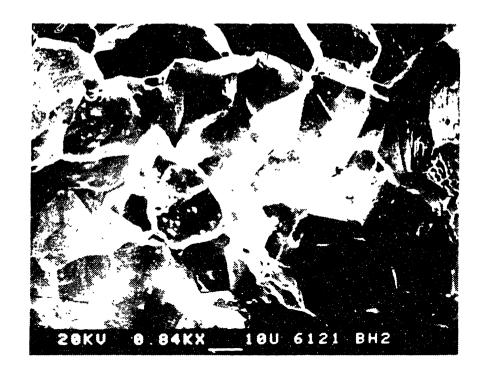
Figure 6.66 Fracture Surface of the AES Specimen for the BH Condition of an Alloy X-750 Heat 96457E6.

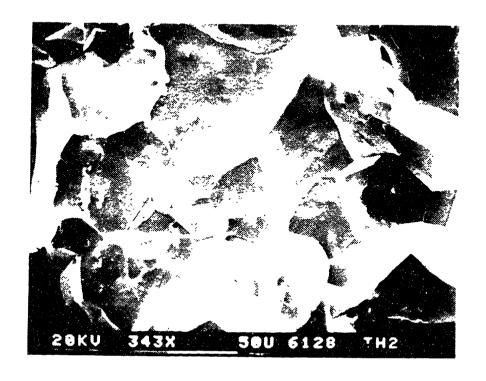
Figure 6.67 Fracture Surface of the AES Specimen for the AHTH Condition of an Alloy X-750 Heat 96457E6.

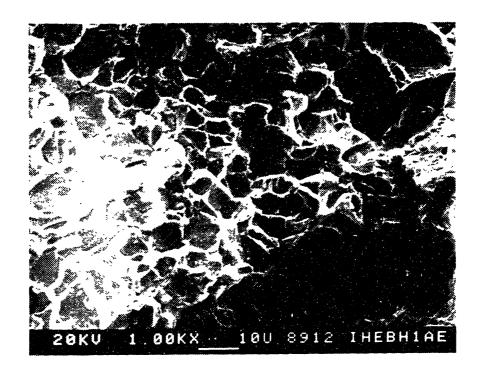
Figure 6.70 Fracture Surface of the AES Specimen for the EBH Condition of an Alloy X-750 Heat 96457E6.

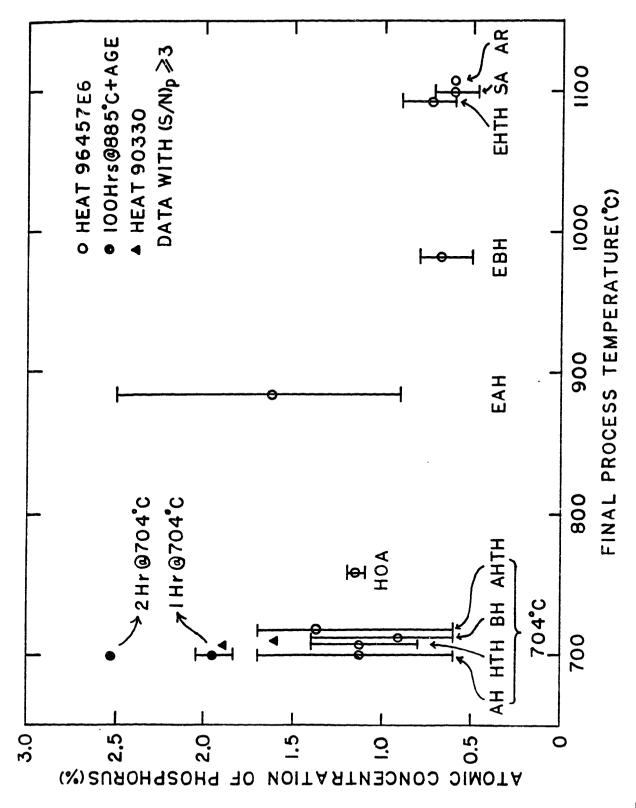
The Measured Concentration of Phosphorus on the AES Specimens of Alloy X-750 as a Function of Final Process Temperature. Figure 6.72

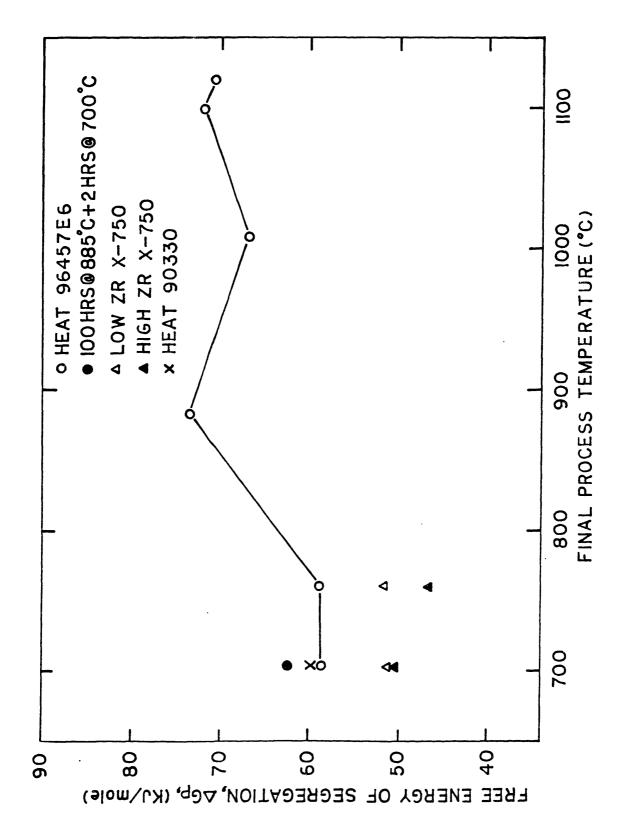
The Free Energy of Phosphorus Segregation as Determined by the McLean Type Equilibrium Model based on the Peak Concentration. Figure 6.74

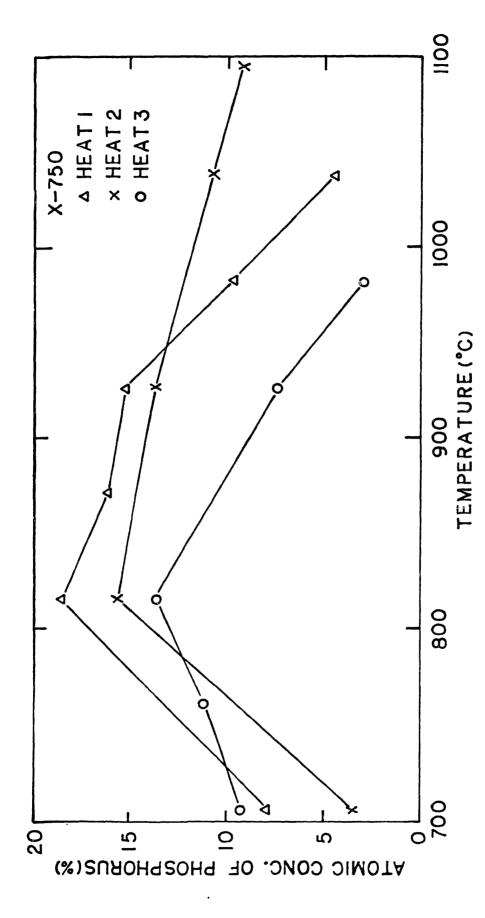
The Measured Concentration of Phosphorus on the Free Surfaces as a Function of Temperature [36]. Figure 6.75

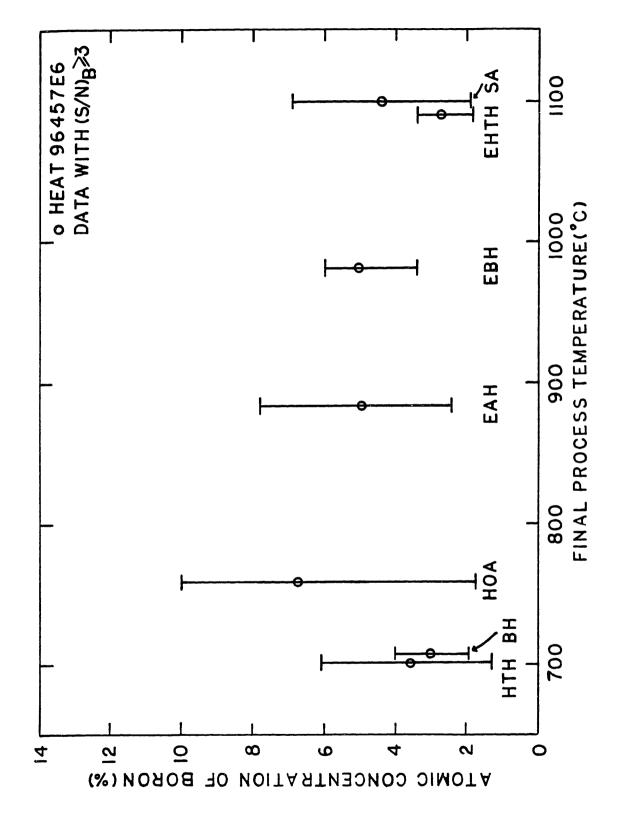
The Measured Boron Concentration on the AES Specimen of Alloy X-750 Heat 96457E6 as a Function of Final Process Temperatures. Figure 6.76

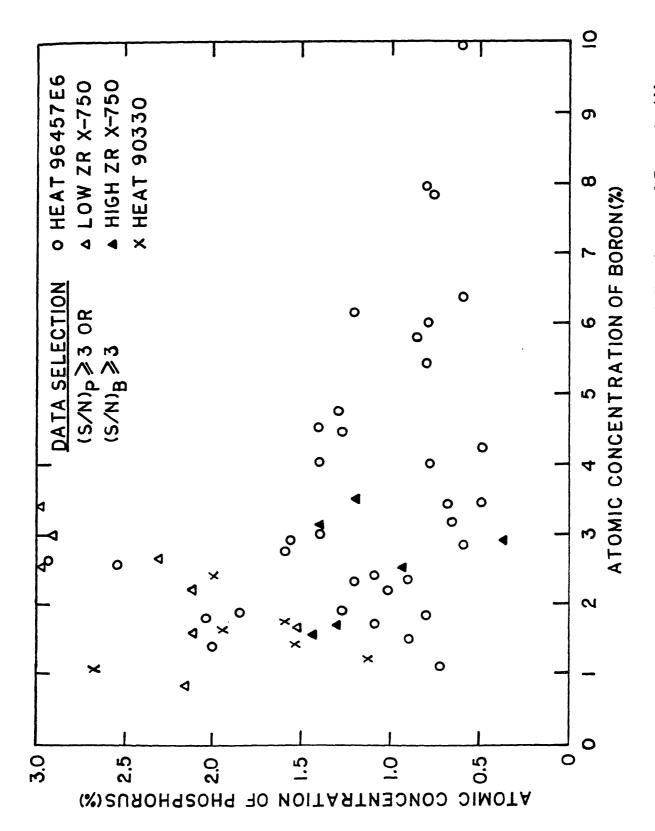
The Relation Between the Measured Concentration of Phosphorus and Boron in Alloy X-750. Figure 6.78

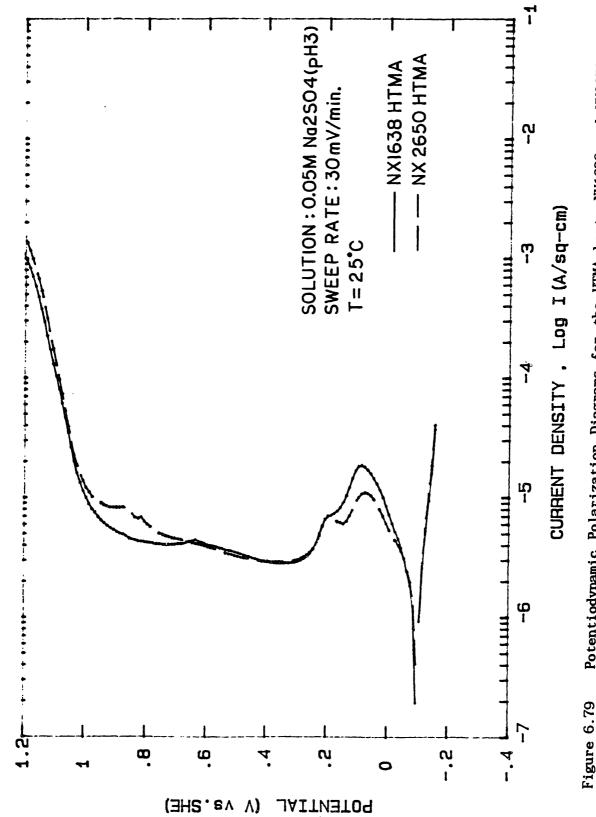
Potentiodynamic Polarization Diagrams for the HTMA heats NX1638 and NX2650 in 0.05M Na $_2$ SO $_4$  (pH=3) Solution at 25 C.

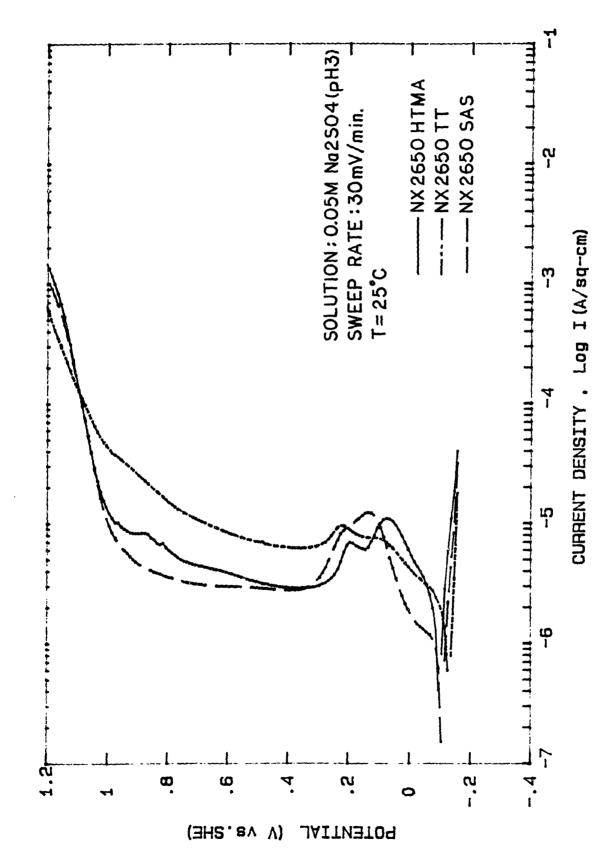
Potentiodynamic Polarization Diagram for the TT and SAS Conditions in Comparison with the HTMA in case of Heat NX2650 in 0.05M  ${\rm Na}_2{\rm SO}_4({\rm pH}=3)$  Solution at 25 C. Figure 6.80

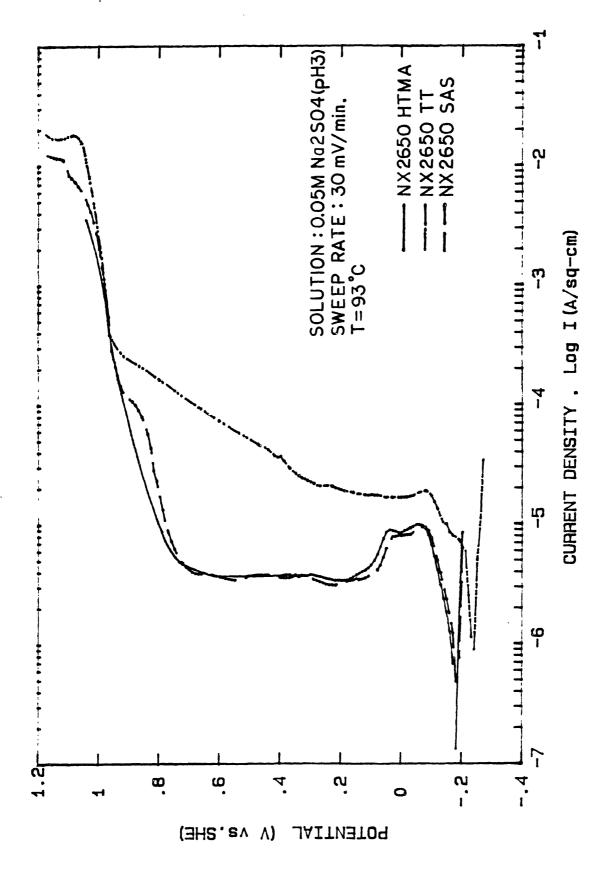
Potentiodynamic Polarization Diagram for the TT and SAS Conditions in Comparison with the HTMA Condition of Heat NX2650 in 0.05M  $\rm Na_2SO_4(pH=3)$  Solution at 93 C. Figure 6.81

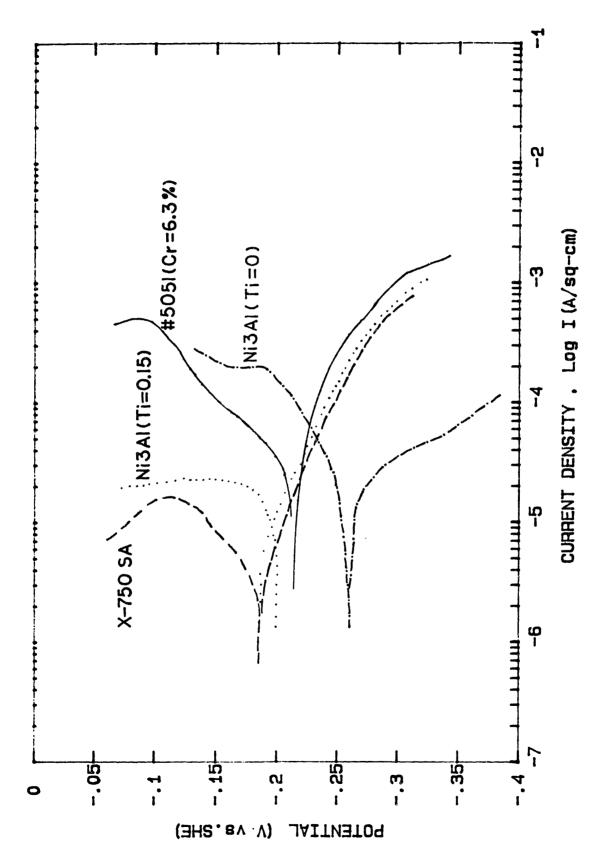
Potentiodynamic Polarization of Alloy X-750 and Representative Grain Boundary Chemistries in 0.05M  ${\rm Na}_2{\rm SO}_4$  Solution (pH=3) at 93 C. Figure 6.82

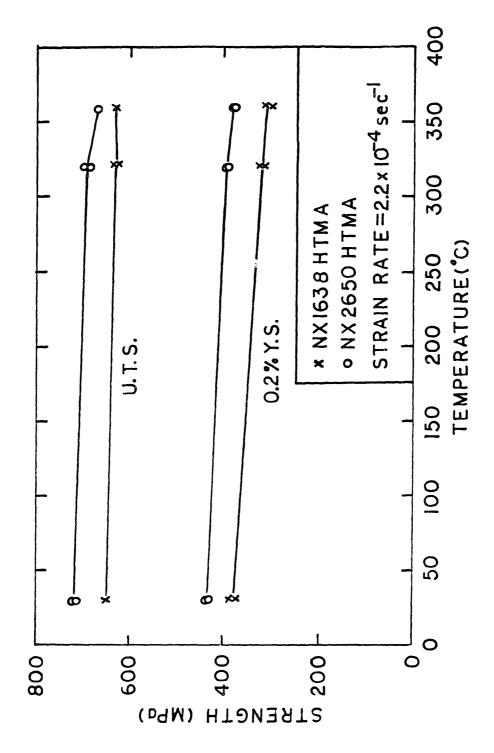
The Tensile Strength of the HTMA Conditions of Alloy 600 Heat NX1638 and NX2650 as a Function of Temperature. Figure 6.90
