# EMBRITTLEMENT MECHANISMS OF

# NICKEL-BASE ALLOYS IN WATER

Submitted to the Department of Nuclear Engineering in Partial Fulfillment of the Requirements of the Degree of Doctor of Philosophy in Nuclear Engineering

Massachusetts Institute of Technology

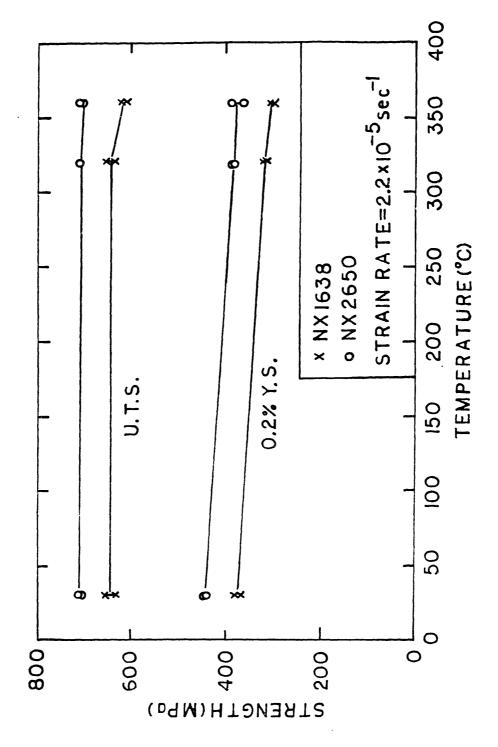
The Tensile Strength of the HTMA Conditions of Alloy 600 Heat NX1638 and NX2650 as a Function of Temperature. Figure 6.91

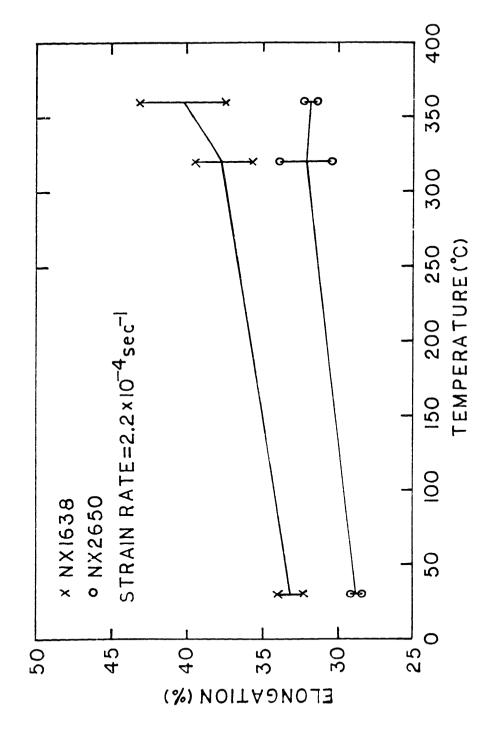
The Elongation of the HTMA Conditions of Alloy 600 Heat NX1638 and NX2650 as a Function of Temperature at a Strain Rate of  $2.2 \mathrm{x} 10^{-4} \mathrm{sec}^{-1}$

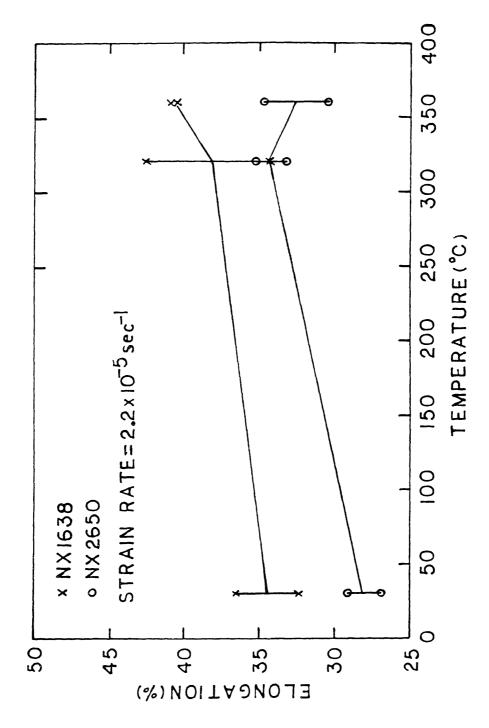
The Elongation of the HTMA Conditions of Alloy 600 Heat NX1638 and NX2650 as a Function of Temperature at a Strain Rate of  $2.2 \mathrm{x} 10^{-5} \mathrm{sec}^{-1}$ Figure 6.93

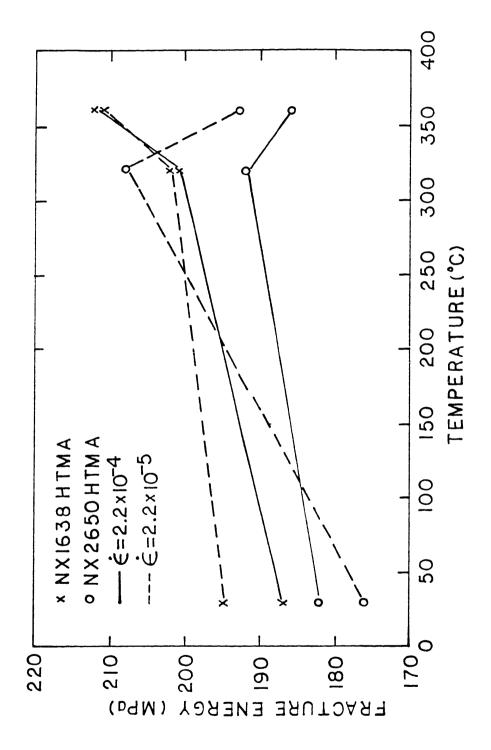
and The Specific Plastic Work of the HTMA Conditions of Alloy 600 Heat NX1638 and Function of Temperature at a Strain Rate of  $2.2 \mathrm{x} 10^{-4} \mathrm{sec}^{-1}$ NX2650 as a F  $2.2 \times 10^{-5} \text{sec}^{-1}$ . Figure 6.94

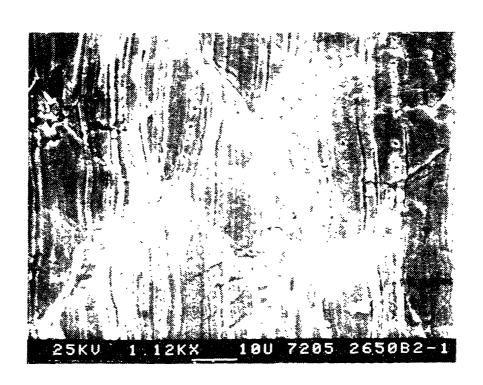
Figure 6.103 The Scanning Electron Micrographs for the Tensile Specimen of The HTMA Condition of Heat NX2650 Tested at a Strain Rate of  $2.2 \times 10^{-4} \, \mathrm{sec}^{-1}$  at 320 C (upper fracture surface lower side wall).

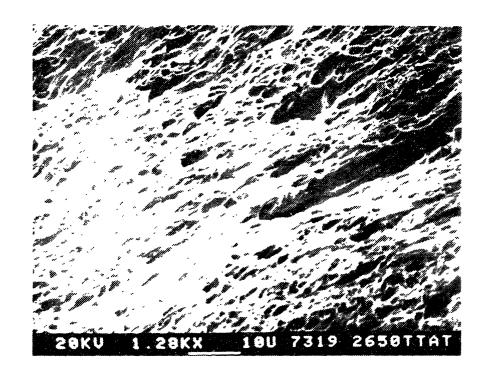
Figure 6.112 The Scanning Electron Micrographs for the Tensile Specimen of the Thermally Treated Condition of Heat NX2650 Tested at a Strain Rate of  $1.7 \times 10^{-4} \, \mathrm{sec}^{-1}$  at 360 C (upper fracture surface lower side wall).

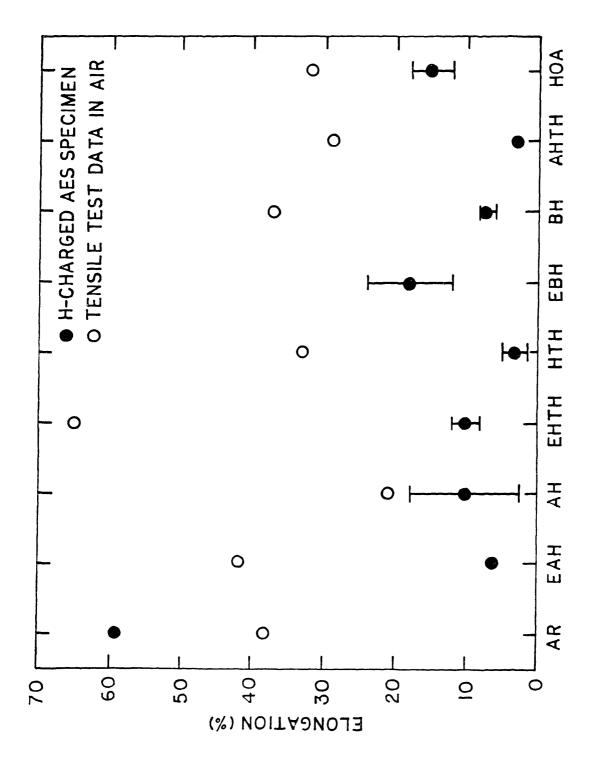
The Estimated Elongation of Hydrogen Charged AES Specimens of Alloy X-750. Figure 6.118

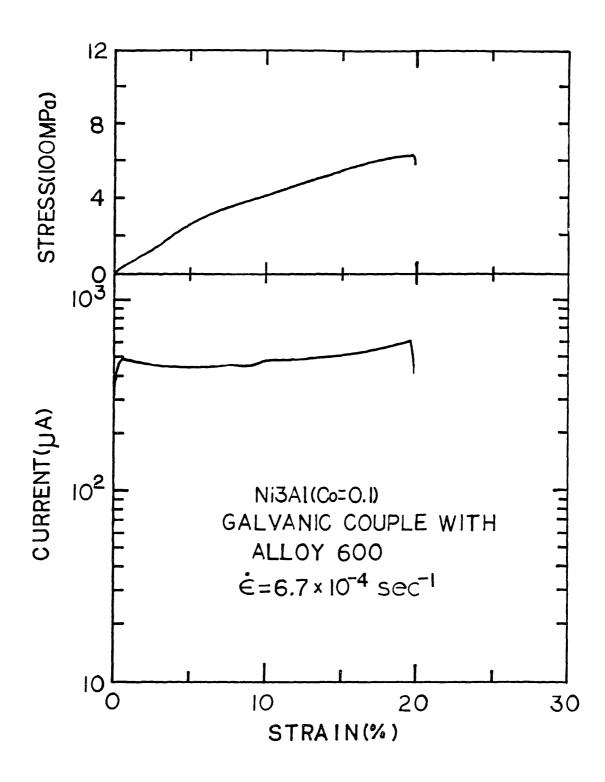
Figure 6.119 The SETT Results of the  $\mathrm{Ni_3Al}(\mathrm{Co=0.1})$  Galvanically Coupled with Alloy 600 in a 0.05M  $\mathrm{Na_2SO_4}$  (pH=3) Solution at 93 C with a Strain Rate of 6.7x10<sup>-4</sup> sec<sup>-1</sup>.

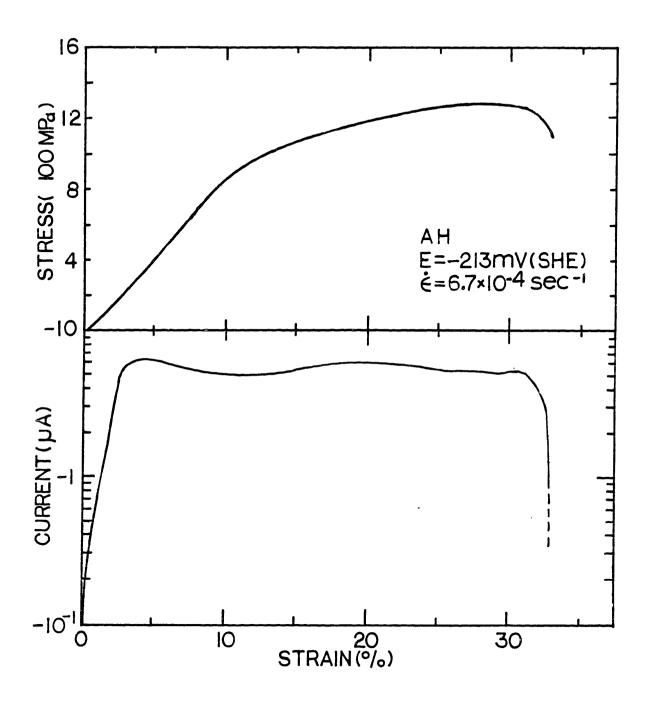
Figure 6.122 The SETT Results of the AH Condition in a 0.05M  $\rm Na_2SO_4$  (pH=3) Solution at 93 C with a Strain Rate of 6.7x10<sup>-4</sup> sec<sup>-1</sup> and a Potential of -213 mV(SHE).

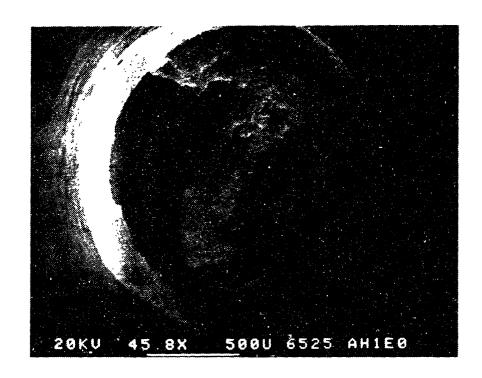
Figure 6.123 The SEM Fractographs of the AH Condition after the SETT in a 0.05M  $\rm Na_2SO_4$  (pH=3) Solution with a Strain Rate of  $6.7 \rm x10^{-4}~sec^{-1}$  and a Potential of -213 mV(SHE).

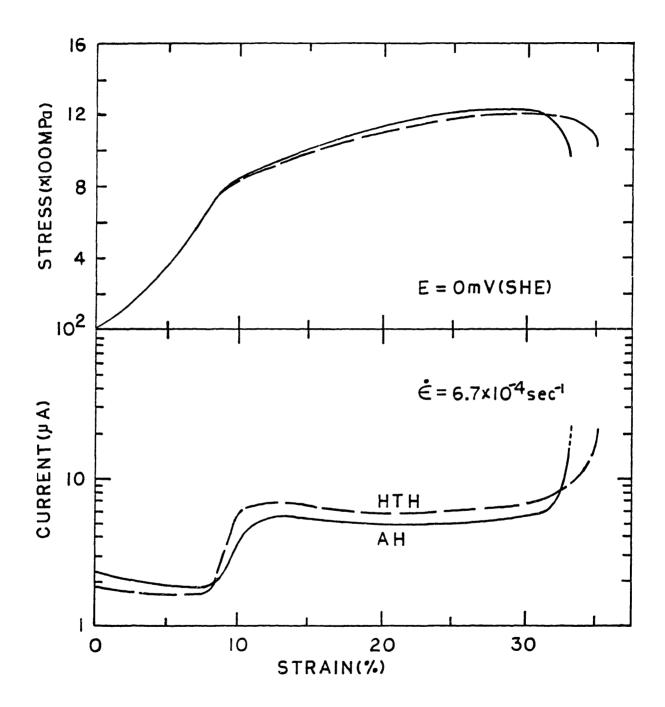
Figure 6.124 The SETT Results of the AH and HTH Conditions in a 0.05M  $\rm Na_2SO_4$  (pH=3) Solution at 93 C with a Strain Rate of  $\rm 6.7x10^{-4}~sec^{-1}$  and a Potential of 0 mV(SHE).

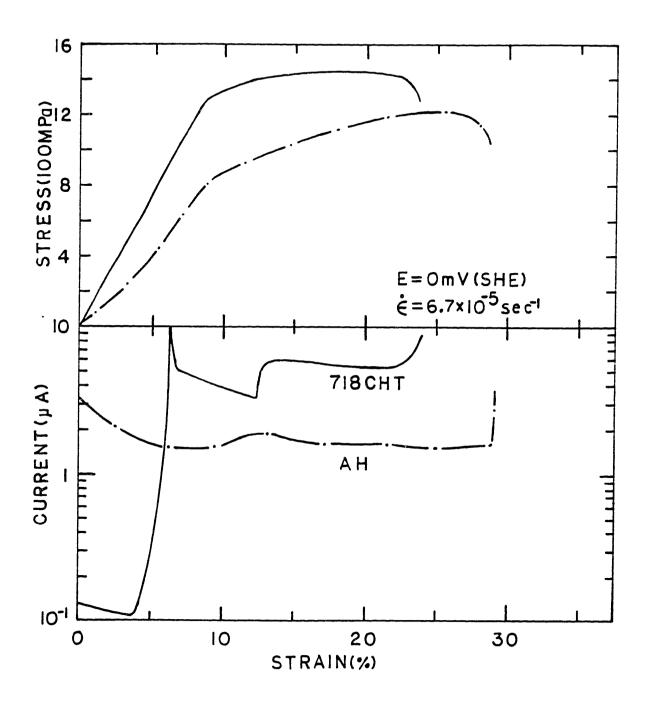
Figure 6.127 The SETT Results of the AH and CHT Conditions in a 0.05M  ${
m Na}_2{
m SO}_4$  (pH=3) Solution at 93 C with a Strain Rate of  $6.7{\rm x}10^{-5}~{
m sec}^{-1}$  and a Potential of 0 mV(SHE).

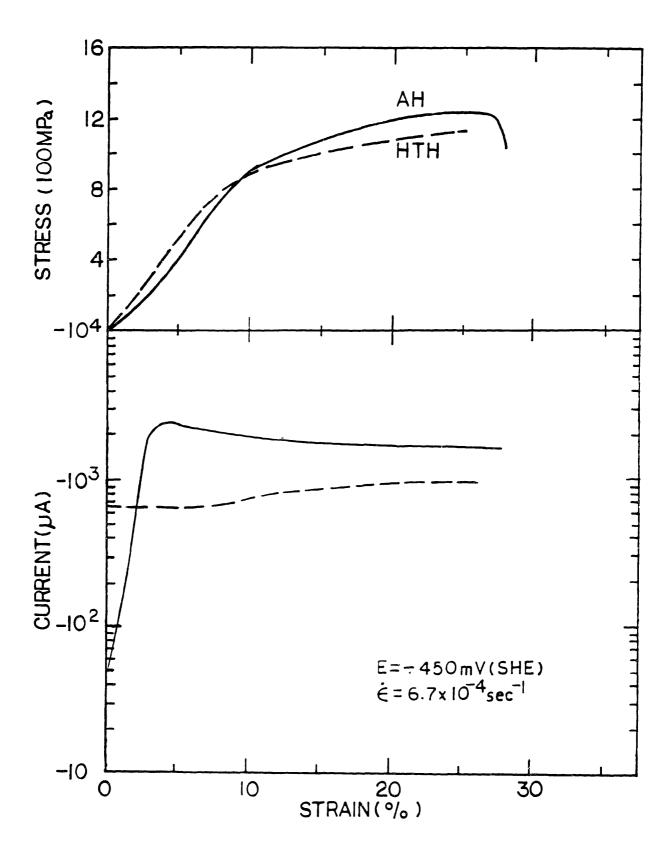
Figure 6.130 The SETT Results of the AH and HTH Conditions in a 0.05M  $\rm Na_2SO_4$  (pH=3) Solution at 93 C with a Strain Rate of  $\rm 6.7x10^{-4}sec^{-1}$  and a Potential of -450 mV(SHE). Page 343

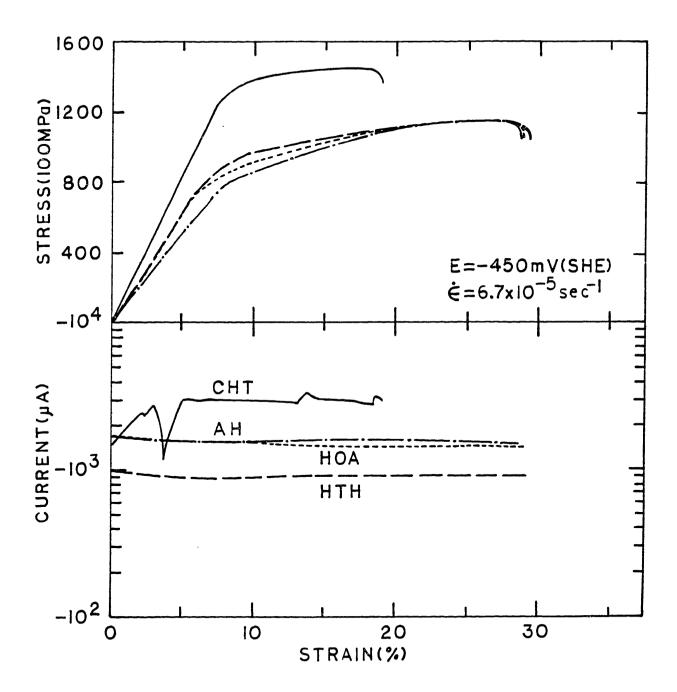
Figure 6.133 The SETT Results of the AH, HTH, HOA, and CHT Conditions in a  $0.65 \text{M Na}_2 \text{SO}_4$  (pH=3) Solution at 93 C with a Strain Rate of  $6.7 \text{x} 10^{-5}$  sec<sup>-1</sup> and a Potential of -450 mV(SHE).

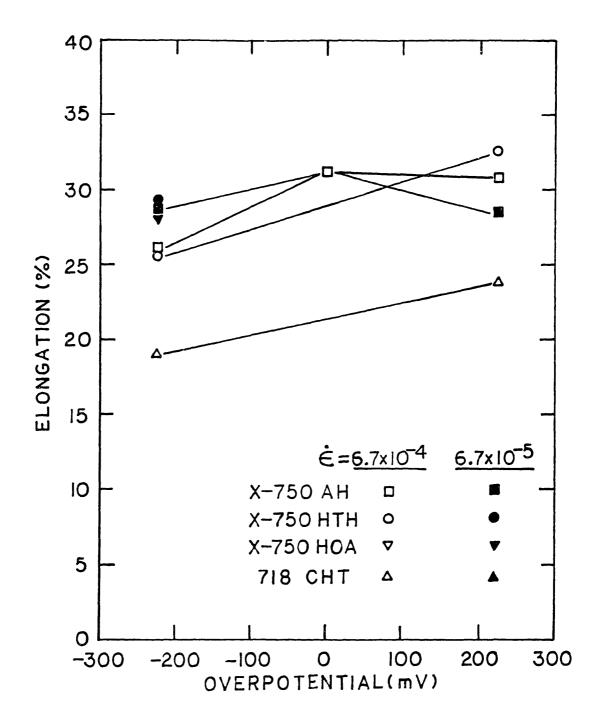
Figure 6.140 Comparison of Elongation of Alloys X-750 and 718 as a Function of Overpotential during SETT.

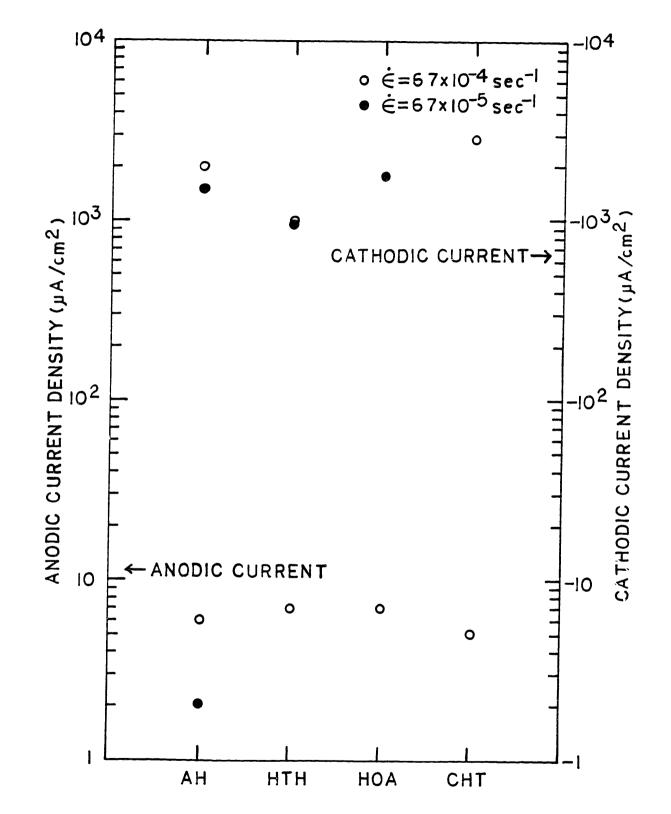
Figure 6.141 Comparison of Steady State Current Density of Alloys X-750 and 718 during SETT as a Function of Heat Treatments.

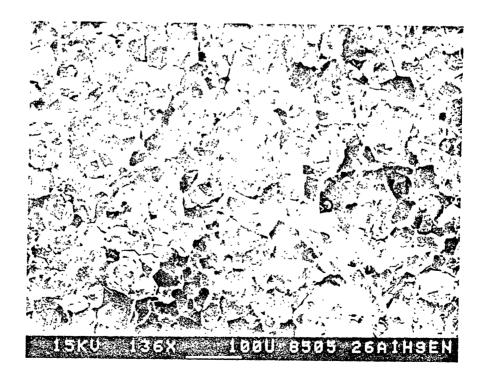
Figure 6.148 The SEM Fractograph of the AH SEN Specimen after a Fatigue Test in Deaerated Water at 60 C with a Frequency of 1.0 Hz at 25 MPa $\sqrt{m}$  and R=0.1 during Free Corrosion.

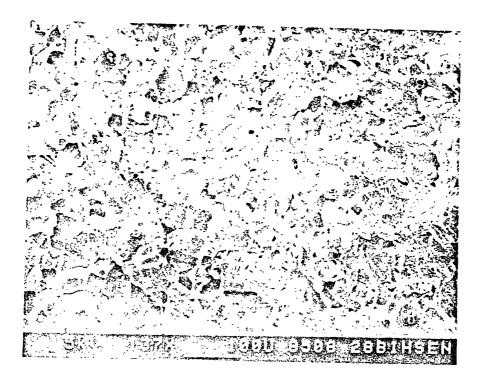
Figure 6.150 The SEM Fractograph of the AH SEN Specimen after a Fatigue Test in Deaerated Water at 60 C with a Frequency of 0.1 Hz at 25 MPa $\sqrt{m}$  and R=0.1 during the Anodic Charging at 0.5mA/cm $^2$ .

The SEM fractograph for the region with the decreased crack growth rate is shown in Figure 6.150. An intergranular crack path is substantially retained but decreased embrittlement is evidenced by the absence of secondary cracks and an increased number of transgranular patches between intergranular facets. Since the crack growth rate was decreased to the value in air the embrittlement is considered to be lowered by the chromate contamination.

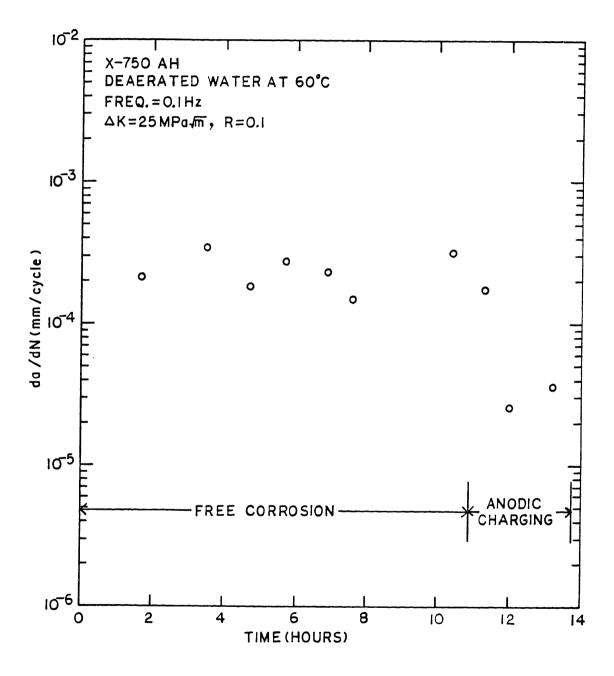
Figure 6.151 The Decreased Fatigue Crack Growth Rate of the AH SEN Specimen by Anodic Charging at 0.5 mA/cm $^2$  and Subsequent Solution Contamination with a Frequency of 0.1 Hz at 25 MPa $\sqrt{m}$  and R=0.1 in the Deaerated Water at 60 C.

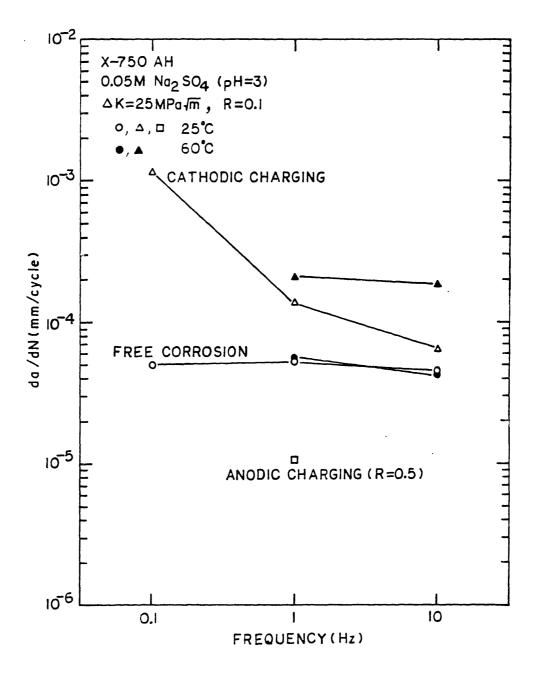
Figure 6.153 The effects of Cathodic and Anodic Charging at  $0.5\text{mA/cm}^2$  on the Fatigue Crack Growth Rate of the AH SEN Specimen in  $0.05\text{M Na}_2\text{SO}_4(\text{pH=3})$  Solution at 25 MPa $\sqrt{\text{m}}$  and R=0.1 as a Function of Frequency.

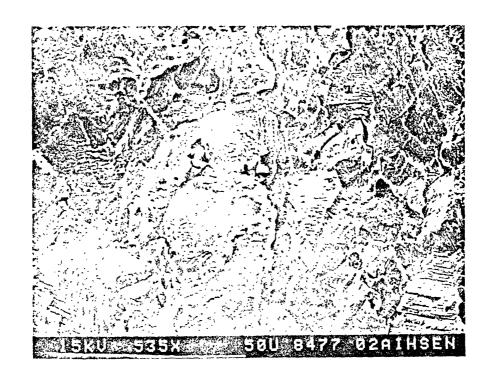
Figure 6.154 The SEM Fractograph of the AH SEN Specimen after a Fatigue Test in 0.05 M  $\rm Na_2SO_4$  (pH=3) Solution at 25 C with a Frequency of 10 Hz at 25 MPa $\sqrt{m}$  and R=0.1 under Free Corrosion.

A more detailed observation was made in the same electrolyte with a second specimen of the same condition. The results are summarized in Figure 6.153. Under free corrosion, the crack growth rates were as low as those in air for a frequency range between 0.1 Hz and 10 Hz at both temperatures of 25 C and 60 C. All the fracture surfaces at the free corrosion potential show a transgranular morphology. A representative micrograph is shown in Figure 6.154 for the case of 10 Hz at 25 C.

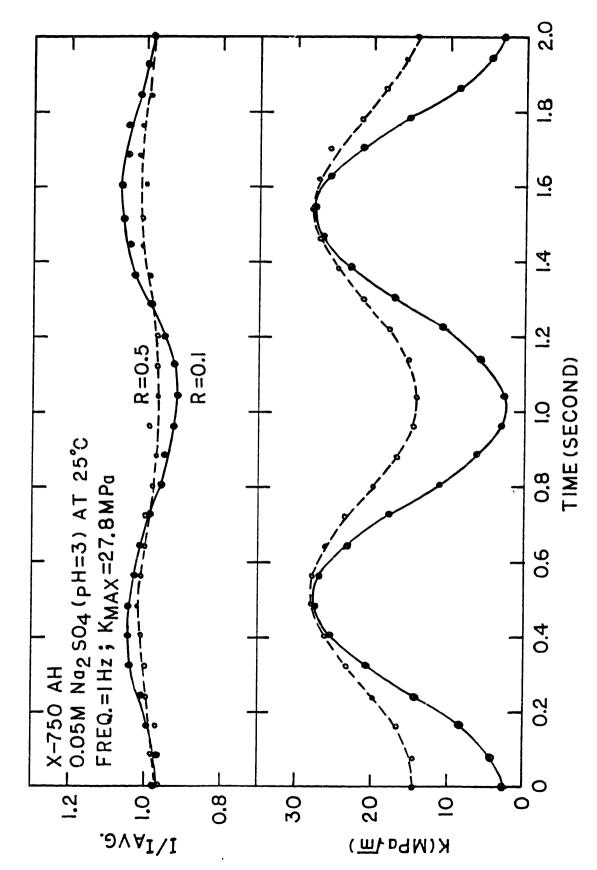
Potentiostatic Controls of the AH SEN Specimen at a K of 27.8 MPavm and two The Oscillation in Cathodic Currents during Load Cycles as Measured under different R-ratios in 0.05 M  $\mathrm{Na_2SO_4}$  (pH=3) Solution at 25 C. Figure 6.160

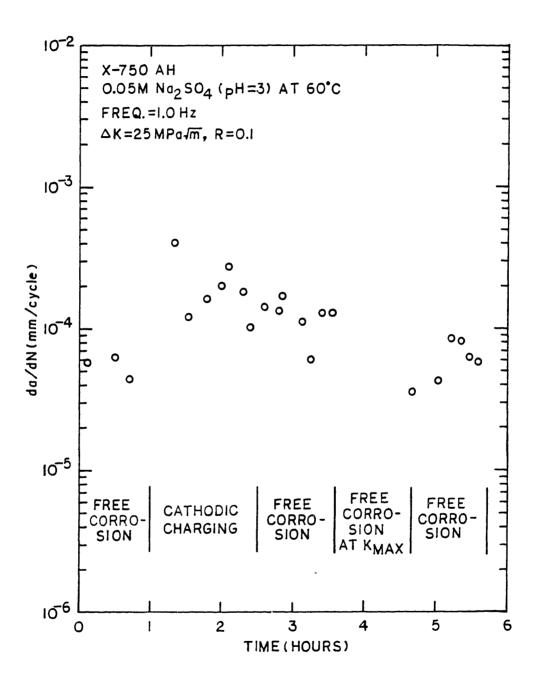
Figure 6.161 The Delayed Effect of Previous Cathodic Charging on the Fatigue Crack Growth Rate of the AH SEN Specimen in 0.05 M Na $_2$ SO $_4$  (pH=3) Solution at 60 C at 25 MPa $\sqrt{m}$  and R=0.1 with a Frequency of 1.0 Hz.

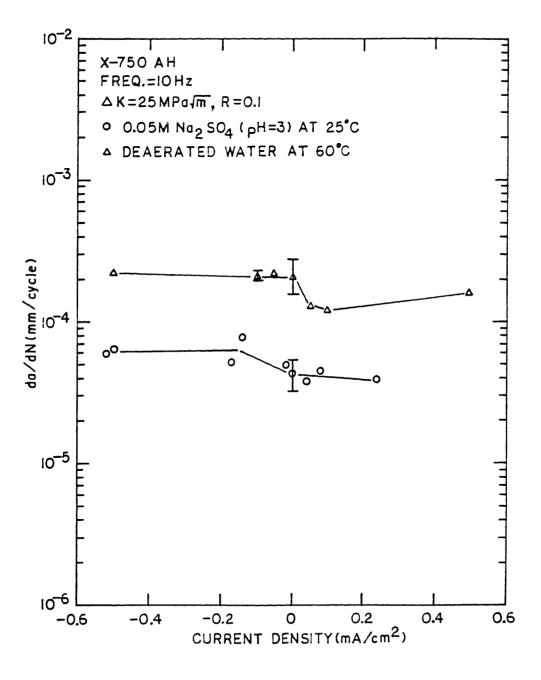
Figure 6.163 The Fatigue Crack Growth Behaviors of the AH SEN Specimen at 60 C in Comparison with that at 25 C at 25 MPa $\sqrt{m}$  and R=0.1 with a Frequency of 10 Hz in 0.05 M Na $_2$ SO $_4$  (pH=3) Solution.

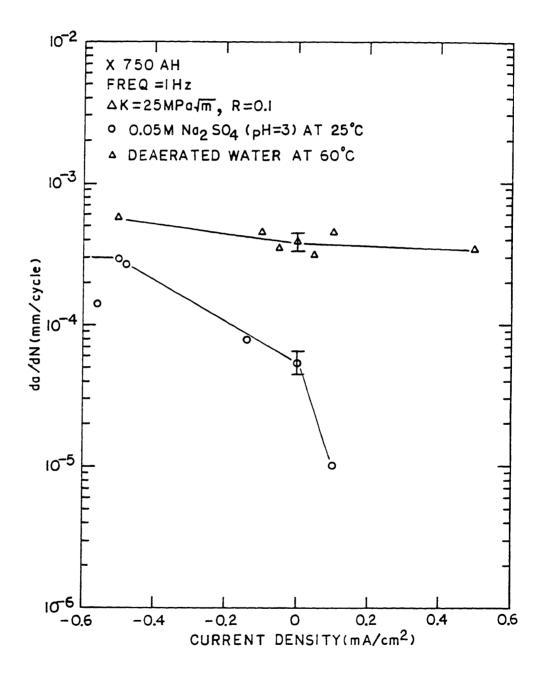
Figure 6.166 Fatigue Crack Growth Rate of the AH SEN Specimen as a Function of Charging Current Density in Two Different Environments at 25 MPa $\sqrt{m}$  and R=0.1 with a Frequency of 1.0 Hz.

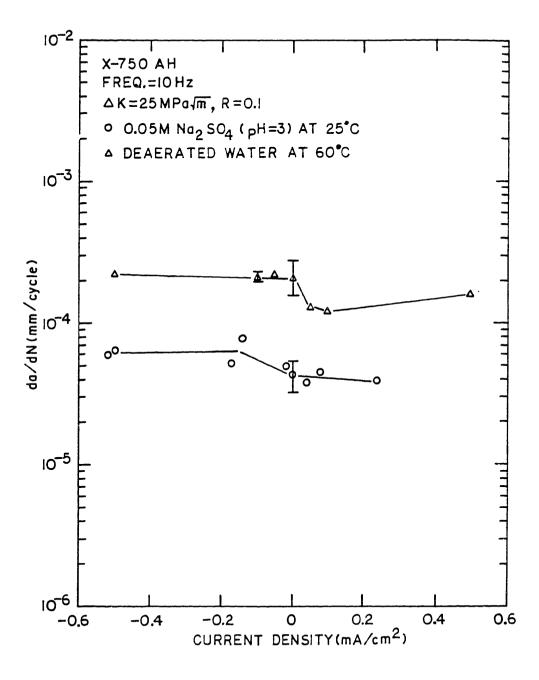
Figure 6.167 Fatigue Crack Growth Rate of the AH SEN Specimen as a Function of Charging Current Density in Two Differnt Environments at 25 MPa $\sqrt{m}$  and R=0.1 with a Frequency of 10 Hz.

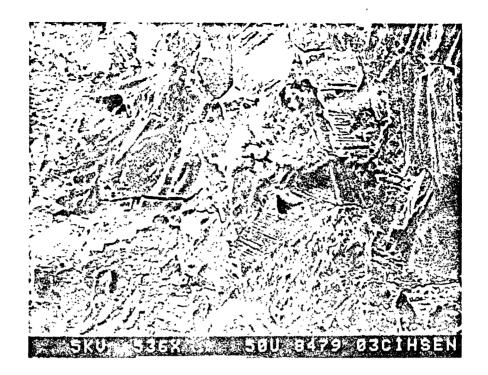
Figure 6.168 The SEM Fractograph of the AH SEN Specimen after a Fatigue Test in 0.05 M  ${\rm Na_2SO_4}$  (pH=3) Solution at 25 C with a Frequency of 10 Hz at 25 MPa $\sqrt{\rm m}$  and R=0.1 during Cathodic Charging at 0.01 mA/cm $^2$ .

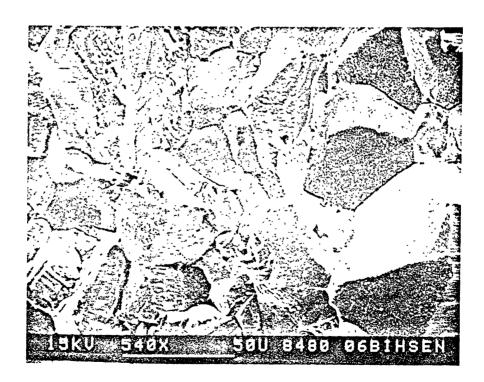
Figure 6.169 The SEM Fractograph of the AH SEN Specimen after a Fatigue Test in 0.05 M Na $_2$ SO $_4$  (pH=3) Solution at 25 C with a Frequency of 10 Hz at 25 MPa $\sqrt{m}$  and R=0.1 during Cathodic Charging at 0.14 mA/cm $^2$ .

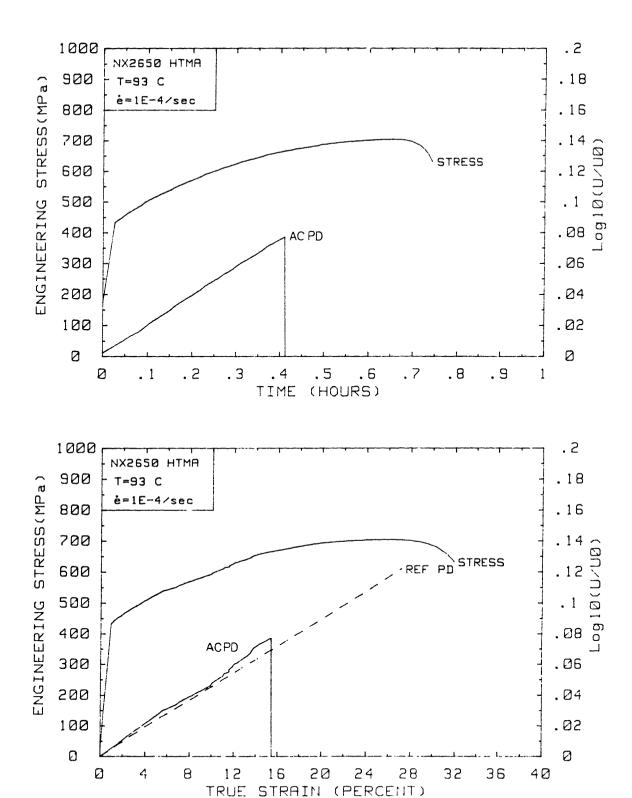
Figure 6.174 Stress and ACPD versus Time (upper) and Strain (lower) for HTMA Condition of NX2650 during a SSRT at a Strain Rate of 1  $\times$  10<sup>-4</sup> sec<sup>-1</sup> in a High Purity Deaerated Water at 93 C.

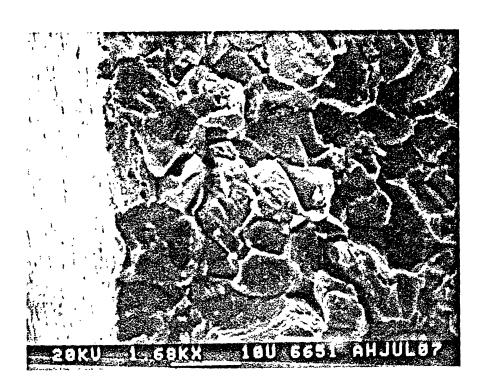
Figure 6.193 SEM Fractographs for the SSRT Specimen of AH Condition of Alloy X-750 Tested at a Strain Rate of 5 x  $10^{-7}$  sec $^{-1}$  in a High Purity Deaerated Water at 337 C (unnotched specimen).

A second smooth bar test was conducted using the same strain rate, but in deaerated water at 337 C. The results are shown in Figure 6.192. The vield strength is 48 MPa, higher than that of the tensile test made on the same heat of AH using a round bar specimen design [50]. Serrated vielding occurs with a stress drop of about 50 MPa. Each load drop is accompanied with a step increase in the strain and ACPD. Several intergranular fracture regions are shown in Figure 6.193. An interconnection between the cracks appears to have occurred during the final fracture step as indicated by the transgranular mode of fracture between the intergranular cracks. The crack depth is, on the average, about  $300\mu m$  with a maximum of  $500\mu m$ . A detailed examination on the edge reveals an oxide layer at the surface with about  $1\mu m$  thickness beneath which intergranular cracking is believed to have been initiated. side wall shows only a few secondary cracks which are widely separated. The oxide layers except at the cracks remain intact. This suggests that cracking of the oxide layer may play an important role in initiation.

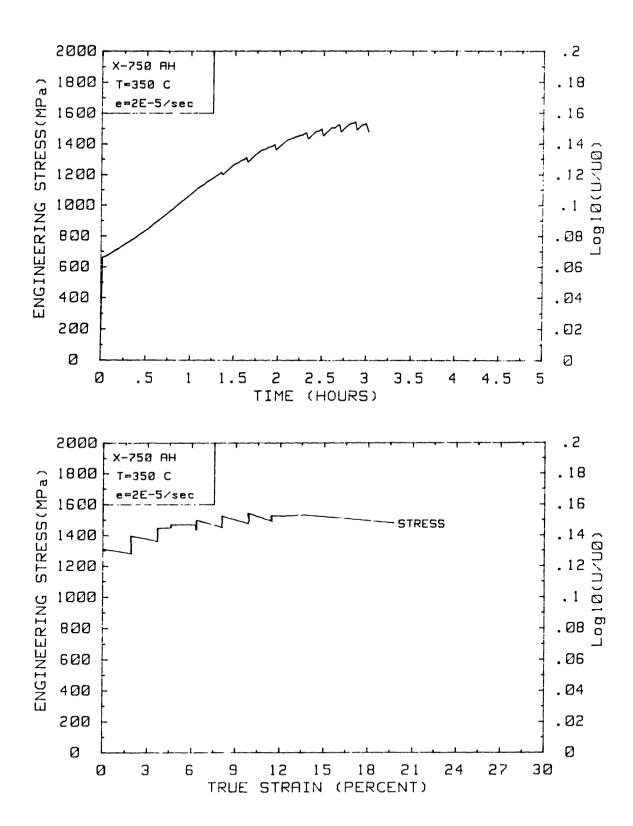
Figure 6.197 Stress versus Time(upper) and Strain(lower) for the SSRT Specimen of AH Condition of Alloy X-750 Tested at a Strain Rate of 2 x  $10^{-5}$  sec $^{-1}$  in a High Purity Deaerated Water at 350 C

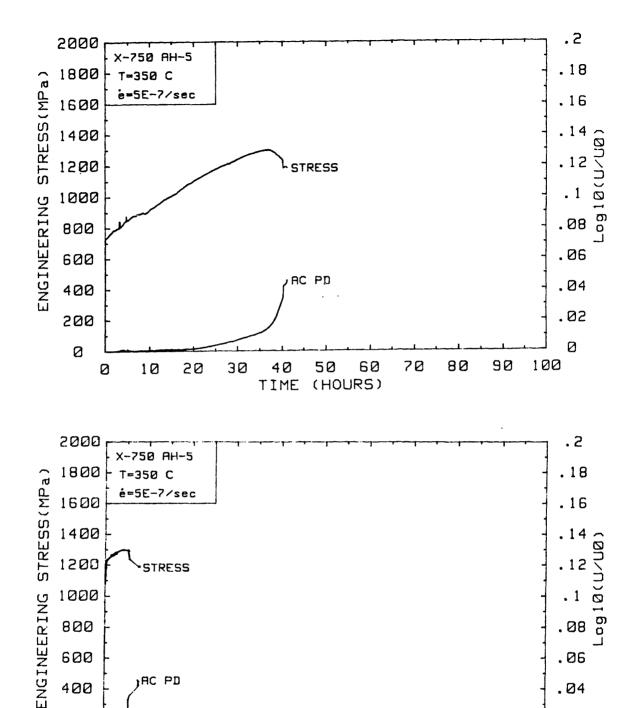
Stress and ACPD versus Time (upper) and Strain (lower) Figure 6.207 for AH Condition of Alloy X-750 During a SSRT at a Strain Rate of 5 x  $10^{-7}$  sec<sup>-1</sup> in a High Purity Deaerated Water at 350 C (test continued until fracture).

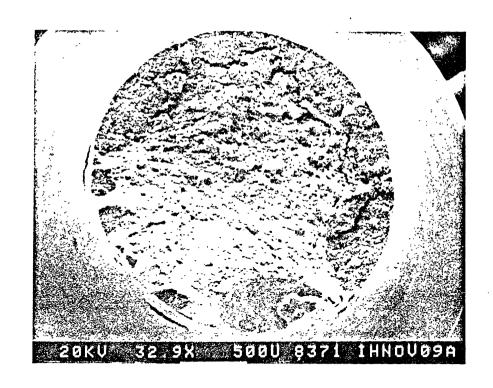
Figure 6.208 SEM Fractographs for the SSRT Specimen of AH Condition of Alloy X-750 Tested at a Strain Rate of 5 x  $10^{-7}$  sec $^{-1}$  in a High Purity Deaerated Water at 350 C (test continued until fracture).

strain scale until the failure. The fracture surfaces are shown in Figure 6.208. Extensive intergranular cracking is visible with a maximum depth of about  $410\mu\text{m}$ . A smaller crack is shown to be at a transition from the semi-circular shape to a wide crack which tends to occur at a crack size of about  $120\mu\text{m}$ . The larger cracks changed the direction of growth toward the loading axis. Increasing degree of the triaxial stress state and resultant change in the direction of principal stress are believed to be responsible for the tendancy towards wider shape for the larger cracks. This suggests the importance of a normal stress as opposed to a shear stress.

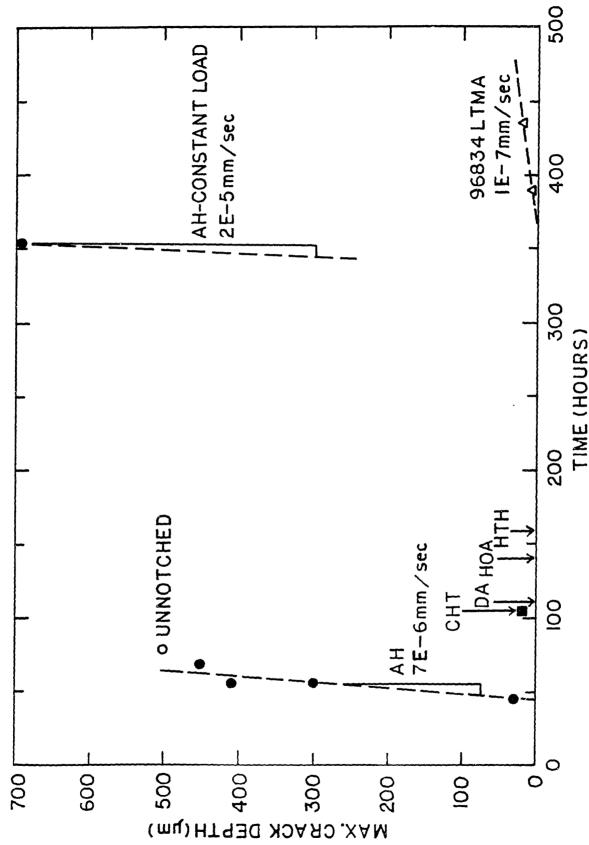
Summary of Crack Initiation and Growth Behaviors of Alloys 600, X-750 and 718 in High Temperature Water with 0.18 MPa Dissolved Hydrogen. Figure 6.220

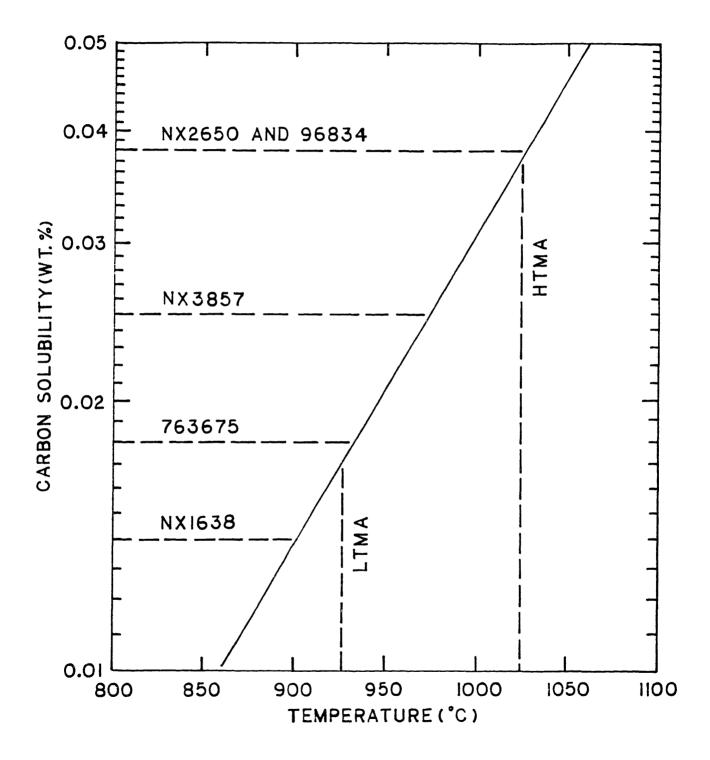
Figure 7.1 Carbon Solubilities of Alloy 600 Tubings at Final Anneal Temperatures
