# Condition Monitoring Technologies for Synthetic Fiber Ropes - a Review

Espen Oland<sup>1</sup>, Rune Schlanbusch<sup>2</sup>, and Shaun Falconer<sup>2</sup>

<sup>1,2</sup> *Teknova AS, Kristiansand, Vest-Agder, 4612, Norway*  
*espen.oland@uit.no*  
*rune.schlanbusch@teknova.no*

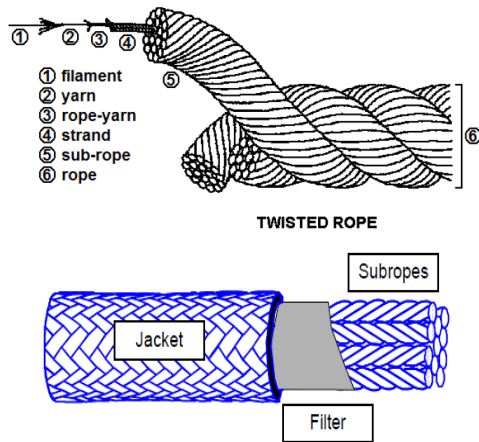
Figure 2. The composite parts of a twisted rope (top), (Lechat et al., 2008) and a parallel sub-rope rope (bottom) (DNV-GL, 2005).

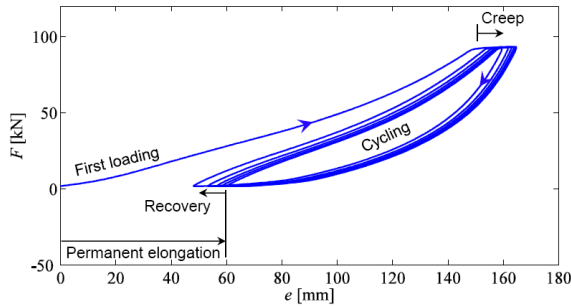
Figure 3. Load extension of a new nylon mooring rope subjected to 10 cycles (Weller et al., 2013).

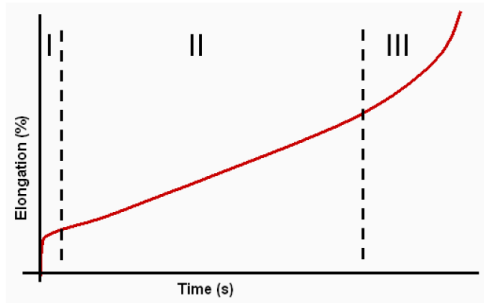
Figure 4. A typical creep curve for HMPE ropes (Vlasblom & Bosman, 2006).

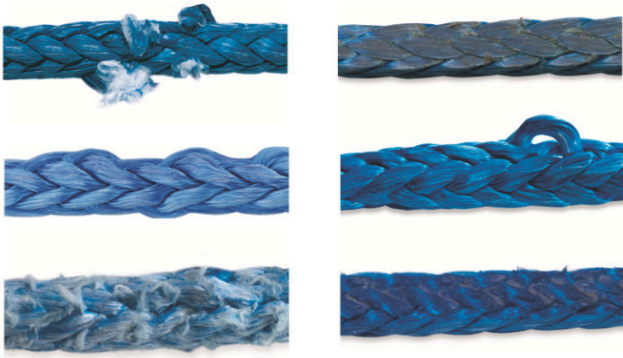
Figure 5. Different kinds of rope damages. Cut strands (top left), compression damage (top right), inconsistent diameter (middle left) and pulled strands (middle right), heavy abrasion (bottom left) and melted fibers (bottom right). Reproduced with permission from Samson Rope Technologies.

Samson Rope Technologies (2014) state that a rope can have cut strands, compression damage, inconsistent diameter, pulled strands, heavy abrasion or melted fibers as shown in Figure 5. Each of these damages (except melted fibers) are de-

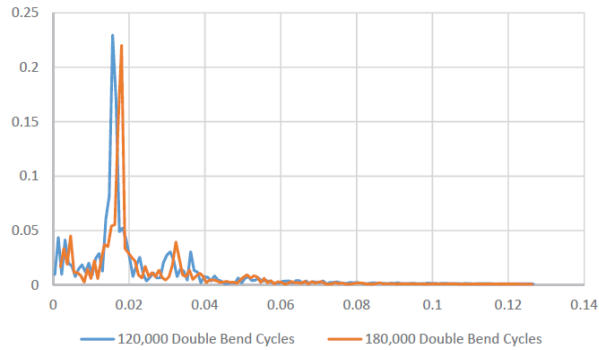
Figure 7. FFT of marked yarn magnetic principle data (Huntley, Grabandt, & Gračan, 2015).

sensor can then be related to the position along the rope, facilitating the use of the Fast Fourier Transform (FFT). Figure 7 shows the FFT of the sensor data at 120,000 and 180,000 cycles after a CBOS test. It is evident that the main peak shifts to the right as the number of cycles increases, thereby providing a good condition indicator of damage in the rope.

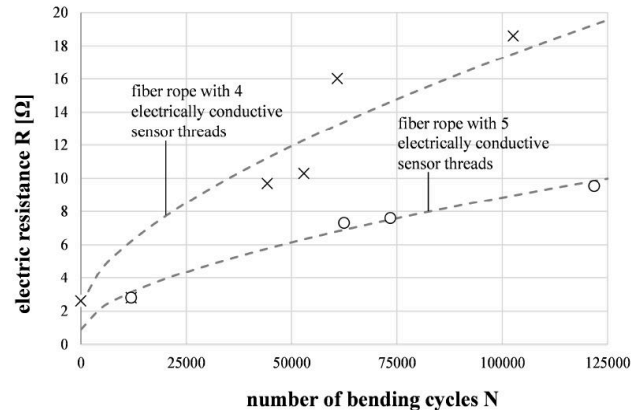
Figure 8. Electrical resistance as a function of bending cycles (Schmieder et al., 2015).

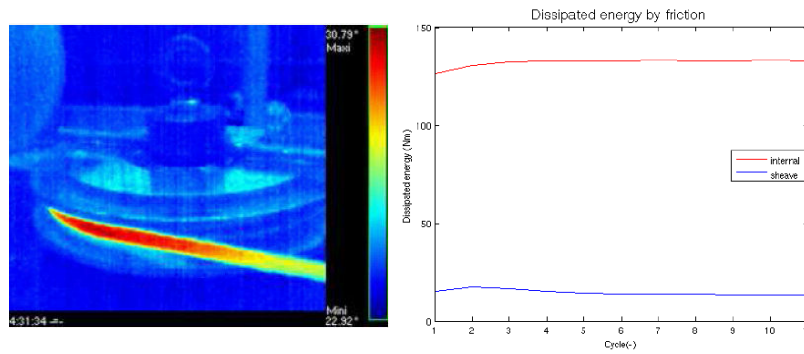
Figure 11. Infrared (IR) image during CBOS testing (left) and dissipated energy as a function of cycles (right) (Davies et al., 2013). The red line is the dissipated energy through internal friction, while the blue line is the energy dissipated through external friction.

The temperature is a measurement that provides vital information of the rope's condition. Davies et al. (2013) state in a recent paper: "...it is the internal abrasion rather than the external pulley/sheave interactions which will govern the rope lifetime". This means that it is of critical importance to monitor the internal temperature inside the rope, as internal abrasion leads to an increase in temperature. Figure 11 shows a comparison between the energy dissipated due to internal

abrasion and the energy dissipated from interactions with the sheave. It is evident that the internal abrasion is the main contributor to the increase in temperature. Törnqvist et al. (2011) support this statement, as they observed that the higher temperatures were between the strands, mainly due to friction from the internal movement.

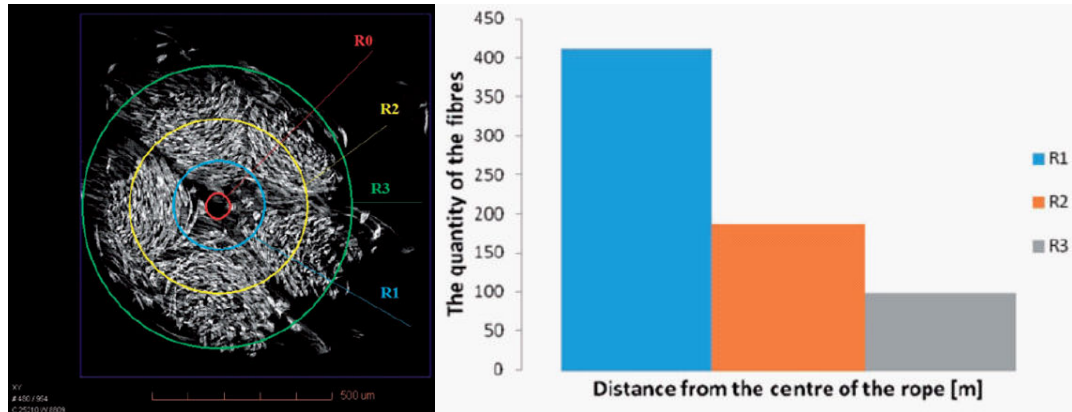
Figure 14. Cross section of the rope (left) and distribution of fibers as a function of distance (right) (Toda et al., 2016).

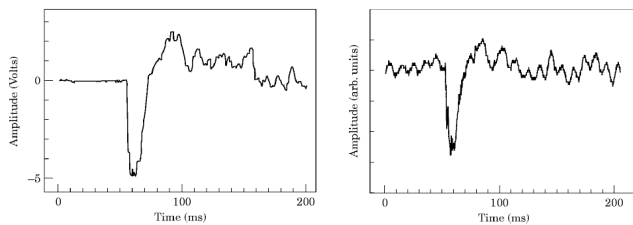
Figure 15. Typical rupture signals for synthetic rope (left) and steel wire rope (right) (Cortázar et al., 1998). Notice the similarity of the two curves.

In two separate papers, (Cortázar, Tomasel, & Laura, 1998) and (Cortázar, Lorrondo, Laura, & Avalos, 1996), the authors present experimental results on using optical fibers for condition monitoring of Kevlar rope and on steel wire ropes. Figure 15 shows the rupture signals for both synthetic and steel wire rope, where it is evident that the shape of the received signals using optical fibers are very similar for both kinds of

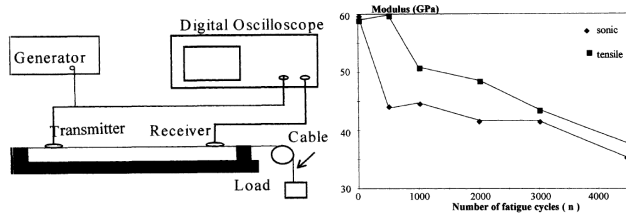
Figure 17. Experimental setup (left) and the dynamic modulus as a function of cycles (right) (Ferreira et al., 2000).

Ferreira, Lam, Koncar, and Delvael (2000) studied the dynamic modulus of a fiber rope by using longitudinal wave propagation. The modulus describes the elastic properties of the rope and has the same behavior as the fatigue of the rope. By measuring the propagation speed along the rope and knowing the density of the rope, the modulus can be determined and serve as a condition indicator. Figure 17 shows the setup as well as their test results. It is evident that there is a correlation between the modulus and the deterioration of the rope. Smith, Nickerson, Palazzola, and Pawrrih (2005) obtained a patent on this approach for evaluating the condition of aramid fiber ropes used in elevators.

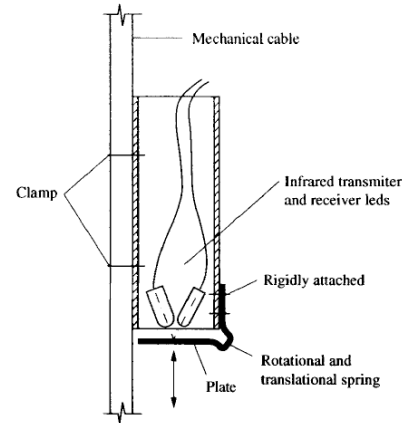
Figure 18. Infrared transducer set-up (Laura et al., 1995).

The results by Ferreira et al. (2000) and Kwun and Burkhardt (1991) can be extended to become non-contact by using laser scanning vibrometry. Laura, Ercoli, and Malfa (1995) presented a setup in a paper where the authors used an infrared emitter diode and a receiver diode to monitor the vibration of a mechanical cable (applicable to both steel wire and synthetic rope). The basic principle is that the infrared incident ray is reflected by the cable where the vibration modifies the reflected ray. This allows for the determination of the frequency of the cable, and facilitates contact-less vibration measurements. Figure 18 shows the experimental set-up by Laura et al. (1995). In addition to using the infrared measurement technique, the authors mounted accelerometers onto the cable, and were able to obtain a good correlation between the infrared technique and accelerometer-based measurements.

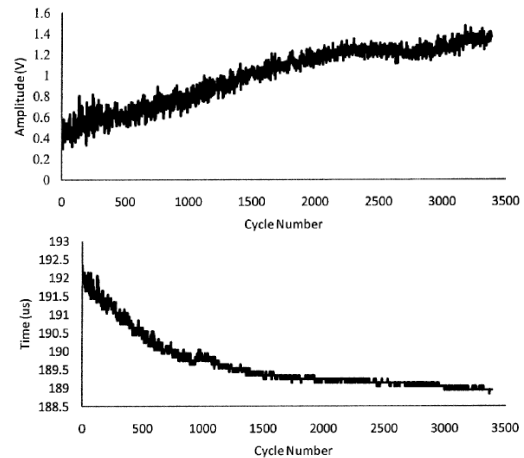
Figure 19. Experimental results using acoustics. Received signal amplitude (top) and propagation time (bottom) as functions of cycles (Padilla et al., 2015).

The patent by Padilla et al. (2015) using acoustic emission shows a clear correlation between the received amplitude and propagation time as functions of cycles. The received amplitude increases about 0.5V from 0 to 3500 cycles. In their experimental results, the inventors considered an HMPE rope exposed to 6 cycles per minute. With the knowledge that creep is one of the dominant failure mechanisms for HMPE ropes, it follows that the HMPE rope becomes longer, and
